**Goulburn Base Hospital, 130 Goldsmith Street, Goulburn, NSW
 Hazardous Building Materials Register - September 2017**

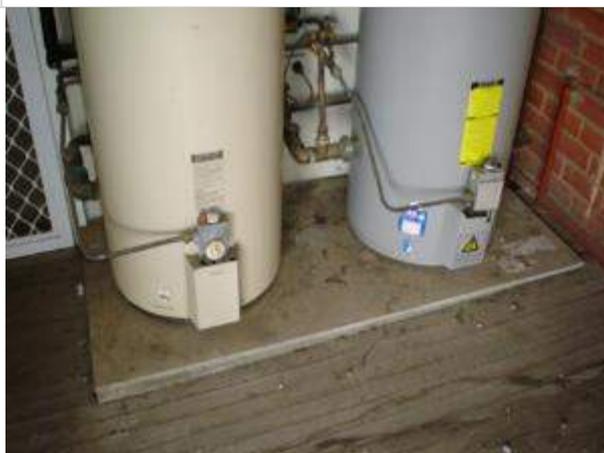
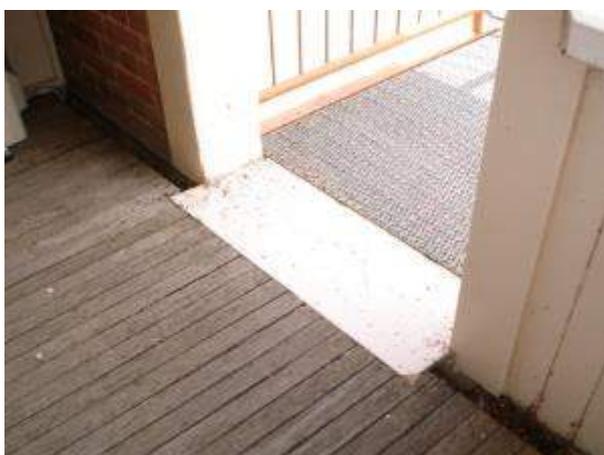
Compressed fibre cement sheet – S11

Building:	Building 2 & 3 - Springfield House / Lady Grose Home / George Gerathy Wing
Location:	Springfield House, external, Level 1, hardstand base for hot water units and joiner plate between landing and veranda
Material Type:	Compressed asbestos fibre cement sheet
Friable / non-friable	Non-friable
Condition:	Generally intact
Extent:	~2m ²
Risk Assessment / Recommendation:	Low risk, leave and maintain in current condition
Reinspection / Removal Date:	Remove prior to refurbishment / demolition works or reinspect in 5 years

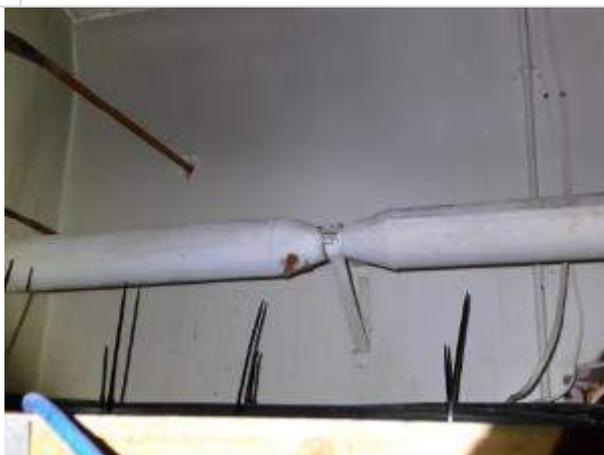
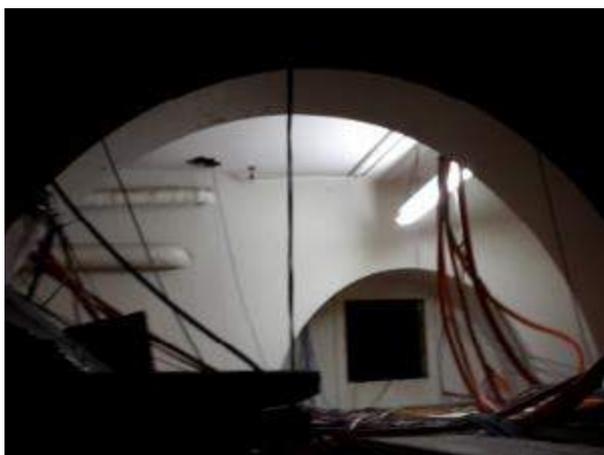
Asbestos lagged pipework– Similar to S14

Building:	Building 24 – Infection Control
Location:	Internal, ceiling space above toilets and main corridor of hospital
Material Type:	Wrapped asbestos lagging
Friable / non-friable	Friable
Condition:	Generally intact
Extent:	Throughout ceiling space of building
Risk Assessment / Recommendation:	High risk, material should be removed as soon as reasonably practicable
Reinspection / Removal Date:	Remove material as soon as reasonably practicable and prior to refurbishment and/or demolition works
