Arboricultural Impact Assessment

St Aloysius' College – Middle School Upper Pitt Street Milsons Point Sydney, NSW

Ref: C91109

RE: Arboricultural Impact Assessment for five (5) trees located in the vicinity of a proposed garden upgrade at St Aloysius' College – Middle School, Milsons Point

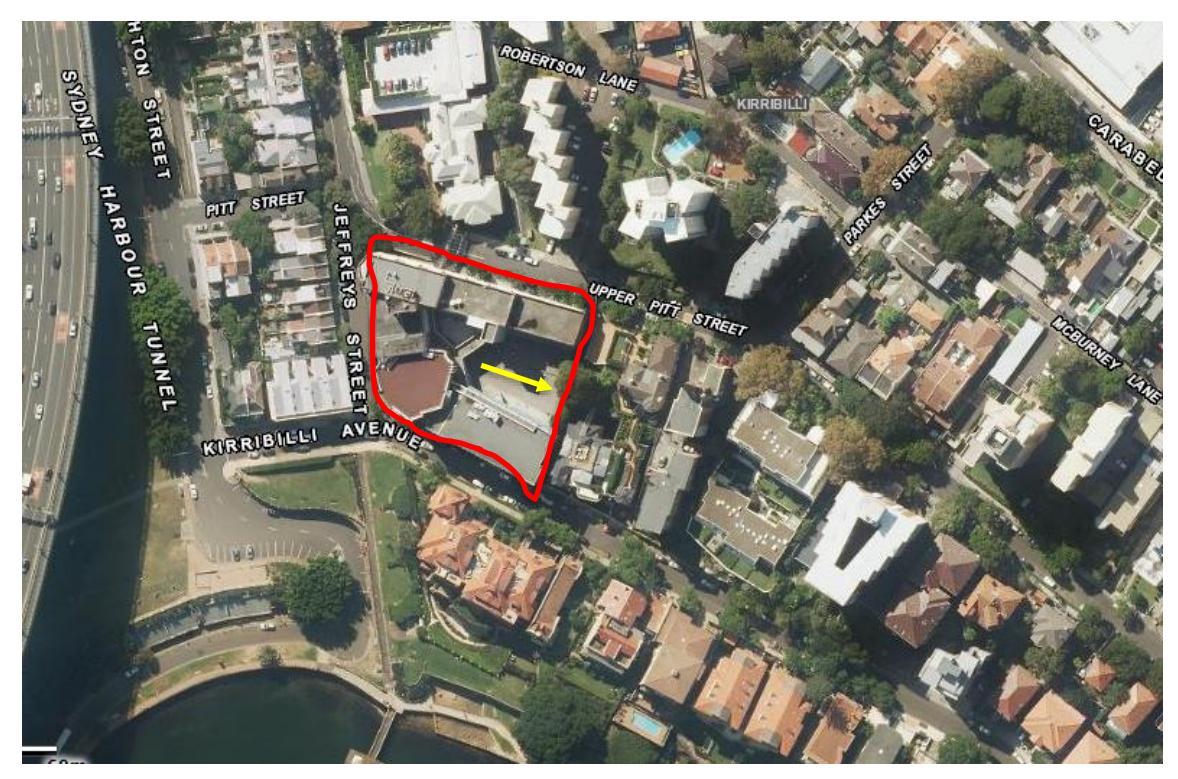
Figure 1: Aerial image showing St Aloysius' College – Middle School in the context of Milsons Point. The red line delineates the College boundary. The yellow arrow sits astride the central quadrangle and points to the garden bed area which is the subject of the proposed development. Source: Six Maps 2018

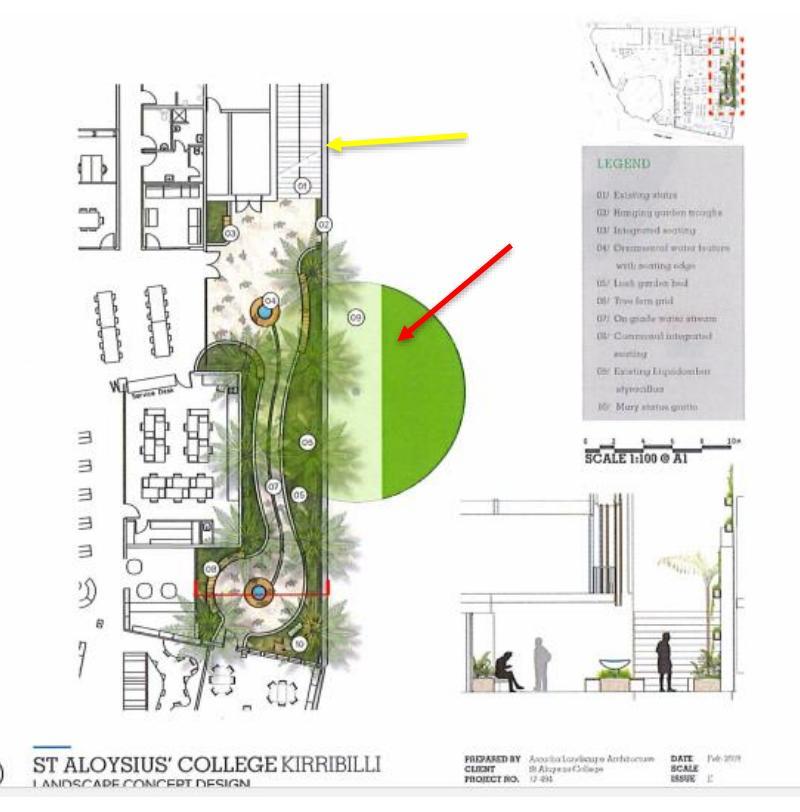
Figure 2: Excerpt from Arcadia Landscape Plan, St Aloysius' College, Feb 2018. The yellow arrow points to the stone boundary wall. The red arrow identifies the category tree numbered 60 and located on the adjacent property. Source: Bloompark Consulting 2018

- 8.2.1 Tree 60 was recommended for retention and requires specific protection measures during construction to ensure it remains viable following the completion of works.

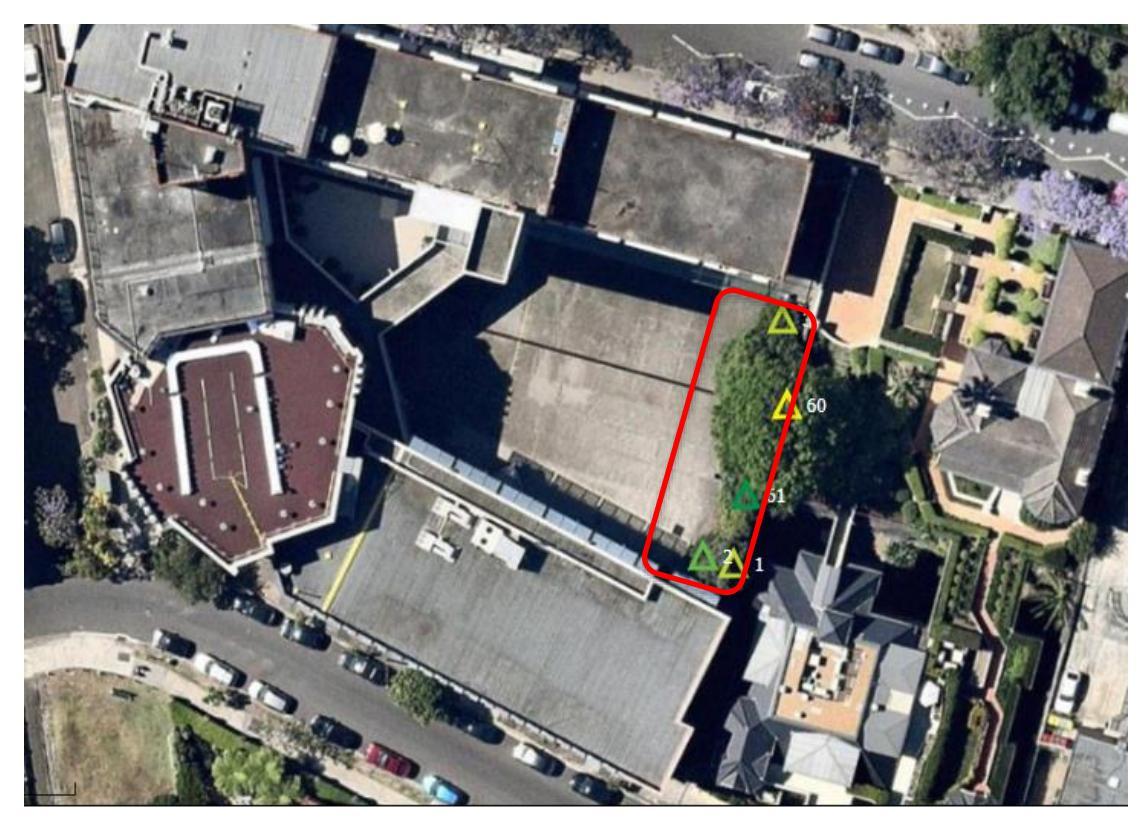
Figure 3: Sitemap showing subject trees. Note that icon colour indicates trees current risk rating (not Retention Value). Tree attributes are to be obtained from Appendix C – Tree Assessment Data. Source: ArborSite 2018
