# **REPORT: HAZARDOUS MATERIALS SURVEY UPDATE**

Job Number: **J50944**

**ST GEORGE PRIVATE HOSPITAL**

**1 SOUTH STREET, KOGARAH, NSW**

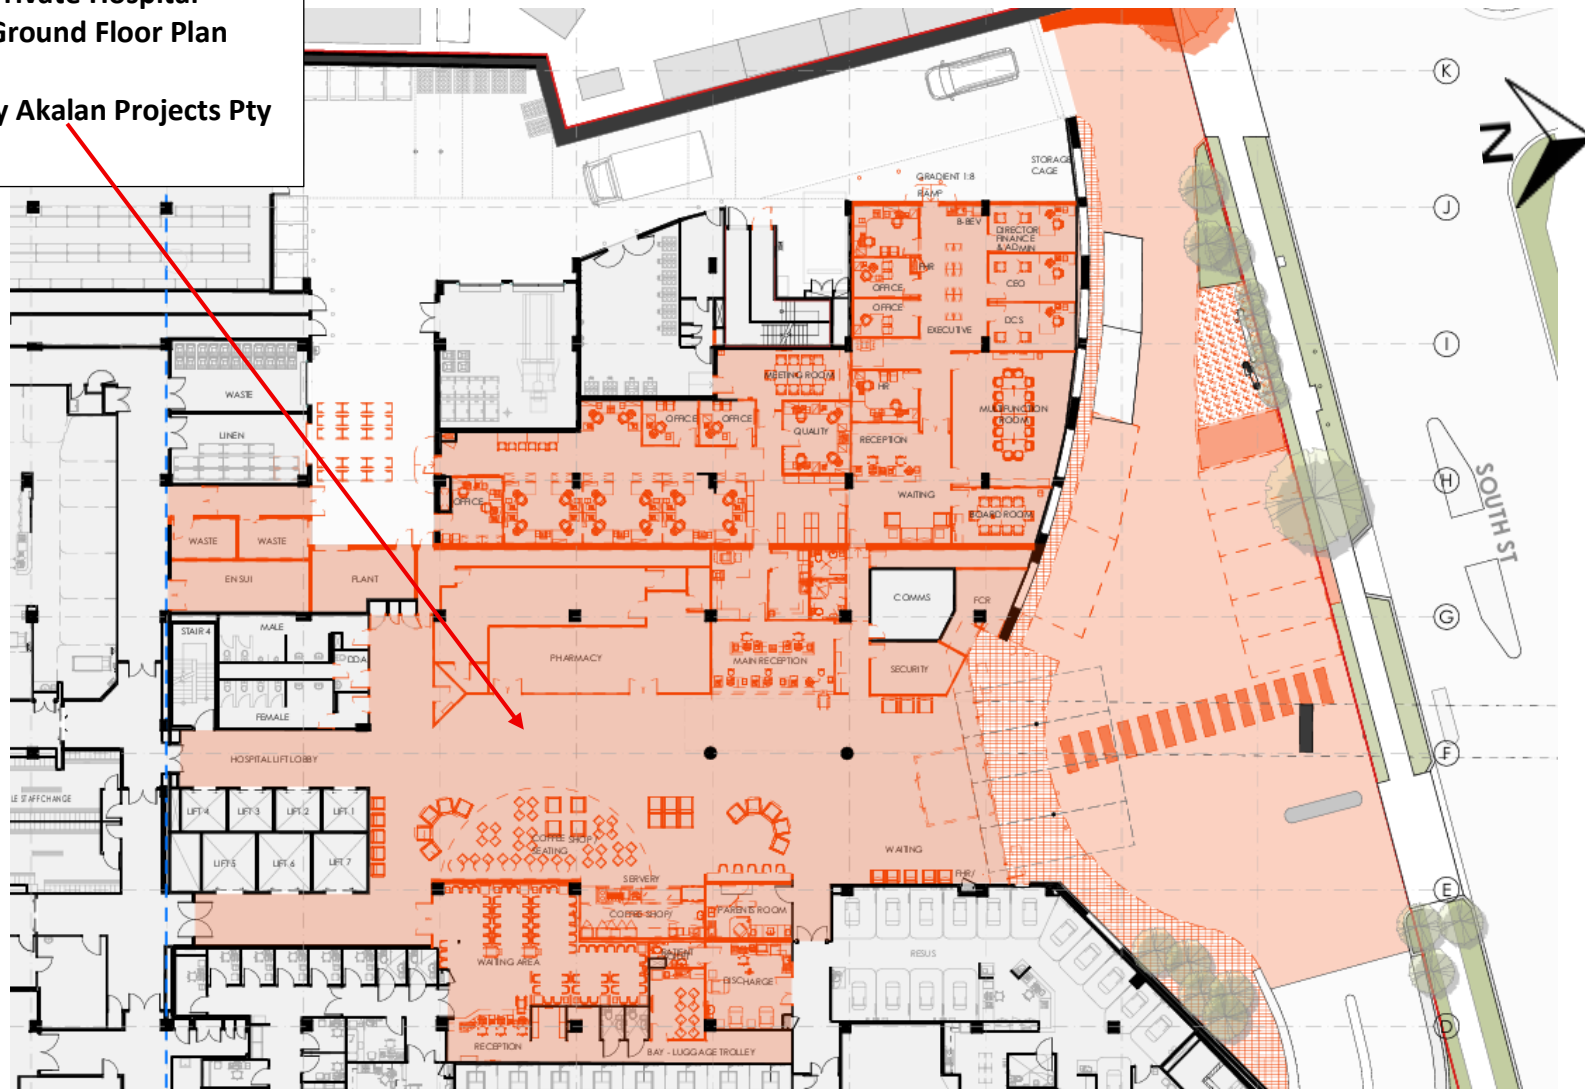
## Appendix 4. Inspected Ground Floor Plan Area

St George Private Hospital  
Inspected Ground Floor Plan  
Area  
provided by Akalan Projects Pty  
Ltd
