Report on
Desktop Geotechnical Assessment

Proposed Residential Development
Ivanhoe Estate, Macquarie Park

Prepared for
Frasers Property Australia Pty Ltd

Project 86043.00
November 2017

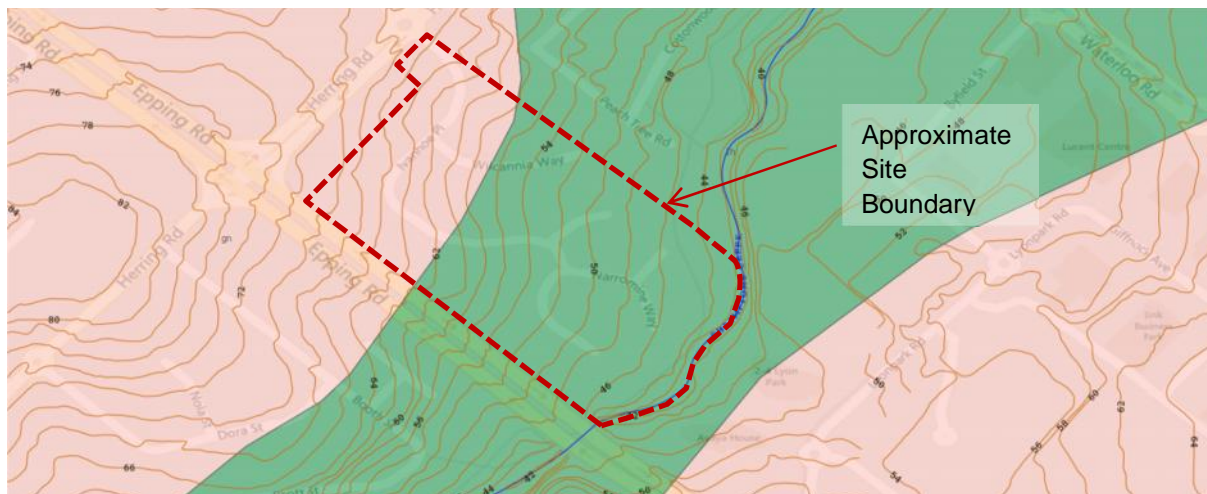
Figure 8: Extract of Soils Landscape Series Mapping (pink = Glenorie; green = Lucas Heights)

Reference to the Sydney Soils Landscape Series Sheet (see Figure 8) indicates that the site is largely underlain by the residual Lucas Heights soil landscape, though partly underlain by the erosional Glenorie soils towards Herring Road, over the upper (north-western) third of the site.

Based on previous DP experience in the area, the natural soils are likely to comprise sandy clay and clayey sand soils, possibly with some sandstone gravel or ironstone bands, and possibly some silty clay soils towards Herring Road.

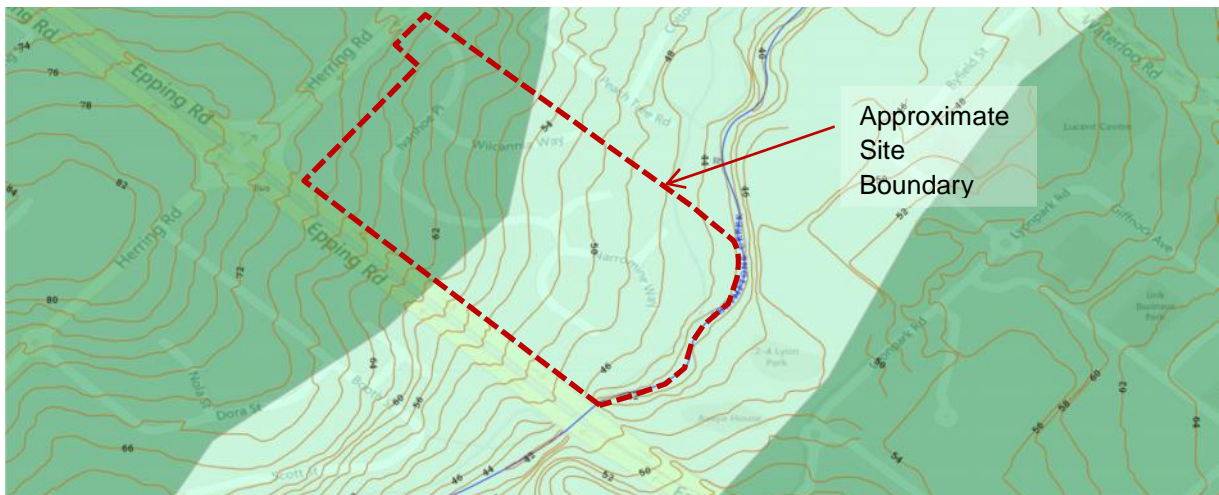
Figure 9: Edited Extract of Geological Series Mapping (dark green = Ashfield Shale, light green = Hawkesbury Sandstone)

Reference to the Sydney Geology Series Sheet, shown in Figure 9, suggests that the site is underlain by Ashfield Shale towards Herring Road (typically comprising shale and laminite); and by Hawkesbury Sandstone in the lower half of the site (typically comprising medium to coarse grained sandstone with very minor shale and laminite lenses). The Ashfield Shale, where present, would be underlain by Hawkesbury Sandstone, possibly with a transitional Mittagong Formation (interbedded shale, laminite and sandstone) between the two layers. DP experience varies somewhat from this mapping and is discussed in greater detail in Section 4.1.

A review of past DP projects in the site vicinity indicates that, in contrast to the geological mapping, Ashfield Shale is not likely to be present on the subject site, but that some limited depth of Mittagong Formation (presenting as up to approximately 3 m of siltstone, laminite or fine grained sandstone) is likely towards Herring Road, with Hawkesbury Sandstone underlying the Mittagong Formation and below the remainder of the site. This is consistent with the thinly bedded strata observed in the northern part of the site during the walkover.

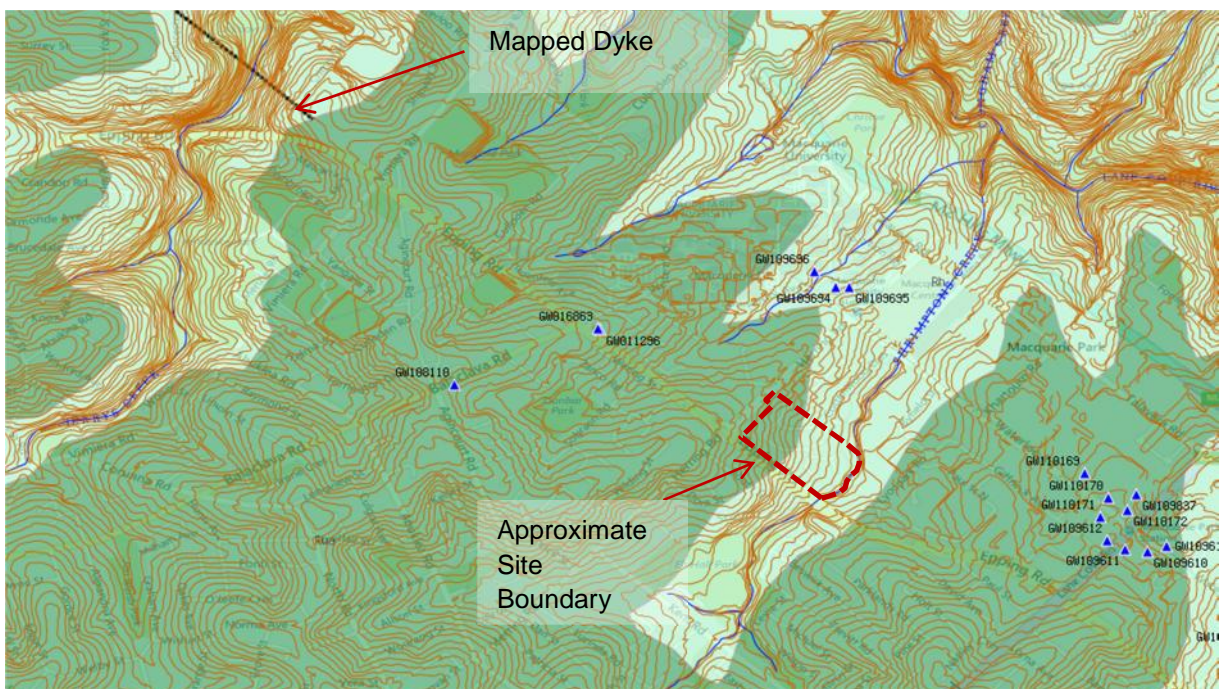
Figure 10: Registered Groundwater Bores (blue triangles) and Geological Series Mapping – Note diagonal black line at top left corner (mapped dyke)

A broader view of the geological mapping, as shown in Figure 10, indicates that a dyke has been identified approximately 2 km north-west of the site, oriented parallel to and near Epping Road. Dykes are often long, linear (in plan) features in the Sydney area, and, while not yet mapped at the subject site, may potentially extend to or near it.

Also shown in Figure 10 are the registered groundwater bores in the site vicinity. These bores are clustered at the university, near the intersection of Lane Cove Road and Waterloo Road, and west of the subject site, and are approximately 300 m to 1 km from the subject site.

- J In addition to the dyke noted in Figure 10, a second, unmapped, approximately north-south oriented dyke is present to the north-east of the site. If extended, this dyke would be present on the far side of Shrimptons Creek (i.e. east of the subject site), although it is noted that dykes may “step” or fork in plan, and thus may intersect the subject site.

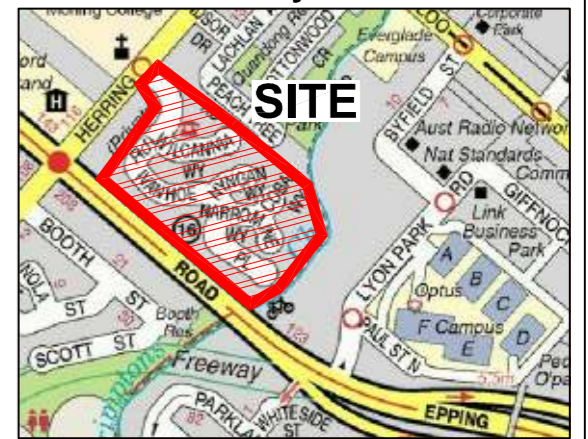
Gravelly clay, clayey sand and sand filling was also exposed in the faces of some batters at the site, likely due to past construction works for building platforms and road embankments, and are noted in Drawing 1 in Appendix B.

The banks of Shrimptons Creek slope were gently to moderately steep, and were generally vegetated or comprised exposed filling. Numerous sandstone boulders were present in the banks and creek bed (refer feature "F" in Drawing 1). It is considered probable that the boulders were used to stabilise the slope against erosion, although this appear largely ineffective in their current alignment. Some sandstone boulder headwalls are present near stormwater outlets, and appear to be in better condition.

Groundwater seepage was not observed at cuts or creek banks. Throughout the site, however, mossy growth was observed between pavers and on walls, suggesting that the existing soils are poorly drained. Some of these areas are shown in Drawing 1 (Appendix B) and are denoted by the letter "D".

- (A)** Rock Cut. Following strata observed.
Soil to ~ R.L. 66.8
Very low to low strength shale to ~ R.L. 66.5
Low to medium and high strength laminated shale and siltstone to ~ R.L. 65.5
Medium strength, fine grained sandstone to ~ R.L. 65
- (B)** Extremely weathered shale and medium strength sandstone
(Inaccessible for inspection)
- (C)** Very low, low and medium strength sandstone
(Inaccessible for inspection)
- (D)** Mossy growth/moist ground
- (E)** Fill batter
- (F)** Disturbed ground and sandstone boulders
- (G)** Medium strength sandstone
- Rock outcrop/exposure
