## **Hazardous Materials Survey**

13-15 Oxford Street, 17 Oxford Street & 2 Verona Street,  
Paddington NSW

**Report No:** E25559.E10\_Rev0

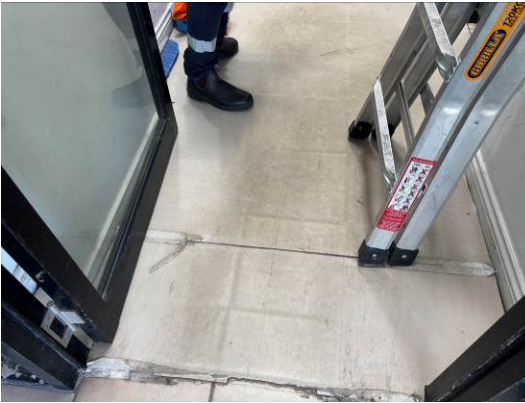
| Location | Material | Friability | Sample | Analysis Result | Quantity | Condition / Accessibility | Priority | Date of Identification | Recommendations / Comments | Photograph |
|---|---|---|---|---|---|---|---|---|---|---|
| Internal, ground floor, southern entrance corridor, cream vinyl floor sheeting | VFS | Non-friable | Asb-01 | No Asbestos Detected | N/A | N/A | N/A | N/A | N/A | |

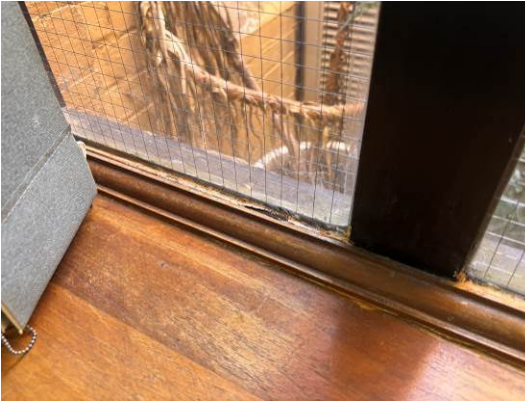
| Location | Material | Friability | Sample | Analysis Result | Quantity | Condition / Accessibility | Priority | Date of Identification | Recommendations / Comments | Photograph |
|---|---|---|---|---|---|---|---|---|---|---|
| Internal, ground floor, window frames throughout | Sealant | Non-friable | Asb-02 | No Asbestos Detected | N/A | N/A | N/A | N/A | N/A | |

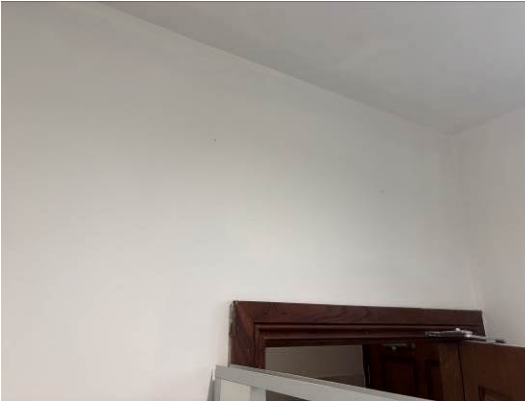
| Location | Material | Friability | Sample | Analysis Result | Quantity | Condition / Accessibility | Priority | Date of Identification | Recommendations / Comments | Photograph |
|---|---|---|---|---|---|---|---|---|---|---|
| Internal, ground floor, male bathroom, walls | FCS | Non-friable | Asb-03 | No Asbestos Detected<br>Organic Fibres Detected | N/A | N/A | N/A | N/A | N/A | |

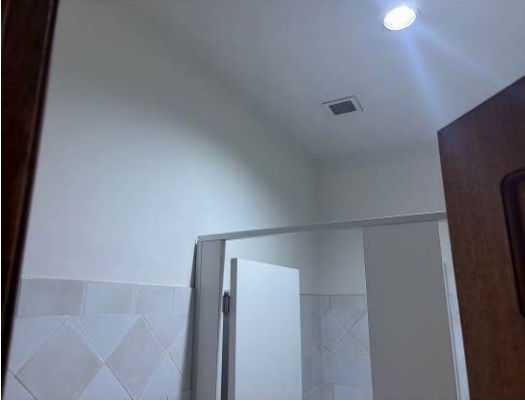
| Location | Material | Friability | Sample | Analysis Result | Quantity | Condition / Accessibility | Priority | Date of Identification | Recommendations / Comments | Photograph |
|---|---|---|---|---|---|---|---|---|---|---|
| Internal, ground floor, female bathroom, walls | FCS | Non-friable | Asb-04 | No Asbestos Detected<br>Organic Fibres Detected | N/A | N/A | N/A | N/A | N/A | |

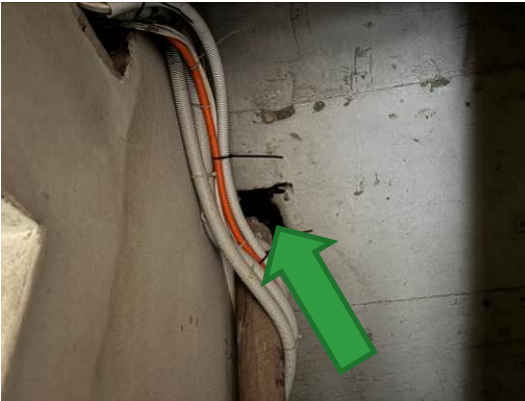
| Hazardous Materials Register<br>13-15 Oxford Street, 17 Oxford Street & 2 Verona Street, Paddington NSW | | | | | | | | | | 2 Verona Street – Commercial Building |
|---|---|---|---|---|---|---|---|---|---|---|
| Internal, ground floor, storage area underneath stairwell, ceiling, packer | Bituminous Sheeting | Non-friable | Asb-05 | No Asbestos Detected<br>Organic Fibres Detected | N/A | N/A | N/A | N/A | N/A | |

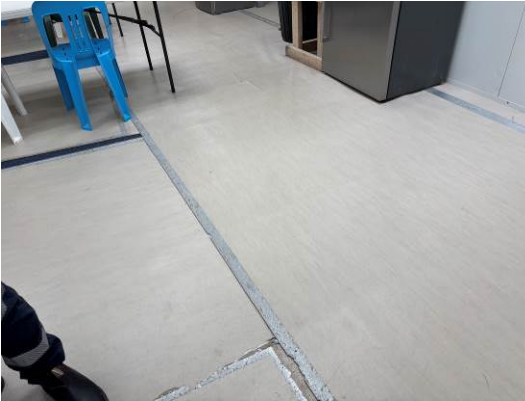
| Hazardous Materials Register<br>13-15 Oxford Street, 17 Oxford Street & 2 Verona Street, Paddington NSW | | | | | | | | | | 2 Verona Street – Commercial Building |
|---|---|---|---|---|---|---|---|---|---|---|
| Internal, 1 <sup>st</sup> floor, cream vinyl floor sheeting | VFS | Non-friable | Visual inspection – similar to Asb-01 | - | N/A | N/A | N/A | N/A | N/A | |

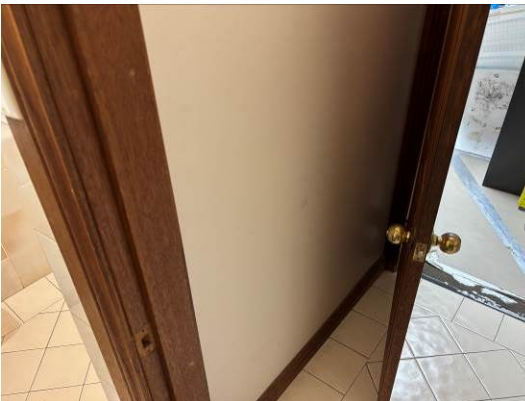
| Hazardous Materials Register<br>13-15 Oxford Street, 17 Oxford Street & 2 Verona Street, Paddington NSW | | | | | | | | | | 2 Verona Street – Commercial Building |
|---|---|---|---|---|---|---|---|---|---|---|
| Internal, 1 <sup>st</sup> floor, southern offices, eastern bathroom, partition walls | FCS | Non-friable | Asb-08 | No Asbestos Detected<br>Organic Fibres Detected | N/A | N/A | N/A | N/A | N/A | |

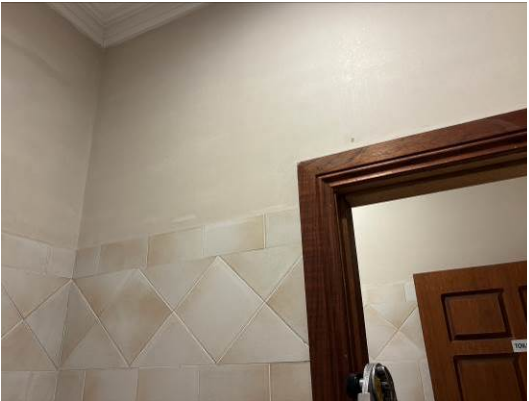
| Location | Material | Friability | Sample | Analysis Result | Quantity | Condition / Accessibility | Priority | Date of Identification | Recommendations / Comments | Photograph |
|---|---|---|---|---|---|---|---|---|---|---|
| Internal, 1 <sup>st</sup> floor, southern offices, central bathroom, partition walls | FCS | Non-friable | Asb-09 | No Asbestos Detected<br>Organic Fibres Detected | N/A | N/A | N/A | N/A | N/A | |

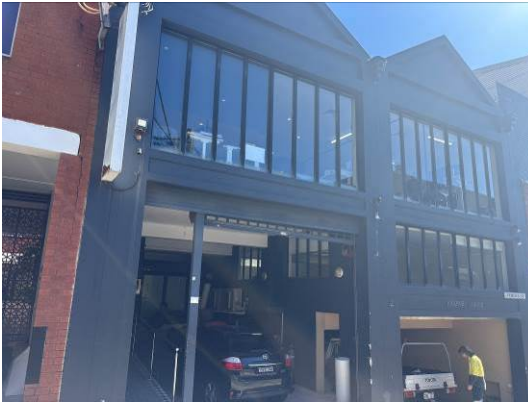
| Hazardous Materials Register<br>13-15 Oxford Street, 17 Oxford Street & 2 Verona Street, Paddington NSW | | | | | | | | | | 2 Verona Street – Commercial Building |
|---|---|---|---|---|---|---|---|---|---|---|
| External, southern wall | Dark Grey Paint | Non-friable | LBP-01 | 0.001% w/w | N/A | N/A | N/A | N/A | N/A | |

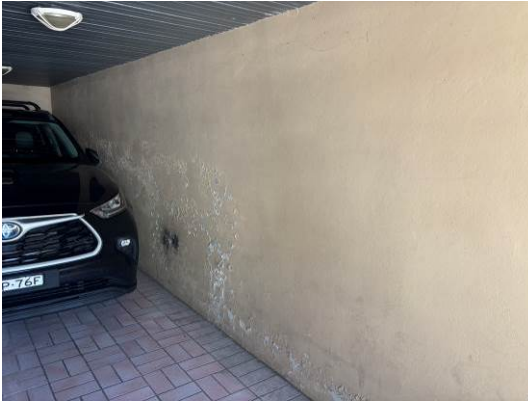
| Hazardous Materials Register<br>13-15 Oxford Street, 17 Oxford Street & 2 Verona Street, Paddington NSW | | | | | | | | | | 2 Verona Street – Commercial Building |
|---|---|---|---|---|---|---|---|---|---|---|
| Internal, ground floor, car park, walls and ceilings | Yellow Paint | Friable | LBP-02 | <0.001% w/w | N/A | N/A | N/A | N/A | N/A | |

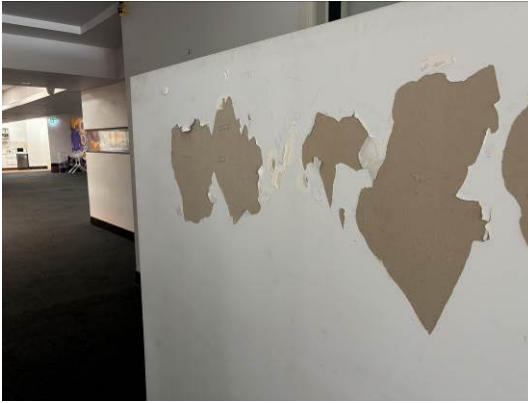
| Hazardous Materials Register<br>13-15 Oxford Street, 17 Oxford Street & 2 Verona Street, Paddington NSW | | | | | | | | | | 2 Verona Street – Commercial Building |
|---|---|---|---|---|---|---|---|---|---|---|
| Internal, ground floor, office, walls and ceilings throughout | White Paint | Non-friable | LBP-03 | <0.001% w/w | N/A | N/A | N/A | N/A | N/A | |

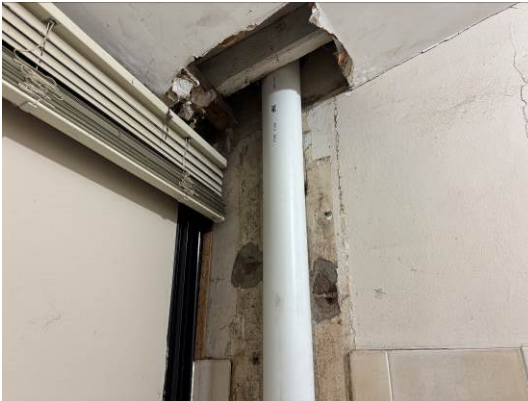
| Location | Material | Friability | Sample | Analysis Result | Quantity | Condition / Accessibility | Priority | Date of Identification | Recommendations / Comments | Photograph |
|---|---|---|---|---|---|---|---|---|---|---|
| Internal, 1 <sup>st</sup> floor, offices, eastern bathroom, walls throughout | Cream Paint | Non-friable | LBP-05 | 0.077% w/w | N/A | N/A | N/A | N/A | N/A | |

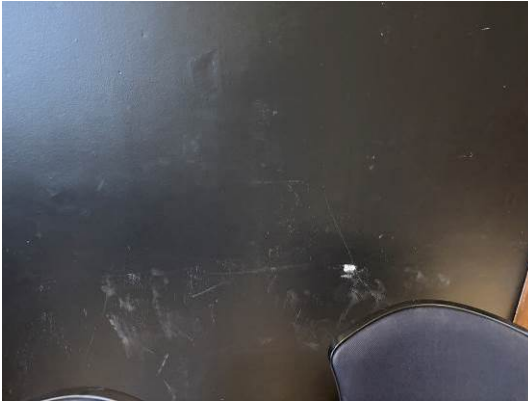
| Location | Material | Friability | Sample | Analysis Result | Quantity | Condition / Accessibility | Priority | Date of Identification | Recommendations / Comments | Photograph |
|---|---|---|---|---|---|---|---|---|---|---|
| Internal, 1 <sup>st</sup> floor, offices, meeting room and corridors, walls throughout | Black Paint | Non-friable | LBP-07 | 0.001% w/w | N/A | N/A | N/A | N/A | N/A | |

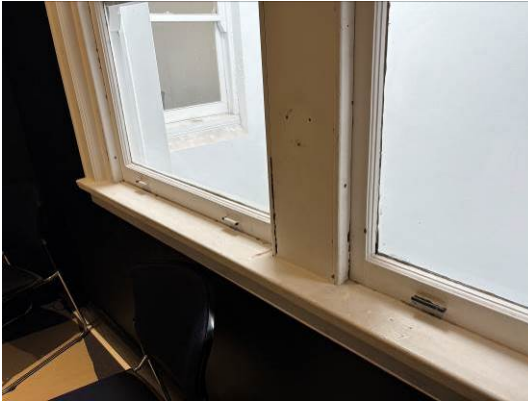
| Location | Material | Friability | Sample | Analysis Result | Quantity | Condition / Accessibility | Priority | Date of Identification | Recommendations / Comments | Photograph |
|---|---|---|---|---|---|---|---|---|---|---|
| Internal, 1 <sup>st</sup> floor, offices, window frames throughout | White Paint | Non-friable | LBP-08 | 0.005% w/w | N/A | N/A | N/A | N/A | N/A | |

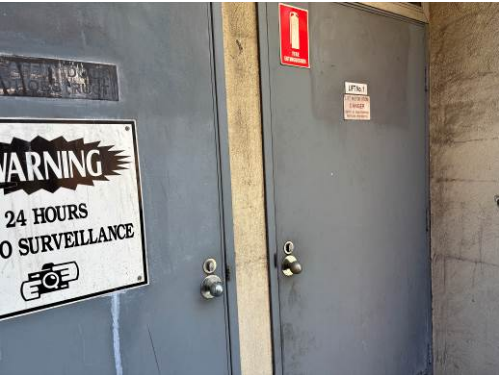
| Hazardous Materials Register | | | | | | | | | | 17 Oxford Street – Commercial Building |
|---|---|---|---|---|---|---|---|---|---|---|
| Internal, lift motor rooms | Possible hazardous materials | Unknown | - | - | Unknown | Unknown | Unknown | - | Inspect when access is made available, prior to demolition | |

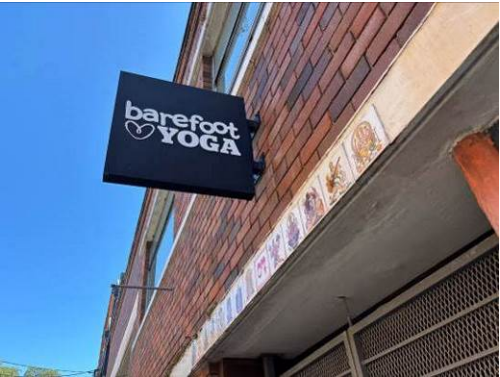
| Hazardous Materials Register | | | | | | | | | | 17 Oxford Street – Commercial Building |
|---|---|---|---|---|---|---|---|---|---|---|
| Internal, ground floor, 'barefoot yoga' | Possible hazardous materials | Unknown | - | - | Unknown | Unknown | Unknown | - | Inspect when access is made available, prior to demolition | |

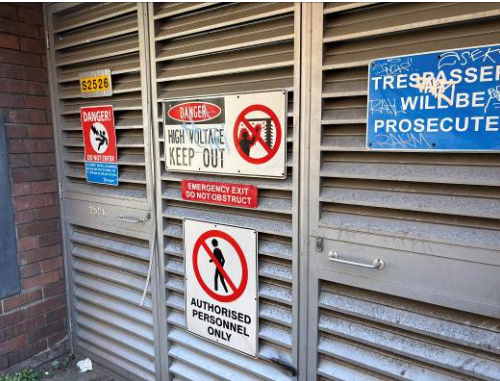
| Hazardous Materials Register | | | | | | | | | | 17 Oxford Street – Commercial Building |
|---|---|---|---|---|---|---|---|---|---|---|
| Internal, ground floor, southern side, high voltage room | Possible hazardous materials | Unknown | - | - | Unknown | Unknown | Unknown | - | Inspect when access is made available, prior to demolition | |

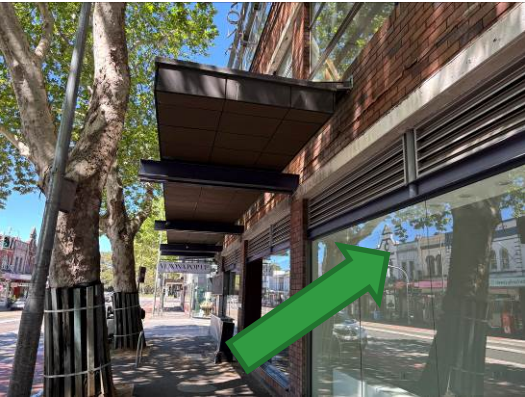
| Internal, ground floor, north-eastern shop | Possible hazardous materials | Unknown | - | - | Unknown | Unknown | Unknown | - | Inspect when access is made available, prior to demolition | |

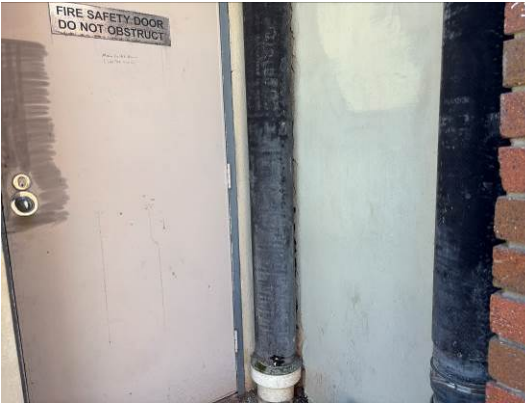
| External, southern side, service piping | FCS | Non-friable | Asb-10 | No Asbestos Detected<br>Organic Fibres Detected | N/A | N/A | N/A | N/A | N/A | |

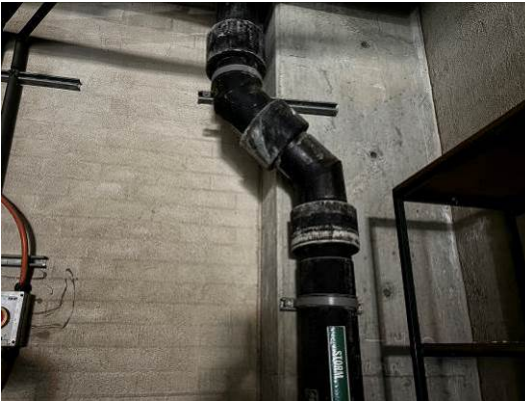
| Internal, ground floor, garage, northern corner, service piping | FCS | Non-friable | Visual inspection – similar to Asb-10 | - | N/A | N/A | N/A | N/A | N/A | |

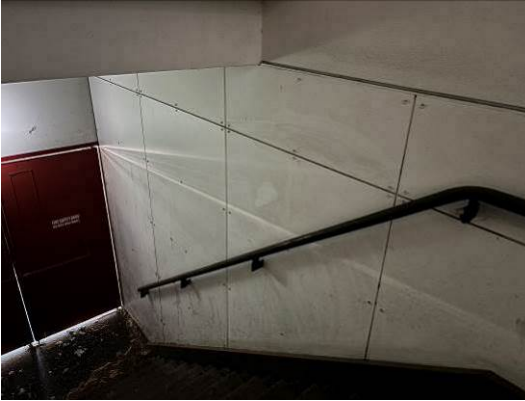
| Internal, ground floor, north-eastern cinema entrance stairwell, wall panels | FCS | Non-friable | Asb-12 | No Asbestos Detected<br>Organic Fibres Detected | N/A | N/A | N/A | N/A | N/A | |

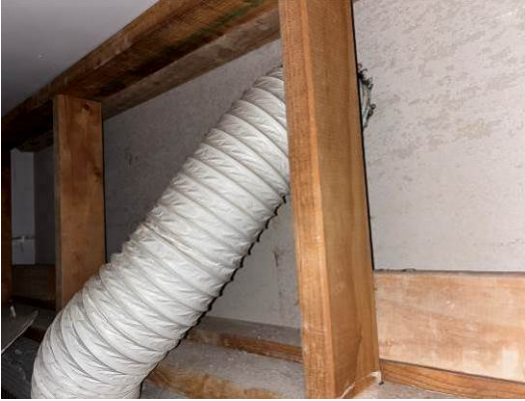
| Internal, 1 <sup>st</sup> floor, florist, bathroom, concealed eastern wall (accessible from ceiling cavity) | FCS | Non-friable | Asb-13 | No Asbestos Detected<br>Organic Fibres Detected | N/A | N/A | N/A | N/A | N/A | |

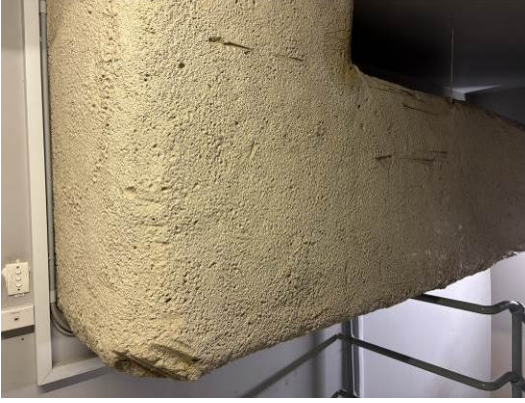
| Internal, 3 <sup>rd</sup> floor, stairwell ceiling and ducting throughout, spray insulation | Vermiculite | Friable | Asb-14 | No Asbestos Detected<br>Organic Fibres Detected | N/A | N/A | N/A | N/A | N/A | |

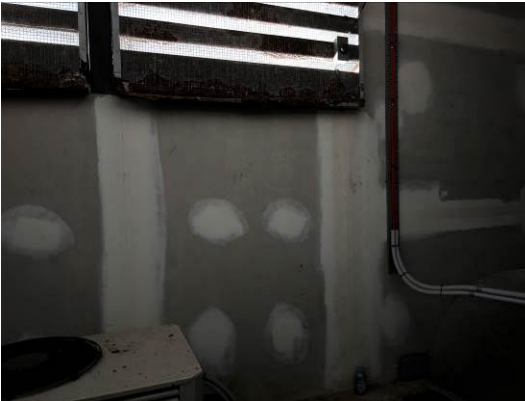
| Internal, 3 <sup>rd</sup> floor, plant room, walls throughout | FCS | Non-friable | Asb-16 | No Asbestos Detected<br>Organic Fibres Detected | N/A | N/A | N/A | N/A | N/A | |

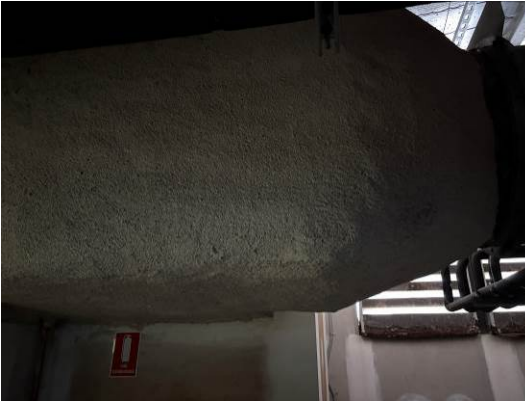
| Internal, 3 <sup>rd</sup> floor, plant room, ducting, spray insulation | Vermiculite | Friable | Asb-17 | No Asbestos Detected<br>Organic Fibres Detected | N/A | N/A | N/A | N/A | N/A | |

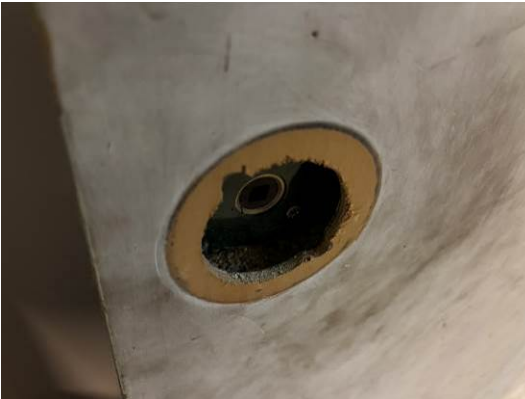
| Internal, 3 <sup>rd</sup> floor, fire door to plant room, internal insulation | Vermiculite | Friable | Asb-18 | No Asbestos Detected | N/A | N/A | N/A | N/A | All fire doors manufactured by Cecon Fire Doors with year of manufacture dated in 1990s are assumed the same | |

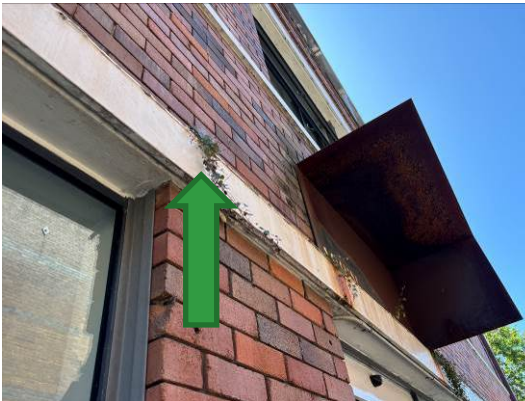
| Hazardous Materials Register<br>13-15 Oxford Street, 17 Oxford Street & 2 Verona Street, Paddington NSW | | | | | | | 17 Oxford Street – Commercial Building | | | |
|---|---|---|---|---|---|---|---|---|---|---|
| External, all floors, concrete slab | White LBP | Friable | LBP-11 | 18% w/w | Approximately 50m <sup>2</sup> | Fair / Maintenance only | Priority 3 - Low Risk Level | 3/10/2025 | Remove grossly peeling paint. Stabilise remaining membrane. Minimise abrasive works that will disturb paint during demolition. | |

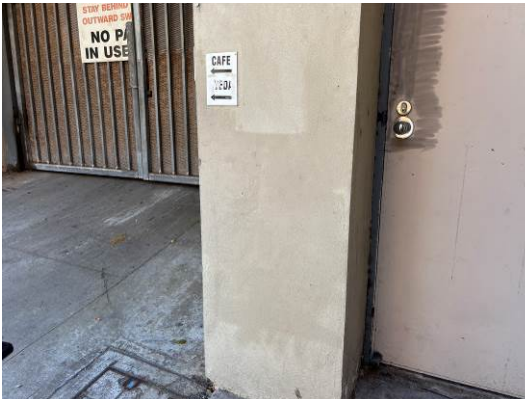
| Hazardous Materials Register<br>13-15 Oxford Street, 17 Oxford Street & 2 Verona Street, Paddington NSW | | | | | | | 17 Oxford Street – Commercial Building | | | |
|---|---|---|---|---|---|---|---|---|---|---|
| External, ground floor, southern wall | Cream Paint | Non-friable | LBP-09 | 0.002% w/w | N/A | N/A | N/A | N/A | N/A | |

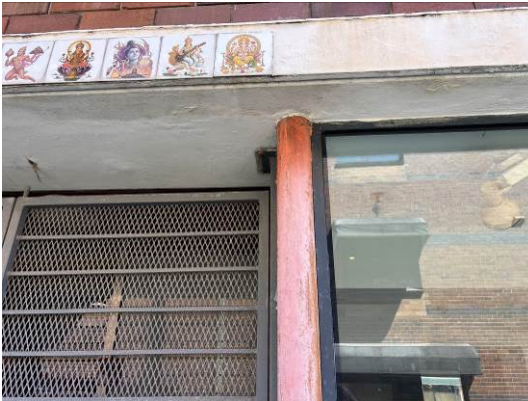
| External, ground floor, southern side, down pipes | Red Paint | Friable | LBP-10 | 0.016% w/w | N/A | N/A | N/A | N/A | N/A |

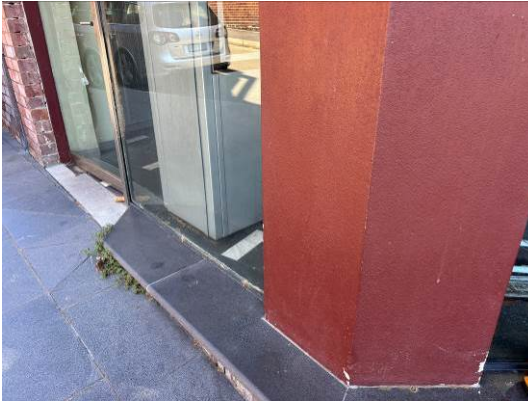
| External, ground floor, south-eastern cinema entrance, walls | Maroon Paint | Friable | LBP-12 | 0.008% w/w | N/A | N/A | N/A | N/A | N/A |

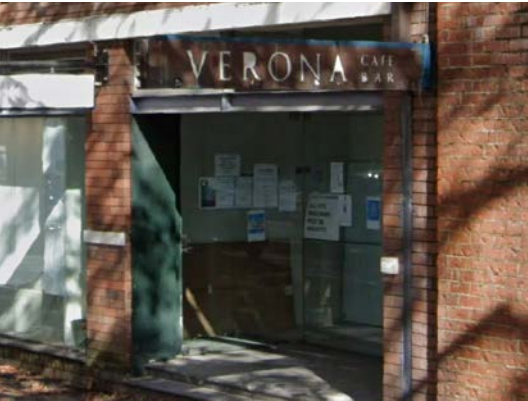
| External, north-eastern shop, entrance walls | Green Paint | Non-friable | LBP-14 | 0.004% w/w | N/A | N/A | N/A | N/A | N/A |

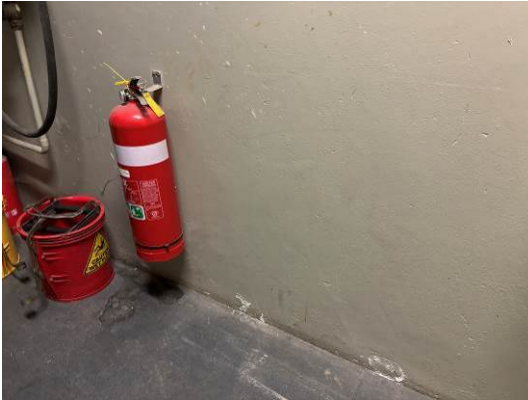
| Internal, basement, walls | Grey Paint | Non-friable | LBP-23 | 0.001% w/w | N/A | N/A | N/A | N/A | N/A |

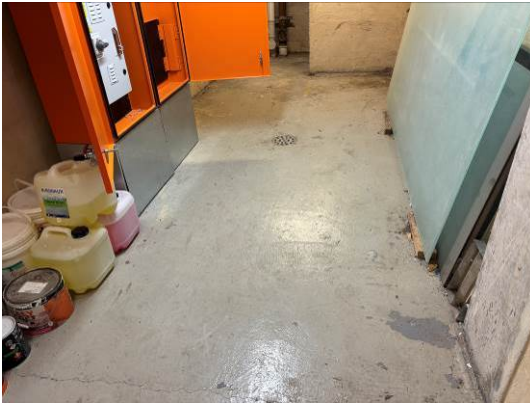
| Internal, basement, switch room, floor | Grey Paint | Non-friable | LBP-24 | 0.002% w/w | N/A | N/A | N/A | N/A | N/A | |

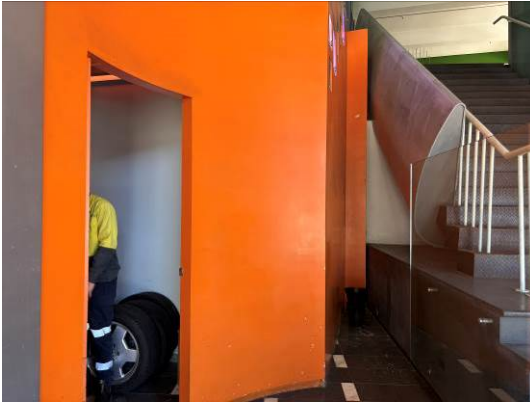
| Internal, ground floor, south-east entrance lobby to cinema, walls | Orange Paint | Non-friable | LBP-15 | <0.001% w/w | N/A | N/A | N/A | N/A | N/A | |

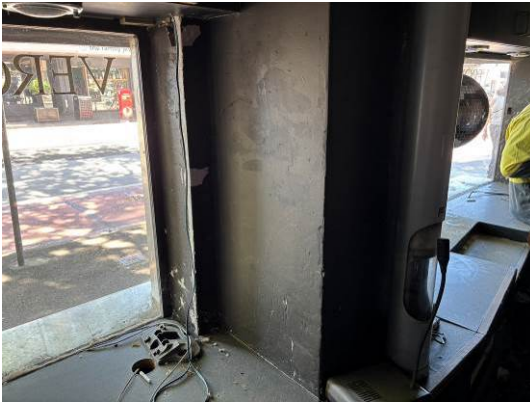
| Internal, ground floor, cinema, box office room, walls and ceiling | Black Paint | Non-friable | LBP-16 | 0.003% w/w | N/A | N/A | N/A | N/A | N/A | |

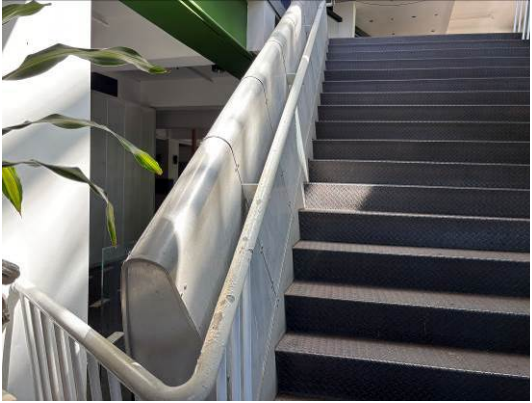
| Internal, all floors, southern stairwell, handrails throughout | White Paint | Non-friable | LBP-17 | 0.021% w/w | N/A | N/A | N/A | N/A | N/A | |

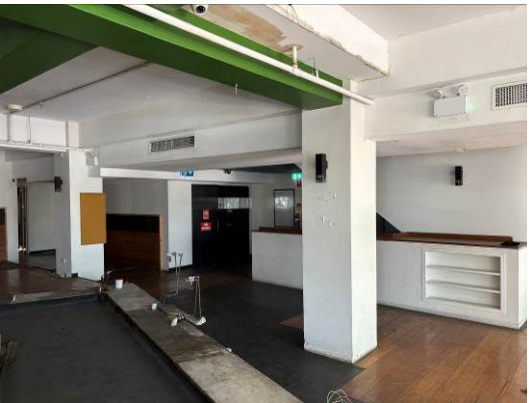
| Internal, 1 <sup>st</sup> floor, cinema, walls and ceilings throughout | White Paint | Non-friable | LBP-18 | <0.001% w/w | N/A | N/A | N/A | N/A | N/A |

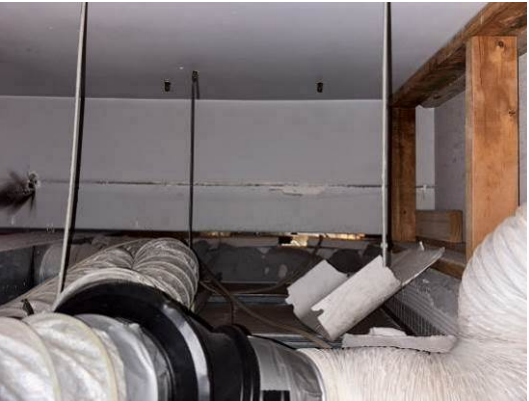
| Ceiling cavity, 1 <sup>st</sup> floor, above bathrooms, walls and ceiling | Grey Paint | Friable | LBP-20 | 0.010% w/w | N/A | N/A | N/A | N/A | N/A |

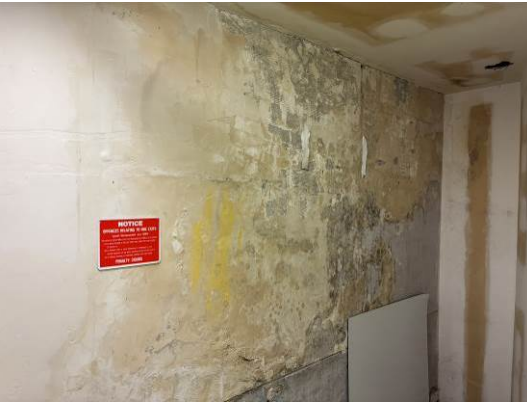
| Internal, 2 <sup>nd</sup> floor, northern stairwell, walls | Cream Paint | Non-friable | LBP-21 | 0.006% w/w | N/A | N/A | N/A | N/A | N/A |

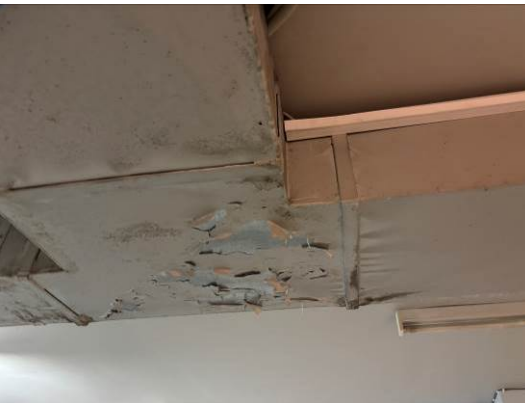
| Internal, 3 <sup>rd</sup> floor, ducting throughout | Grey Paint | Non-friable | LBP-22 | 0.006% w/w | N/A | N/A | N/A | N/A | N/A |

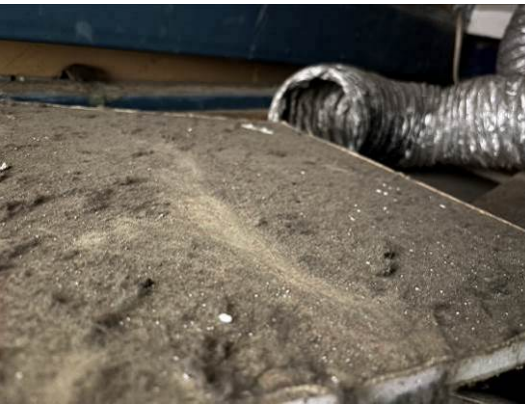
| Ceiling cavity, ground floor, above box office room, dust | Dust / debris | Non-Friable | LD-02 | 130 mg/kg | Low Load | N/A | N/A | N/A |

Review levels as part of a risk assessment for management, and remediate dust under controlled conditions prior to demolition works.

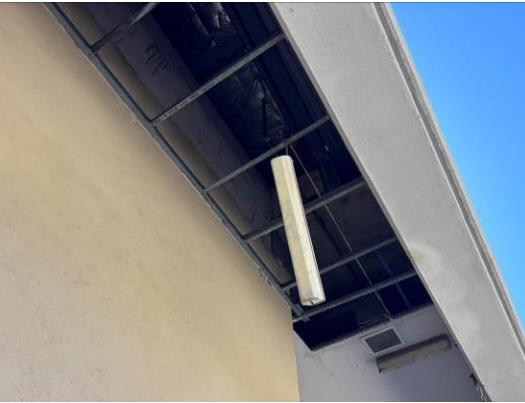
External / internal, ceiling, fluorescent light fittings

Visual inspection - electrical hazard

Remove prior to demolition works.  
Avoid damage to capacitors.

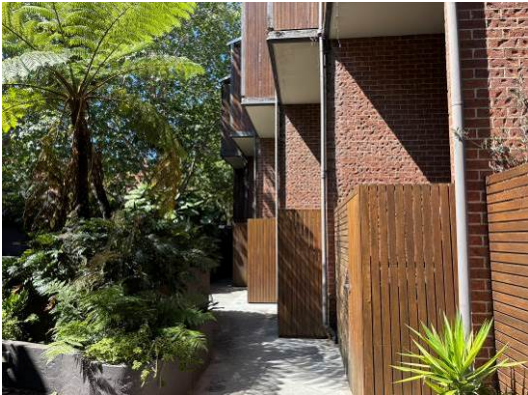
| Hazardous Materials Register | | | | | | | | | | 13-15 Oxford Street – Residential Townhouses |
|---|---|---|---|---|---|---|---|---|---|---|
| Internal, ground and 1 <sup>st</sup> floor, townhouses throughout | Possible hazardous materials | Unknown | - | - | Unknown | Unknown | Unknown | - | Inspect when access is made available, prior to demolition | |

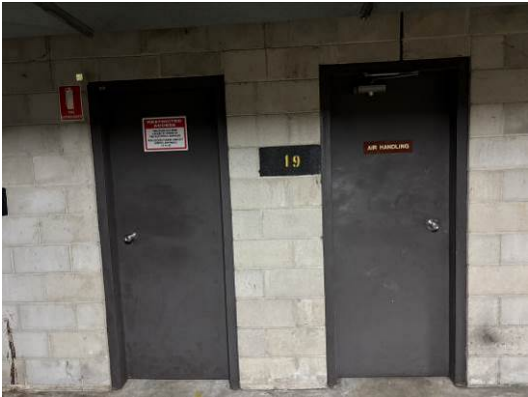
| Hazardous Materials Register | | | | | | | | | | 13-15 Oxford Street – Residential Townhouses |
|---|---|---|---|---|---|---|---|---|---|---|
| Internal, basement, electrical and air handling room | Possible hazardous materials | Unknown | - | - | Unknown | Unknown | Unknown | - | Inspect when access is made available, prior to demolition | |

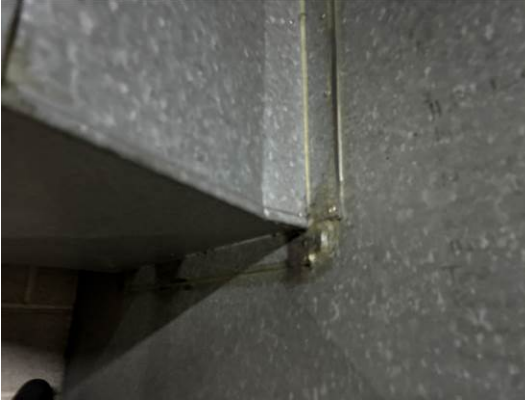
| Internal, basement 2, ducting, mastic | Rubber | Non-friable | Asb-19 | No Asbestos Detected | N/A | N/A | N/A | N/A | N/A | |

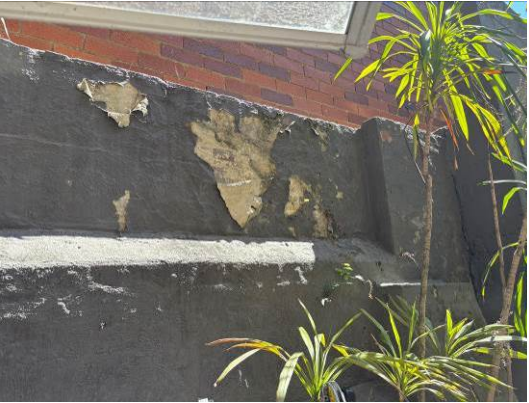
| External, ground floor, courtyard, walls | Navy Paint | Non-friable | LBP-26 | 0.005% w/w | N/A | N/A | N/A | N/A | N/A | |

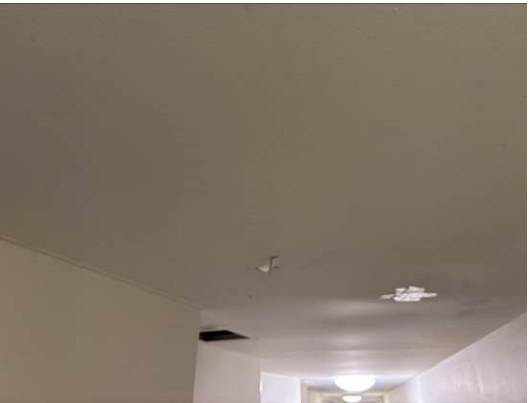
| Internal, 1 <sup>st</sup> floor, corridor to units 22-27, walls and ceilings | White Paint | Friable | LBP-28 | 0.003% w/w | N/A | N/A | N/A | N/A | N/A | |
