## COMPLIANCE HAZARDOUS MATERIAL INSPECTION AND RISK ASSESSMENT

JULY 2023

J053229

40 Stewart St  
Ermington NSW (P027)  
2115

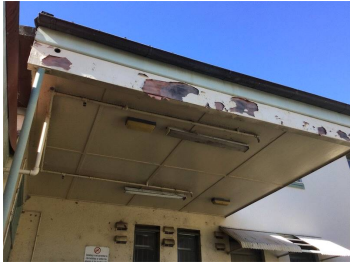
| Item Number | 73 | Material Score | 3 | Disturbance Score | 6 |

| Location | P027-H01 - External - Ground Level - All Areas - Awning - Throughout - Fibre Cement Sheeting | | | | |
| Hazard Type | Asbestos | Material Assessment | | Disturbance Assessment | |
| Friability | Non-friable | Product Type | 1 | Occupancy | 1 |

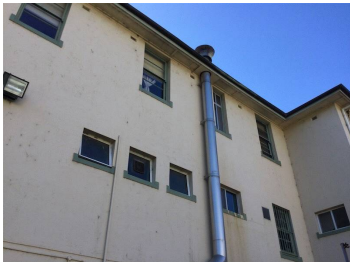
| Item Number | 115 | Material Score | 3 | Disturbance Score | 6 |

| Location | P027-H01 - External - All Levels - Eaves - Throughout - Paint Systems - White (1.6% w/w) | | | | |
| Hazard Type | Lead Paint | Material Assessment | | Disturbance Assessment | |

| Item No. | Hazard Type | Item Location and Description | Recommendations |
|---|---|---|---|
| Item 111 | Lead Paint | P027-H01, External, All Levels, Eaves - Throughout , Paint Systems - White (1.6% w/w) | Encapsulate / Repair & Manage In Situ |

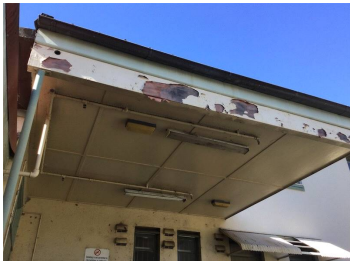
| Item Number | 111 | Material Score | - | Disturbance Score | - |

| Location | P027-H01 - External - All Levels - Timber Works - Fascias & Various Frames - Upper & Lower Paint Systems - Light Green (1.1% w/w) | | | | |
| Hazard Type | Lead Paint | Material Assessment | | Disturbance Assessment | |

| Item No. | Hazard Type | Item Location and Description | Recommendations |
|---|---|---|---|
| Item 112 | Lead Paint | P027-H01, External, All Levels, Timber Works - Fascias & Various Frames , Upper & Lower Paint Systems - Light Green (1.1% w/w) | Encapsulate / Repair & Manage In Situ |

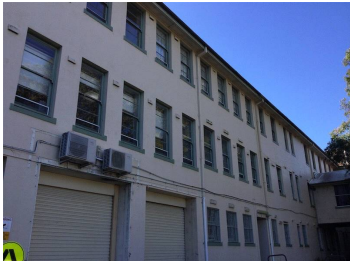
| Item Number | 112 | Material Score | - | Disturbance Score | - |

| Location | P027-H01 - External - All Levels - Window & Frames - Throughout - Paint Systems - Dark Green (4.7% w/w) | | | | |
| Hazard Type | Lead Paint | Material Assessment | | Disturbance Assessment | |

| Item No. | Hazard Type | Item Location and Description | Recommendations |
|---|---|---|---|
| Item 114 | Lead Paint | P027-H01, External, All Levels, Window & Frames - Throughout , Paint Systems - Dark Green (4.7% w/w) | Encapsulate / Repair & Manage In Situ |

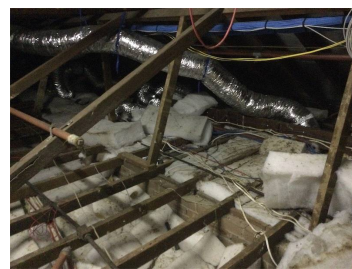
| Item Number | 2 | Material Score | Disturbance Score |

| Location | P027-H01 - 2nd Floor - Ceiling Space - Flexible Ductwork - Various Throughout - Insulation Material | | |
| Hazard Type | SMF | Material Assessment | Disturbance Assessment |

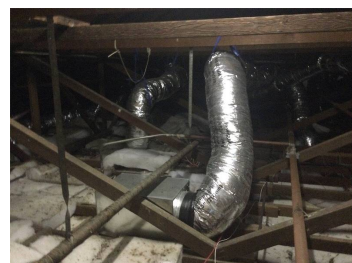
| Item Number | 3 | Material Score | Disturbance Score |

| Location | P027-H01 - 2nd Floor - Ceiling Space - Ductwork - Various Throughout - Insulation Material | | |
| Hazard Type | SMF | Material Assessment | Disturbance Assessment |

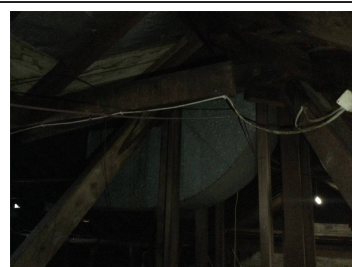
| Item Number | 4 | Material Score | Disturbance Score |

| Location | P027-H01 - 2nd Floor - Ceiling Space - Fire Door - East Adjacent Ladder Entrance - Fire Door Core (tagged metalbilt 1973) | | |
| Hazard Type | Asbestos | Material Assessment | Disturbance Assessment |

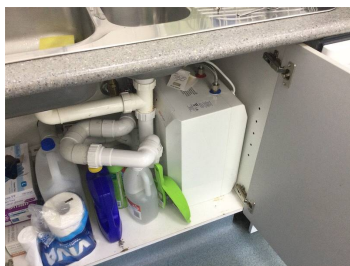
| Item Number | | 36 | Material Score | - | Disturbance Score | - |

| Location | | P027-H01 - 2nd Floor - Bright Futures - Kitchen - Hot Water Heater (zip econbol) - Above Sink - Insulation Material | | | | |
| Hazard Type | | SMF | Material Assessment | | Disturbance Assessment | |

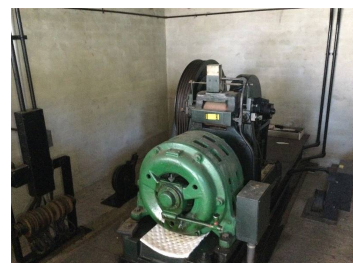
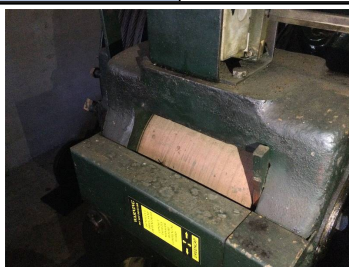
| Item Number | 30 | Material Score | 2 |

| Location | | P027-H01 - 2nd Floor - Lift Motor Room - Electrical Distribution Board - Entry Landing - Compressed Bituminous Panel - Not Sampled - Live Electrical Hazard | |
| Hazard Type | Asbestos | Material Assessment | Disturbance Assessment |

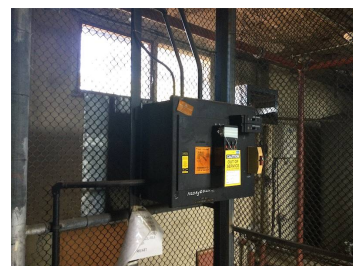
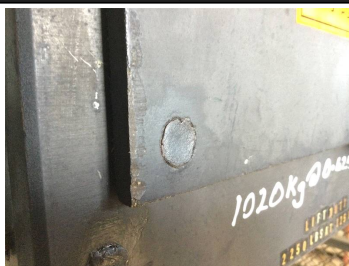
| Item Number | 31 | Material Score | 2 |

| Location | | P027-H01 - 2nd Floor - Lift Motor Room - Electrical Distribution Board - North - Compressed Bituminous Panel - Not Sampled - Live Electrical Hazard | |
| Hazard Type | Asbestos | Material Assessment | Disturbance Assessment |

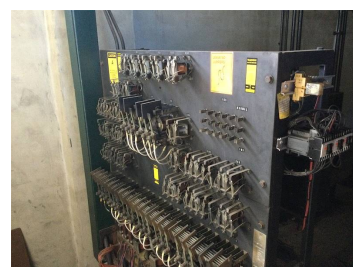
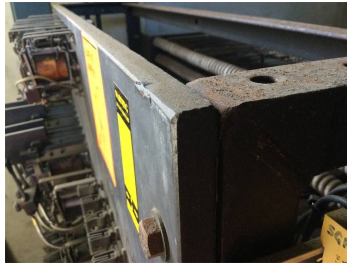
| Hazard Type | Asbestos | Material Assessment | | Disturbance Assessment | |
|---|---|---|---|---|---|
| Item Number | 32 | Material Score | 2 | Disturbance Score | 4 |

**Location** P027-H01 - 2nd Floor - Lift Motor Room - Electrical Distribution Board - Arc Shields - Throughout - Compressed Bituminous Material - Not Sampled - live Electrical Hazard

| Hazard Type | Asbestos | Material Assessment | | Disturbance Assessment | |

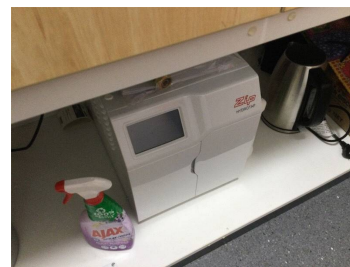
| Item Number | 98 | Material Score | Disturbance Score |

| Location | | P027-H01 - 2nd Floor - Training Centre - Main Kitchen - Hot Water Heater - Below Sink - Insulation Material | |
| Hazard Type | SMF | Material Assessment | Disturbance Assessment |

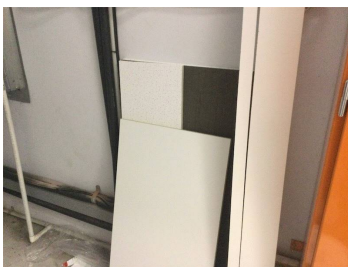
| Item Number | 38 | Material Score | Disturbance Score | |

| Location | | P027-H01 - 1st Floor - Bright Futures - Plantroom 3 - Stored Item - Central - Compressed Ceiling Tiles | | |
| Hazard Type | SMF | Material Assessment | Disturbance Assessment | |

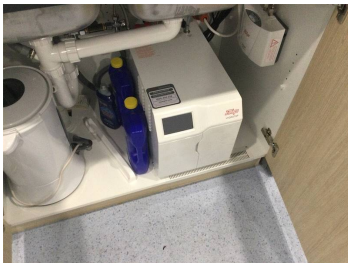
| Item Number | 39 | Material Score | Disturbance Score | |

| Location | | P027-H01 - 1st Floor - Bright Futures - Kitchen - Hot Water Heater (zip hydrotap)- Below Sink - Insulation Material | | |
| Hazard Type | SMF | Material Assessment | Disturbance Assessment | |

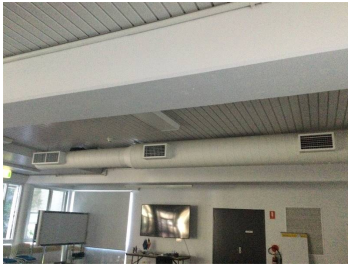
| Item Number | 40 | Material Score | Disturbance Score | |

| Location | | P027-H01 - 1st Floor - Bright Futures - All Areas - Ductwork - Various Throughout - Insulation Material | | |
| Hazard Type | SMF | Material Assessment | Disturbance Assessment | |

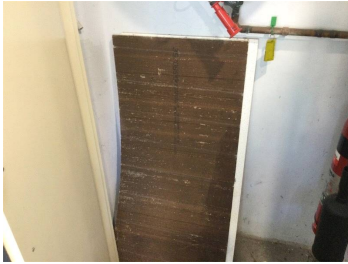
| Item Number | 41 | Material Score | Disturbance Score | |

| Location | | P027-H01 - 1st Floor - Bright Futures - Fire Hose Reel - Stored Item - Central - Compressed Ceiling Tiles | | |
| Hazard Type | SMF | Material Assessment | Disturbance Assessment | |

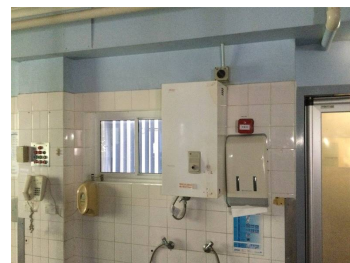
| Item Number | 46 | Material Score | Disturbance Score |

| Location | | P027-H01 - 1st Floor - Main Kitchen - Ceiling lining - Throughout - Fibre Cement Sheetting | |
| Hazard Type | Asbestos | Material Assessment | Disturbance Assessment |

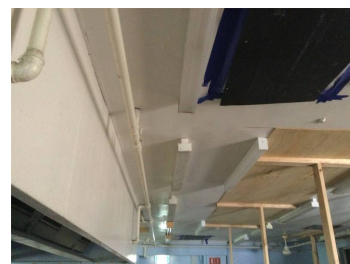
| Item Number | 48 | Material Score | Disturbance Score |

| Location | | P027-H01 - 1st Floor - Main Kitchen - Ductwork Insulation - Various Throughout - Insulation Material | |
| Hazard Type | SMF | Material Assessment | Disturbance Assessment |

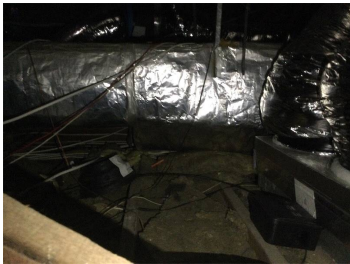
| Item Number | 49 | Material Score | Disturbance Score |

| Location P027-H01 - 1st Floor - Main Kitchen - Insulation Batts - Throughout - Insulation Material | | | | |
| Hazard Type | SMF | Material Assessment | Disturbance Assessment | |

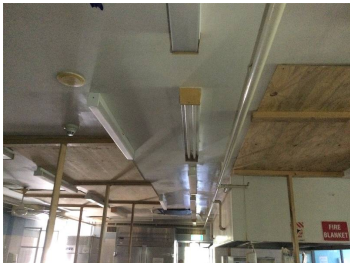
| Item Number | 50 | Material Score | - | |

| Location P027-H01 - 1st Floor - Main Kitchen - Double Tube Capacitor - Throughout - Fluorescent light fitting | | | | |
| Hazard Type | PCB | Material Assessment | Disturbance Assessment | |

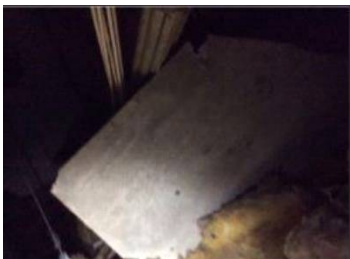
| Item Number | 51 | Material Score | - | |

| Location P027-H01 - 1st Floor - Main Kitchen - Various Throughout - Fibre cement sheeting - debris within ceiling space - not accessible at time of 2023 inspection. | | | | |
| Hazard Type | Asbestos | Material Assessment | Disturbance Assessment | |
| Sample No. | As J154849-01-005-004 {SO001924} | Extent of damage | 3 | |
| | | Priority Score | 13 | |
| | | | | Medium |

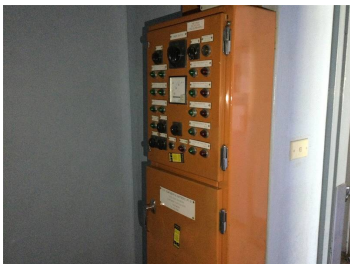
| Location P027-H01 - 1st Floor - Kitchen - Adjacent Coolroom - Electrical Distribution Board - South - Internal Components - HRC fuses | | | | |
| Hazard Type | Asbestos | Material Assessment | Disturbance Assessment | |
| Friability | Friable | Product Type | 2 | |
| | | Priority Score | 7 | |
| | | | | Very Low |

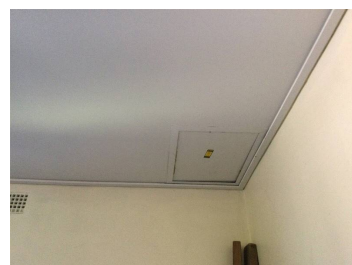
| Item Number | 58 | Material Score | 3 | Disturbance Score | 7 |

| Location | | P027-H01 - 1st Floor - Therapy Unit - Ceiling Space - Ductwork - Various Throughout - Insulation Material | | | |
| Hazard Type | SMF | Material Assessment | | Disturbance Assessment | |

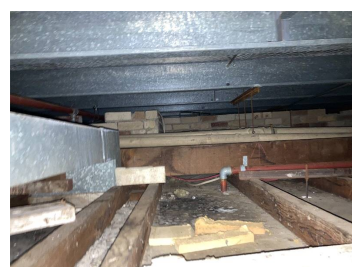
| Item Number | 59 | Material Score | - | Disturbance Score | - |

| Location | | P027-H01 - 1st Floor - Therapy Unit - Ceiling Space - Sarking - Roof Lining - Throughout - Insulation Material | | | |
| Hazard Type | SMF | Material Assessment | | Disturbance Assessment | |

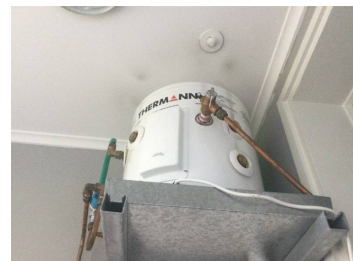
| Item Number | 102 | Material Score | - |

| Location | | P027-H01 - 1st Floor - Home Modifications - Kitchen - Hot Water Heater - Above Sink - Insulation Material | |
| Hazard Type | SMF | Material Assessment | Disturbance Assessment |

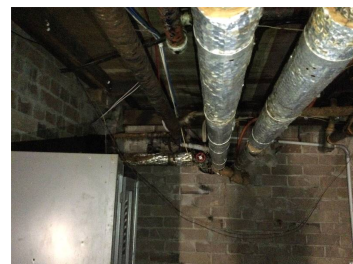
| Item Number | 63 | Material Score | - |

| Location P027-H01 - Subfloor - Pbax - Ductwork - Various Throughout - Insulation Material | | | |
| Hazard Type | SMF | Material Assessment | Disturbance Assessment |

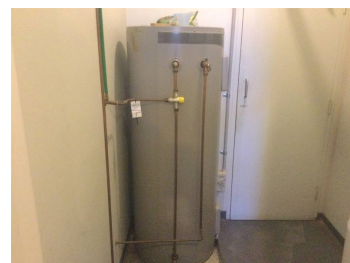
| Item Number | 99 | Material Score | - | Disturbance Score | - |

| Location | | P027-H01 - Basement Level - Kitchen - Hot Water Heater - Above Sink - Insulation Material | | | |
| Hazard Type | SMF | Material Assessment | | Disturbance Assessment | |

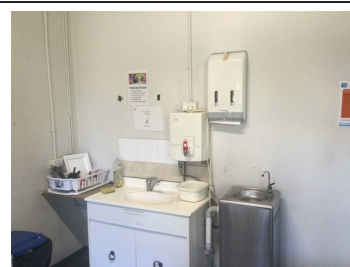
| Item Number | 100 | Material Score | - | Disturbance Score | - |

| Location | | P027-H01 - Basement Level - Kitchen - Hot Water Heater - Below Sink - Insulation Material | | | |
| Hazard Type | SMF | Material Assessment | | Disturbance Assessment | |

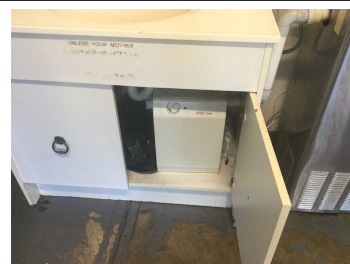
| Item Number | 101 | Material Score | - | Disturbance Score | - |

| Location | | P027-H01 - Basement Level - Plant Room - Pipework - Various Throughout - Insulation Material | | | |
| Hazard Type | SMF | Material Assessment | | Disturbance Assessment | |

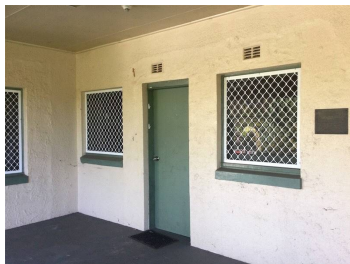
| Location | | P027-S01 - External - Entrance - Front Entrance Door & Frame - Throughout - Upper & Lower Paint Systems - Green (0.67% w/w) | | |
| Hazard Type | Lead Paint | Material Assessment | Disturbance Assessment | |

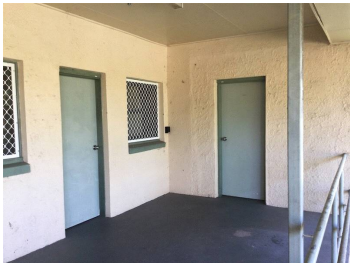
| Location | P027-S01 - External - Entrance - Door - South Entrance - Paint Systems - Pale Blue (0.553% w/w) | | | |
| Hazard Type | Lead Paint | Material Assessment | Disturbance Assessment | |

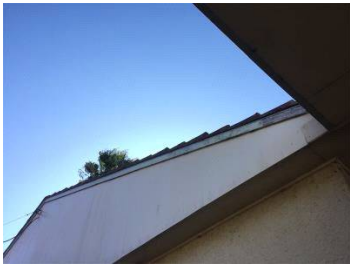
| Item Number | 82 | Material Score | Disturbance Score | |

| Location | P027-S01 - External - East & West - Gable End - Wood - Upper & Lower Paint Systems - Green on Brown (1/.1% w/w) | | | |
| Hazard Type | Lead Paint | Material Assessment | Disturbance Assessment | |

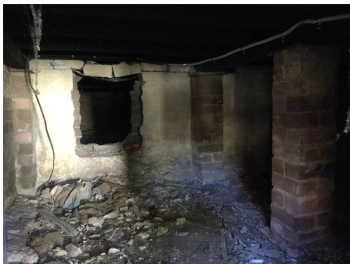
| Item Number | 123 | Material Score | Disturbance Score | |

| Location | P027-S01 - External - Subfloor - Packer - Columns - Fibre Cement Sheet - Not Sampled - Restricted Access | | | |
| Hazard Type | Asbestos | Material Assessment | Disturbance Assessment | |

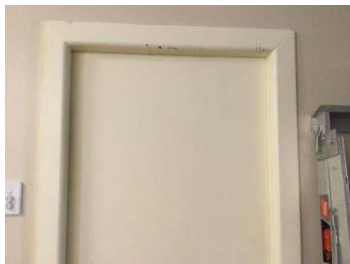
| Location | | P027-S01 - Ground Floor - All areas - Doors and frames - throughout - Paint systems - Light tan (0.65% w/w) | | |
| Hazard Type | Lead Paint | Material Assessment | Disturbance Assessment | |

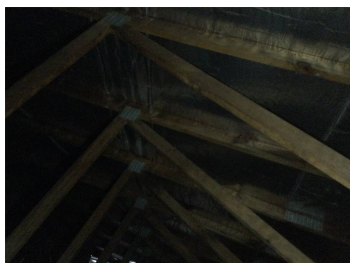
| Item Number | 85 | Material Score | Disturbance Score | |

| Location | | P027-S01 - Ground Floor - Ceiling Space - Sarking - Roof Lining - Throughout - Insulation Material | | |
| Hazard Type | SMF | Material Assessment | Disturbance Assessment | |

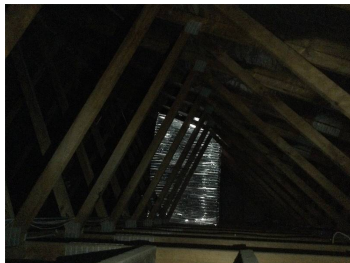
| Item Number | 91 | Material Score | Disturbance Score | |

| Location | | P027-S01 - Ground Floor - Ceiling Space - Flexible Ductwork - Various Throughout - Insulation Material | | |
| Hazard Type | SMF | Material Assessment | Disturbance Assessment | |
| Friability | Bonded | Product Type | Occupancy | |
| Sample No. | Visual | Extent of damage | Disturbance | |
