# Hazardous Materials Inspection

| <b>Prepared for:</b> | Loreto Normanhurst |
| <b>Site:</b> | <b>4 Mount Pleasant Ave, Normanhurst<br/>NSW 2076</b> |
| <b>Date:</b> | Monday, 7 December 2020 |

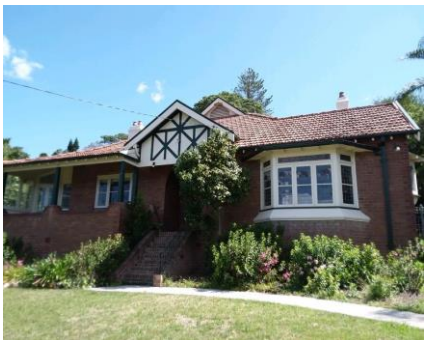
| Item | Location | Level | Room-Specific Location | Hazard Type | Item description | Sample Reference | Sample Status | Photo No | Extent | Condition | Friability | Disturbance Potential | Risk Rating | Current Label | Control Priority | Control Recommendation |
|---|---|---|---|---|---|---|---|---|---|---|---|---|---|---|---|--|
| 28 | Exterior | Ground Floor | Northern elevation of the house - infill panels to window | Asbestos | FC sheeting | 18 | Negative | | | | | | | | | |
| 29 | Exterior | Ground Floor | Electrical meter board | Asbestos | backing board | Nil - energised | Presumed Positive | 200928-124950 | 1 | Good | Non-Friable | Low | Low | No | P4 | <p>P4 - No short term remediation works required. Review periodically and manage as part of an AMP</p> |

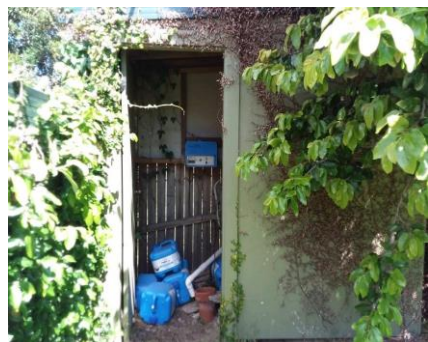
| Item | Location | Level | Room-Specific Location | Hazard Type | Item description | Sample Reference | Sample Status | Photo No | Extent | Condition | Friability | Disturbance Potential | Risk Rating | Current Label | Control Priority | Control Recommendation |
|---|---|---|---|---|---|---|---|---|---|---|---|---|---|---|---|---|
| 1 | Interior and Exterior | Ground Floor | All elevation of shed - walls | Asbestos | FC sheeting | 19 | Negative | | | | | | | | | |
