ARMIDALE SECONDARY COLLEGE, Butler Street Armidale**Introduction**

Appendix A – McArdle and Sons Tree Report.

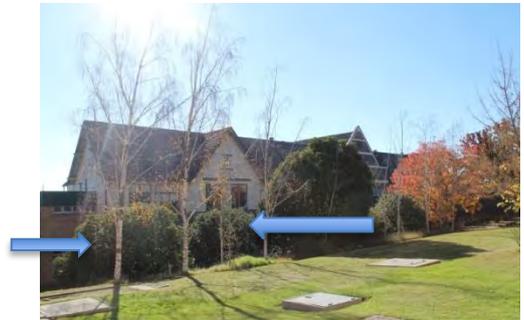
TREE 100 & 101 Union separation

Trees identified for removal on TREE REMOVAL PLAN (fig 3), of these trees; Tree 47 E. *cinerea* is significant in size, Trees 49, 101 & 102 have Structural splits at the unions.

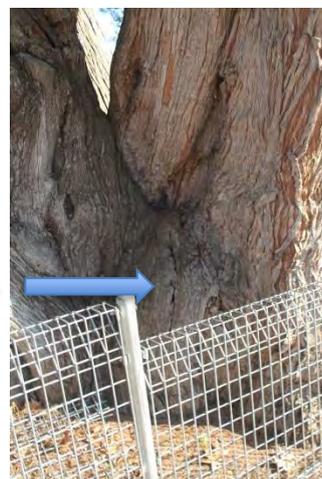
Several trees have been identified with structural faults or other and I have made comment in the Tree survey ie; Trees 46,105,118 and 122* (*Memorial Tree*). This report does not include a risk assessment, only comments have made been made as a point of reference to the trees condition and TULE rating applied. No Indigenous trees on site are listed as a threatened species.

Tree 105 fracture at union
