| Mudgee District Hospital, Meares Street, Mudgee, NSW<br>Hazardous Building Materials Register - September 2017 | | | | | | | | | |

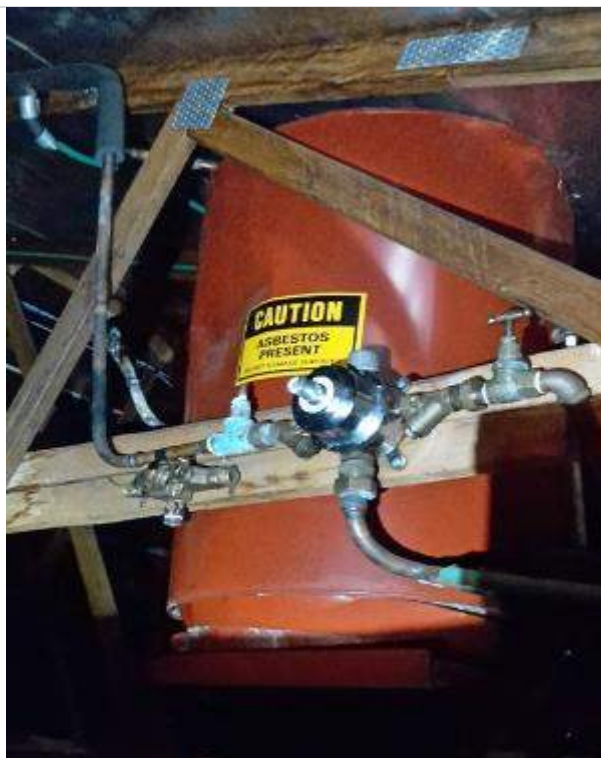
**Water tank insulation – Not sampled (height restriction)**

| <b>Condition:</b> | Generally contained |
| <b>Risk Assessment / Recommendation:</b> | Low risk, leave and maintain in current condition |

| <b>Reinspection / Removal Date:</b> | Remove prior to refurbishment / demolition works or reinspect in 5 years |

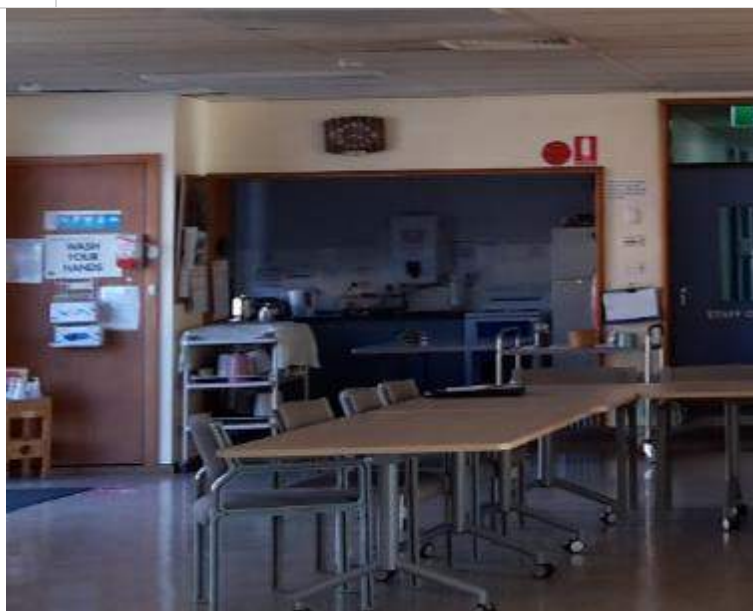
## Flat fibre cement sheet – S22

| <b>Condition:</b> | Generally intact |
| <b>Risk Assessment / Recommendation:</b> | Low risk, leave and maintain in current condition |

| <b>Reinspection / Removal Date:</b> | Remove prior to refurbishment / demolition works or reinspect in 5 years |

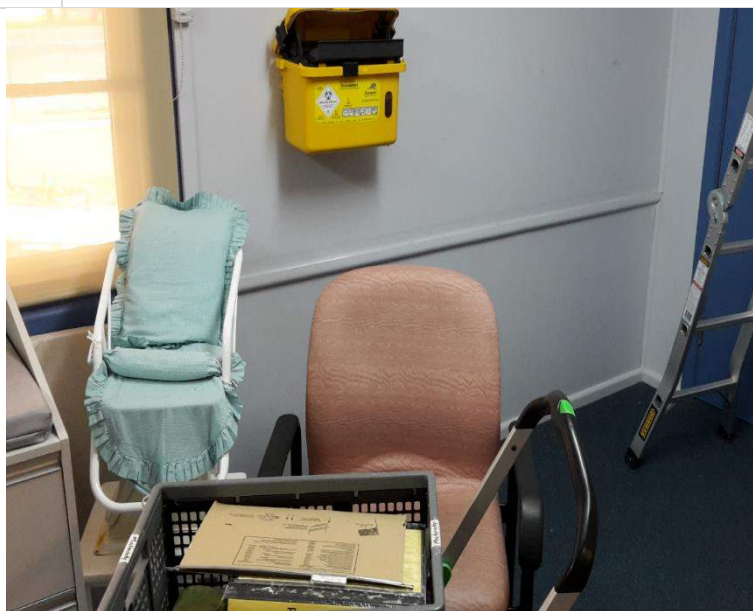
## Flat fibre cement sheet – S23

| <b>Condition:</b> | Generally intact |
| <b>Risk Assessment / Recommendation:</b> | Low risk, leave and maintain in current condition |

| <b>Reinspection / Removal Date:</b> | Remove prior to refurbishment / demolition works or reinspect in 5 years |

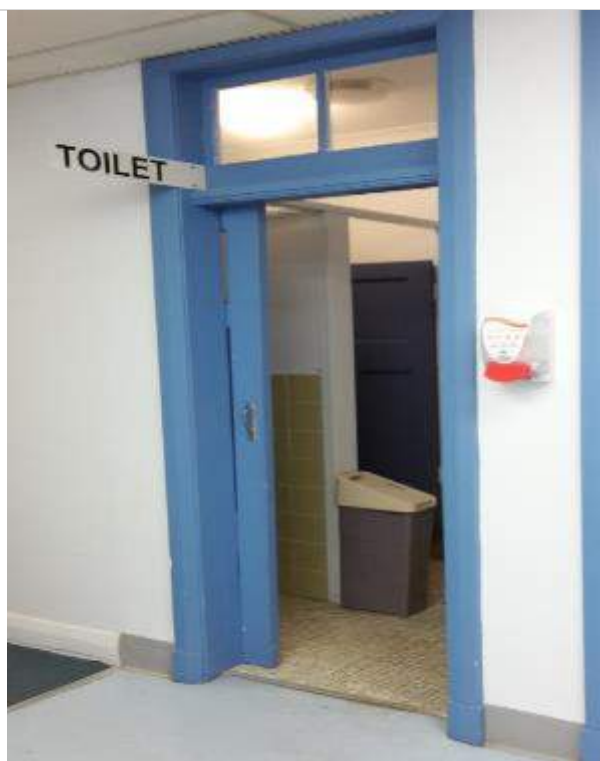
## Flat fibre cement sheet – S24

| <b>Condition:</b> | Generally intact |
| <b>Risk Assessment / Recommendation:</b> | Low risk, leave and maintain in current condition |

| <b>Reinspection / Removal Date:</b> | Remove prior to refurbishment / demolition works or reinspect in 5 years |

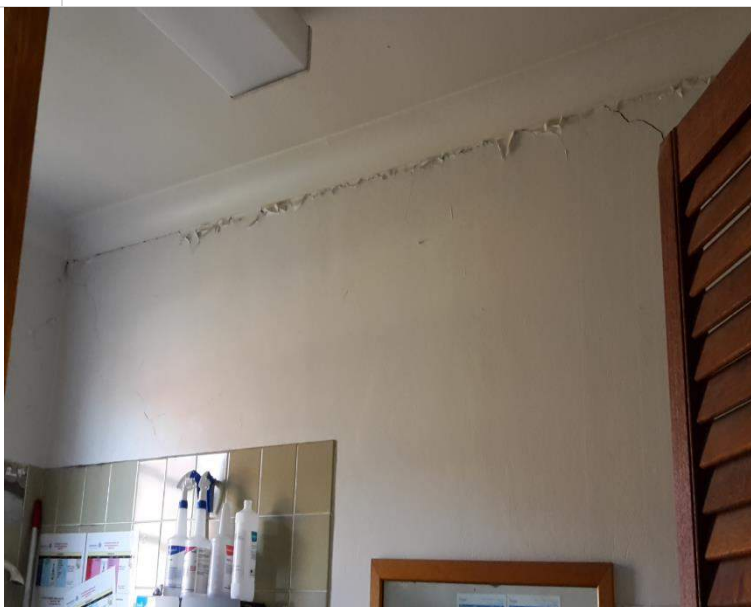
## Flat fibre cement sheet – S25

| <b>Condition:</b> | Generally intact |
| <b>Risk Assessment / Recommendation:</b> | Low risk, leave and maintain in current condition |

| <b>Reinspection / Removal Date:</b> | Remove prior to refurbishment / demolition works or reinspect in 5 years |

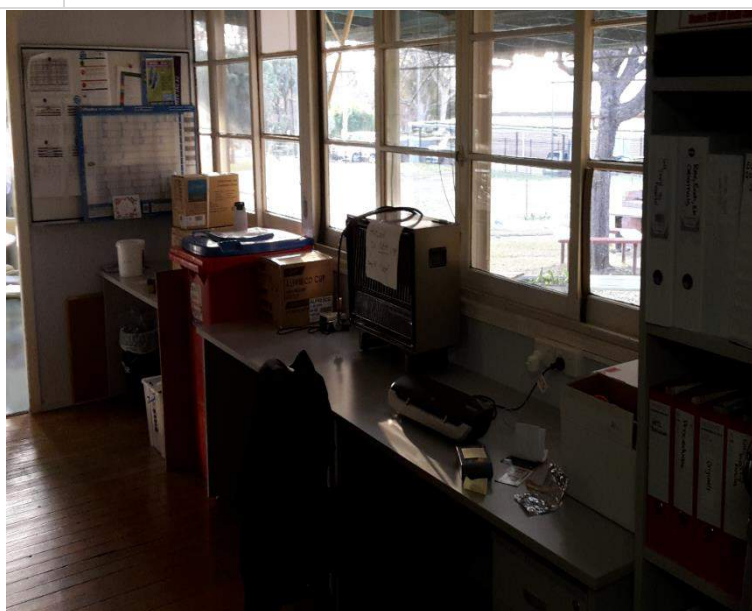
## Flat fibre cement sheet – S28

| <b>Condition:</b> | Generally intact |
| <b>Risk Assessment / Recommendation:</b> | Low risk, leave and maintain in current condition |

| <b>Reinspection / Removal Date:</b> | Remove prior to refurbishment / demolition works or reinspect in 5 years |

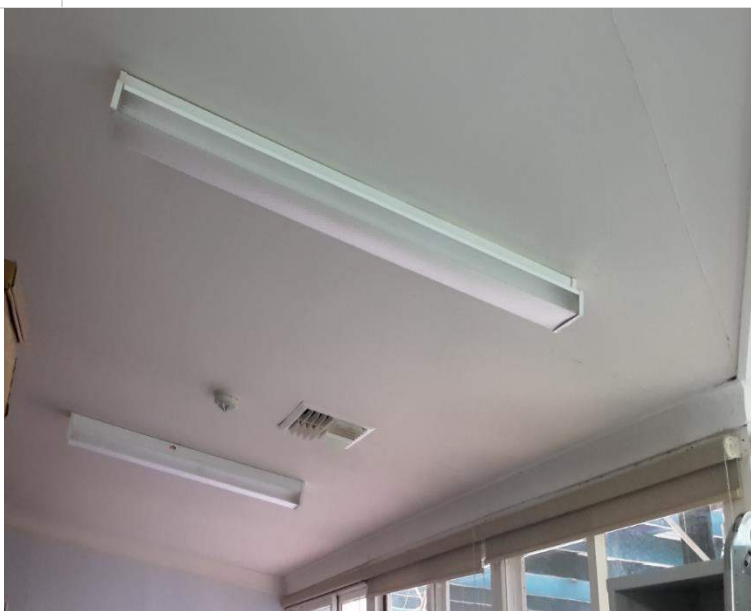
## Flat fibre cement sheet – S29

| <b>Condition:</b> | Generally intact |
| <b>Risk Assessment / Recommendation:</b> | Low risk, leave and maintain in current condition |

| <b>Reinspection / Removal Date:</b> | Remove prior to refurbishment / demolition works or reinspect in 5 years |

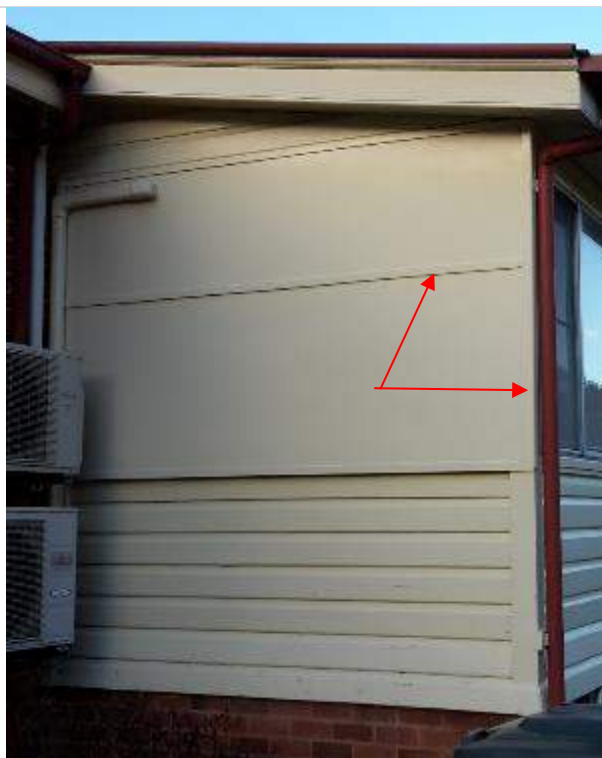
**Moulded fibre cement sheet – S30**

| <b>Condition:</b> | Generally intact |
| <b>Risk Assessment / Recommendation:</b> | Low risk, leave and maintain in current condition |

| <b>Reinspection / Removal Date:</b> | Remove prior to refurbishment / demolition works or reinspect in 5 years |

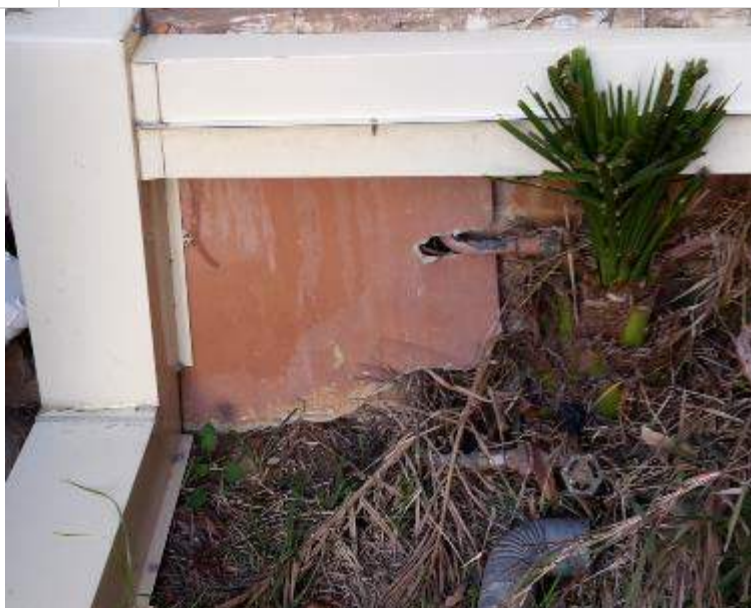
**Debris & fibre cement sheet – S31**

| <b>Condition:</b> | Generally intact |
| <b>Risk Assessment / Recommendation:</b> | Low risk, leave and maintain in current condition |

| <b>Reinspection / Removal Date:</b> | Remove prior to refurbishment / demolition works or reinspect in 5 years |

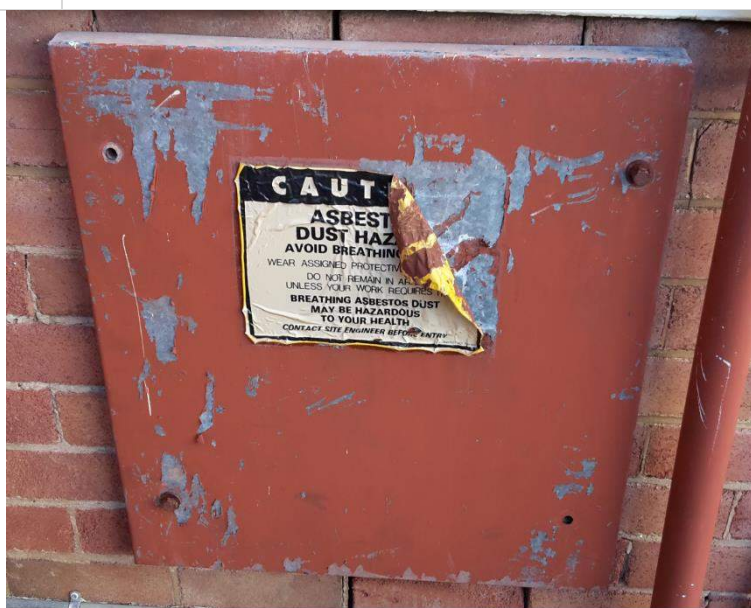
**Dust & Debris– Not sampled (no access)**

| <b>Condition:</b> | Generally contained |
| <b>Risk Assessment / Recommendation:</b> | Low risk, leave and maintain in current condition |

| <b>Reinspection / Removal Date:</b> | Remove prior to refurbishment / demolition works or reinspect in 5 years |

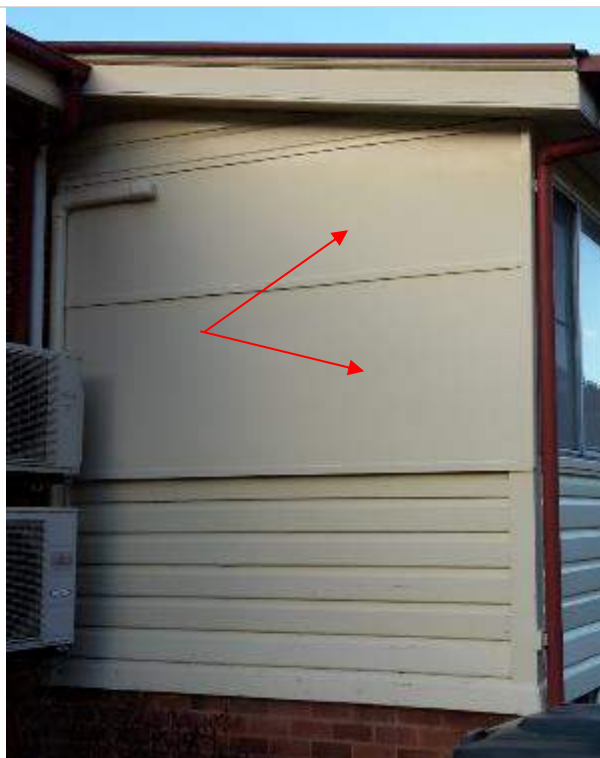
## Flat fibre cement sheet – S32

| <b>Condition:</b> | Generally intact |
| <b>Risk Assessment / Recommendation:</b> | Low risk, leave and maintain in current condition |

| <b>Reinspection / Removal Date:</b> | Remove prior to refurbishment / demolition works or reinspect in 5 years |

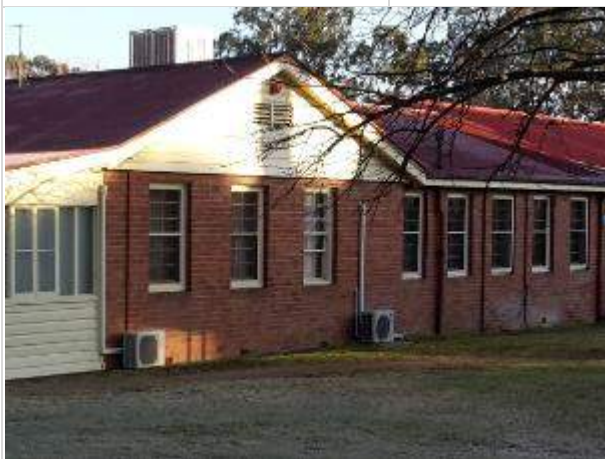
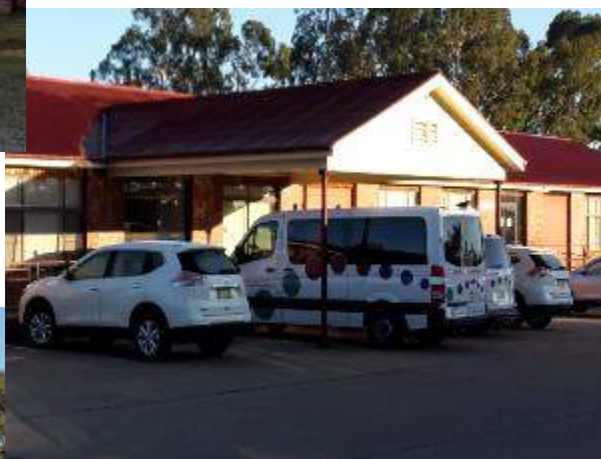
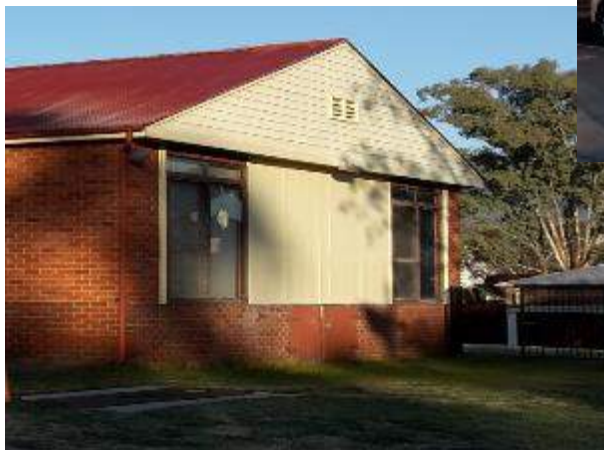
## Compressed fibre cement sheet – S85

| <b>Condition:</b> | Generally intact |
| <b>Risk Assessment / Recommendation:</b> | Low risk, leave and maintain in current condition |

| <b>Reinspection / Removal Date:</b> | Remove prior to refurbishment / demolition works or reinspect in 5 years |

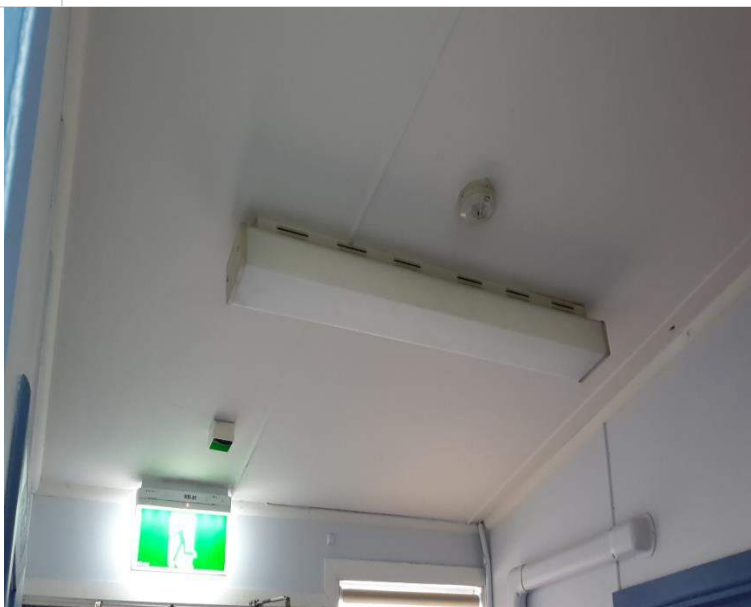
## Flat fibre cement sheet – S40

| <b>Condition:</b> | Generally intact |
| <b>Risk Assessment / Recommendation:</b> | Low risk, leave and maintain in current condition |

| <b>Reinspection / Removal Date:</b> | Remove prior to refurbishment / demolition works or reinspect in 5 years |

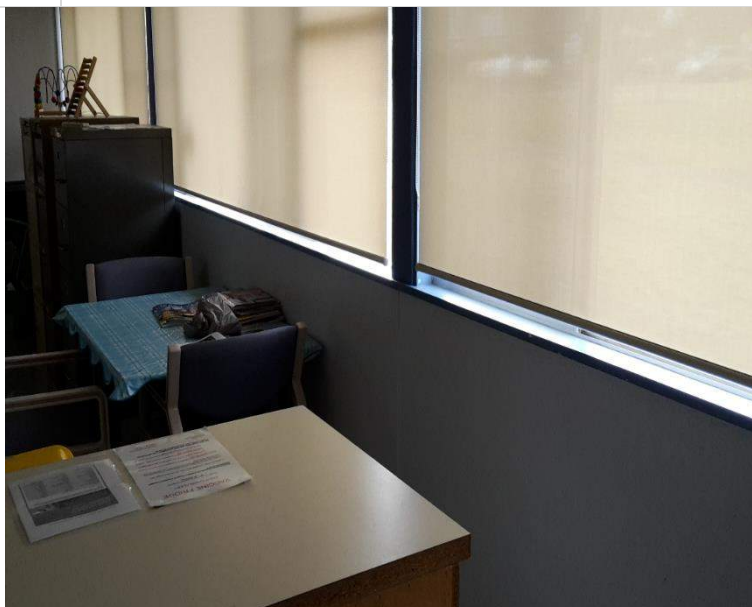
## Flat fibre cement sheet – S42

| <b>Condition:</b> | Generally intact |
| <b>Risk Assessment / Recommendation:</b> | Low risk, leave and maintain in current condition |

| <b>Reinspection / Removal Date:</b> | Remove prior to refurbishment / demolition works or reinspect in 5 years |

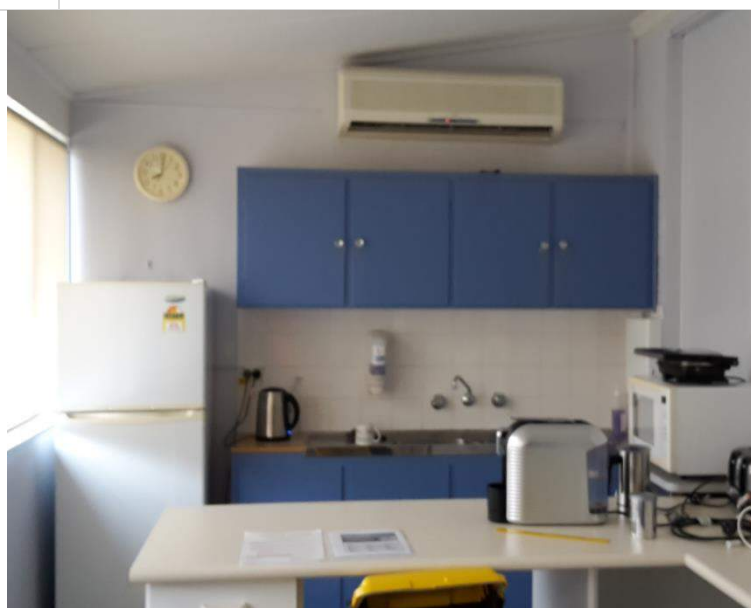
## Flat fibre cement sheet – S43

| <b>Condition:</b> | Generally intact |
| <b>Risk Assessment / Recommendation:</b> | Low risk, leave and maintain in current condition |

| <b>Reinspection / Removal Date:</b> | Remove prior to refurbishment / demolition works or reinspect in 5 years |

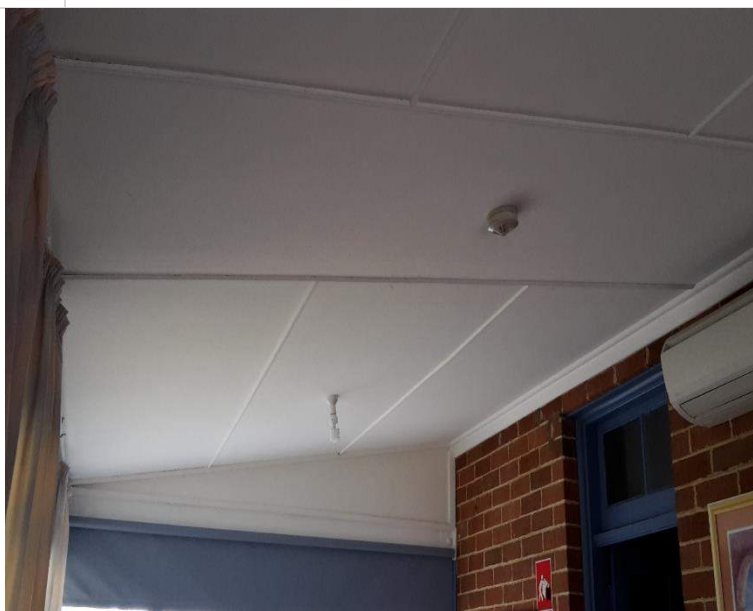
## Flat fibre cement sheet – S53

| <b>Condition:</b> | Generally intact |
| <b>Risk Assessment / Recommendation:</b> | Low risk, leave and maintain in current condition |

| <b>Reinspection / Removal Date:</b> | Remove prior to refurbishment / demolition works or reinspect in 5 years |

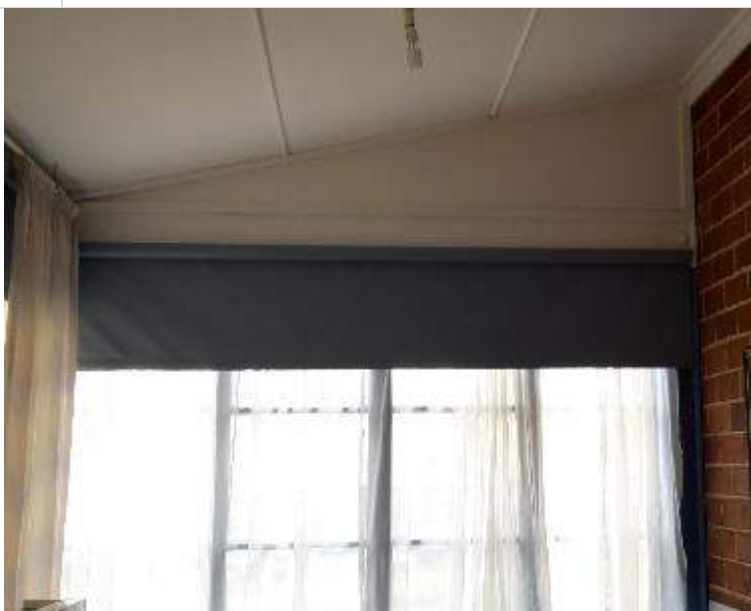
**Flat fibre cement sheet – Similar to S53**

| <b>Condition:</b> | Generally intact |
| <b>Risk Assessment / Recommendation:</b> | Low risk, leave and maintain in current condition |

| <b>Reinspection / Removal Date:</b> | Remove prior to refurbishment / demolition works or reinspect in 5 years |

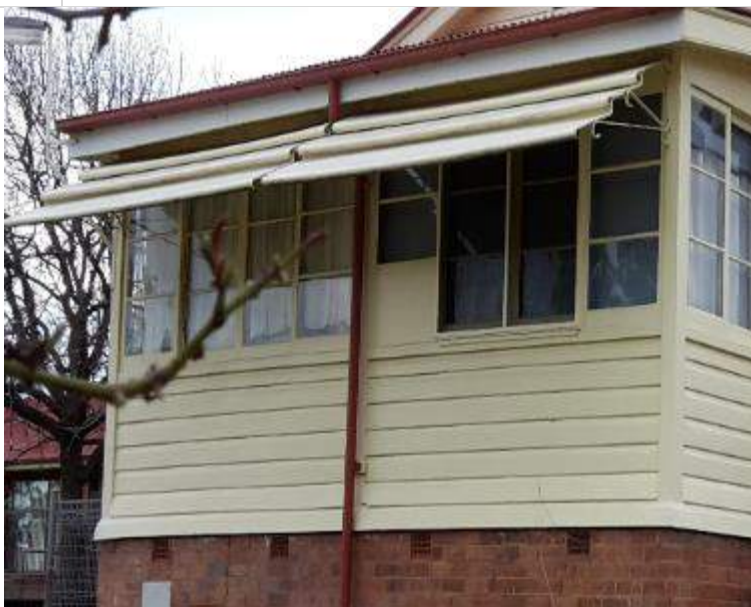
## Flat fibre cement sheet – S54

| <b>Condition:</b> | Generally intact |
| <b>Risk Assessment / Recommendation:</b> | Low risk, leave and maintain in current condition |

| <b>Reinspection / Removal Date:</b> | Remove prior to refurbishment / demolition works or reinspect in 5 years |

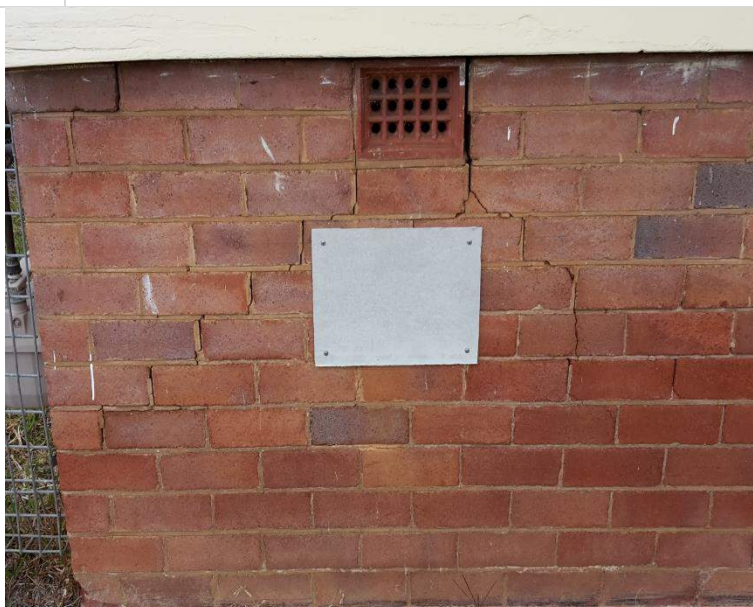
## Flat fibre cement sheet – S55

| <b>Condition:</b> | Generally intact |
| <b>Risk Assessment / Recommendation:</b> | Low risk, leave and maintain in current condition |

| <b>Reinspection / Removal Date:</b> | Remove prior to refurbishment / demolition works or reinspect in 5 years |

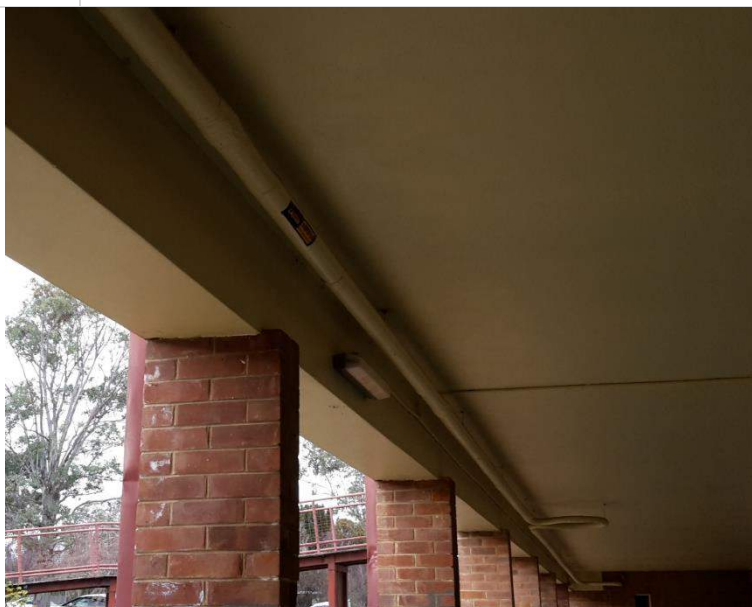
**Wrapped asbestos lagging on pipework – Similar to S07**

| <b>Condition:</b> | Generally intact |
| <b>Risk Assessment / Recommendation:</b> | High risk, material should be removed as soon as reasonably practicable. There is a height restriction for access to the wrapped lagging, however access to this area is unrestricted. Although in a good condition, the wrapping could easily be penetrated. |

| <b>Reinspection / Removal Date:</b> | Remove material as soon as reasonably practicable and prior to refurbishment and/or demolition works |

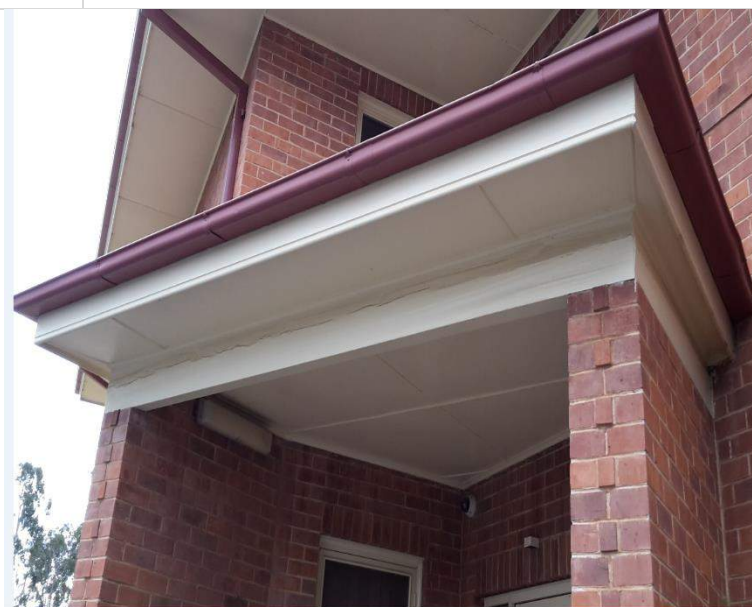
## Flat fibre cement sheet – S45

| <b>Condition:</b> | Generally intact |
| <b>Risk Assessment / Recommendation:</b> | Low risk, leave and maintain in current condition |

| <b>Reinspection / Removal Date:</b> | Remove prior to refurbishment / demolition works or reinspect in 5 years |

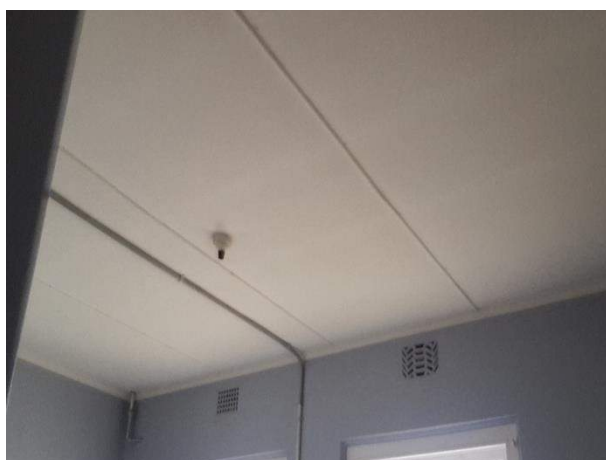
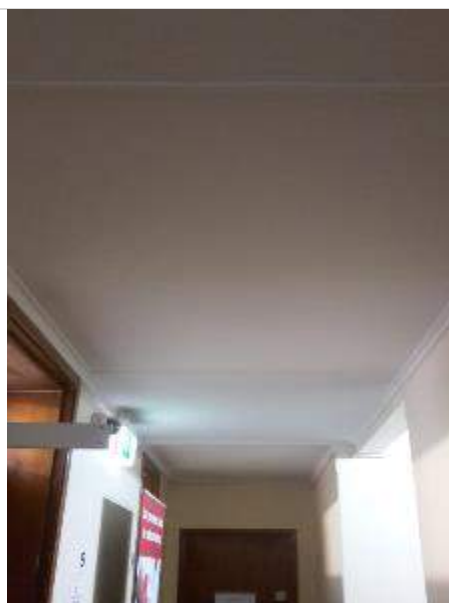
## Flat fibre cement sheet – S47

| <b>Condition:</b> | Generally intact |
| <b>Risk Assessment / Recommendation:</b> | Low risk, leave and maintain in current condition |

| <b>Reinspection / Removal Date:</b> | Remove prior to refurbishment / demolition works or reinspect in 5 years |

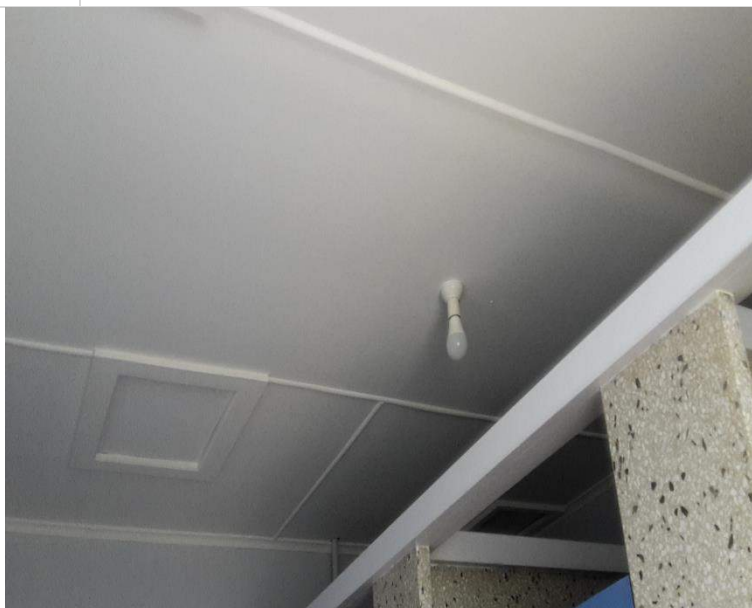
## Flat fibre cement sheet – S48

| <b>Condition:</b> | Generally intact |
| <b>Risk Assessment / Recommendation:</b> | Low risk, leave and maintain in current condition |

| <b>Reinspection / Removal Date:</b> | Remove prior to refurbishment / demolition works or reinspect in 5 years |

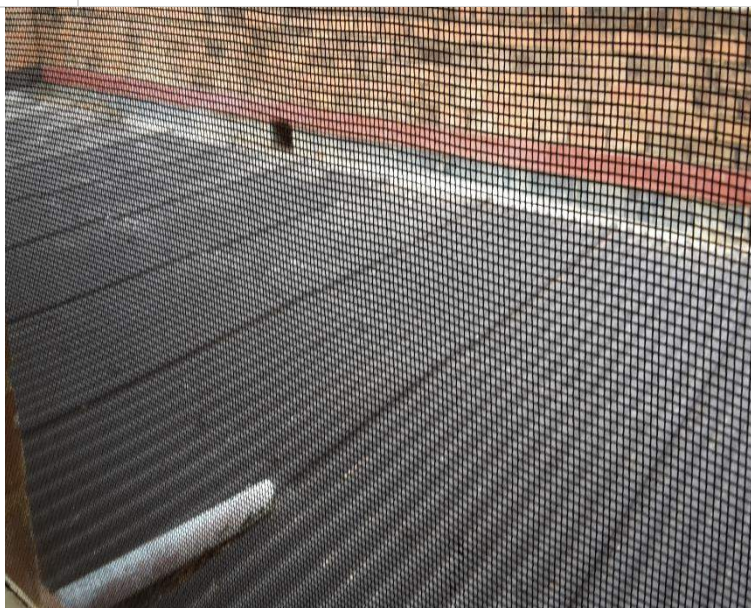
**Corrugated fibre cement sheet – Not sampled (height/access restriction)**

| <b>Condition:</b> | Generally intact |
| <b>Risk Assessment / Recommendation:</b> | Low risk, leave and maintain in current condition |

| <b>Reinspection / Removal Date:</b> | Remove prior to refurbishment / demolition works or reinspect in 5 years |

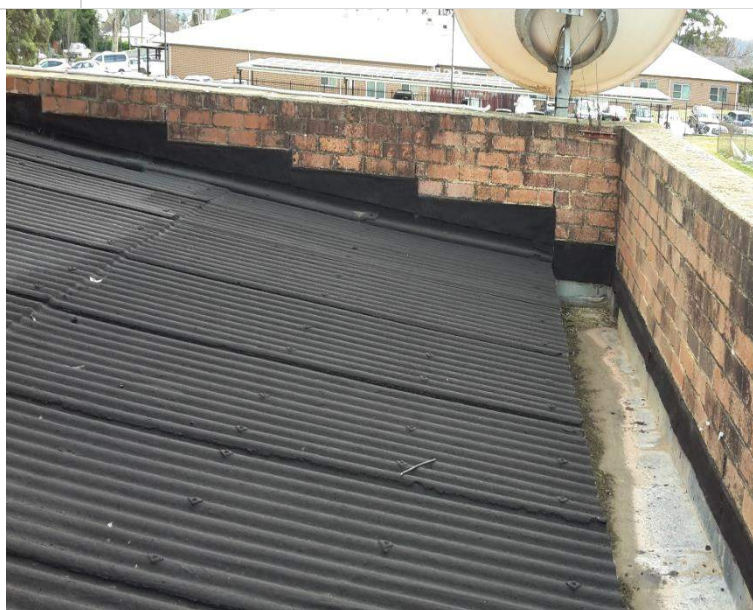
**Corrugated fibre cement sheet – Not sampled (height/access restriction)**

| <b>Condition:</b> | Generally intact |
| <b>Risk Assessment / Recommendation:</b> | Low risk, leave and maintain in current condition |

| <b>Reinspection / Removal Date:</b> | Remove prior to refurbishment / demolition works or reinspect in 5 years |

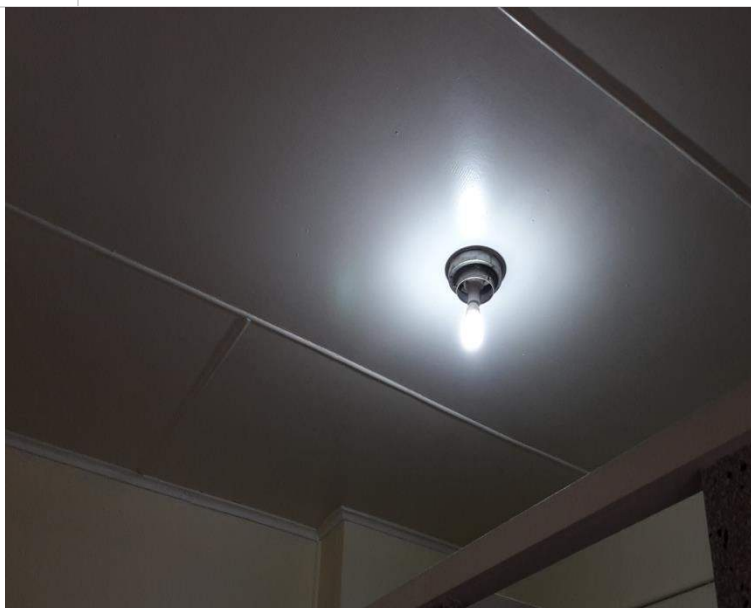
## Flat fibre cement sheet – S49

| <b>Condition:</b> | Generally intact |
| <b>Risk Assessment / Recommendation:</b> | Low risk, leave and maintain in current condition |

| <b>Reinspection / Removal Date:</b> | Remove prior to refurbishment / demolition works or reinspect in 5 years |

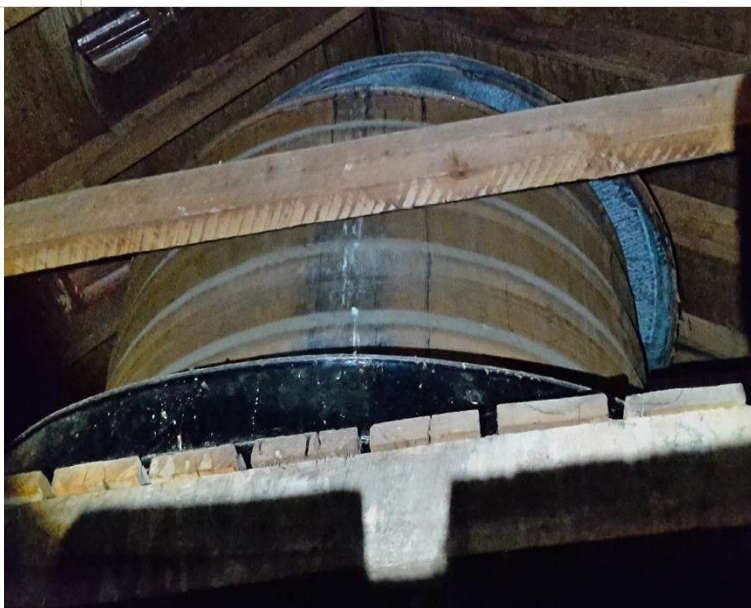
**Water tank insulation – Not sampled (height/safety restriction)**

| <b>Condition:</b> | Generally intact |
| <b>Risk Assessment / Recommendation:</b> | Low risk, leave and maintain in current condition |

| <b>Reinspection / Removal Date:</b> | Remove prior to refurbishment / demolition works or reinspect in 5 years |

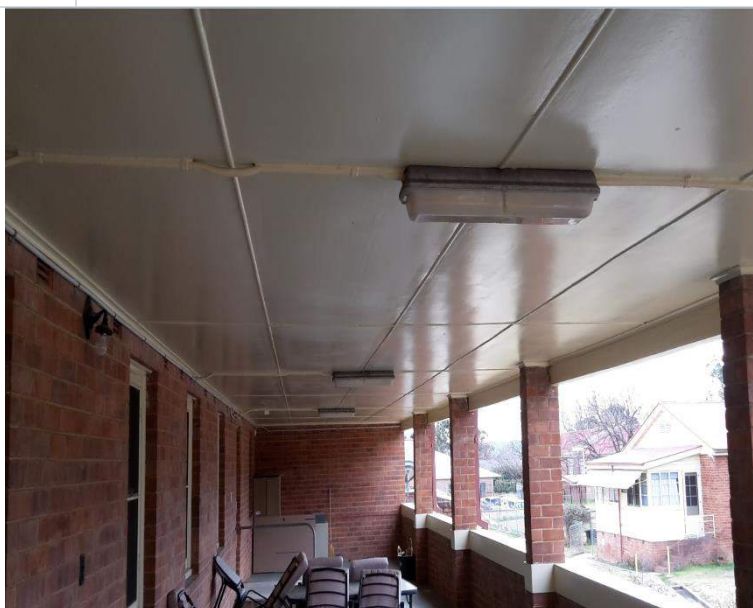
## Flat fibre cement sheet – S51

| <b>Condition:</b> | Generally intact |
| <b>Risk Assessment / Recommendation:</b> | Low risk, leave and maintain in current condition |

| <b>Reinspection / Removal Date:</b> | Remove prior to refurbishment / demolition works or reinspect in 5 years |

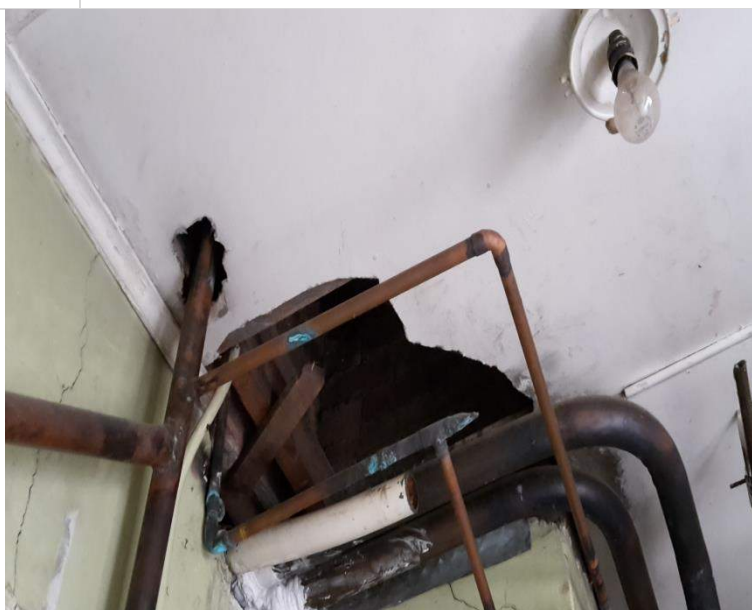
**Wrapped asbestos lagging on pipework – Similar to S07**

| <b>Condition:</b> | Generally intact |
| <b>Risk Assessment / Recommendation:</b> | High risk, material should be removed as soon as reasonably practicable. Access to the plant room is restricted (padlocked), access into subfloor is restricted (no access identified). Although in reasonable condition, the wrapping could easily be penetrated. |

| <b>Reinspection / Removal Date:</b> | Remove material as soon as reasonably practicable and prior to refurbishment and/or demolition works |

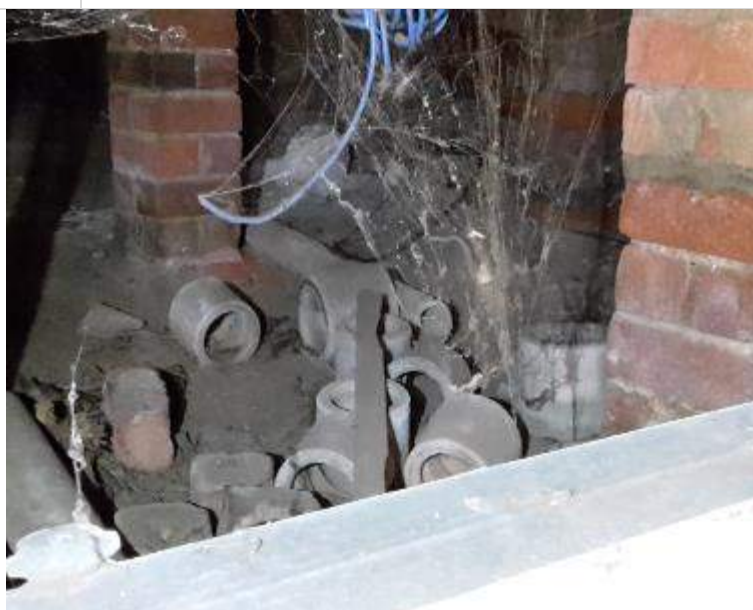
**Stored asbestos cement pipework – S57**

| <b>Condition:</b> | Generally intact |
| <b>Risk Assessment / Recommendation:</b> | Low risk, leave and maintain in current condition |

| <b>Reinspection / Removal Date:</b> | Remove prior to refurbishment / demolition works or reinspect in 5 years |

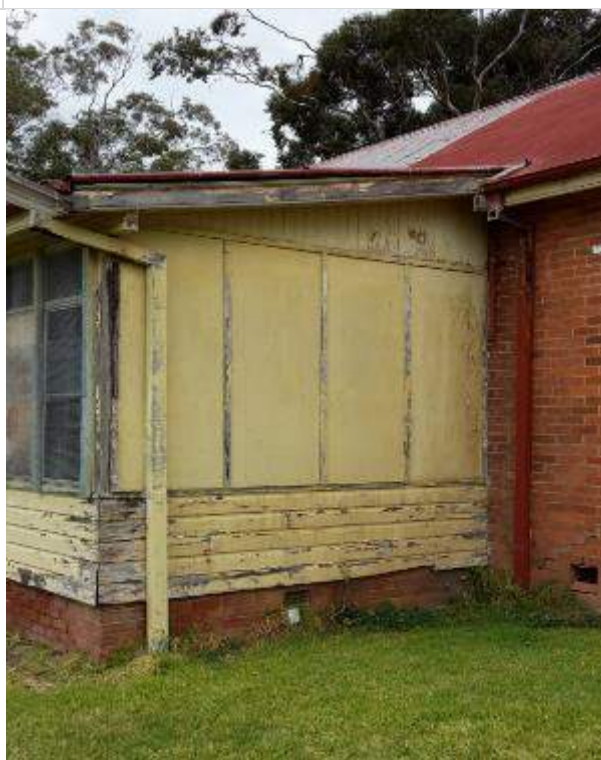
## Flat fibre cement sheet – S56

| <b>Condition:</b> | Generally intact |
| <b>Risk Assessment / Recommendation:</b> | Low risk, leave and maintain in current condition |

| <b>Reinspection / Removal Date:</b> | Remove prior to refurbishment / demolition works or reinspect in 5 years |

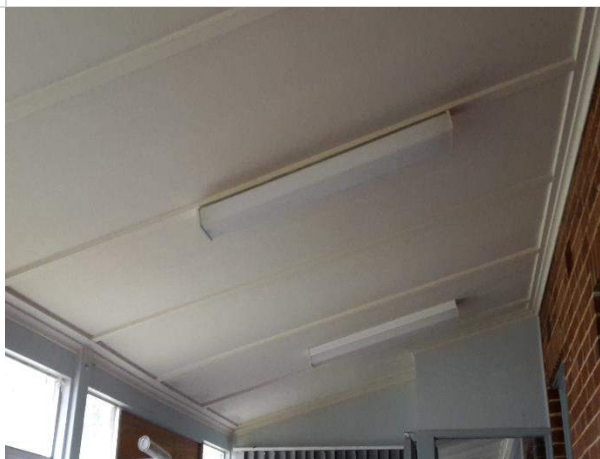
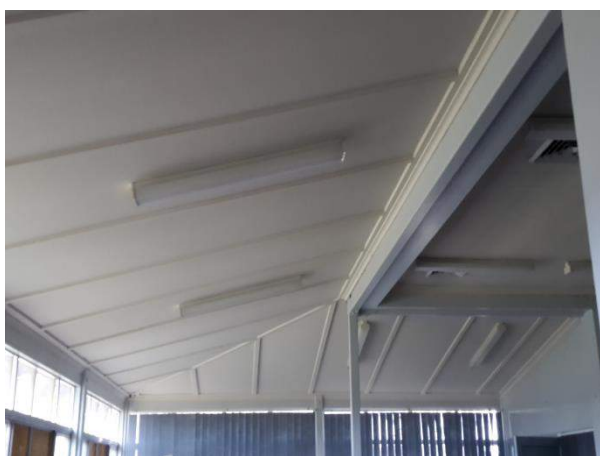
## Flat fibre cement sheet – S59

| <b>Condition:</b> | Generally intact |
| <b>Risk Assessment / Recommendation:</b> | Low risk, leave and maintain in current condition |

| <b>Reinspection / Removal Date:</b> | Remove prior to refurbishment / demolition works or reinspect in 5 years |

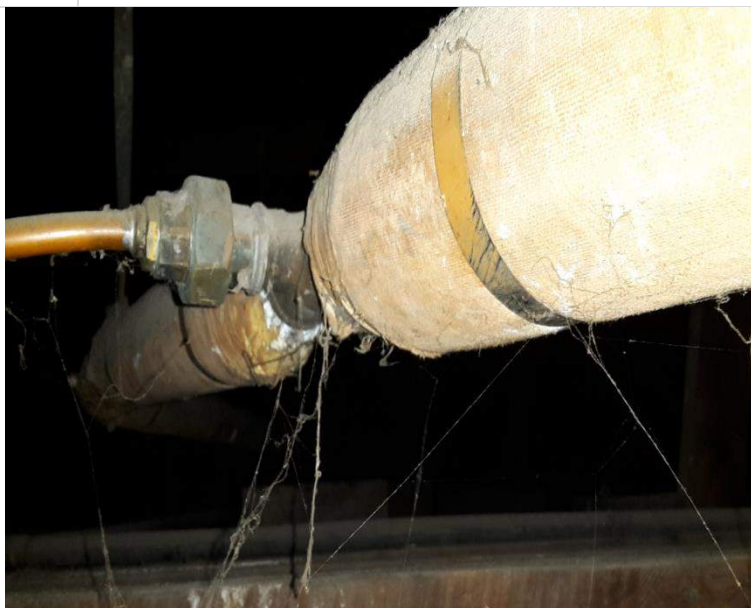
**Wrapped asbestos lagging on pipework – Similar to S07**

| <b>Condition:</b> | Generally intact |
| <b>Risk Assessment / Recommendation:</b> | High risk, material should be removed as soon as reasonably practicable. Access to this building is restricted (padlocked). Although in a good condition, the wrapping could easily be penetrated. |

| <b>Reinspection / Removal Date:</b> | Remove material as soon as reasonably practicable and prior to refurbishment and/or demolition works |

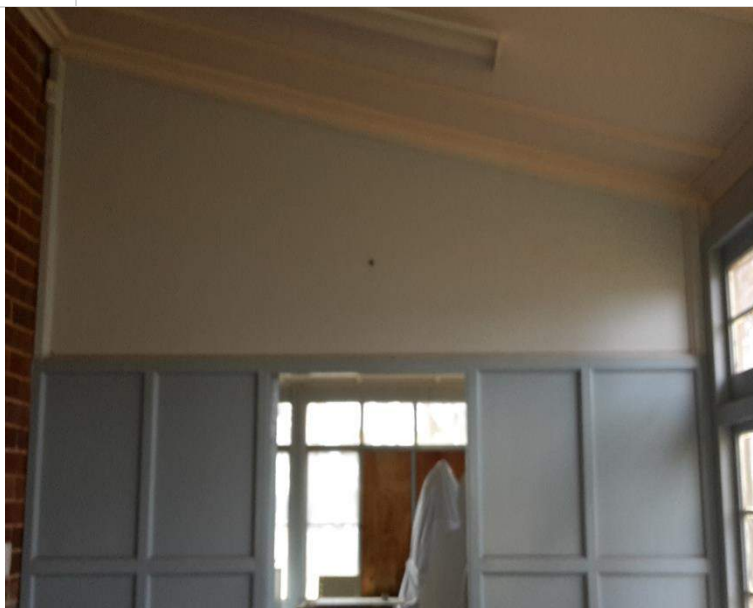
## Flat fibre cement sheet – 60

| <b>Condition:</b> | Generally intact |
| <b>Risk Assessment / Recommendation:</b> | Low risk, leave and maintain in current condition |

| <b>Reinspection / Removal Date:</b> | Remove prior to refurbishment / demolition works or reinspect in 5 years |

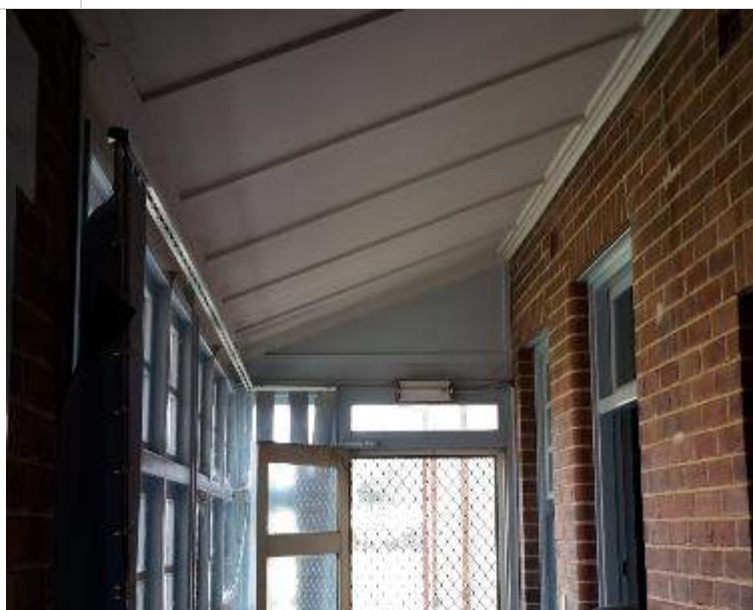
**Flat fibre cement sheet – Similar to S60**

| <b>Condition:</b> | Generally intact |
| <b>Risk Assessment / Recommendation:</b> | Low risk, leave and maintain in current condition |

| <b>Reinspection / Removal Date:</b> | Remove prior to refurbishment / demolition works or reinspect in 5 years |

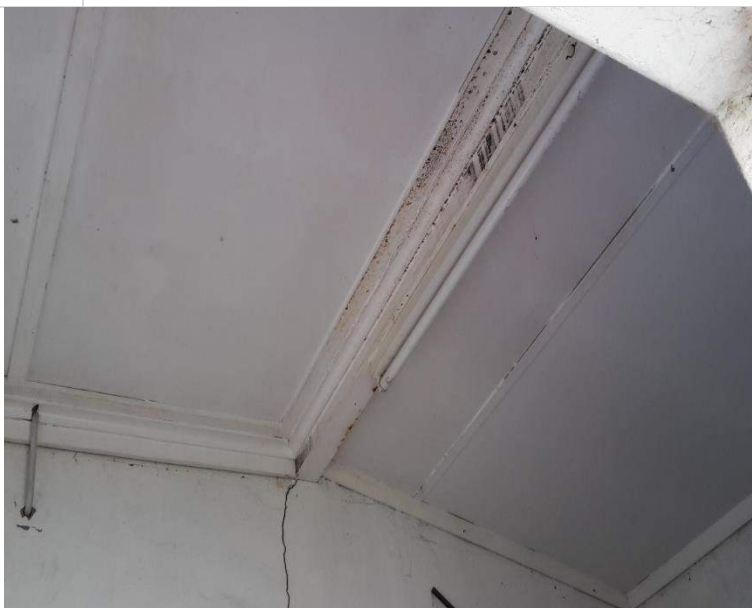
## Flat fibre cement sheet – S61

| <b>Condition:</b> | Generally intact |
| <b>Risk Assessment / Recommendation:</b> | Low risk, leave and maintain in current condition |

| <b>Reinspection / Removal Date:</b> | Remove prior to refurbishment / demolition works or reinspect in 5 years |

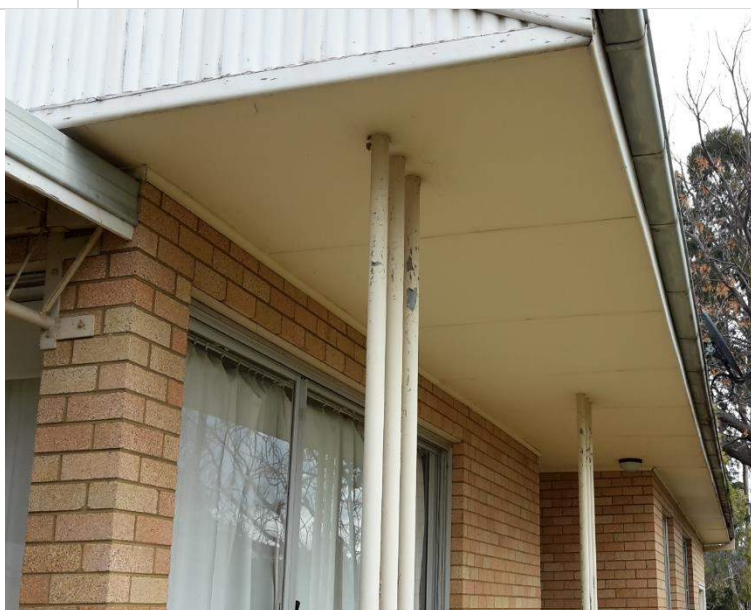
## Flat fibre cement sheet – S62

| <b>Condition:</b> | Generally intact |
| <b>Risk Assessment / Recommendation:</b> | Low risk, leave and maintain in current condition |

| <b>Reinspection / Removal Date:</b> | Remove prior to refurbishment / demolition works or reinspect in 5 years |

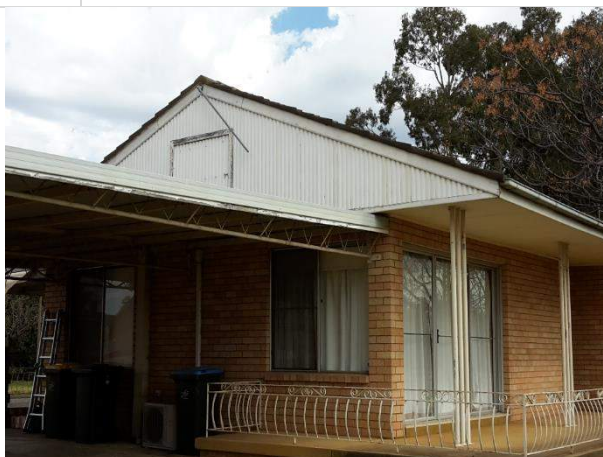
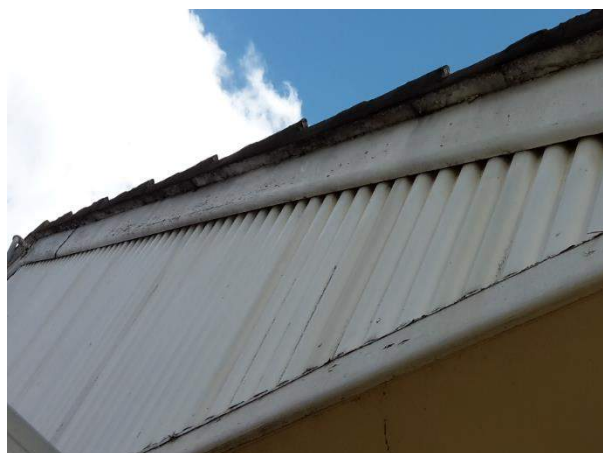
**Moulded fibre cement sheet – S63**

| <b>Condition:</b> | Generally intact |
| <b>Risk Assessment / Recommendation:</b> | Low risk, leave and maintain in current condition |

| <b>Reinspection / Removal Date:</b> | Remove prior to refurbishment / demolition works or reinspect in 5 years |

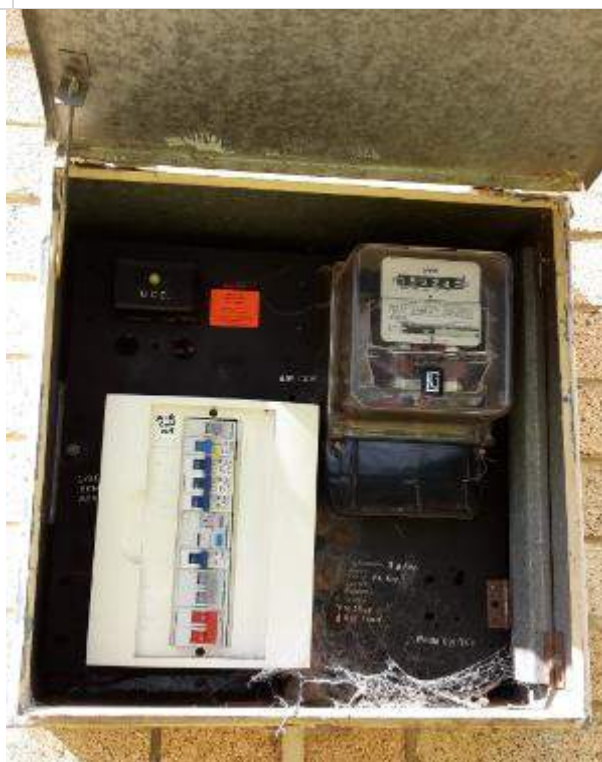
**Asbestos electrical backing board– S64**

| <b>Condition:</b> | Generally intact |
| <b>Risk Assessment / Recommendation:</b> | Low risk, leave and maintain in current condition |

| <b>Reinspection / Removal Date:</b> | Remove prior to refurbishment / demolition works or reinspect in 5 years |

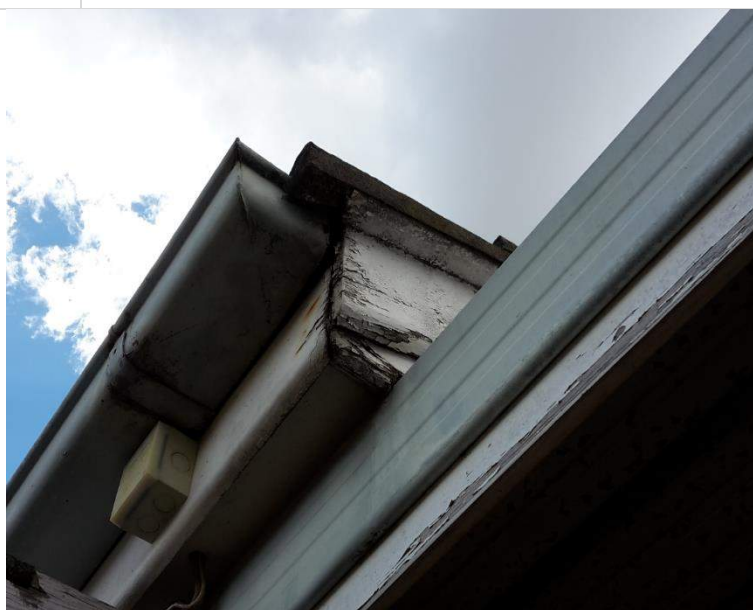
## Flat fibre cement sheet – S65

| <b>Condition:</b> | Generally intact |
| <b>Risk Assessment / Recommendation:</b> | Low risk, leave and maintain in current condition |

| <b>Reinspection / Removal Date:</b> | Remove prior to refurbishment / demolition works or reinspect in 5 years |

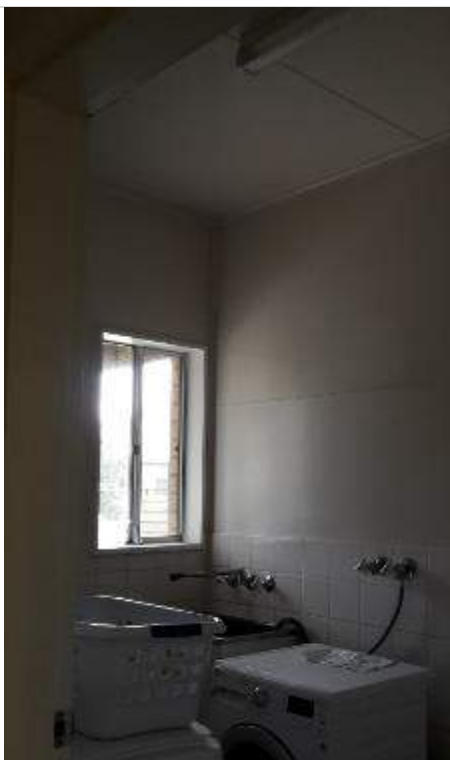
## Flat fibre cement sheet – S66

| <b>Condition:</b> | Generally intact |
| <b>Risk Assessment / Recommendation:</b> | Low risk, leave and maintain in current condition |

| <b>Reinspection / Removal Date:</b> | Remove prior to refurbishment / demolition works or reinspect in 5 years |
