| Mudgee District Hospital, Meares Street, Mudgee, NSW<br>Hazardous Building Materials Register - September 2017 | | | | | | | | | |

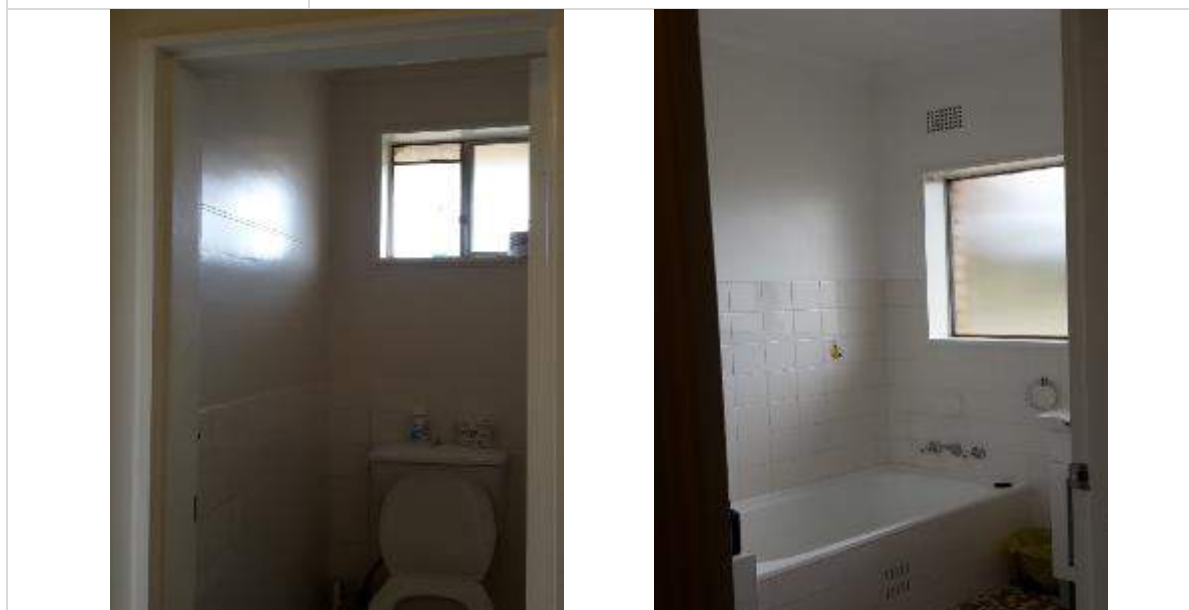
## Flat fibre cement sheet – S68

| <b>Condition:</b> | Generally intact |
| <b>Risk Assessment / Recommendation:</b> | Low risk, leave and maintain in current condition |

| <b>Reinspection / Removal Date:</b> | Remove prior to refurbishment / demolition works or reinspect in 5 years |
