Re: Request for Secretary Discretion – Wollar Solar Farm

Road Safety Audit

Stage 7 – Existing Condition

Intersection of Wollar Road (MR208) and Barigan Road,
Wollar

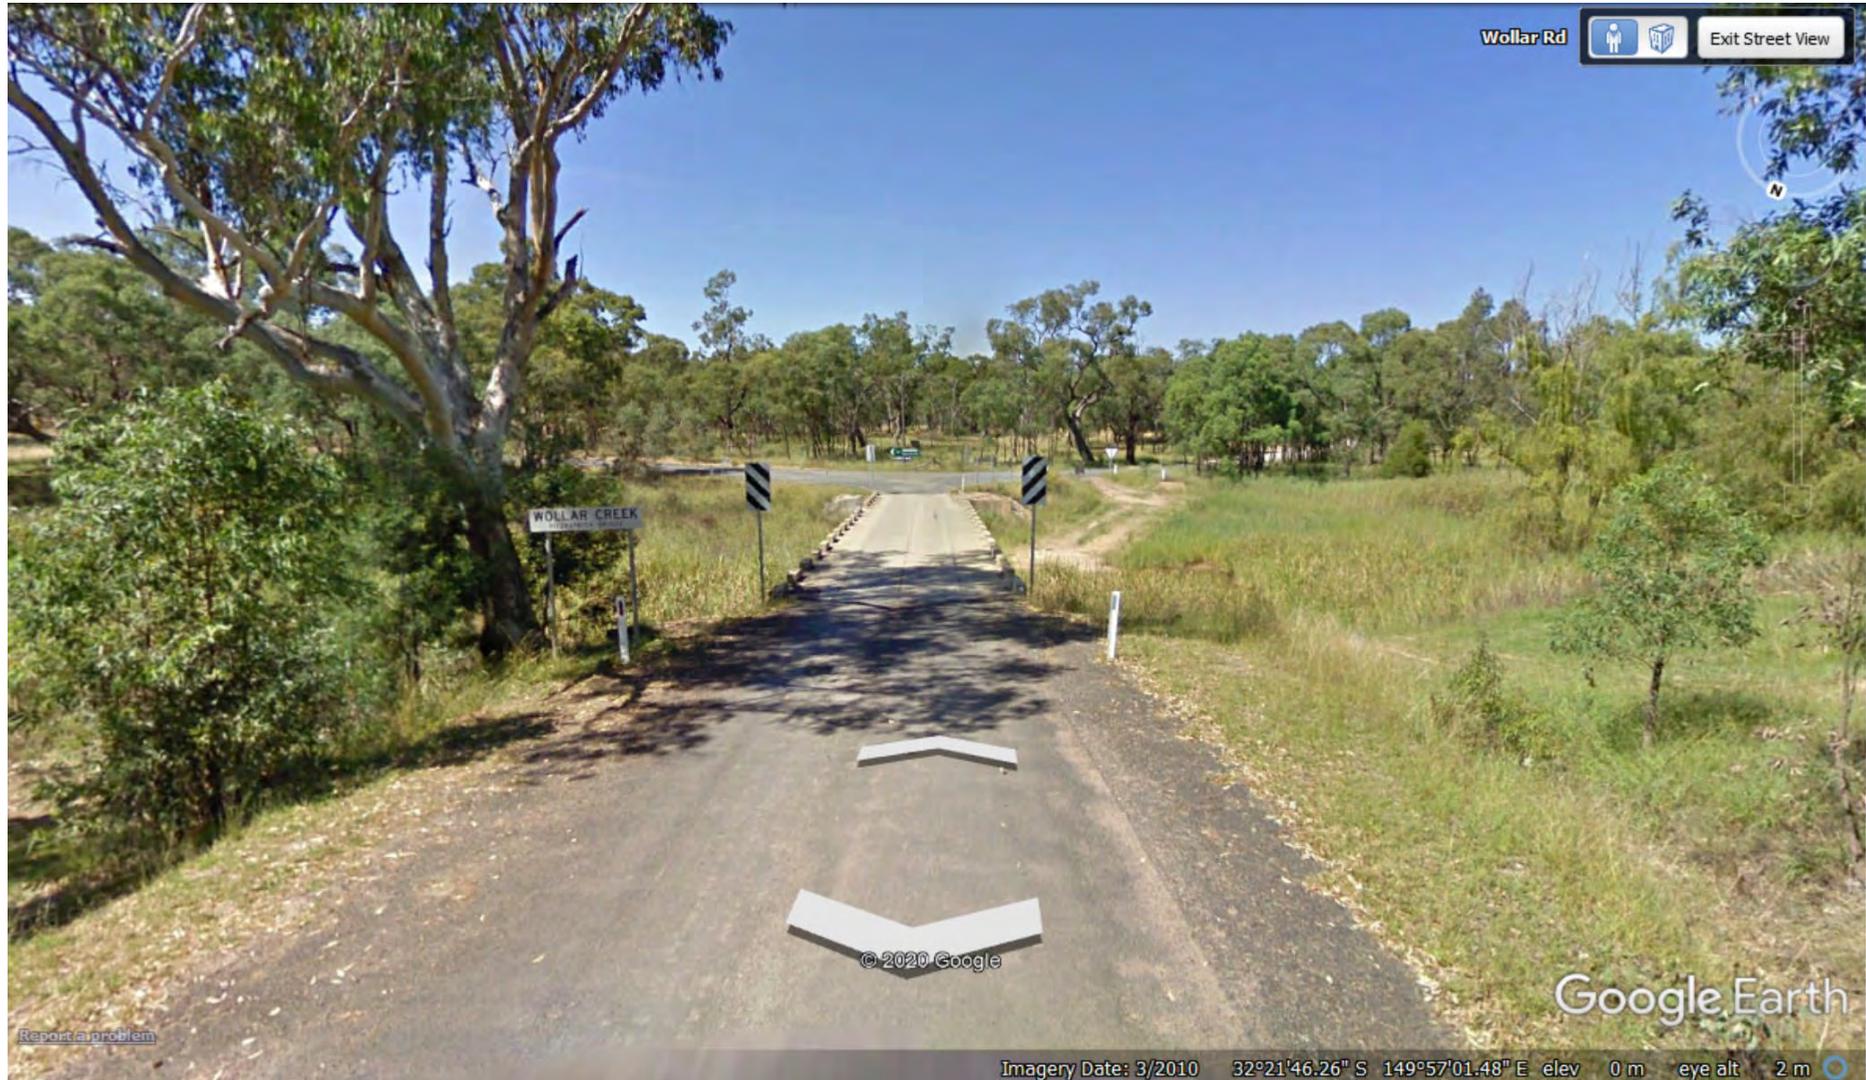
Travelling east on Wollar Road, away from Wollar village, intersection with Barigan Road visible on other side of bridge

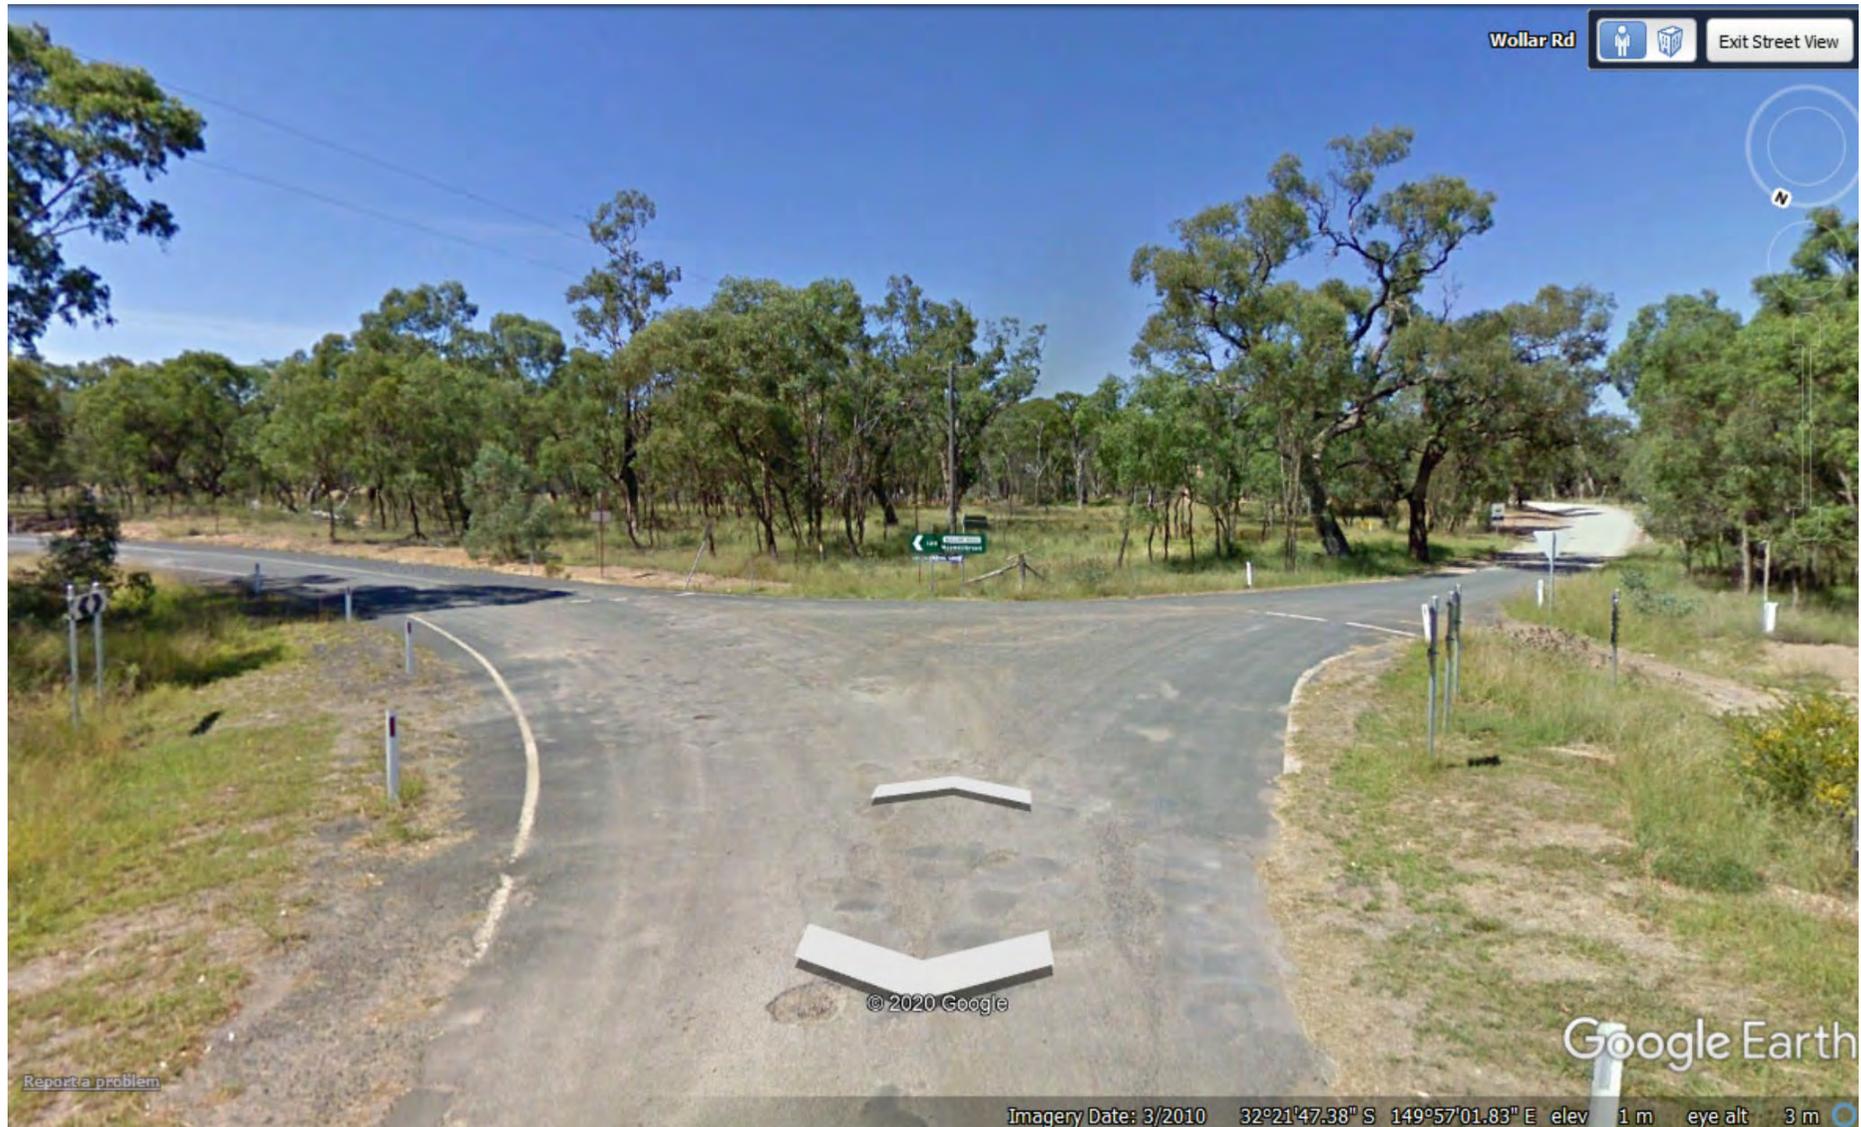
Travelling east on Wollar Rd, away from Wollar village, arriving at Barrigan Road intersection (Barrigan Road is road on the right of photo)
