# TREETALK

Arboricultural Impact Assessment  
Wentworthville Public School  
70 - 100 Fullagar Rd  
Wentworthville

Project No 5230/D2  
February 2019

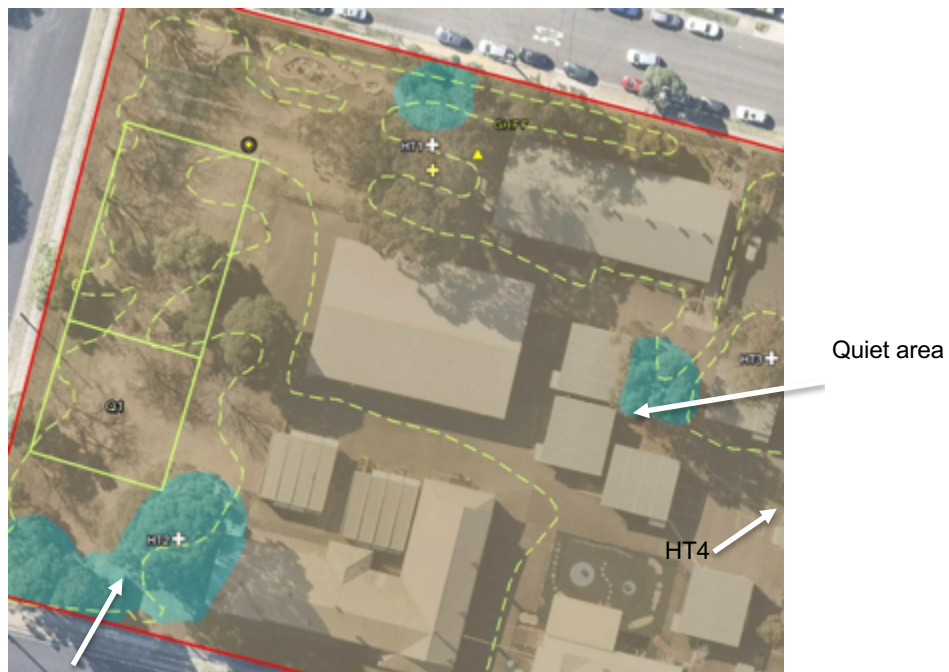
Image 18: Map of habitat tree locations as numbered and ecologically significant area in green

Nearby trees are semi-mature. They and are predominantly *Eucalyptus moluccana* and other endemic species. These have been accommodated within the design process. Some branches/trunks leaning on demountable buildings require management. Soil has been mulched and further mulching will be beneficial. Copy of plan in Image below.
