# Dilapidation Report Pre-Construction

## Bonshaw Solar Farm Development

Bonshaw Solar Farm Road Dilapidation Survey

9/09/2025

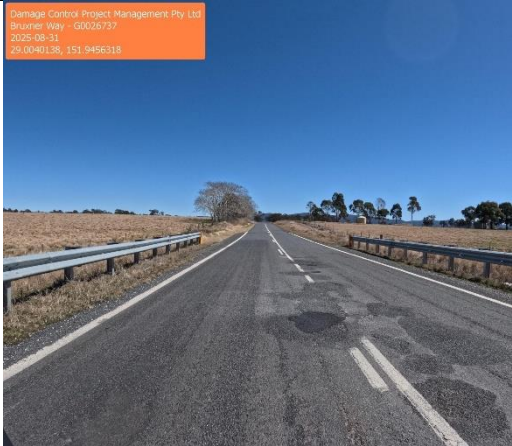
| Defect ID | Start CH | End CH | Defect Type (and side of road) | Image |
|---|---|---|---|---|
| 1 | 5609 | 5619 | Seal – stripping (centre)<br><br>Pavement failure (centre) | |

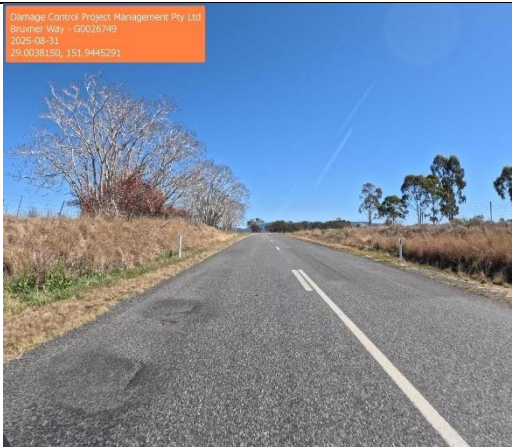
| Defect ID | Start CH | End CH | Defect Type (and side of road) | Image |
|---|---|---|---|---|
| 2 | 5719 | 5719 | Pavement failure/depression (left) | |

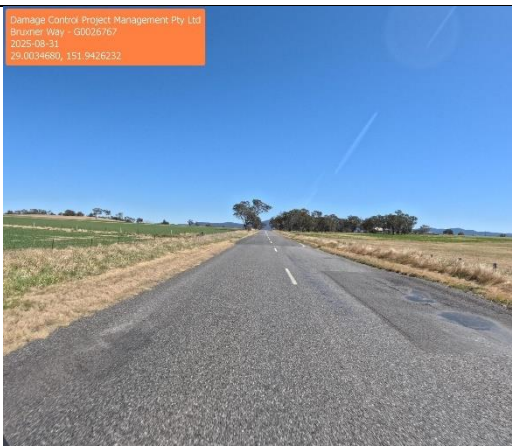
| Defect ID | Start CH | End CH | Defect Type (and side of road) | Image |
|---|---|---|---|---|
| 3 | 5889 | 5939 | Pavement failure (both) | |

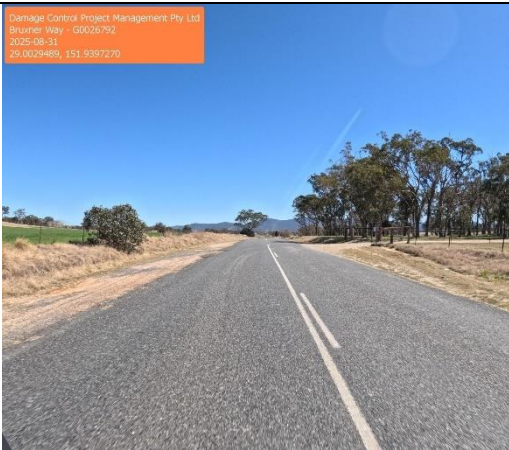
| 4 | 6169 | 6249 | Edge break (left) | <p>Damage Control Project Management Pty Ltd<br/>Bruner Way - G0026792<br/>2025-08-31<br/>29.0029485, 151.9397270</p> |

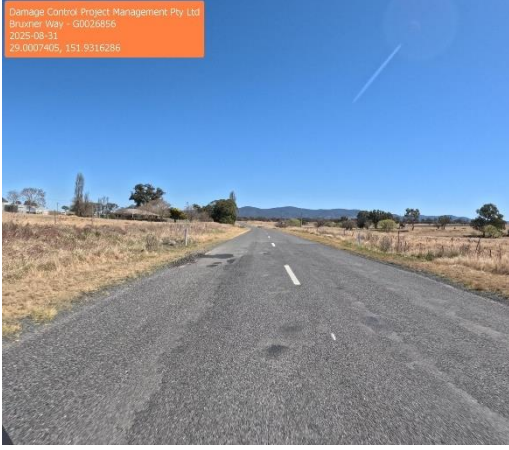
| 5 | 7019 | 7029 | Pavement failure (left) | <p>Damage Control Project Management Pty Ltd<br/>Bruner Way - G0026856<br/>2025-08-31<br/>29.0007405, 151.9316286</p> |

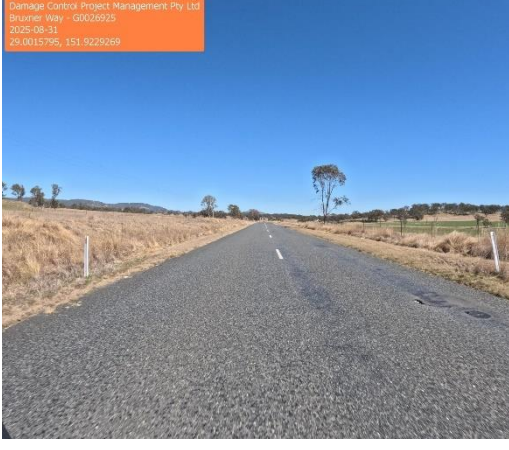
| 6 | 7909 | 7949 | Potholes (right)<br><br>Pavement failure (right)<br><br>Seal – flushing (right) | <p>Damage Control Project Management Pty Ltd<br/>Bruner Way - G0026925<br/>2025-08-31<br/>29.0015795, 151.9229269</p> |

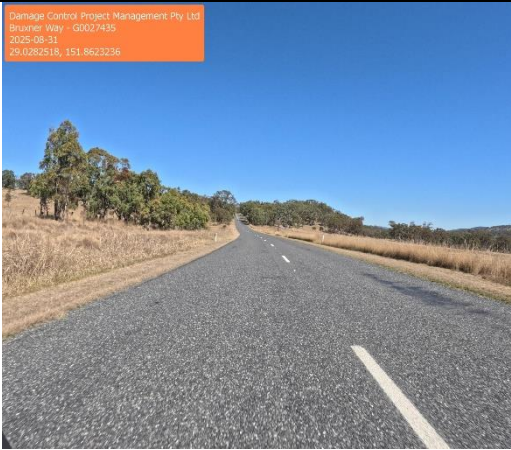
| 10 | 14789 | 14789 | Seal – flushing (right)<br><br>Pavement deformation (right) | |

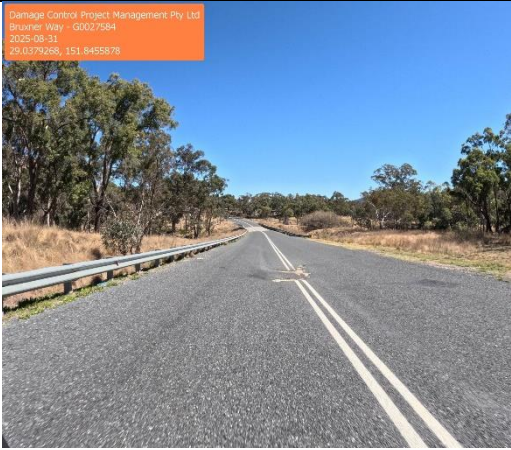
| 11 | 16809 | 16809 | Potholes (centre) | |

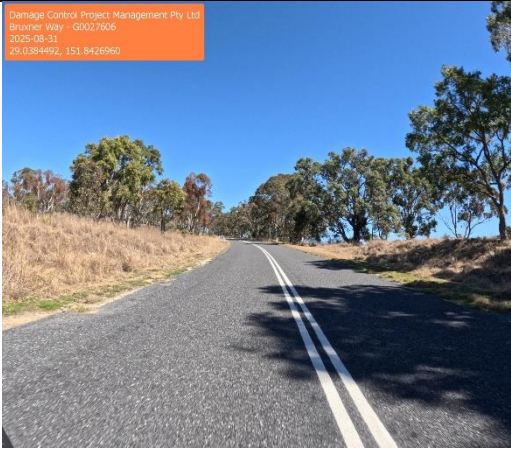
| 12 | 17119 | 17139 | Edge drop (left) | |

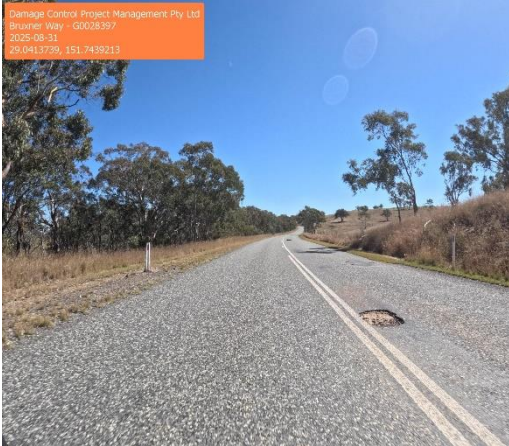
| 19 | 27719 | 27759 | Potholes (right)<br><br>Seal – flushing (right) | |

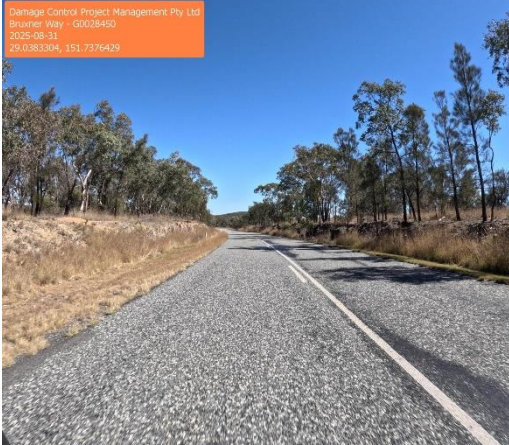
| 20 | 28549 | 28669 | Seal – flushing (right) | |

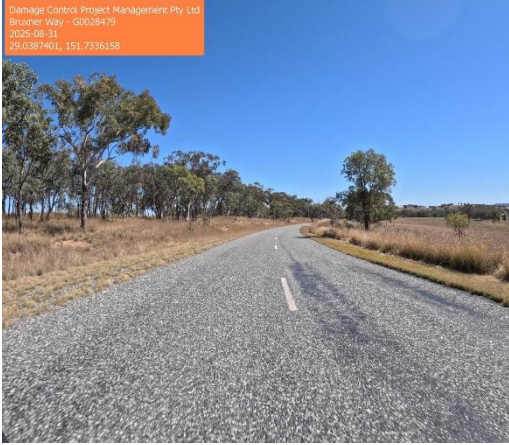
| 21 | 28839 | 29569 | Seal – flushing (right)<br><br>Rutting (right) | |

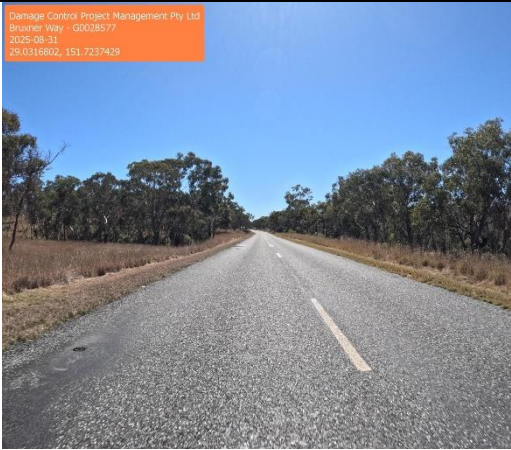
| 22 | 30149 | 30200 | Pavement deformation (left)<br><br>Potholes (left) | <p>Damage Control Project Management Pty Ltd<br/>Braemar Way - G0028577<br/>2025-08-31<br/>29.0316892, 151.7237429</p> |

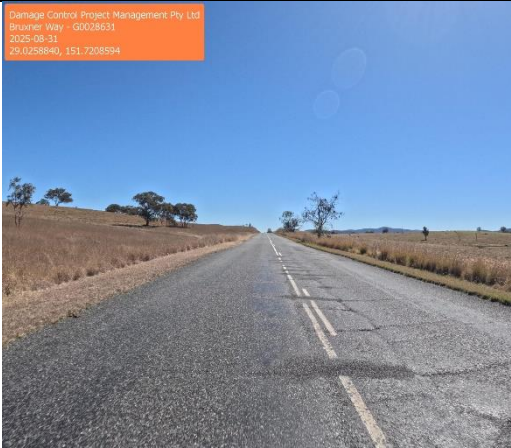
| 23 | 30879 | 31379 | Cracking – block (right) | <p>Damage Control Project Management Pty Ltd<br/>Braemar Way - G0028631<br/>2025-08-31<br/>29.0258846, 151.7208594</p> |

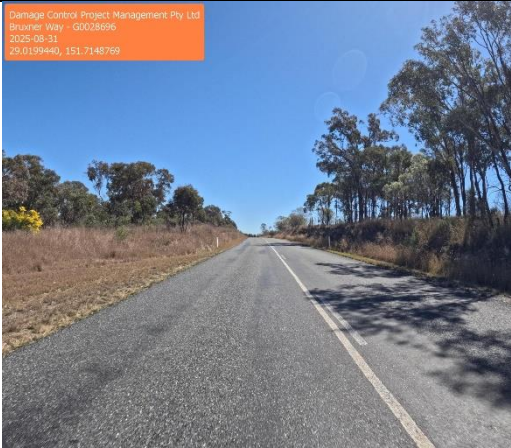
| 24 | 31779 | 32029 | Seal – flushing (both) | <p>Damage Control Project Management Pty Ltd<br/>Braemar Way - G0028696<br/>2025-08-31<br/>29.0199440, 151.7148769</p> |

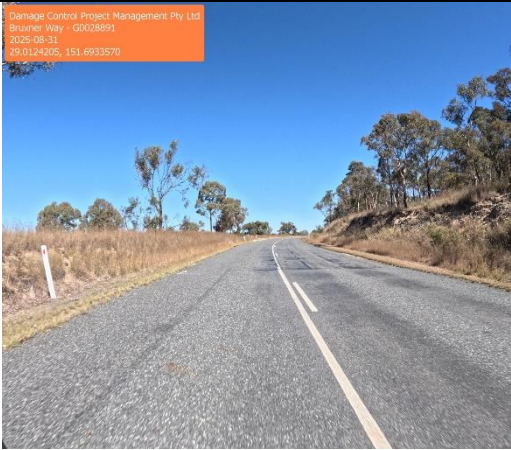
| 28 | 34399 | 34439 | Pavement failure (both) | <p>Damage Control Project Management Pty Ltd<br/>Braemar Way - G0028891<br/>2025-08-31<br/>29.0124205, 151.6933570</p> |

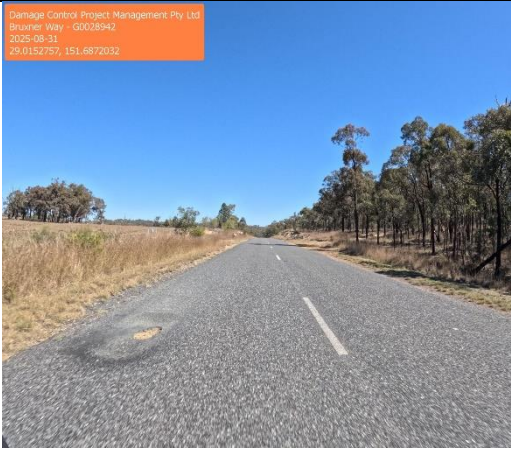
| 29 | 35019 | 35289 | Potholes (left) | <p>Damage Control Project Management Pty Ltd<br/>Braemar Way - G0028942<br/>2025-08-31<br/>29.0152757, 151.6872032</p> |

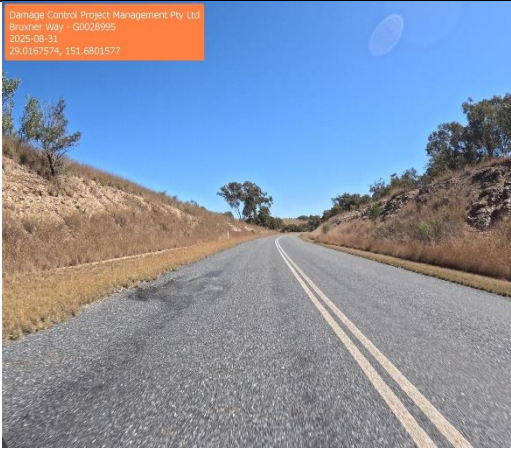
| 30 | 35799 | 35809 | Pavement failure (left) | <p>Damage Control Project Management Pty Ltd<br/>Braemar Way - G0028995<br/>2025-08-31<br/>29.0167574, 151.6801577</p> |

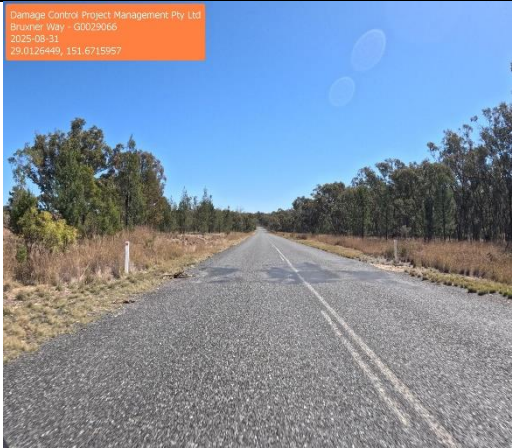
| 32 | 36759 | 36769 | Pavement failure (both) | <div> <div> Damage Control Project Management Pty Ltd<br/> Braemar Way - G0029066<br/> 2025-08-31<br/> 29.0125448, 151.6715957 </div> </div> |

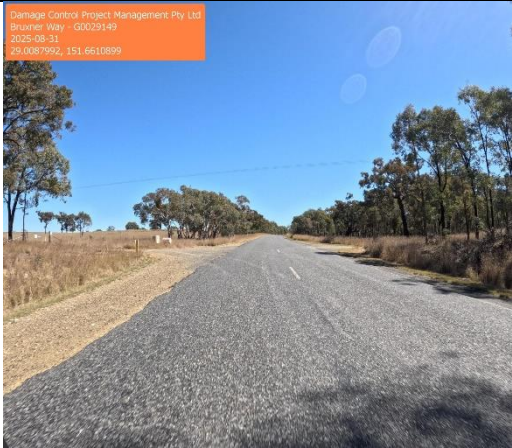
| 33 | 37839 | 37939 | Edge break (left) | <div> <div> Damage Control Project Management Pty Ltd<br/> Braemar Way - G0029149<br/> 2025-08-31<br/> 29.0087992, 151.6610899 </div> </div> |

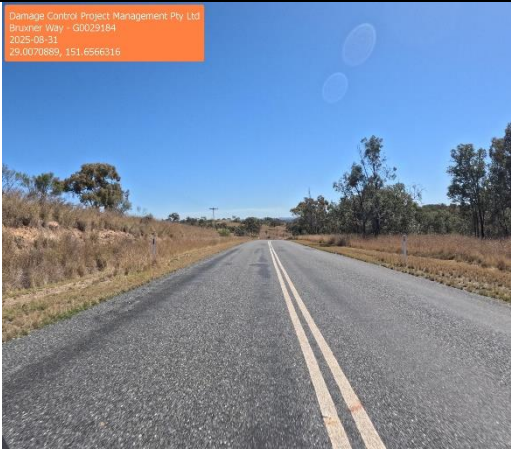
| 34 | 38349 | 38449 | Seal – flushing (left) | <p>Damage Control Project Management Pty Ltd<br/>Brunner Way - G0029184<br/>2025-08-31<br/>29.0070880, 151.6566316</p> |

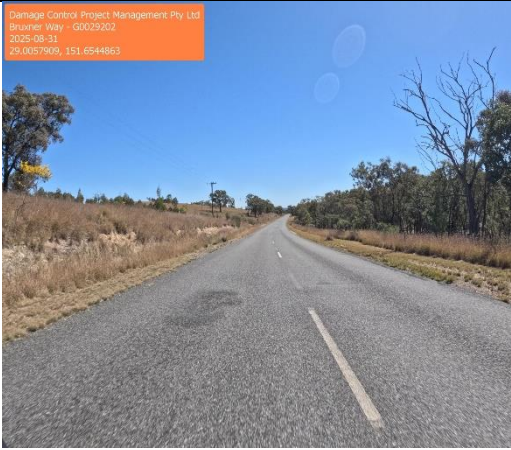
| 35 | 38599 | 38609 | Cracking (left) | <p>Damage Control Project Management Pty Ltd<br/>Brunner Way - G0029202<br/>2025-08-31<br/>29.0057908, 151.6544863</p> |

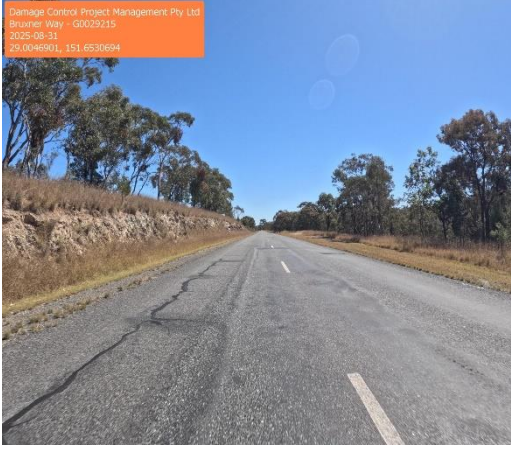
| 36 | 38769 | 38869 | Pavement failure (both) | <p>Damage Control Project Management Pty Ltd<br/>Brunner Way - G0029215<br/>2025-08-31<br/>29.0048901, 151.6530694</p> |

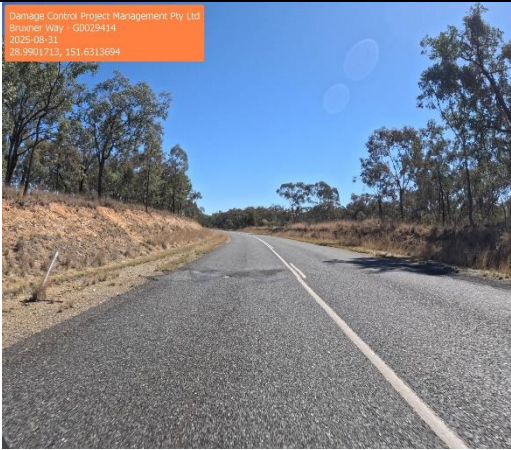
| 40 | 41489 | 41489 | Pavement failure (left) | |

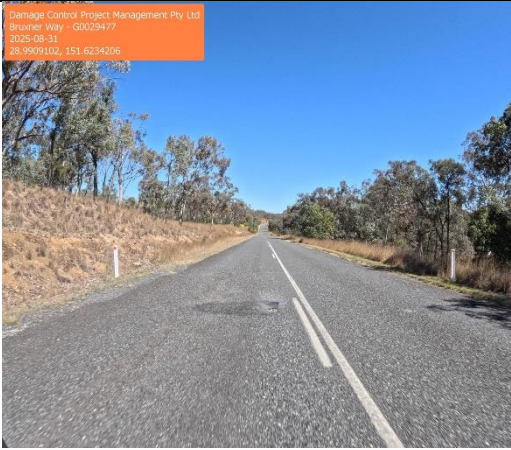
| 41 | 42329 | 46159 | Potholes (left) | |

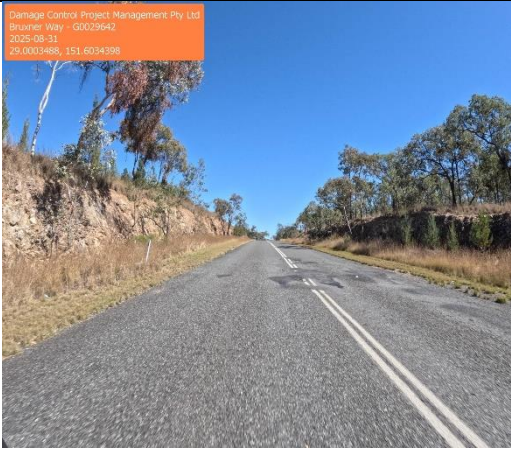
| 42 | 44569 | 44599 | Pavement failures (right) | |

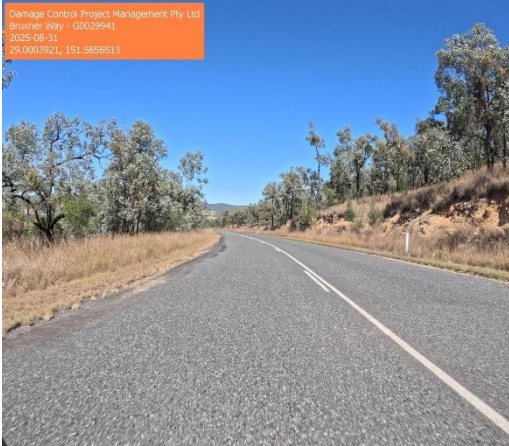
| 43 | 48629 | 48649 | Pavement failure (left)<br><br>Edge break (left) | |

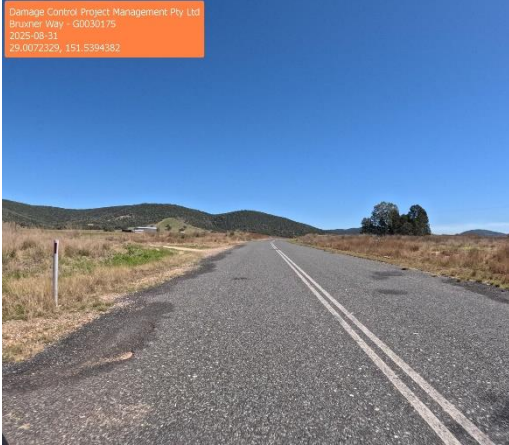
| 44 | 51779 | 51919 | Edge break (left) | |

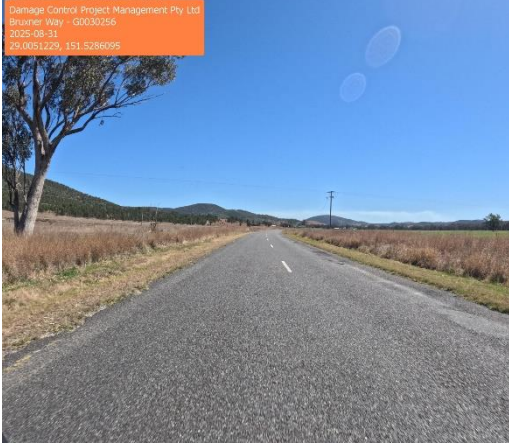
| 45 | 52869 | 53189 | Pavement failure (right) | |

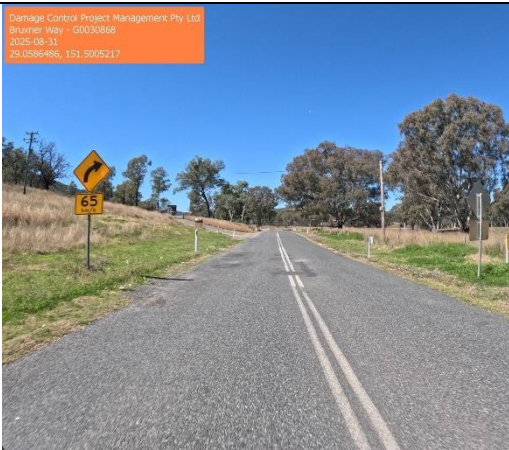
| 49 | 61089 | 61189 | Pavement failures (left) | <p>Damage Control Project Management Pty Ltd<br/>Bruner Way - G0030868<br/>2025-08-31<br/>29.058485, 151.505217</p> |

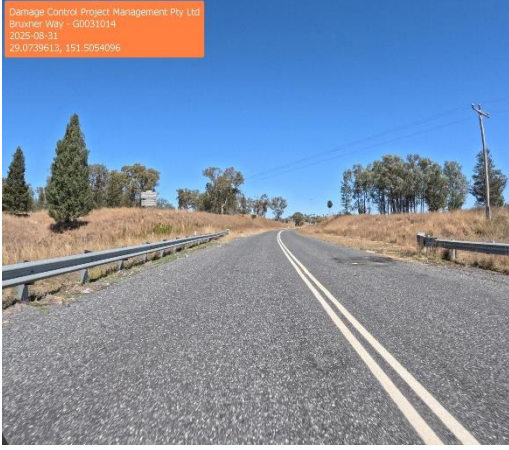
| 50 | 63009 | 63789 | Potholes (right) | <p>Damage Control Project Management Pty Ltd<br/>Bruner Way - G0031014<br/>2025-08-31<br/>29.0739613, 151.5054096</p> |

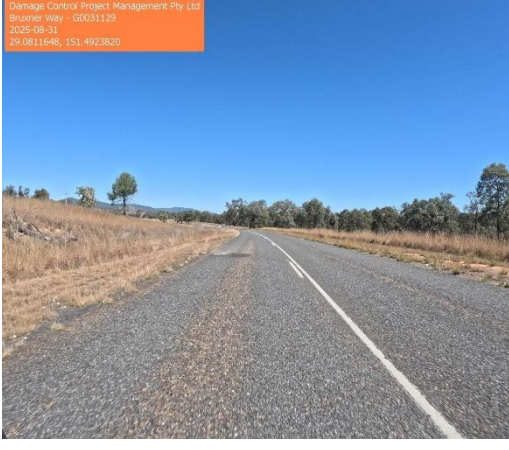
| 51 | 64589 | 65089 | Potholes (left) | <p>Damage Control Project Management Pty Ltd<br/>Bruner Way - G0031129<br/>2025-08-31<br/>29.0811648, 151.4923820</p> |

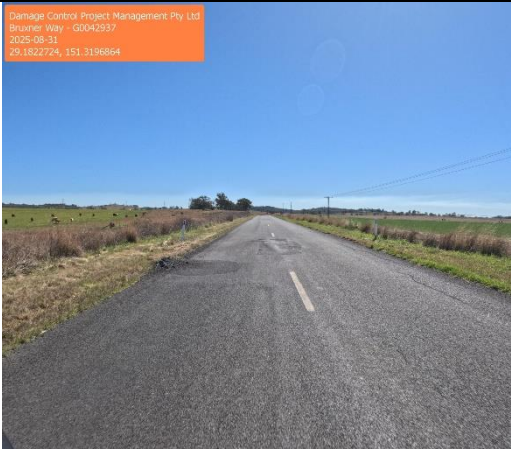
| 55 | 87789 | 87989 | Pavement failures (both)<br><br>Cracking (right) | <p>Damage Control Project Management Pty Ltd<br/>Braemar Way - G0042937<br/>2025-08-31<br/>29.1822724, 151.3186864</p> |

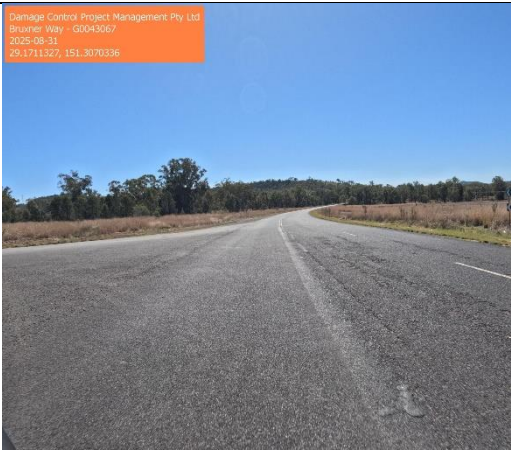
| 56 | 89489 | 89589 | Seal stripping (left) | <p>Damage Control Project Management Pty Ltd<br/>Braemar Way - G0043067<br/>2025-08-31<br/>29.1711327, 151.3070336</p> |

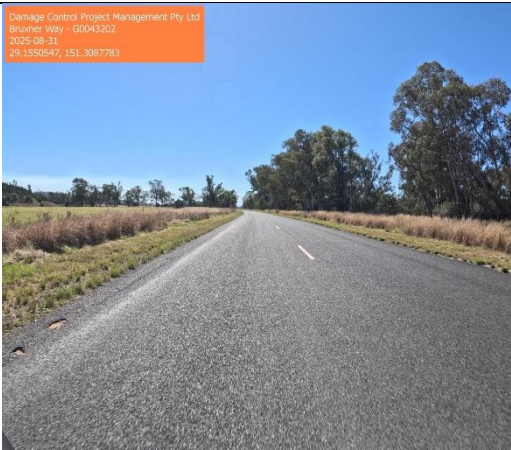
| 57 | 91369 | 91369 | Potholes (left) | <p>Damage Control Project Management Pty Ltd<br/>Braemar Way - G0043202<br/>2025-08-31<br/>29.1550547, 151.3087783</p> |

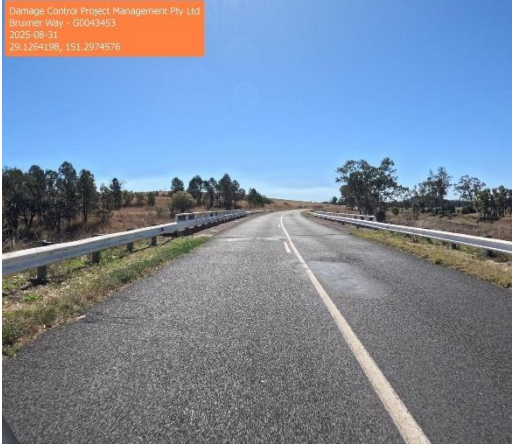
| 58 | 94759 | 94769 | Pavement failures (both) | <p>Damage Control Project Management Pty Ltd<br/>Brunner Way - G0043453<br/>2025-08-31<br/>29.1264136, 151.2974576</p> |

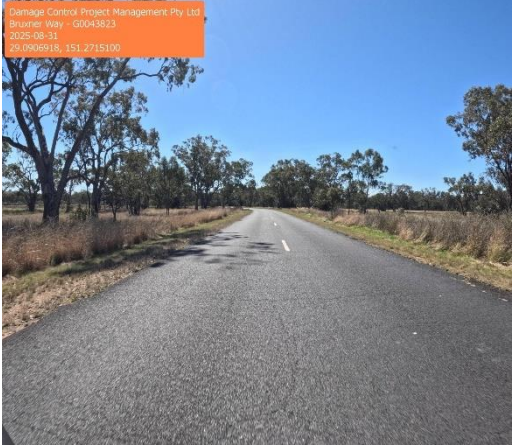
| 59 | 99489 | 100439 | Cracking (both) | <p>Damage Control Project Management Pty Ltd<br/>Brunner Way - G0043823<br/>2025-08-31<br/>29.0906918, 151.2715100</p> |

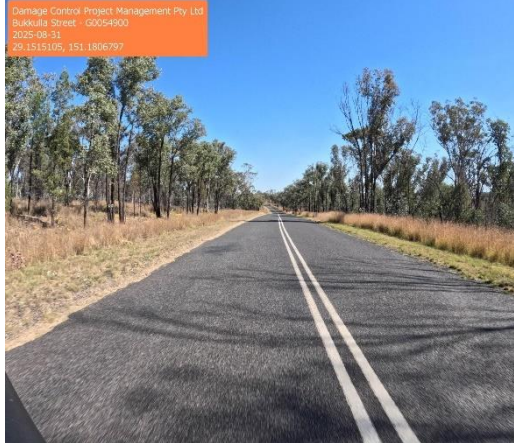
| 16 | 13000 | 13100 | Edge drop (left) | <p>Damage Control Project Management Pty Ltd<br/>Bukkalla Street - G0054900<br/>2025-08-31<br/>29.1515105, 151.1806797</p> |

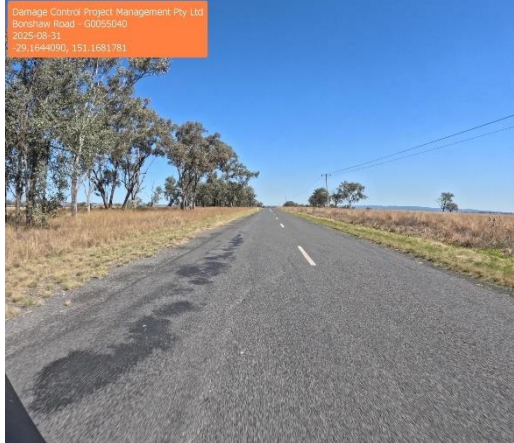
| 17 | 14900 | 14950 | Seal – flushing (left) | <p>Damage Control Project Management Pty Ltd<br/>Bonshaw Road - G0055040<br/>2025-08-31<br/>29.1644050, 151.1661761</p> |

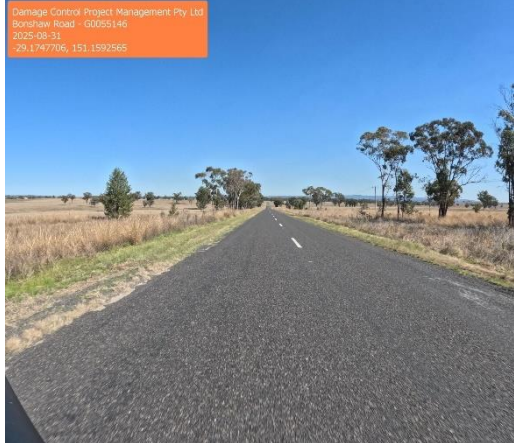
| 18 | 16350 | 16350 | Pavement failure (right)<br><br>Cracking (right) | <p>Damage Control Project Management Pty Ltd<br/>Bonshaw Road - G0055146<br/>2025-08-31<br/>29.1747706, 151.1592565</p> |

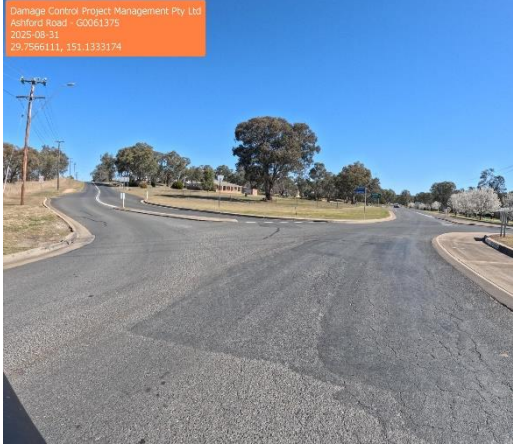
| 10 | 51400 | 51450 | Cracking (left)<br><br>Pavement failures (left) | <div data-bbox="908 159 1114 217" data-label="Text"> <p>Damage Control Project Management Pty Ltd<br/> Ashford Road - G0061375<br/> 2025-08-31<br/> 29,7566111, 151,1333174</p> </div> |

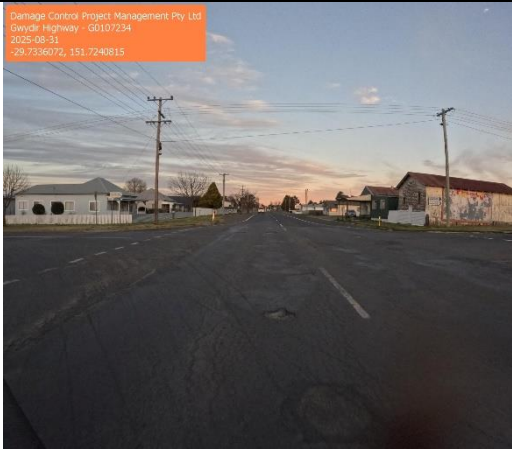
| 9 | 65650 | 65690 | Potholes (both)<br><br>Cracking (both)<br><br>Pavement failures (both) | <div> <div> Damage Control Project Management Pty Ltd<br/> Gwydir Highway - G0107234<br/> 2025-08-31<br/> 29.7336072, 151.7240815 </div> </div> |

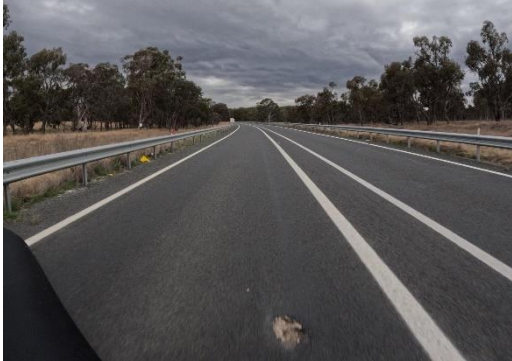
| 3 | 10570 | 10570 | Potholes (left) | <div> <div> Damage Control Project Management Pty Ltd<br/> New England Highway - G0028318<br/> 2025-09-01<br/> 29.65639633, 151.7878523 </div> </div> |

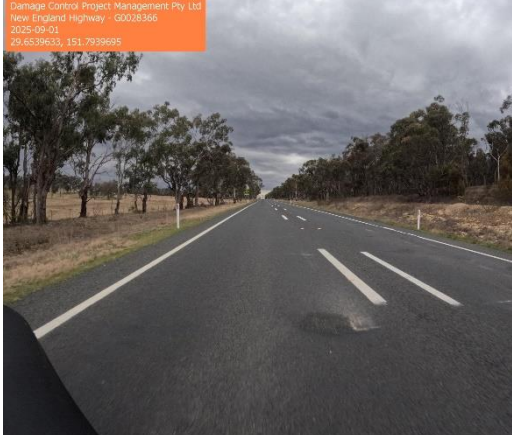
| 4 | 11220 | 12450 | Pavement failures (both)<br><br>Cracking (both)<br><br>Potholes (both) | <div> <div> Damage Control Project Management Pty Ltd<br/> New England Highway - G0028366<br/> 2025-09-01<br/> 29.6539633, 151.7939995 </div> </div> |

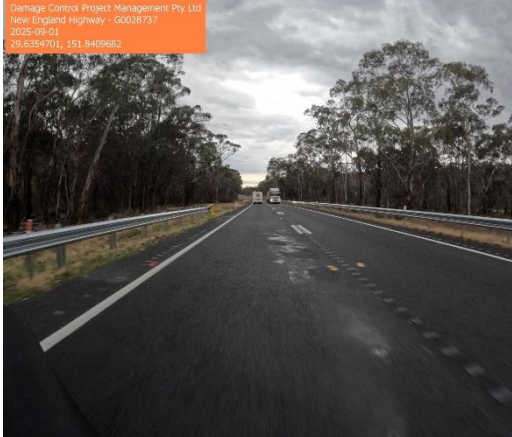
| 5 | 16200 | 16360 | Pavement failures (left)<br><br>Cracking (left) | <div> <div> Damage Control Project Management Pty Ltd<br/> New England Highway - G0028737<br/> 2025-09-01<br/> 29.6354701, 151.8409682 </div> </div> |

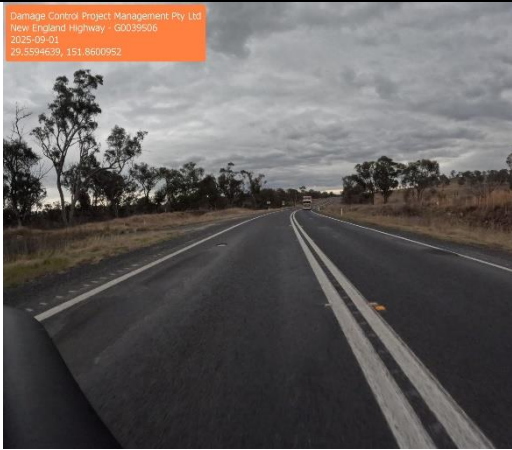
| 6 | 26470 | 26500 | Potholes (left)<br><br>Pavement failures (left) | <div> <div> Damage Control Project Management Pty Ltd<br/> New England Highway - G0039506<br/> 2025-09-01<br/> 29.5594639, 151.8600952 </div> </div> |

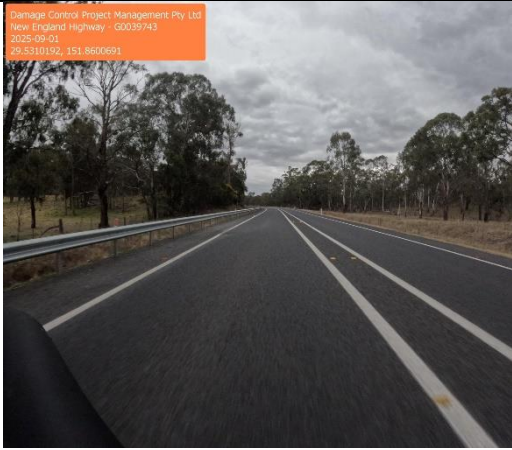
| 7 | 29660 | 29670 | Potholes (left)<br><br>Pavement failures (left) | <div> <div> Damage Control Project Management Pty Ltd<br/> New England Highway - G0039743<br/> 2025-09-01<br/> 29.5310192, 151.8600591 </div> </div> |

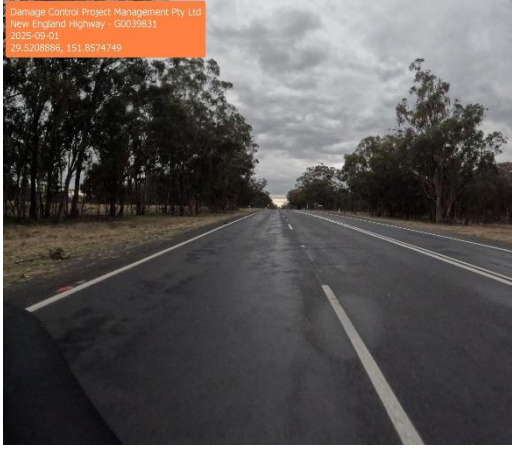
| 8 | 30820 | 31100 | Seal – flushing (both) | <div> <div> Damage Control Project Management Pty Ltd<br/> New England Highway - G0039831<br/> 2025-09-01<br/> 29.5208886, 151.8574749 </div> </div> |

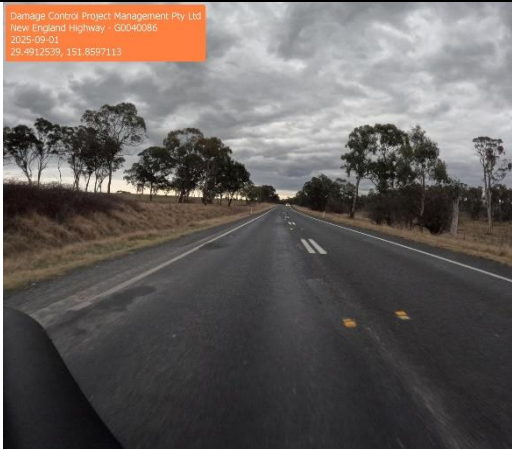
| 9 | 34250 | 34800 | Pavement failures (left)<br><br>Potholes (left) | <div> <div> Damage Control Project Management Pty Ltd<br/> New England Highway - G0040086<br/> 2025-09-01<br/> 29.4912539, 151.8597113 </div> </div> |

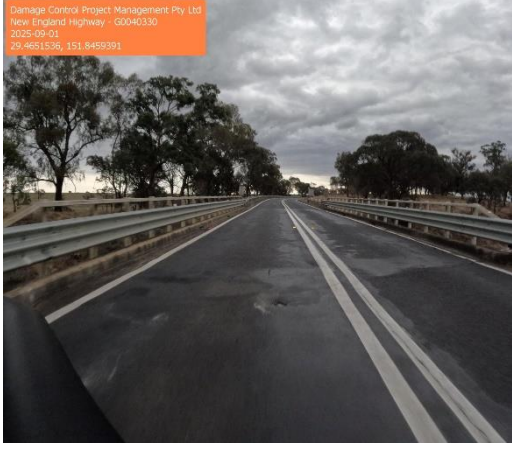
| 10 | 37600 | 37600 | Potholes (left)<br><br>Pavement failures left) | <div> <div> Damage Control Project Management Pty Ltd<br/> New England Highway - G0040130<br/> 2025-09-01<br/> 29.4651536, 151.8459391 </div> </div> |

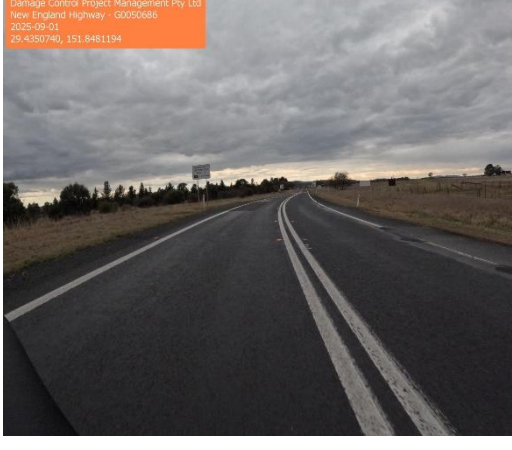
| 11 | 41250 | 41280 | Pavement failures (right) | <div> <div> Damage Control Project Management Pty Ltd<br/> New England Highway - G0050686<br/> 2025-09-01<br/> 29.4350740, 151.8481194 </div> </div> |
