# Arboricultural Impact Assessment

Revision 4

Western Sydney University, Milperra Campus  
NSW, 2214  
2/-/DP129184 + 1/-/DP101147  
Job No. 2400116  
19/03/2026

**Temporal Tree Management Pty Ltd.**

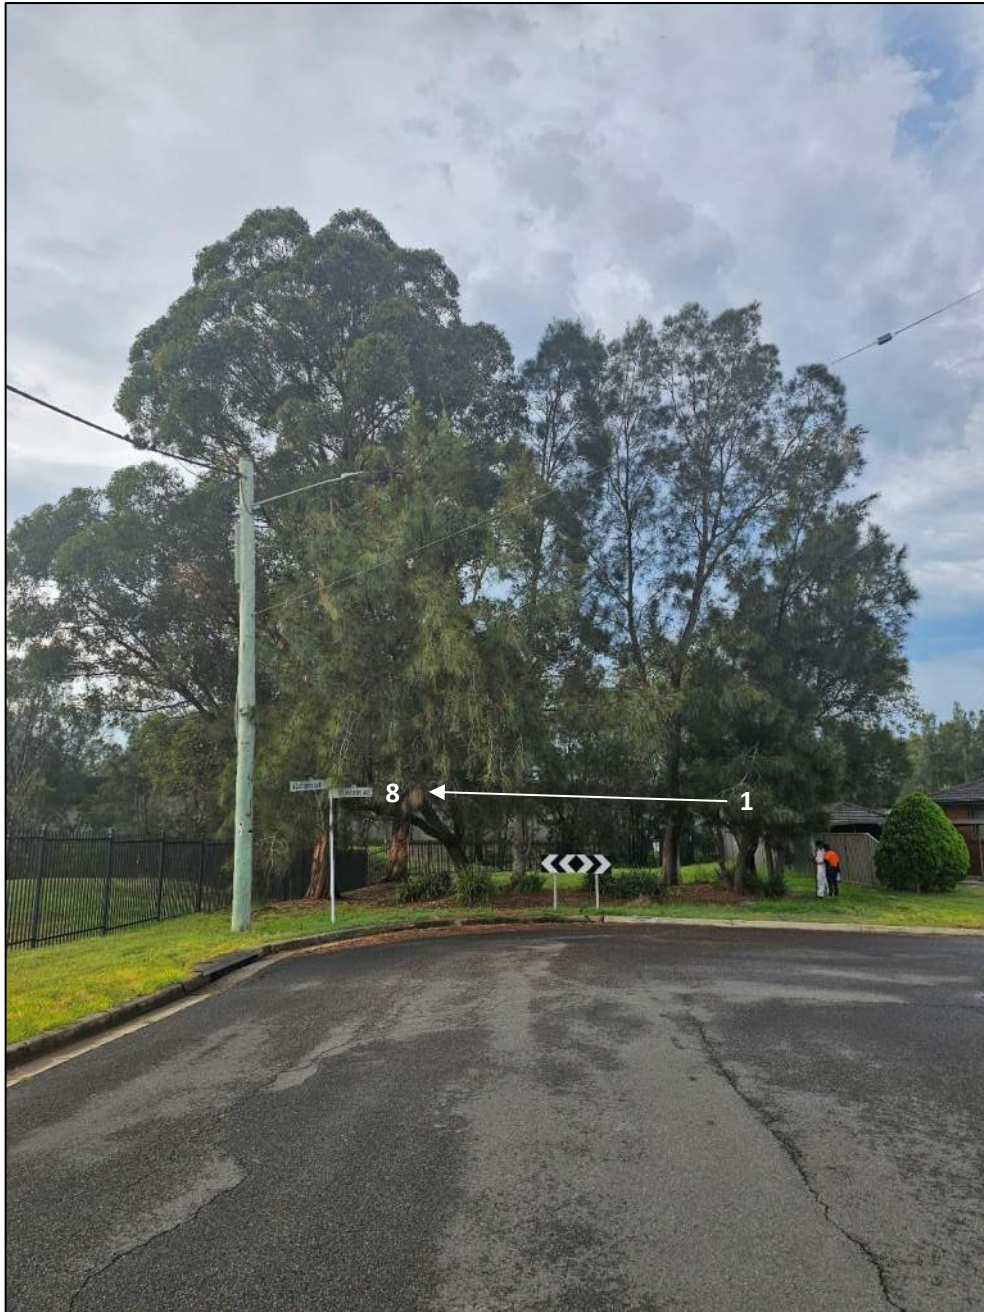
**Figure 1 Council managed Trees 1 - 8 in the drainage reserve**

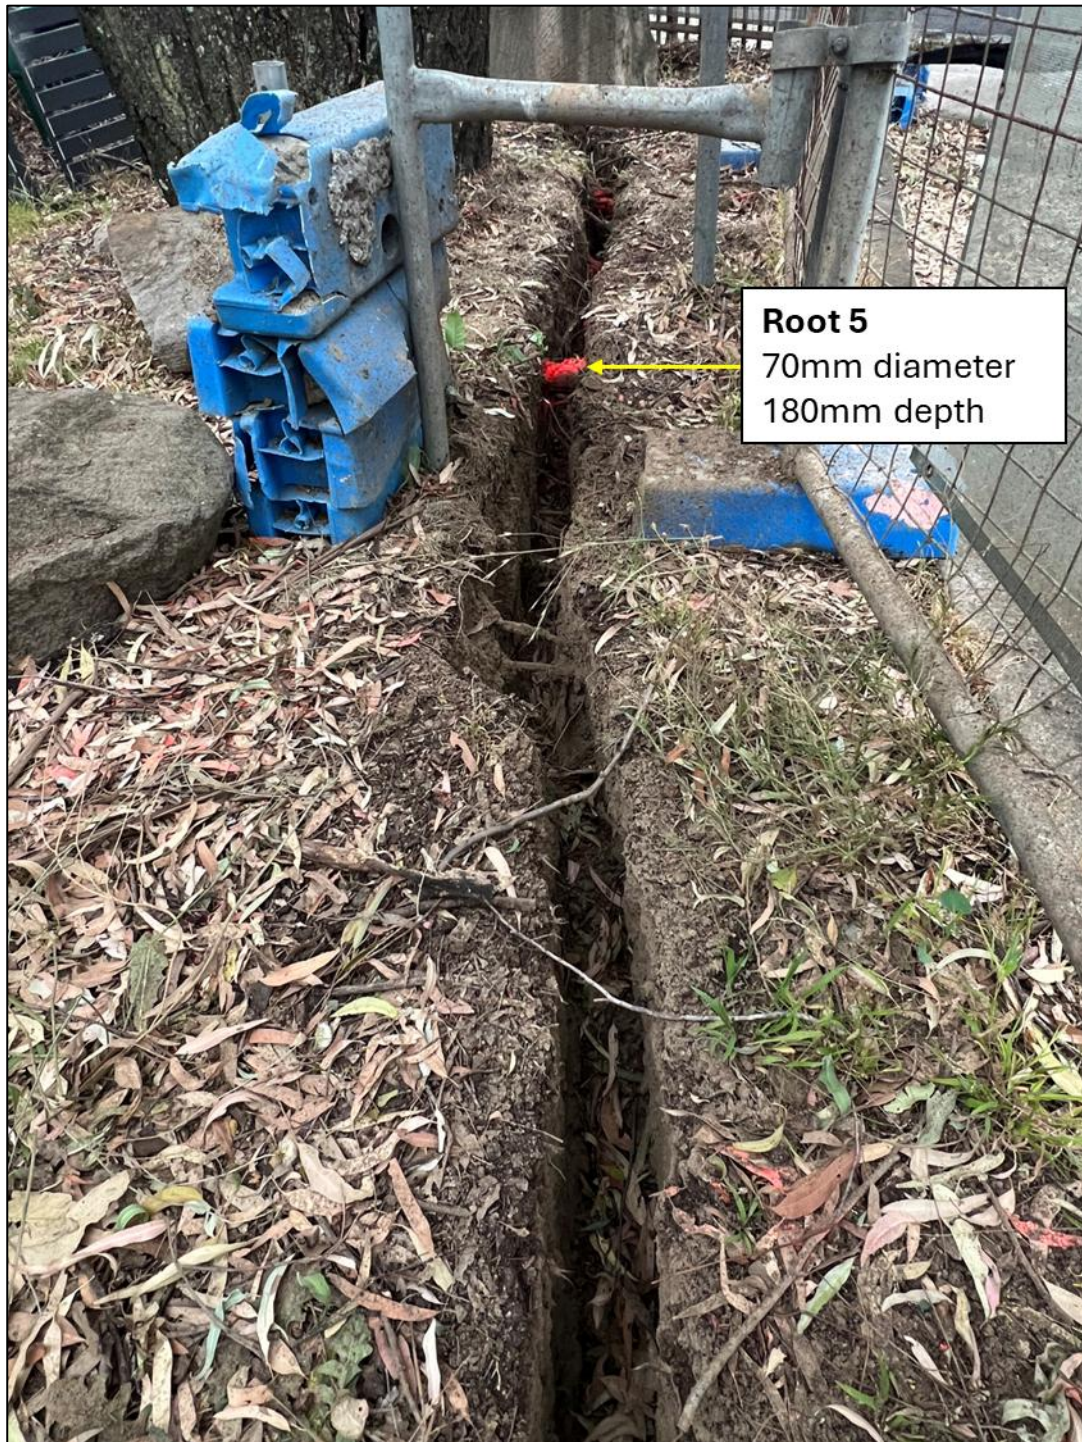
Figure 8. Northern portion of Survey Trench 1.

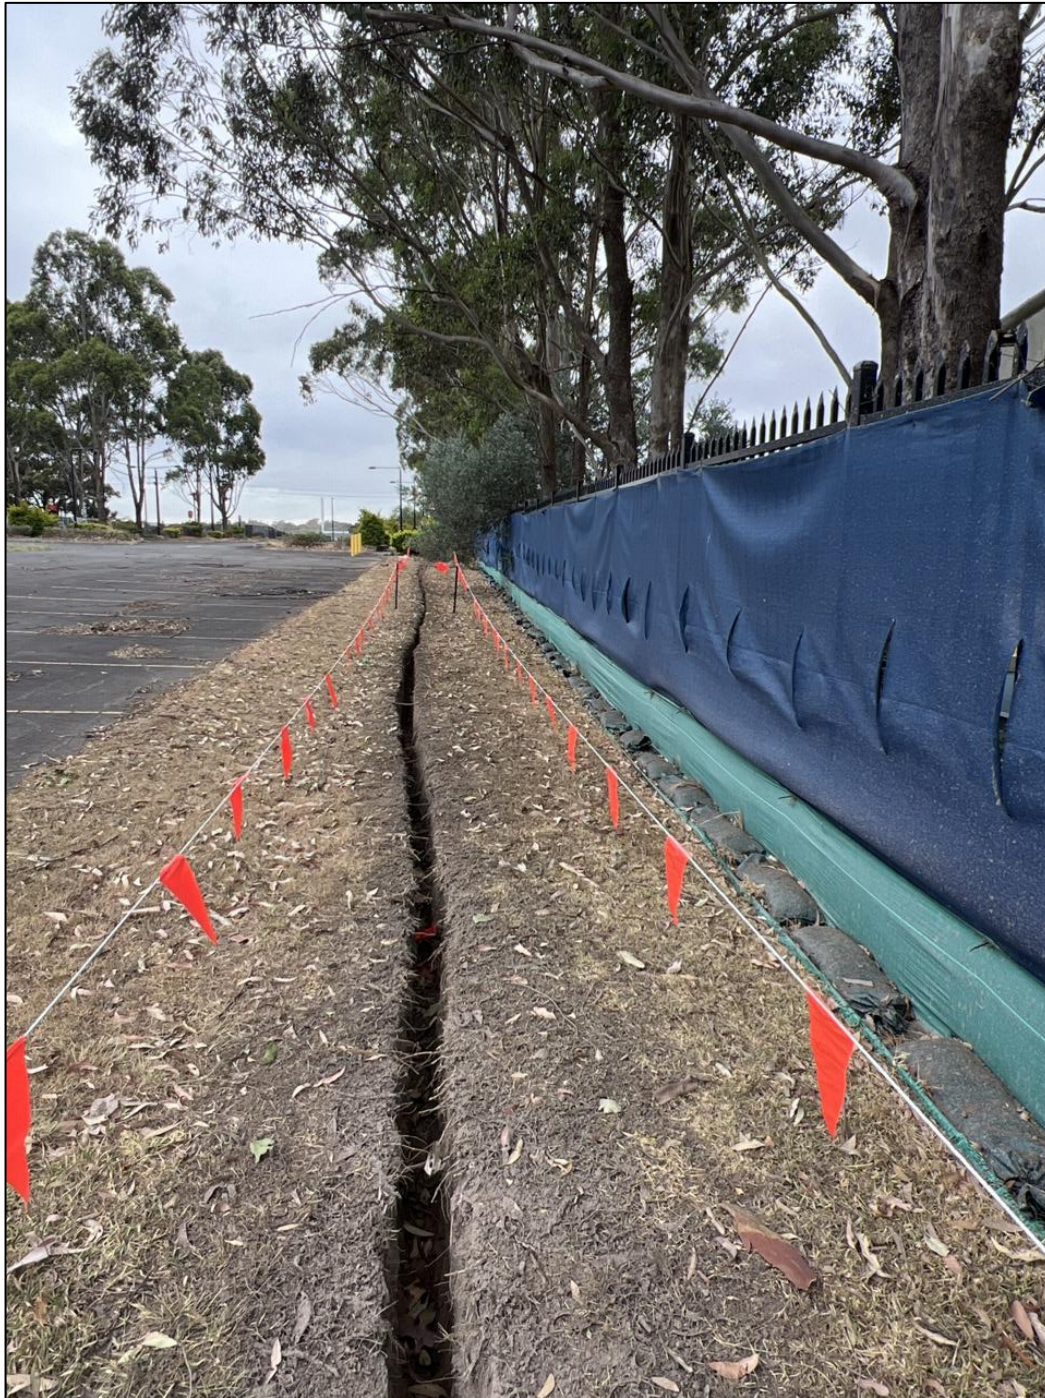
Figure 10. Survey Trench 2 with eleven Major roots encountered. Image taken from western edge of trench.

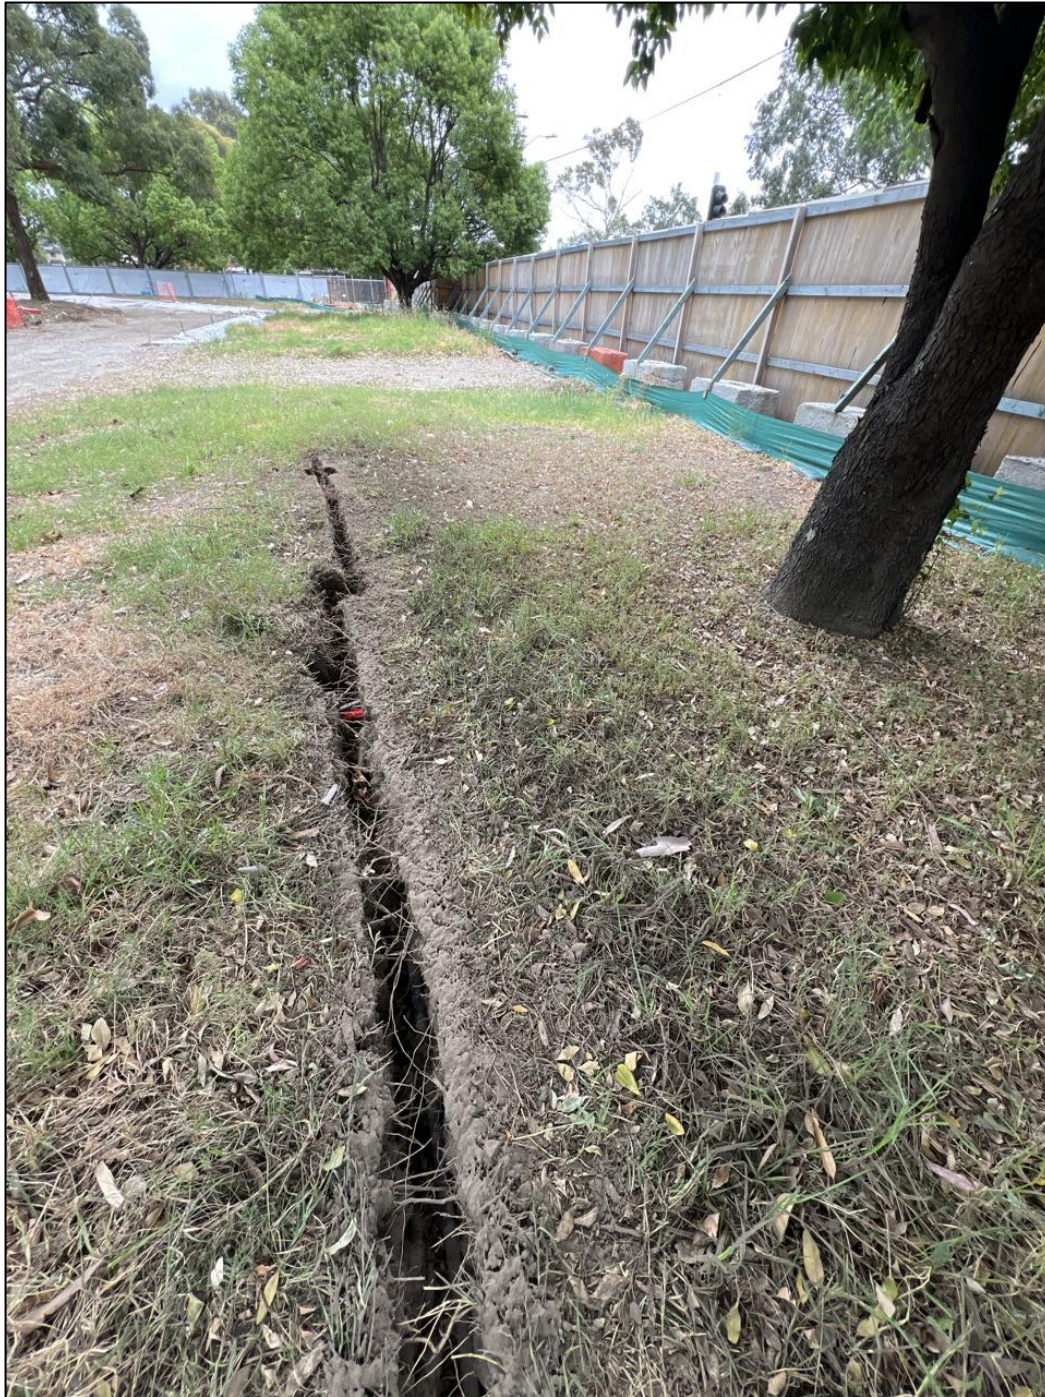
| Root | Distance from<br><u>Eastern</u> edge of<br>trench (m) | Diameter of<br>root (mm) | Depth of<br>root [mm] | Comments |
|---|---|---|---|---|
| 1 | 4.4 | 90 | 400 | Large major root crossing trench laterally. From Tree 151. Root must be retained to ensure tree remains viable. Proposed internal driveway can be installed above root. |

Figure 22. Survey Trench 4 with one Major root encountered. Image taken from eastern edge of trench.

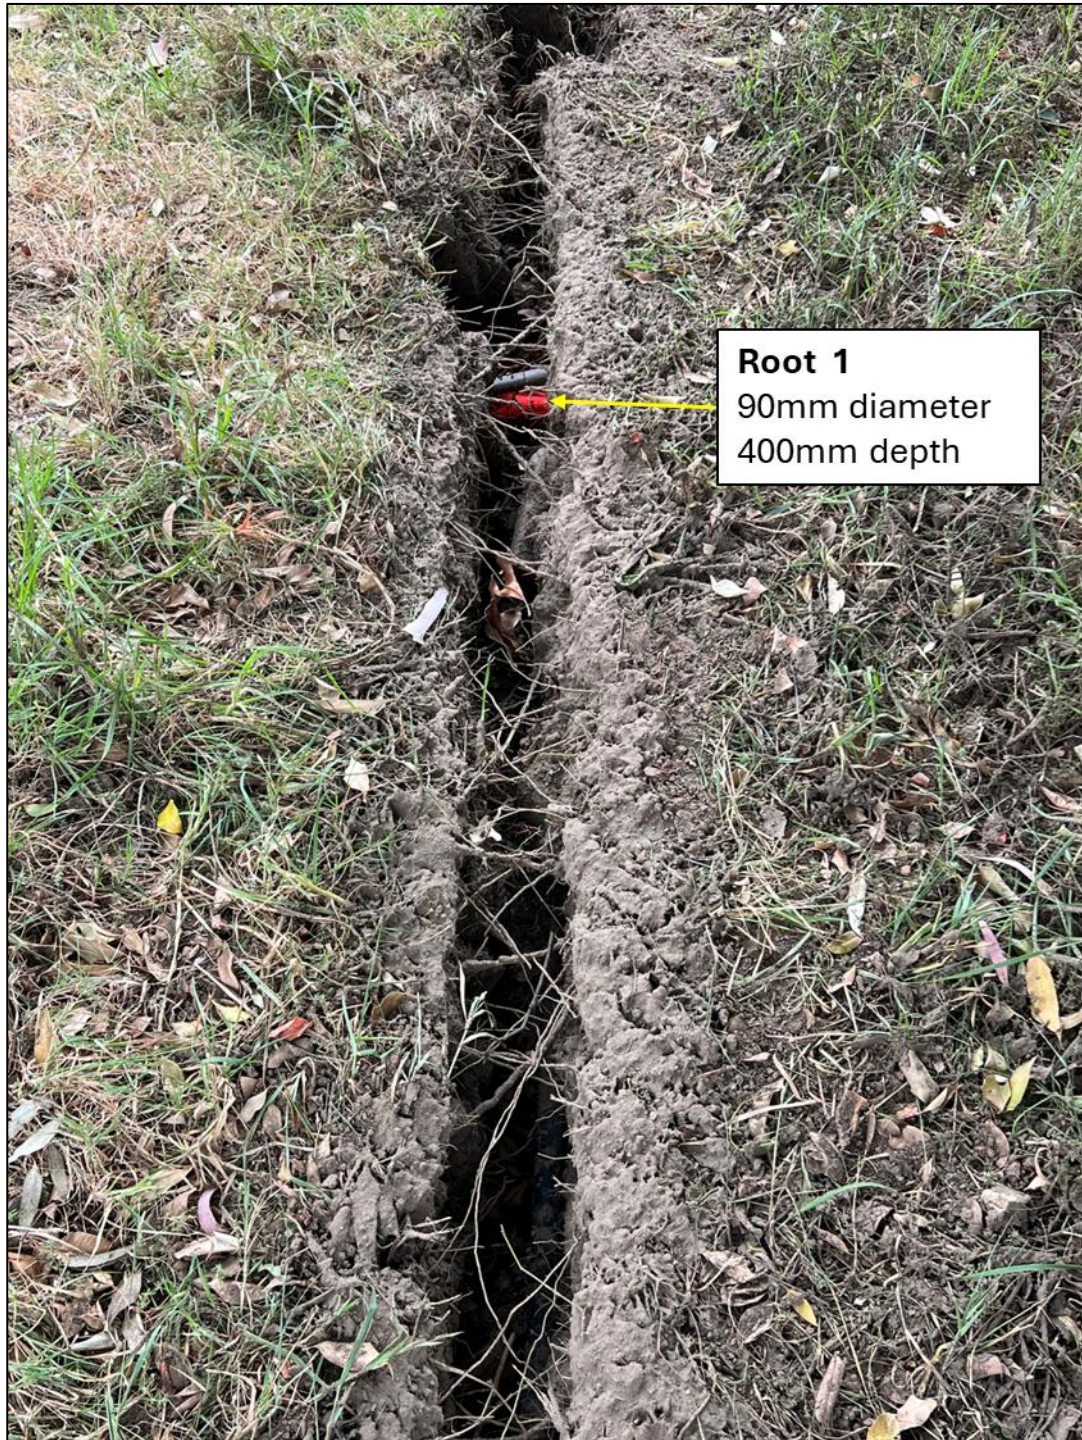
Figure 23. Eastern and central portion of Survey Trench 4.

- **Survey Trench 4** – The proposed driveway within the northern boundary is suitable for construction within the proposed location. Root 1 in Survey Trench 4 is growing from Tree 151 and was observed at 400mm depth and will remain below the required depth of excavation (Figure 23). Sixteen minor roots observed within this trench are suitable for pruning to facilitate the proposed excavation.

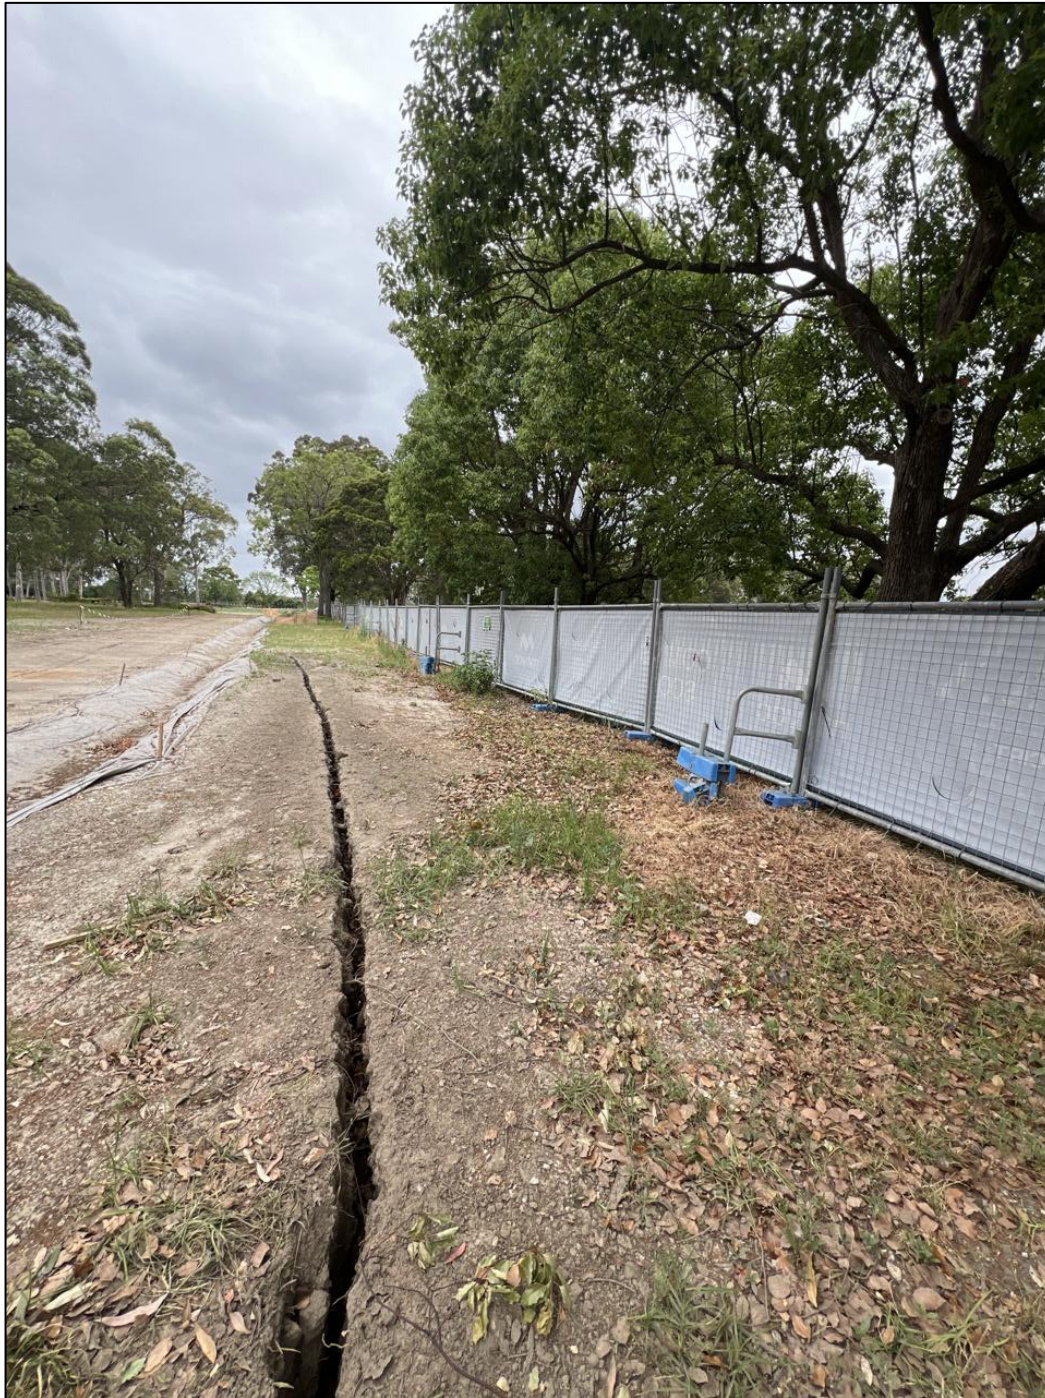
| Root | Distance from Northern edge of trench (m) | Diameter of root (mm) | Depth of root [mm] | Comments |
|---|---|---|---|---|
| 1 | 10 | 50 | 430 | Major root crossing trench laterally. From Tree 158. Root can be retained at encountered depth. |

Figure 25. Survey Trench 5 with one Major root encountered. Image taken from northern edge of trench.

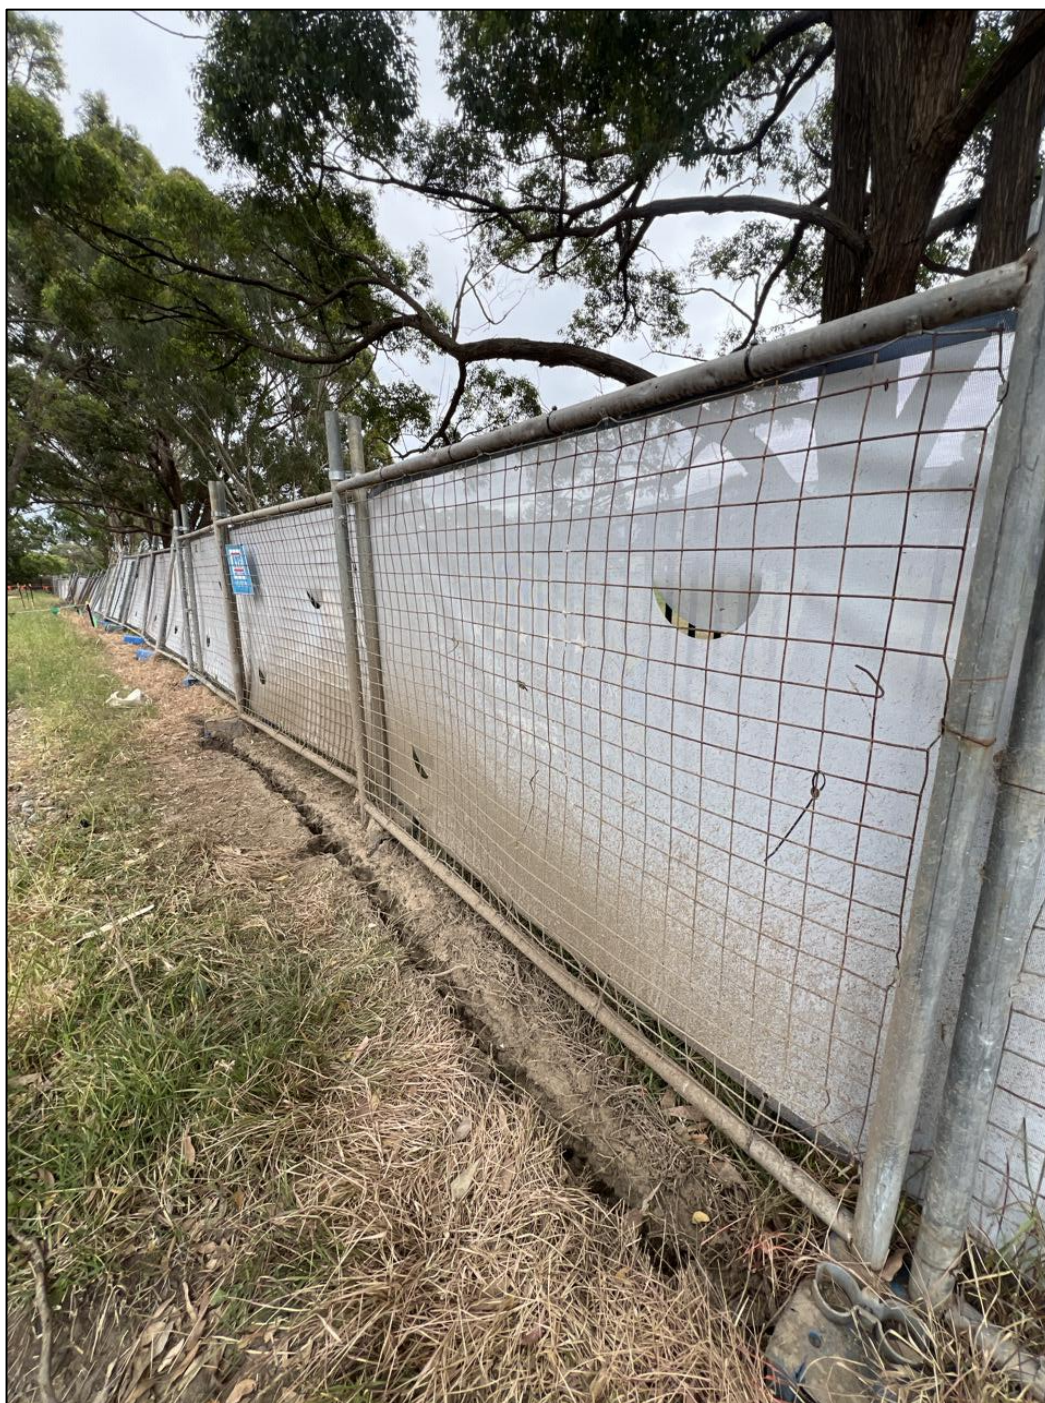
Trench excavated to a depth of 600 mm along nearest edge of proposed footpath that is within the NRZs of Tree 212. No major or minor roots encountered. Heavily compacted clay soils within trench likely to have underpinned restricted root growth from tree. Proposed pathway can be installed in proposed location on eastern side of tree.

Figure 33. Trench 8 with no major or minor roots encountered. Image taken from eastern edge of trench.

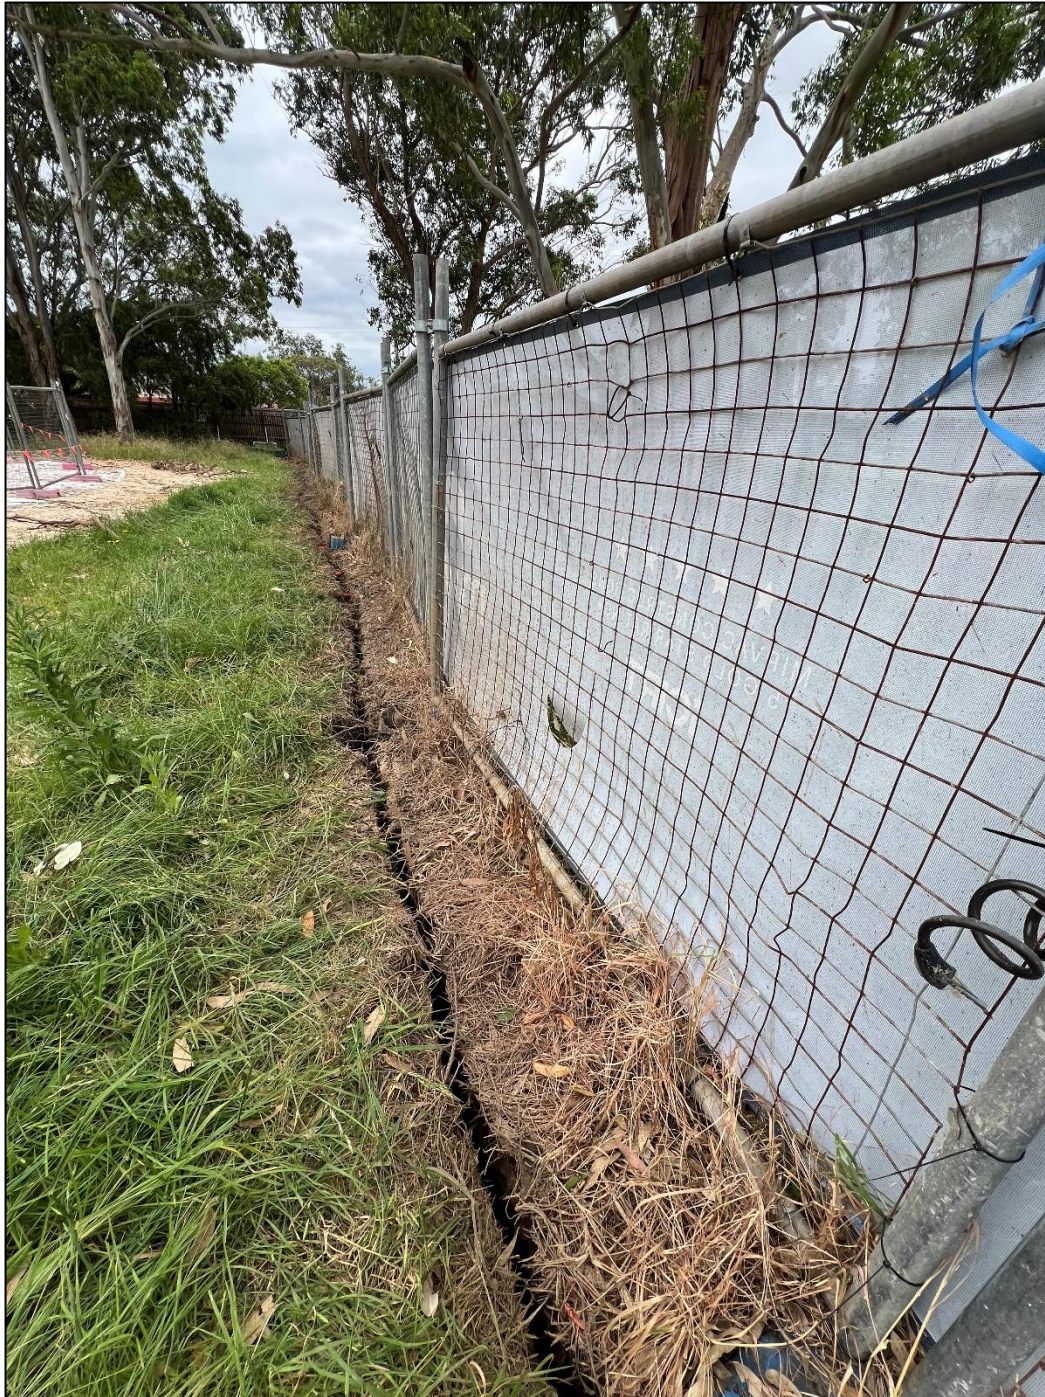
| Root | Distance from <u>Eastern</u> edge of trench (m) | Diameter of root (mm) | Depth of root [mm] | Comments |
|---|---|---|---|---|
| 3 | 8.2 | 50 | 50 | Small major root crossing trench diagonally. From Tree 240. Root suitable for pruning to facilitate proposed pathway due to small size. Considered likely that Tree 240 will require removal within 24 months. |

Figure 36. Trench 10 with three major roots encountered. Image taken from eastern edge of trench.

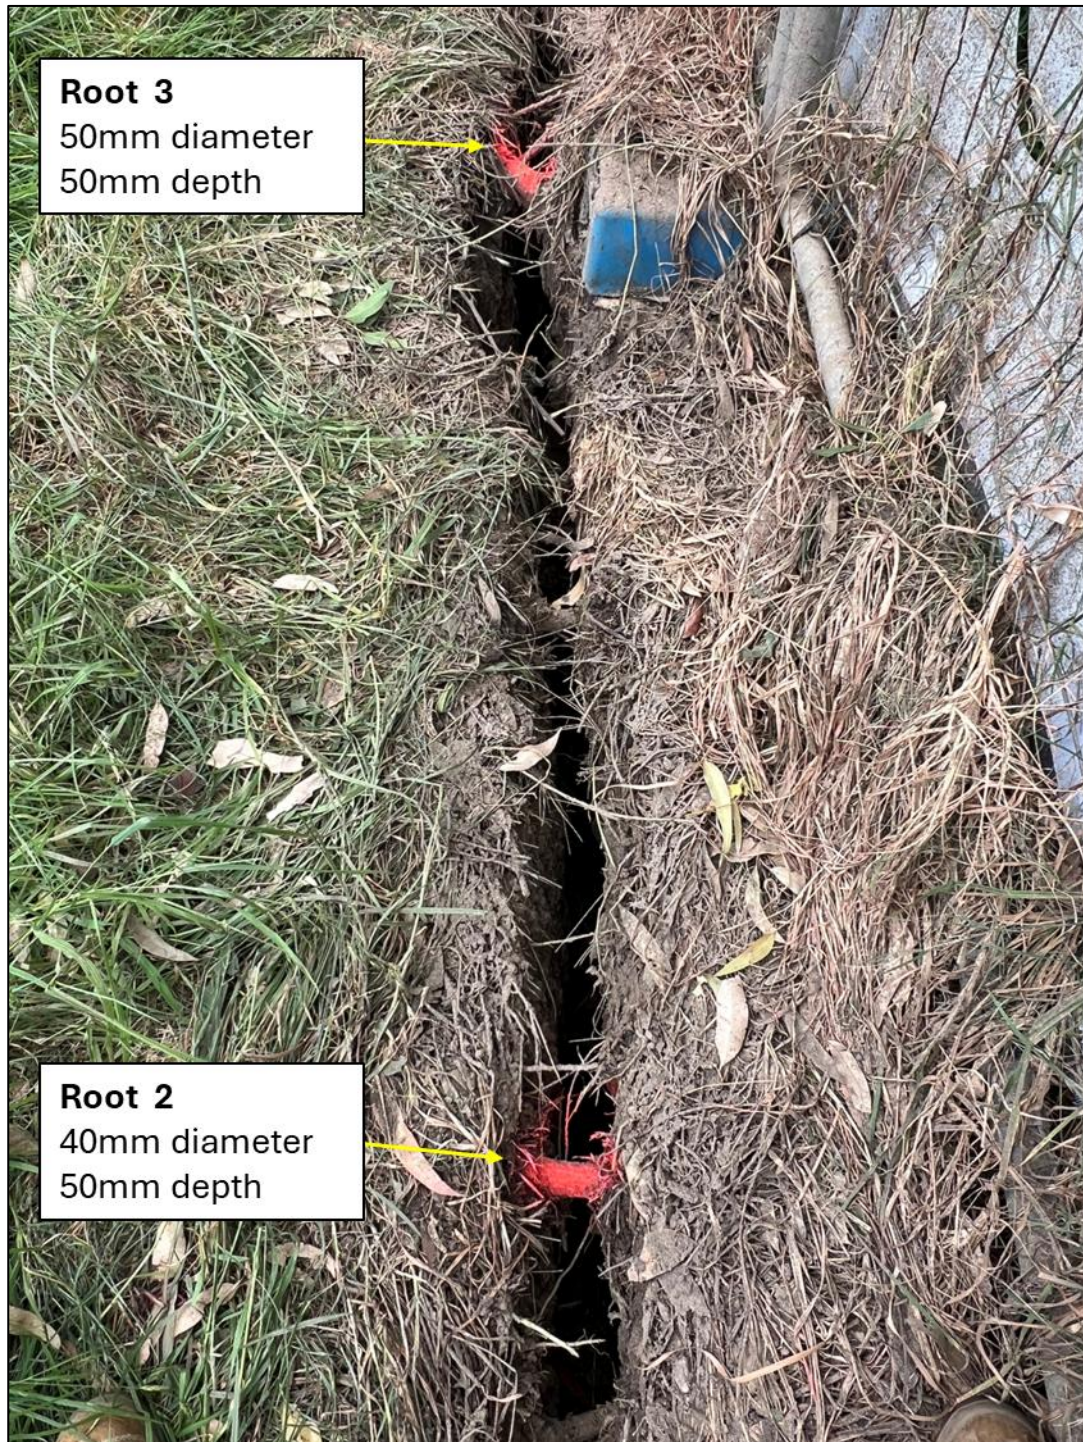
Figure 39. Roots 2 and 3 within central portion of Survey Trench 10.

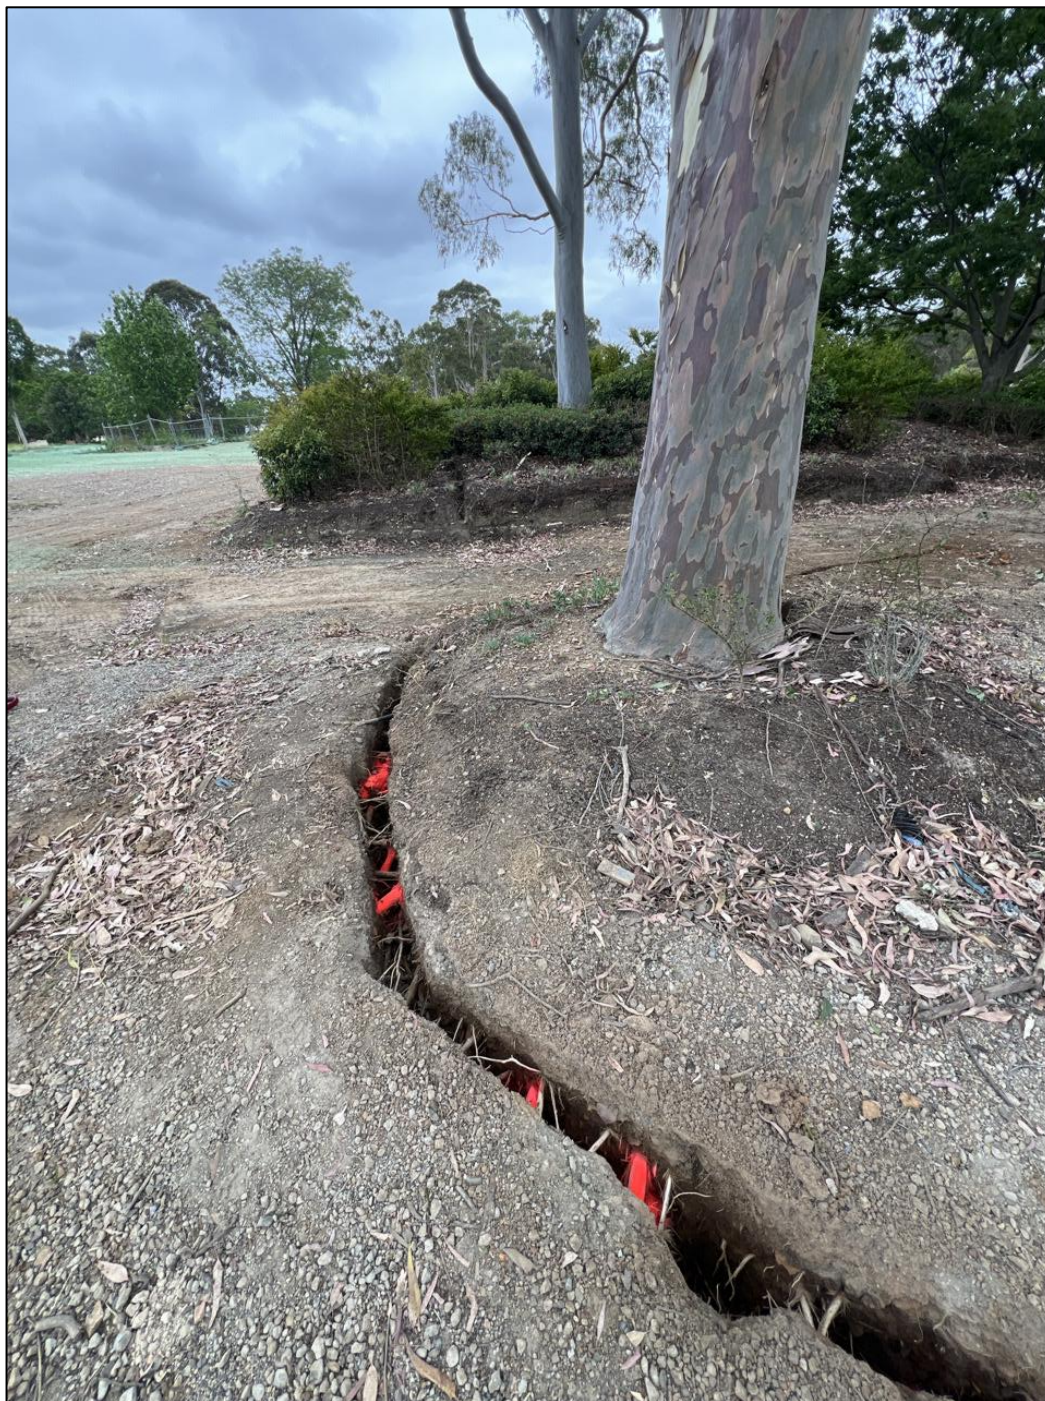
| Root | Distance from Eastern edge of trench (m) | Diameter of root (mm) | Depth of root [mm] | Comments |
|---|---|---|---|---|
| 16 | 13.1 | 40 | 20 | Smaller major root crossing trench diagonally. Originates from Tree 319. Suitable for pruning if required. |

Figure 45. Trench 12 with sixteen major roots encountered. Image taken from south-eastern edge of trench.

Figure 46. Southern portion of Survey Trench 12.

- **Survey Trench 12** – The design of the proposed footpath around Tree 319 within the central park will require amendment. Sixteen major roots were encountered in Survey Trench 12 (Table 8) (Figure 45-Figure 49). Severing these roots will compromise the viability of Tree 319. It is recommended that the pathway is moved to the eastern side of Tree 319 and a maximum NRZ encroachment of 10% is not exceeded.

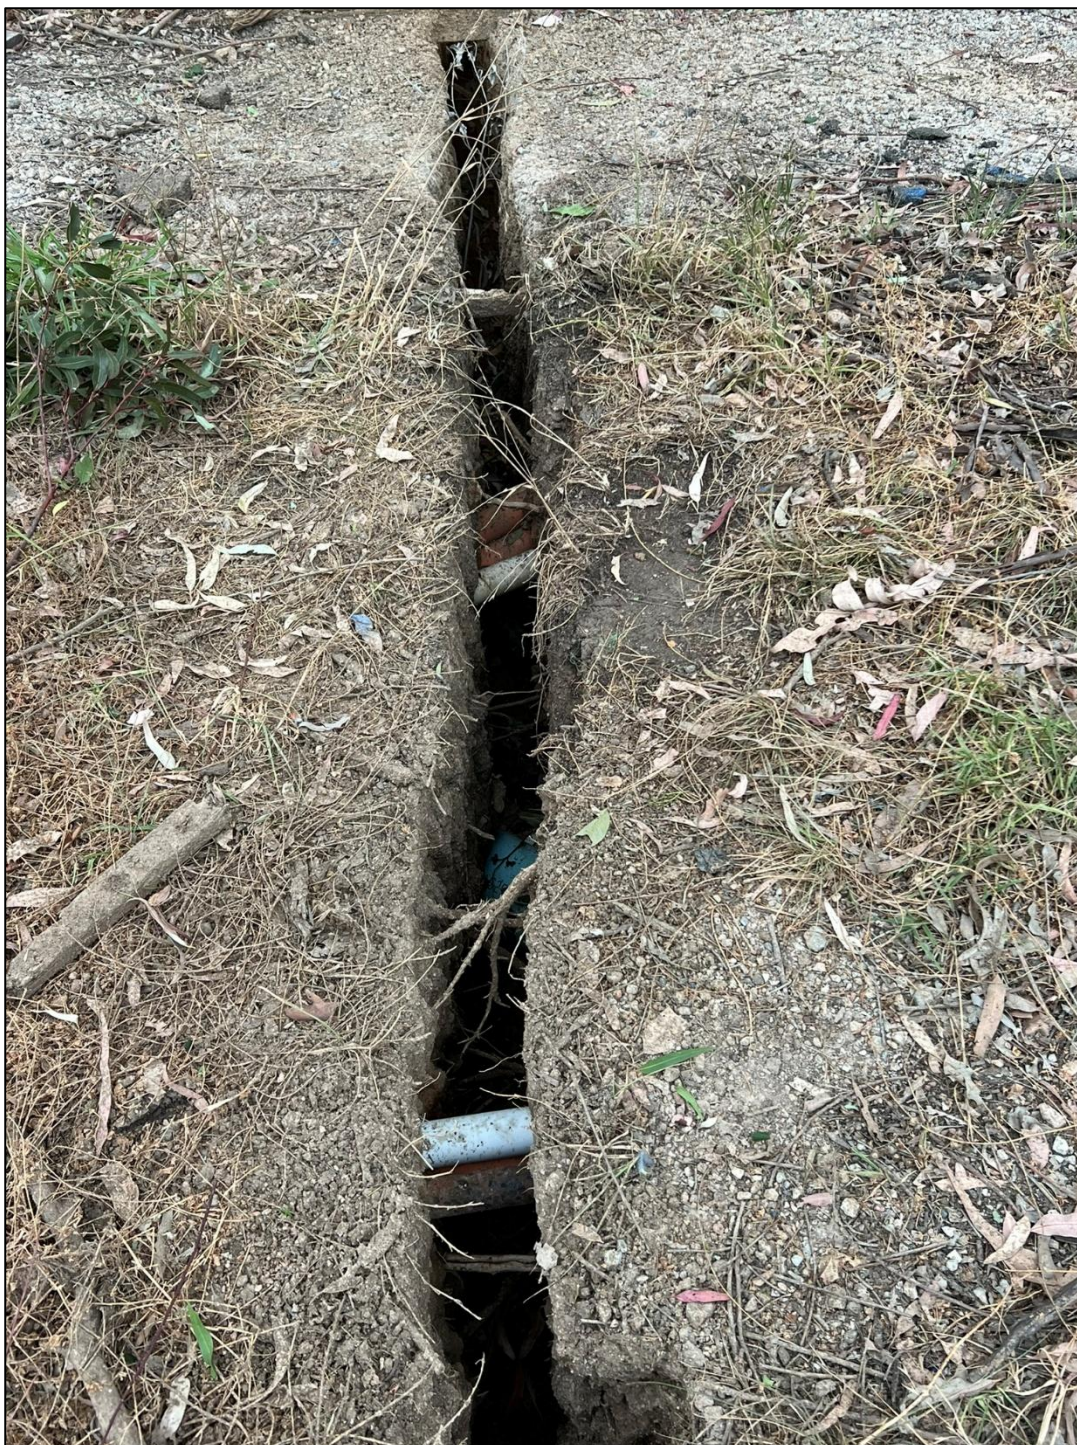
Figure 61. No major roots encountered within the eastern portion of Trench 15.

- **Survey Trench 15** – The footpath within the central park on the northern side of Tree 353 is supported within the proposed location without amendment. Three major roots growing from Tree 353 were observed at greater than 450 mm depth and will remain below the required depth of excavation (Table 11) (Figure 60 and Figure 61).

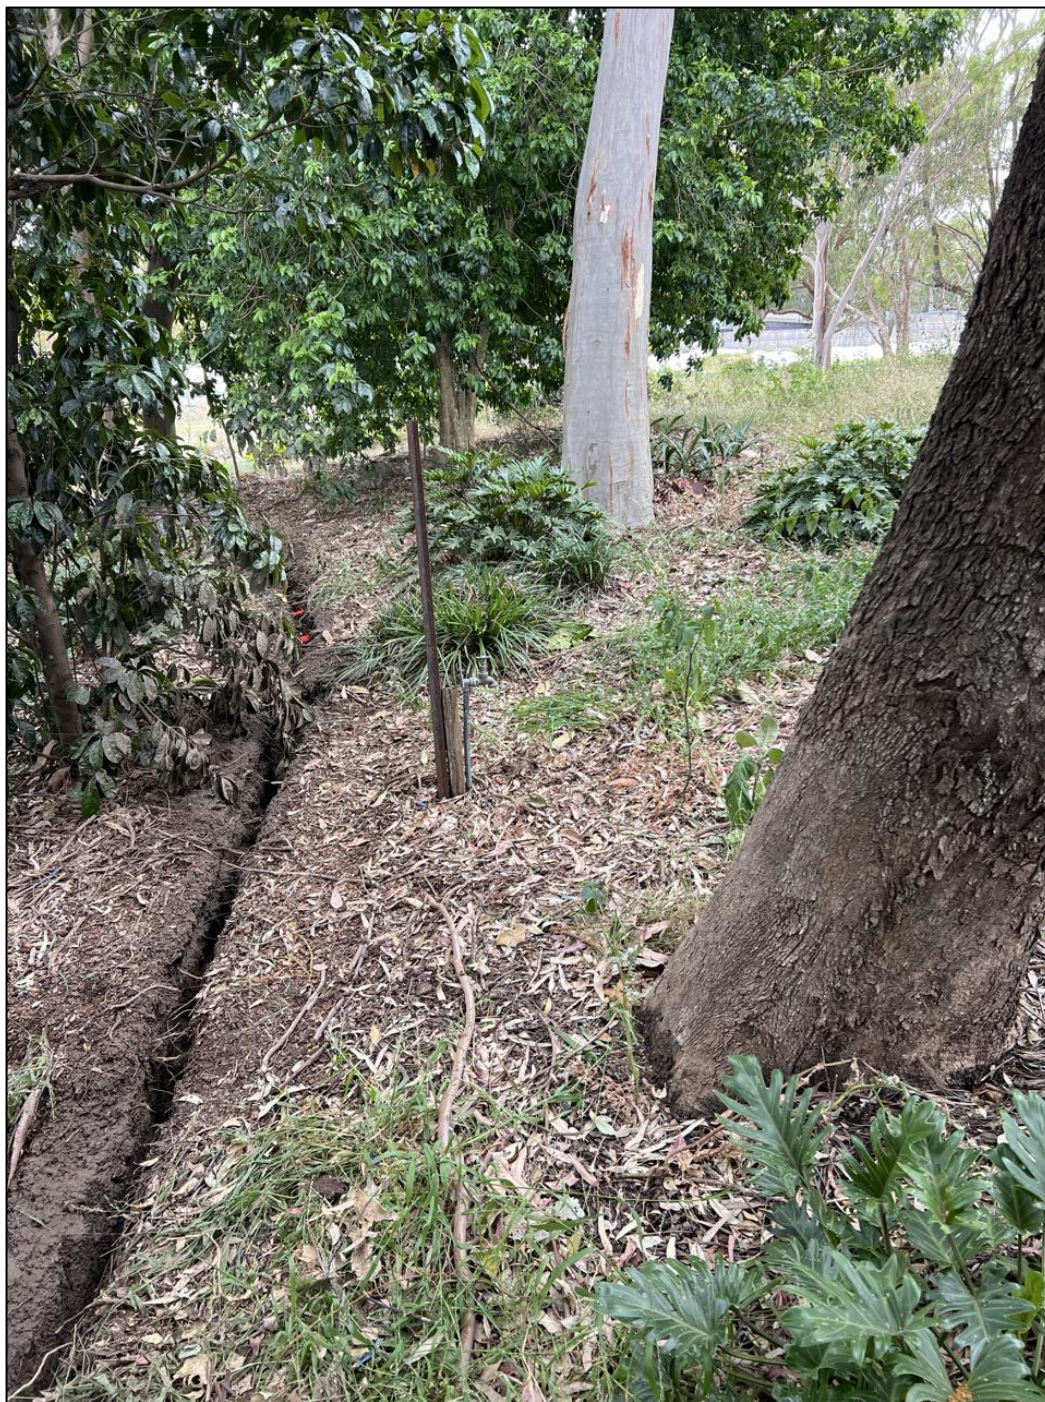
| Root | Distance from Southern edge of trench (m) | Diameter of root (mm) | Depth of root [mm] | Comments |
|---|---|---|---|---|
| 5 | 9 | 40 | 120 | Major root crossing trench diagonally. From Tree 364. Smaller diameter of root and Good health of Tree 364 renders root suitable for pruning. |

Figure 66. Trench 18 with five major roots encountered.

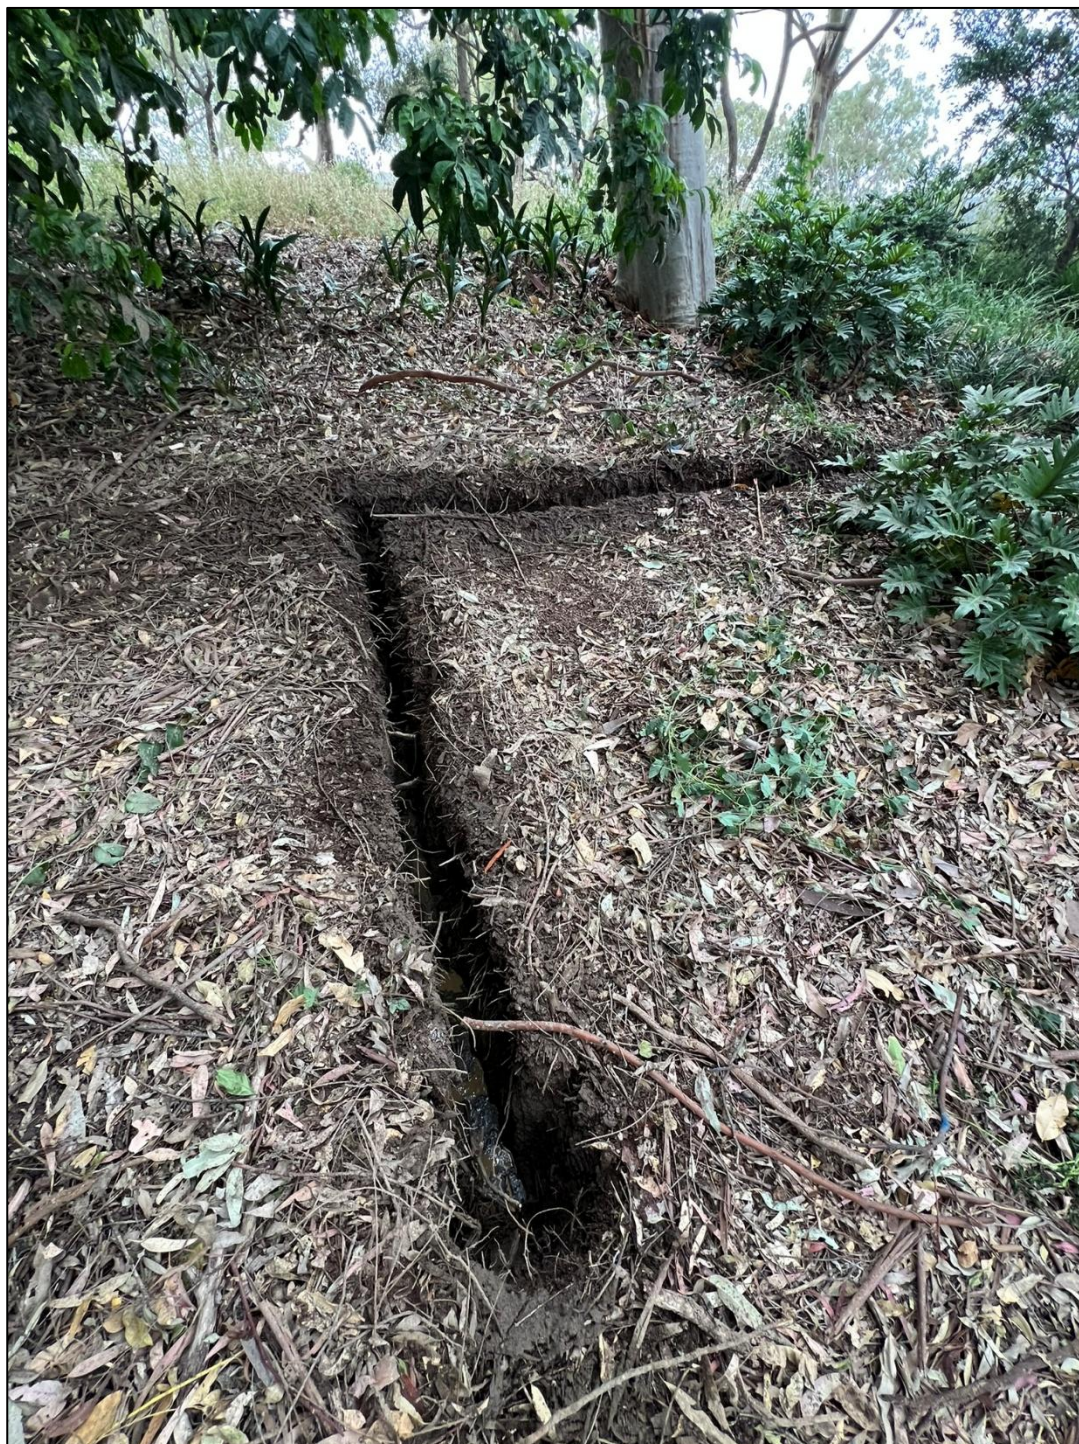
Figure 70. No roots encountered in northern portion of Survey Trench 18.

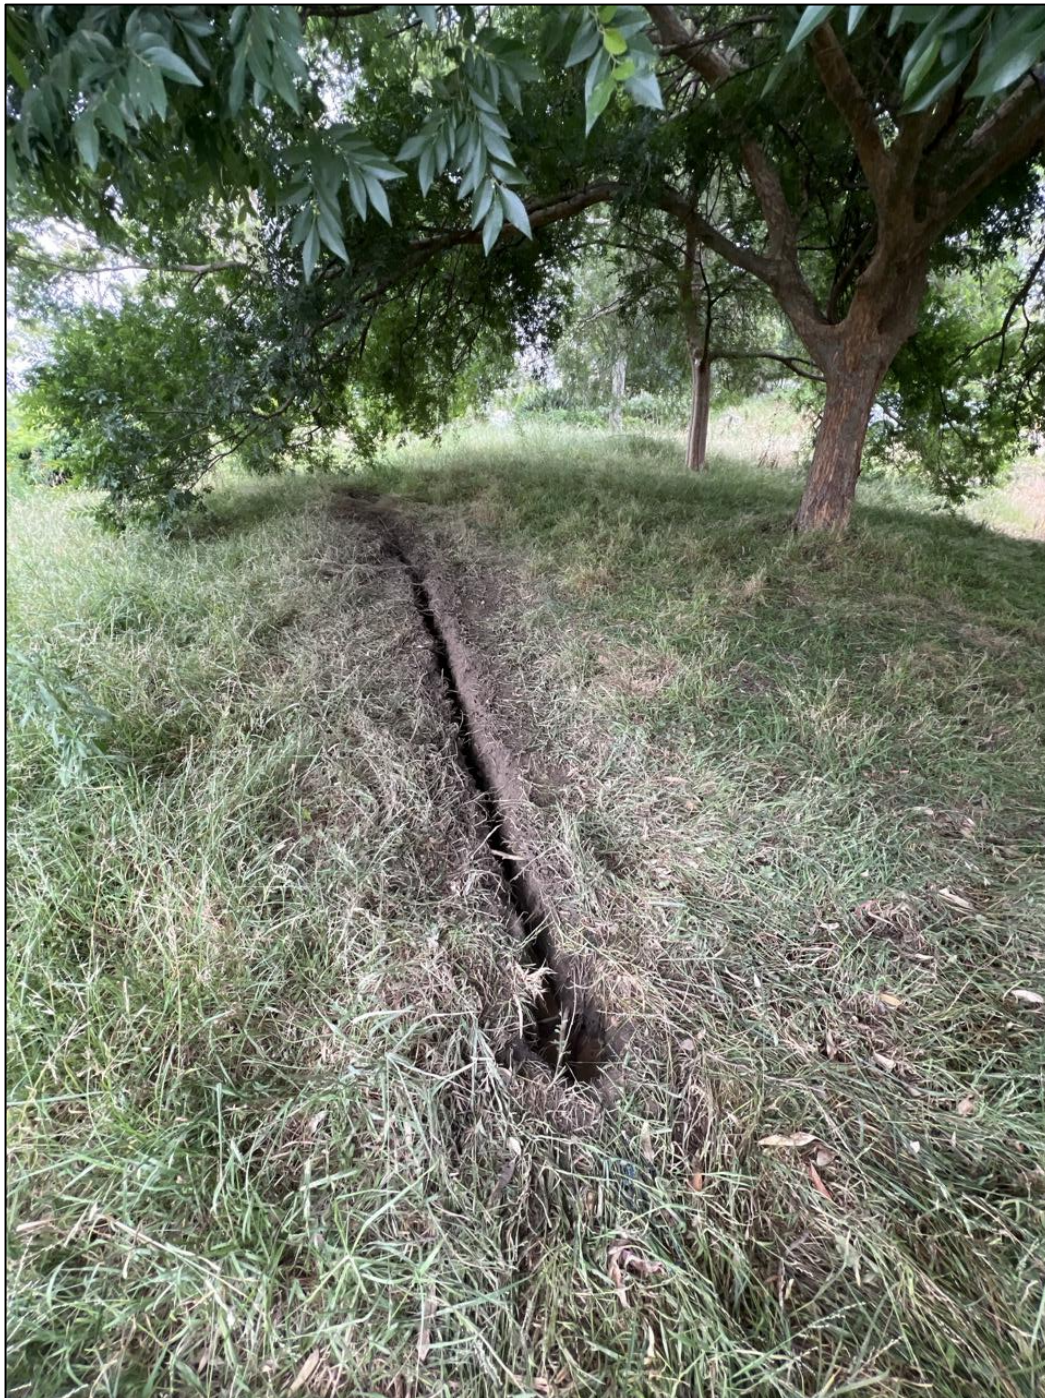
Trench excavated to a depth of 500 mm along nearest edge of proposed footpath that is within the NRZ of Tree 349. No major encountered. Heavily compacted clay soils within trench likely to have underpinned restricted root growth from tree. Four minor roots that were encountered are suitable for pruning where required. Construction of proposed pathway suitable in proposed location.

Figure 71. Trench 19 with no major roots encountered. Image taken from southern edge of trench.
