Royal Hall of Industries - Moore Park

Sydney Swans HQ & Community Centre

<u>Dilapidation</u> <u>Addendum</u> Report - Errol Flynn Blvd

25th August 2021

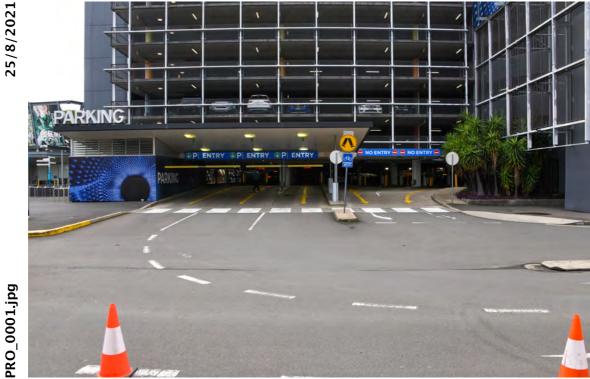
Errol Flynn Boulevard. Facing east from the western side of the road towards the entry and exit from the 'Wilson Parking station'. Photo location.

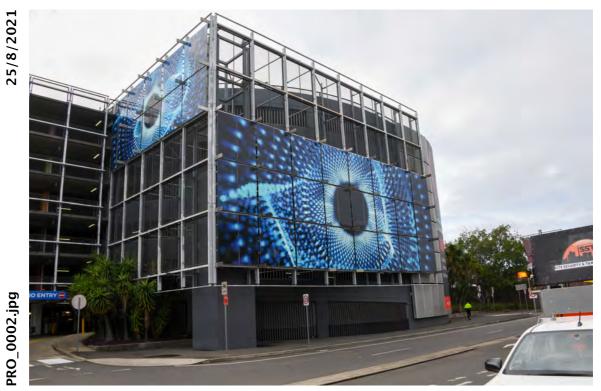
Errol Flynn Boulevard. Facing south-east from the western side of the road towards the entry and exit from the 'Wilson Parking station'. Photo location.

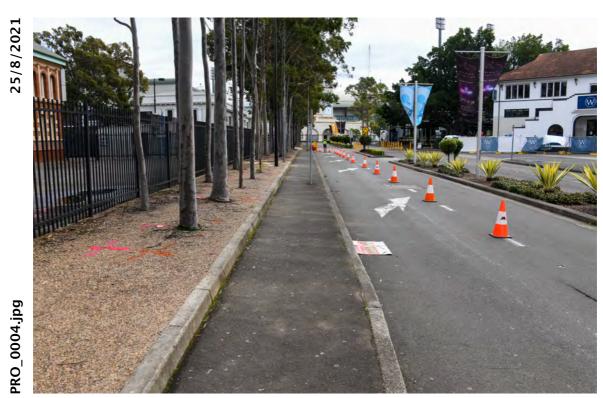
Western side of the Boulevard. Area adjacent to 'The Royal Hall of Industries'. Heading north. Footpath.

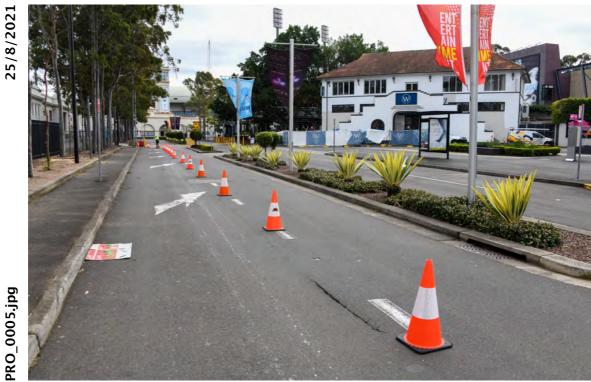
Western side of the Boulevard. Area adjacent to 'The Royal Hall of Industries'. Heading north. Crack in the asphalt road paving.

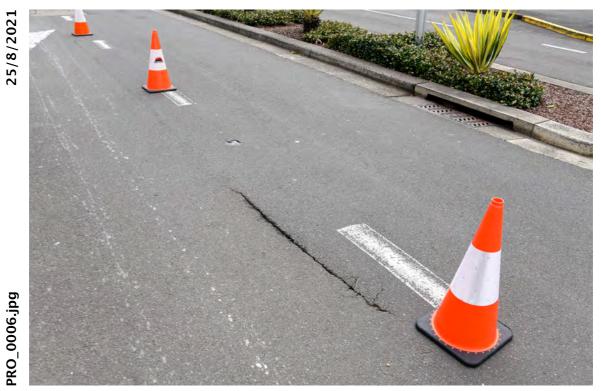
Western side of the Boulevard. Area adjacent to 'The Royal Hall of Industries'. Heading north. Crack in the asphalt road paving.

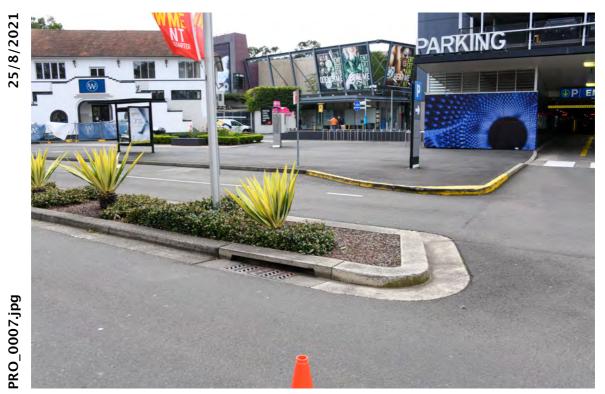
Western side of the Boulevard. Area adjacent to 'The Royal Hall of Industries'. Heading north. Storm water drain in the median strip.

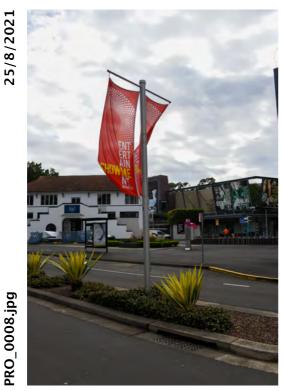
Western side of the Boulevard. Area adjacent to 'The Royal Hall of Industries'. Heading north. Flagpole on the median strip.

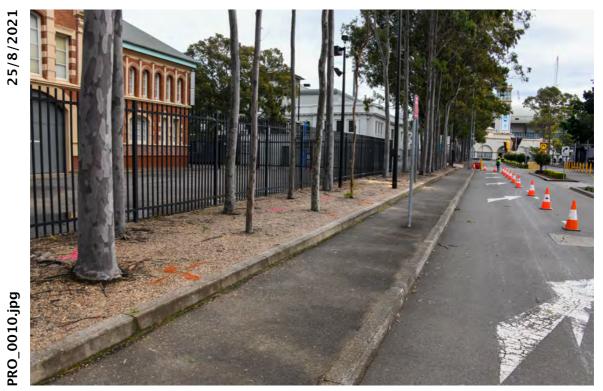
Western side of the Boulevard. Area adjacent to 'The Royal Hall of Industries'. Heading north. Footpath.

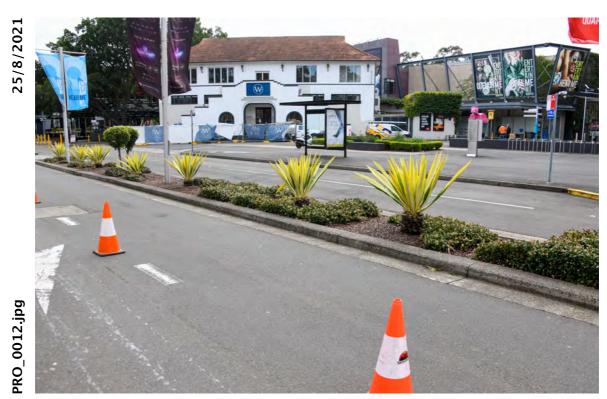
Western side of the Boulevard. Area adjacent to 'The Royal Hall of Industries'. Heading north. Median Strip.

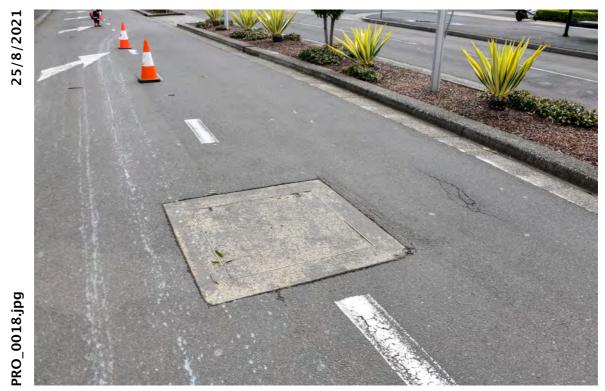
Western side of the Boulevard. Area adjacent to 'The Royal Hall of Industries'. Heading north. Lid to the services pit in the road.

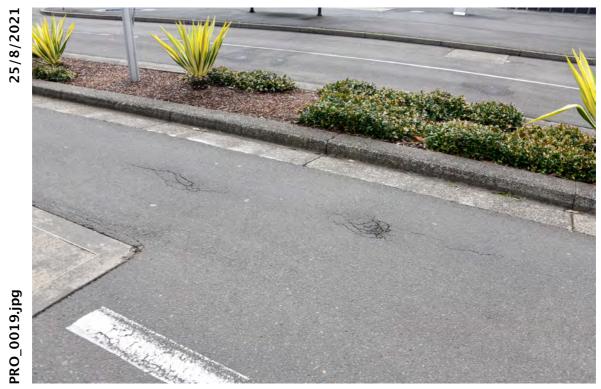
Western side of the Boulevard. Area adjacent to 'The Royal Hall of Industries'. Heading north. Area of the lid to the services pit in the road. Isolated areas of damaged road paving.

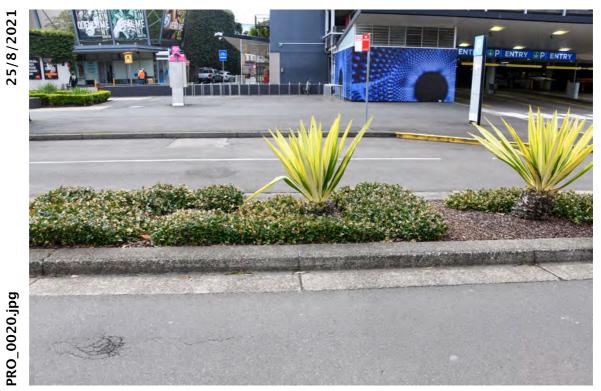
Western side of the Boulevard. Area adjacent to 'The Royal Hall of Industries'. Heading north. Area of the lid to the services pit in the road. Median strip.

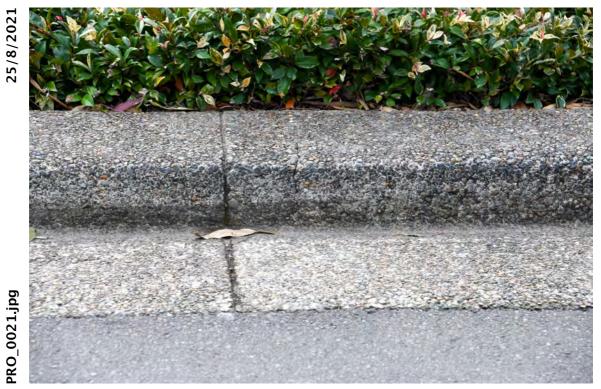
Western side of the Boulevard. Area adjacent to 'The Royal Hall of Industries'. Heading north. Area of the lid to the services pit in the road. Median strip. Cracked kerb.

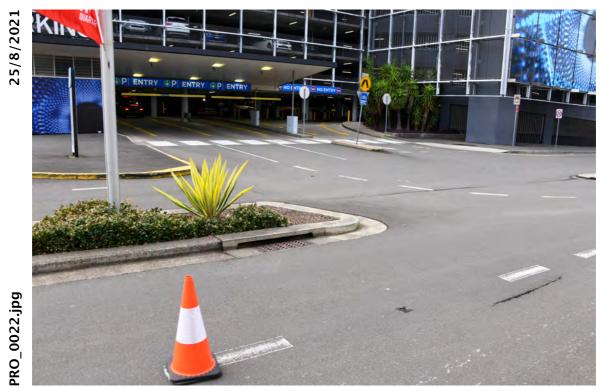
Western side of the Boulevard. Area adjacent to 'The Royal Hall of Industries'. Heading north. Area of the entry / exit to the 'Wilson Car Park'. Storm water drain in the median strip.

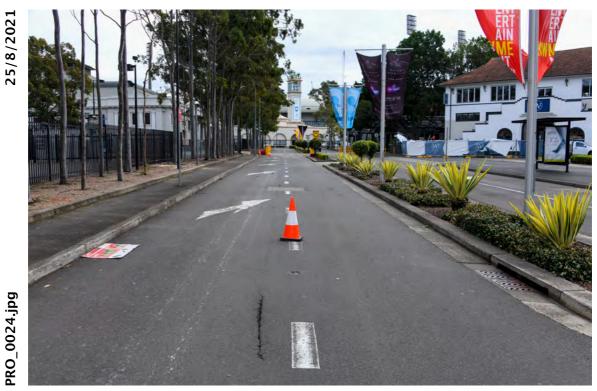
Western side of the Boulevard. Area adjacent to 'The Royal Hall of Industries'. Heading north. Area of the entry / exit to the 'Wilson Car Park'. Crack in the asphalt road paving.

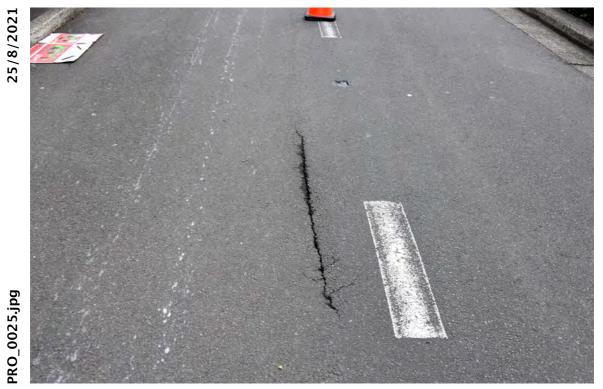
Western side of the Boulevard. Area adjacent to 'The Royal Hall of Industries'. Heading north. Area of the entry / exit to the 'Wilson Car Park'. Crack in the asphalt road paving.

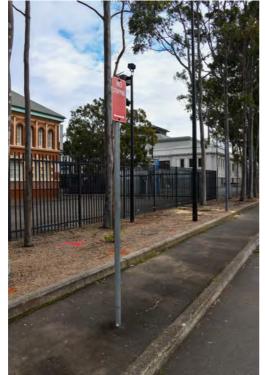
PRO_0027.jpg

Western side of the Boulevard. Area adjacent to 'The Royal Hall of Industries'. Heading north. 'No Stopping' street sign.

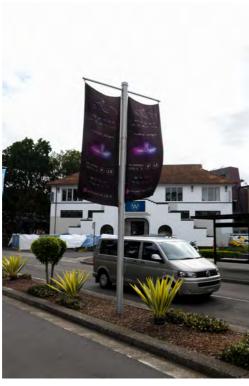
PRO_0028.jpg

Western side of the Boulevard. Area adjacent to 'The Royal Hall of Industries'. Heading north. Flag pole on the median strip. Loose panel on the pole.

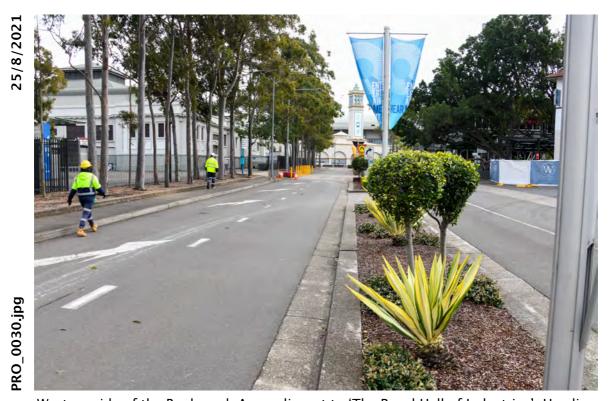
Western side of the Boulevard. Area adjacent to 'The Royal Hall of Industries'. Heading north. Median strip.

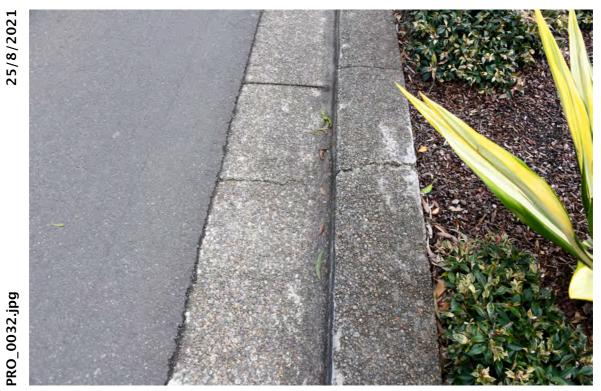
Western side of the Boulevard. Area adjacent to 'The Royal Hall of Industries'. Heading north. Median strip. Cracked kerb and gutter.

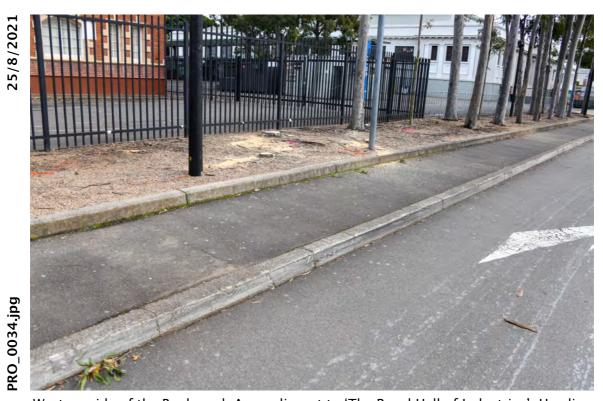
Western side of the Boulevard. Area adjacent to 'The Royal Hall of Industries'. Heading north. Cracked kerb and gutter.

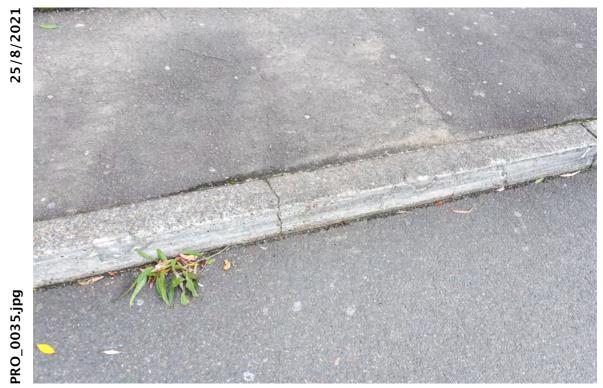
Western side of the Boulevard. Area adjacent to 'The Royal Hall of Industries'. Heading north. Cracked kerb and gutter.

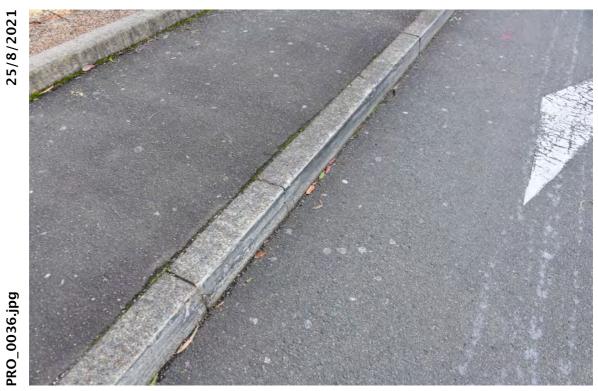
Western side of the Boulevard. Area adjacent to 'The Royal Hall of Industries'. Heading north. Cracked kerb and gutter.

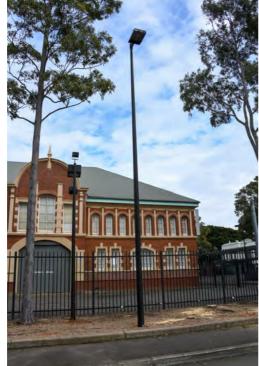
PRO_0037.jpg

Western side of the Boulevard. Area adjacent to 'The Royal Hall of Industries'. Heading north. Light pole.

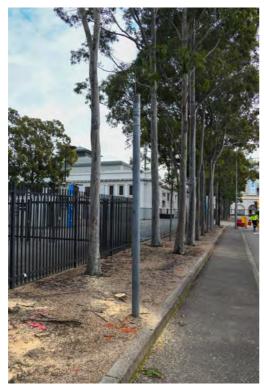
PRO_0038.jpg

Western side of the Boulevard. Area adjacent to 'The Royal Hall of Industries'. Heading north. Pole.

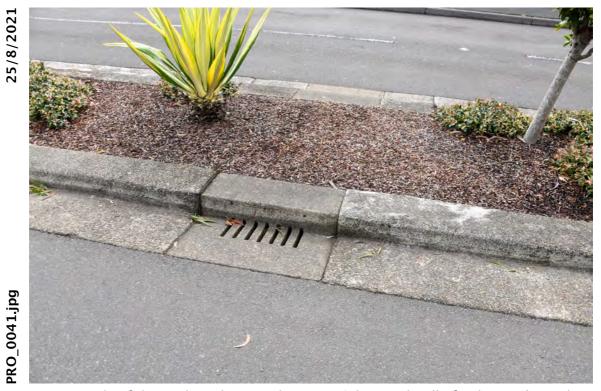
Western side of the Boulevard. Area adjacent to 'The Royal Hall of Industries'. Heading north. Storm water drain in the median strip

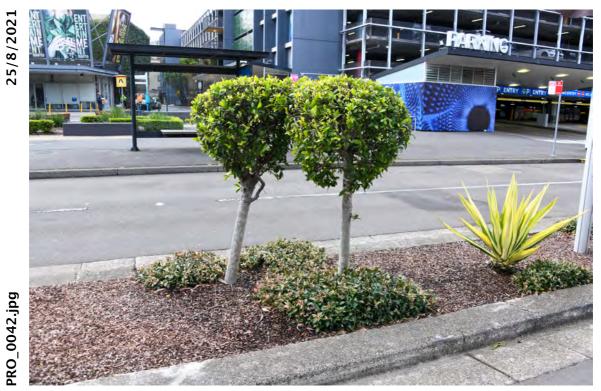
Western side of the Boulevard. Area adjacent to 'The Royal Hall of Industries'. Heading north. Landscaping on the median strip.

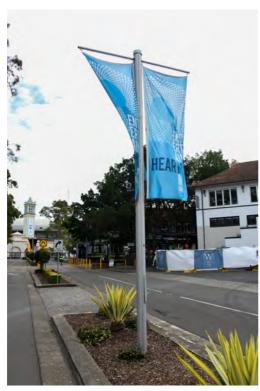
PRO_0044.jpg

Western side of the Boulevard. Area adjacent to 'The Royal Hall of Industries'. Heading north along the median strip. Flag pole.

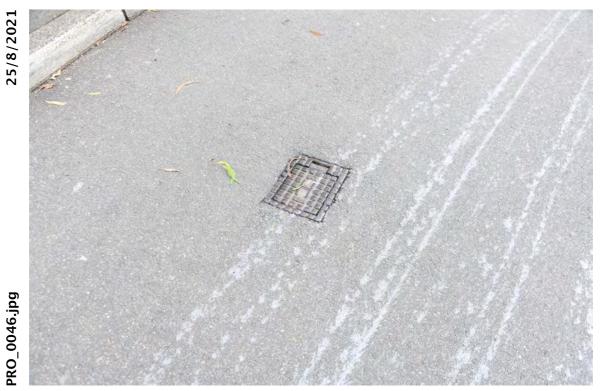
Western side of the Boulevard. Area adjacent to area between 'The Royal Hall of Industries' & 'The Hordern Pavilion'. Heading north. Hydrant valve in the road paving.

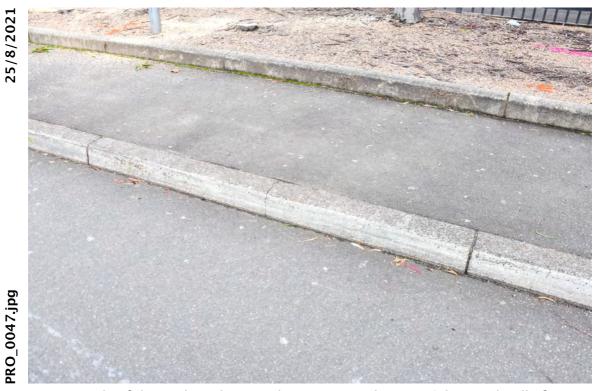
Western side of the Boulevard. Area adjacent to area between 'The Royal Hall of Industries' & 'The Hordern Pavilion'. Heading north. Cracked kerb and gutter.

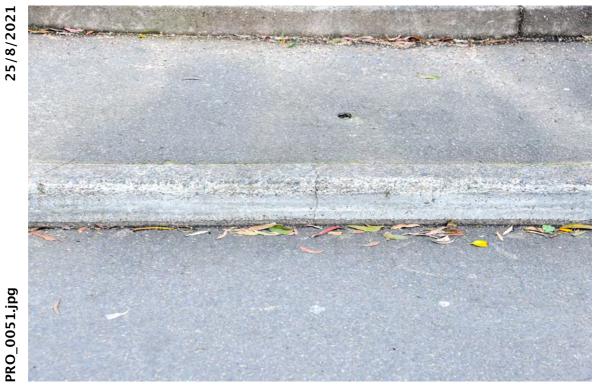
Western side of the Boulevard. Area adjacent to area between 'The Royal Hall of Industries' & 'The Hordern Pavilion'. Heading north. Intersection with Park Road. Cracked kerb and gutter.

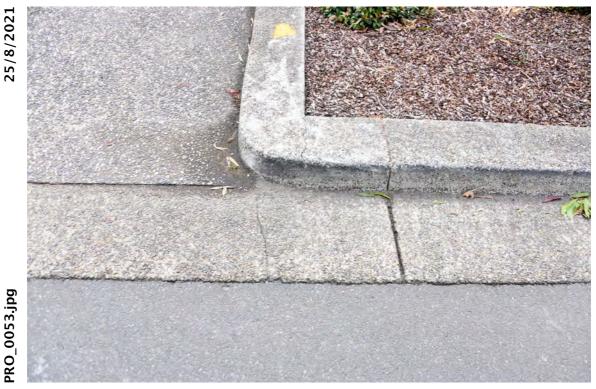
Western side of the Boulevard. Area adjacent to area between 'The Royal Hall of Industries' & 'The Hordern Pavilion'. Heading north. Intersection with Park Road. Median strip. Cracked kerb and gutter.

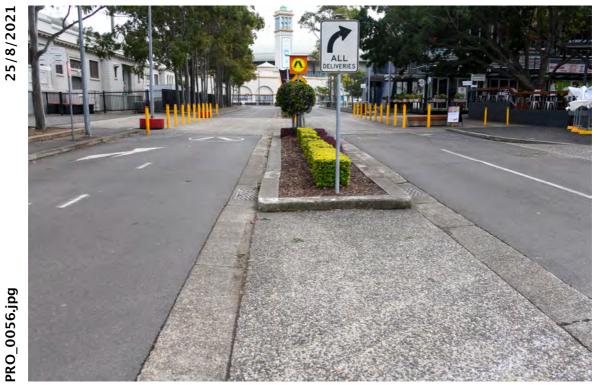
Western side of the Boulevard. Area adjacent to area between 'The Royal Hall of Industries' & 'The Hordern Pavilion'. Heading north. Intersection with Park Road. Gap in the median strip.

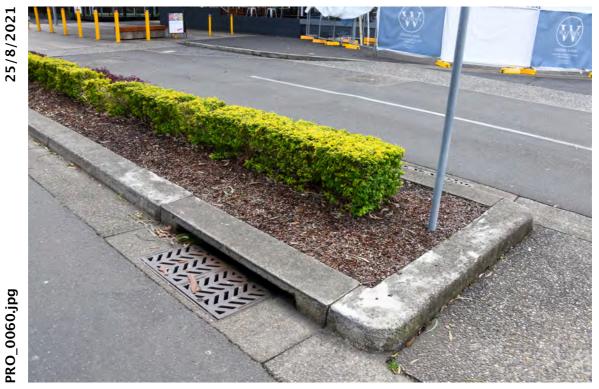
Western side of the Boulevard. Area adjacent to area between 'The Royal Hall of Industries' & 'The Hordern Pavilion'. Heading north. Intersection with Park Road. Median strip.

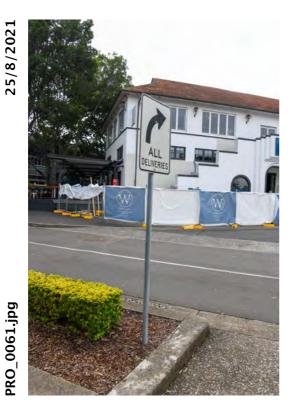
Western side of the Boulevard. Area adjacent to area between 'The Royal Hall of Industries' & 'The Hordern Pavilion'. Heading north. Intersection with Park Road. Median strip. Lean on the street sign.

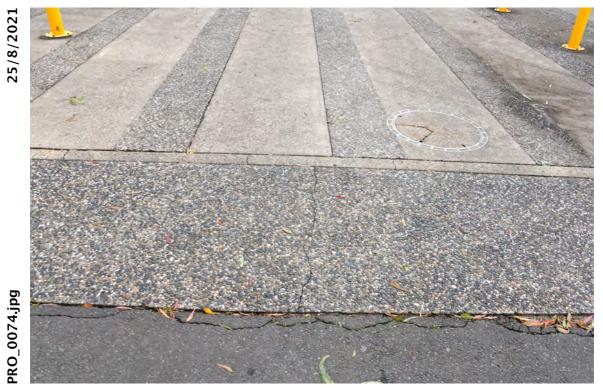
Western side of the Boulevard. Area adjacent to area between 'The Royal Hall of Industries' & 'The Hordern Pavilion'. Heading north. Area of the pedestrian crossing. Cracked concrete and asphalt road paving.

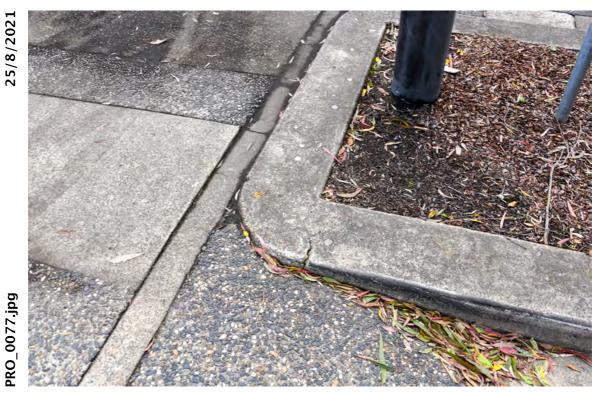
Western side of the Boulevard. Area adjacent to area between 'The Royal Hall of Industries' & 'The Hordern Pavilion'. Heading north. Area of the pedestrian crossing. Cracked median strip kerb.

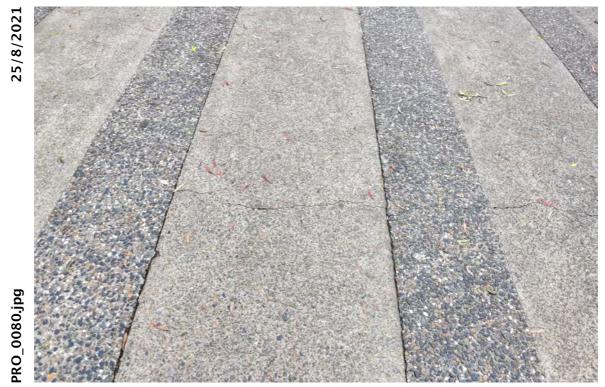
Western side of the Boulevard. Area adjacent to area between 'The Royal Hall of Industries' & 'The Hordern Pavilion'. Heading north. Area of the pedestrian crossing. Cracked paving.

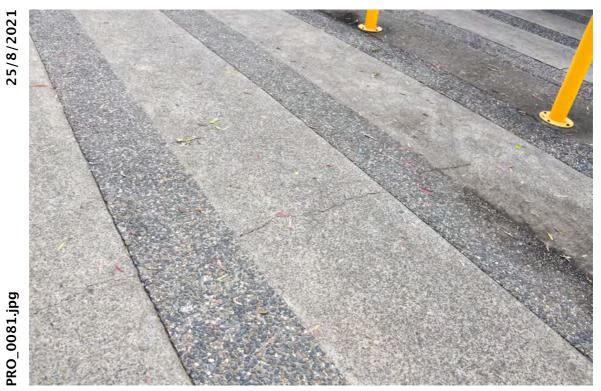
Western side of the Boulevard. Area adjacent to area between 'The Royal Hall of Industries' & 'The Hordern Pavilion'. Heading north. Area of the pedestrian crossing. Cracked paving.

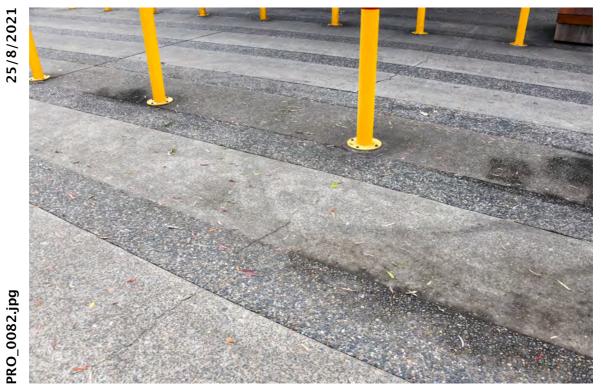
Western side of the Boulevard. Area adjacent to area between 'The Royal Hall of Industries' & 'The Hordern Pavilion'. Heading north. Area of the pedestrian crossing. Cracked paving.

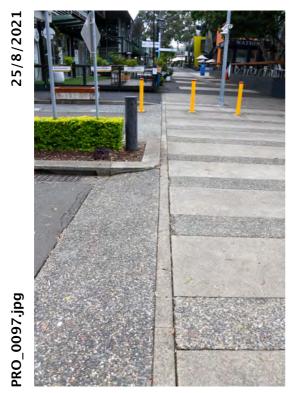
Western side of the Boulevard. Area adjacent to area between 'The Royal Hall of Industries' & 'The Hordern Pavilion'. Heading north. Area of the pedestrian crossing. Cracked kerb.

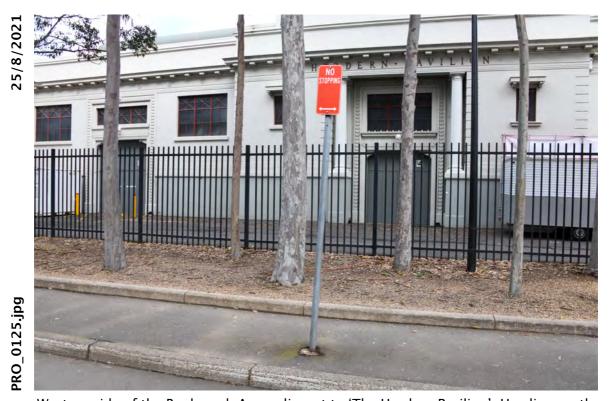
Western side of the Boulevard. Area adjacent to 'The Hordern Pavilion'. Heading north. Lean on the street sign on the western footpath.

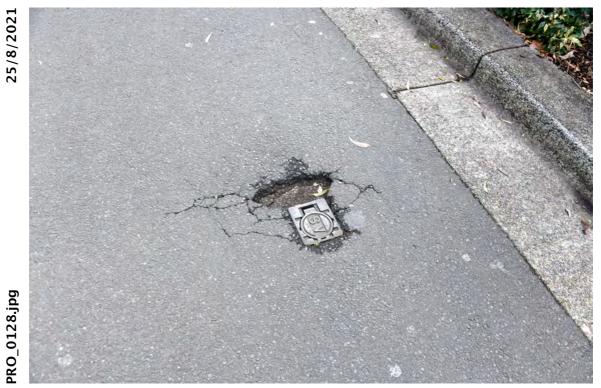
Western side of the Boulevard. Area adjacent to 'The Hordern Pavilion'. Heading north. Damaged paving around the service valve in the road paving.

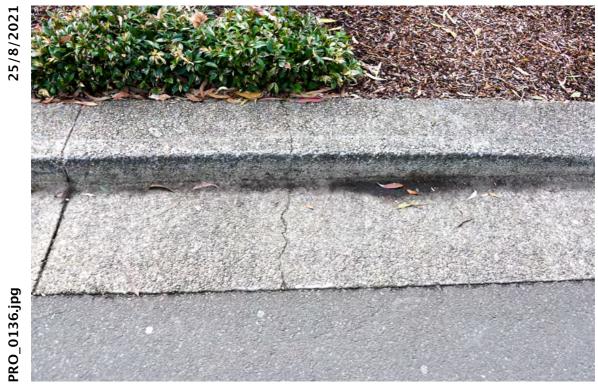
Western side of the Boulevard. Area adjacent to 'The Hordern Pavilion'. Heading north. Median strip. Cracked kerb and gutter.

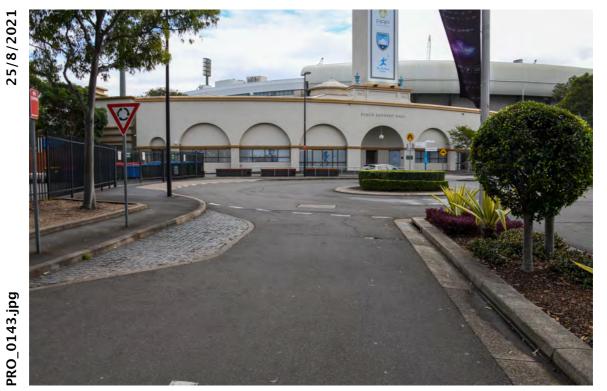
Western side of the Boulevard. Area adjacent to 'The Hordern Pavilion'. Heading north. Cracked paving.

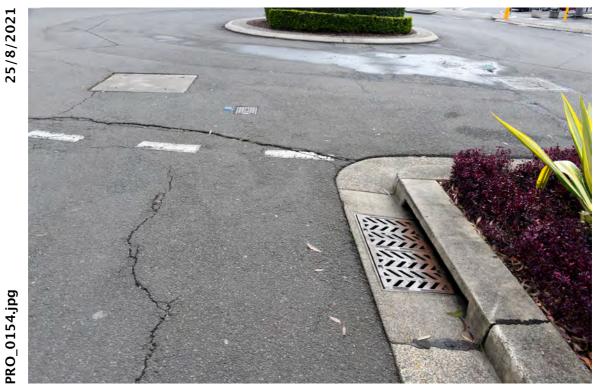
Western side of the Boulevard. Area adjacent to 'The Hordern Pavilion'. Area on the southern side of the roundabout. Damaged road paving.

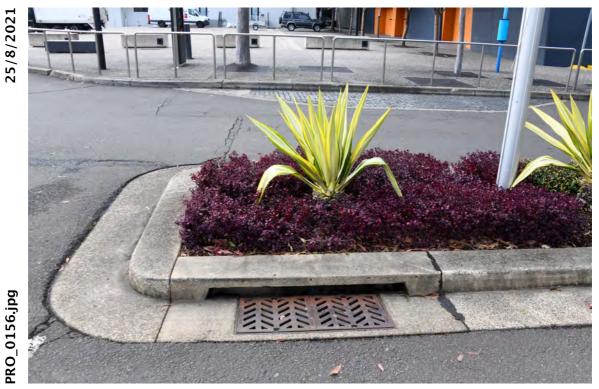
Western side of the Boulevard. Area adjacent to 'The Hordern Pavilion'. Area on the southern side of the roundabout. Cracked median strip gutter.

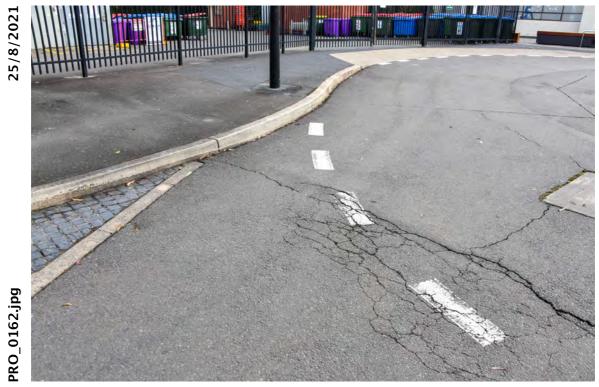
Western side of the Boulevard. Area adjacent to 'The Hordern Pavilion'. Area on the southern side of the roundabout. Cracked road paving.

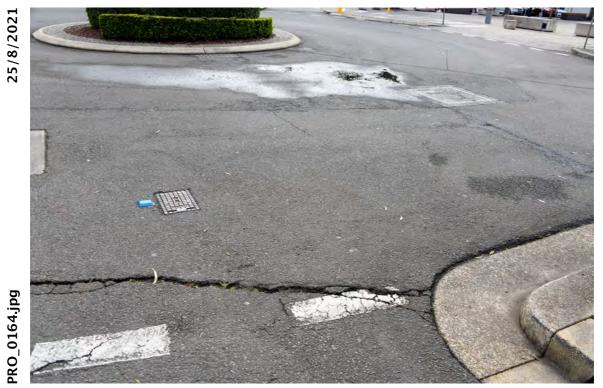
Western side of the Boulevard. Area adjacent to 'The Hordern Pavilion'. Area on the southern side of the roundabout. Cracked road paving.

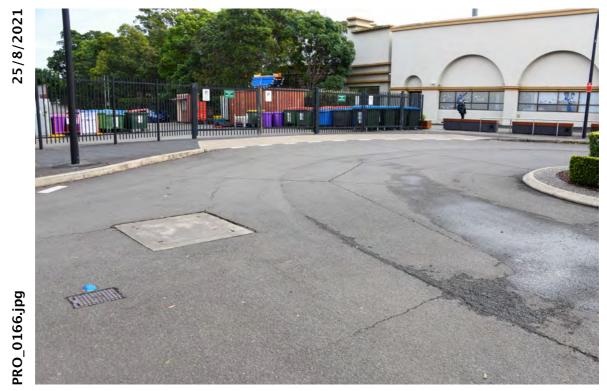
Western side of the Boulevard. Area adjacent to 'The Hordern Pavilion'. Area on the southern side of the roundabout. Facing west. Cracked road paving.

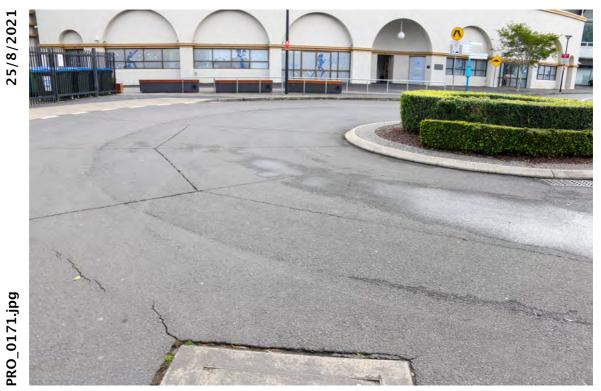
Roundabout at the northern end of the Boulevard. Heading clockwise. South-western side of the roundabout. Cracked road paving.

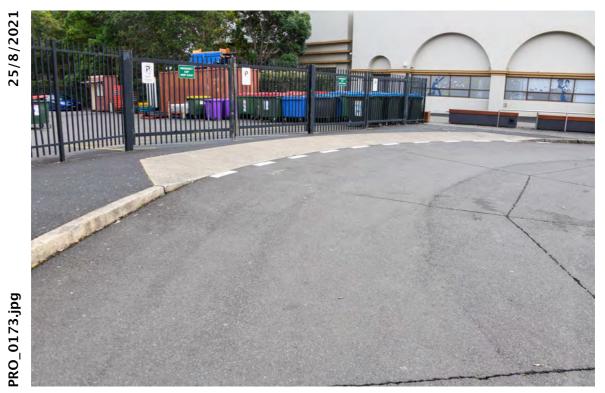
Roundabout at the northern end of the Boulevard. Heading clockwise. South-western side of the roundabout. Cracked kerb.

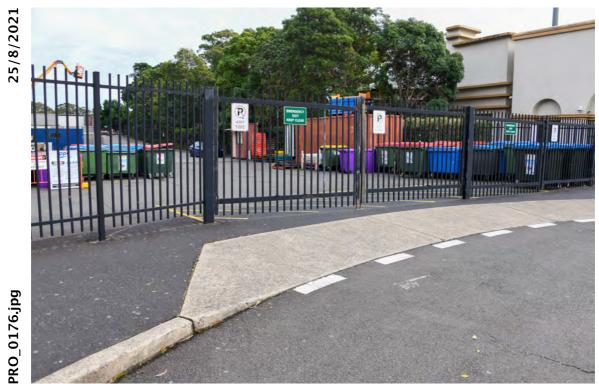
Roundabout at the northern end of the Boulevard. Heading clockwise. Western side of the roundabout. Cracked kerb.

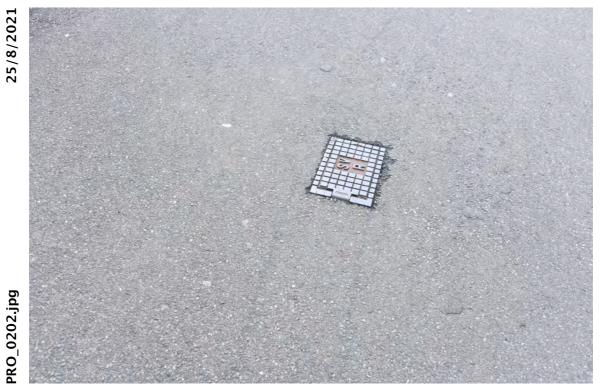
Roundabout at the northern end of the Boulevard. Heading clockwise. Northern side of the roundabout. Intersection with Bent Street. Cracked kerb. Lid to the service in the road.

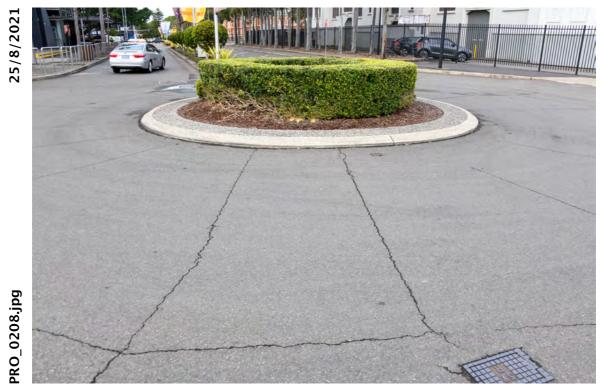
Roundabout at the northern end of the Boulevard. Heading clockwise. Northern side of the roundabout. Intersection with Bent Street. Cracked road paving.

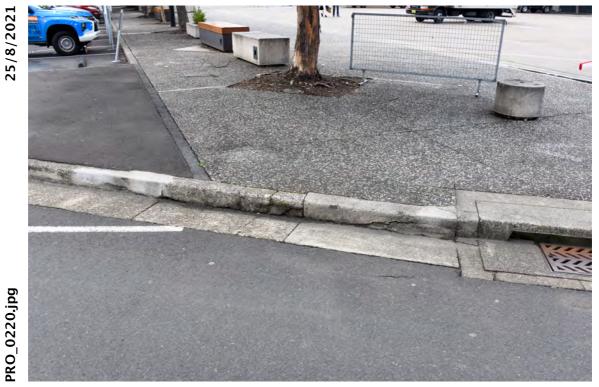
Roundabout at the northern end of the Boulevard. Intersection with Bent Street. Cracked adjacent kerb.

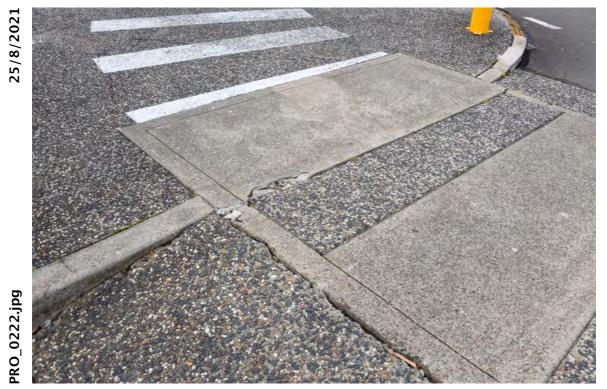
Roundabout at the northern end of the Boulevard. Intersection with Bent Street. Chipped paving.

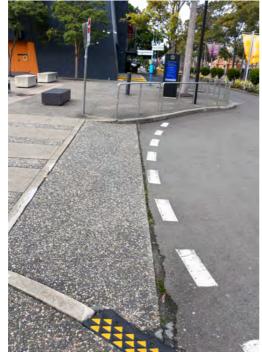
Roundabout at the northern end of the Boulevard. Eastern side of the roundabout. Heading clockwise. Damaged edge of the road paving.

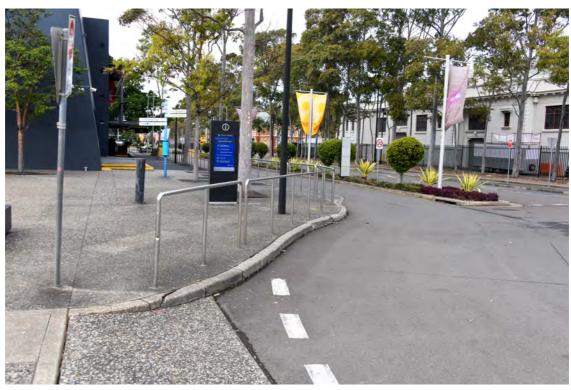
PRO_0227.jpg

Roundabout at the northern end of the Boulevard. Eastern side of the roundabout. Heading clockwise. Cracked kerb and indentations in the balustrade.

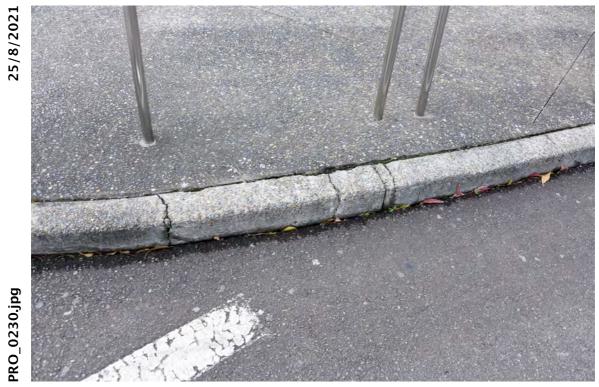
Roundabout at the northern end of the Boulevard. Eastern side of the roundabout. Heading clockwise. Cracked kerb.

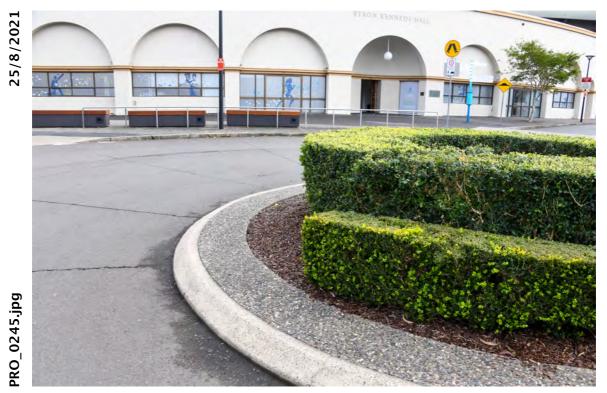
Roundabout at the northern end of the Boulevard. Heading clockwise around the centre of the roundabout. South-western side.

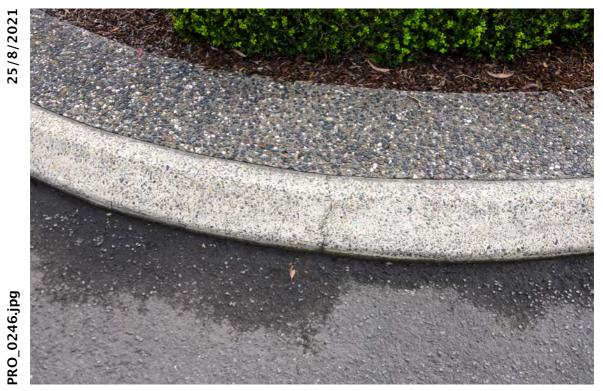
Roundabout at the northern end of the Boulevard. Heading clockwise around the centre of the roundabout. South-western side. Cracked kerb.

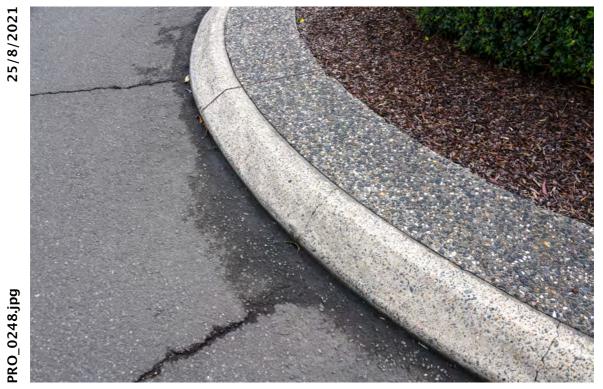
Roundabout at the northern end of the Boulevard. Heading clockwise around the centre of the roundabout. Western side. Cracked kerb.

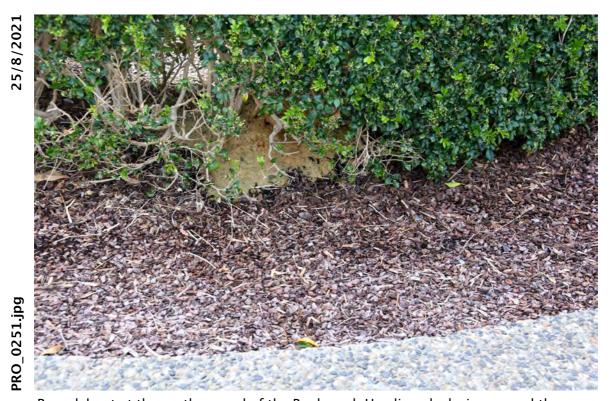
Roundabout at the northern end of the Boulevard. Heading clockwise around the centre of the roundabout. Western side. Dumped sand in the landscaping.

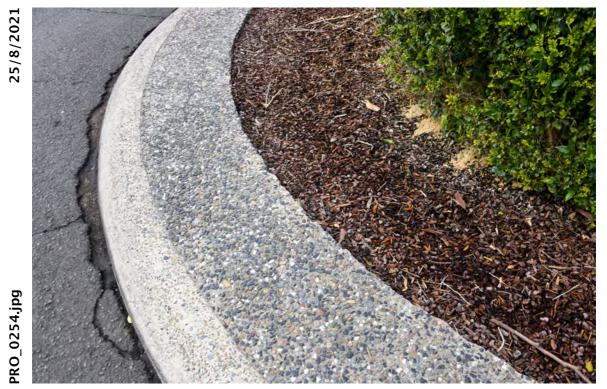
Roundabout at the northern end of the Boulevard. Heading clockwise around the centre of the roundabout. Northern side. Chipped edges of the paving.

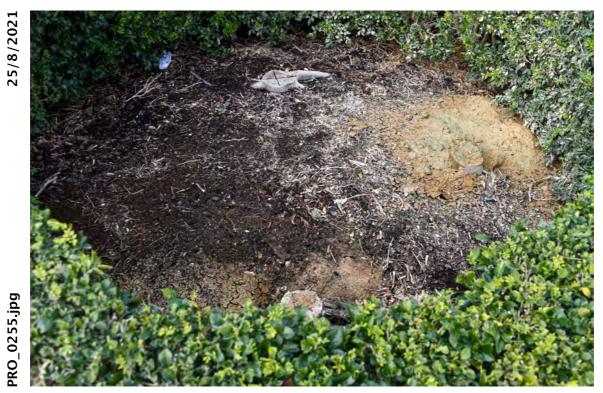
Roundabout at the northern end of the Boulevard. Heading clockwise around the centre of the roundabout. Northern side. Dumped sand in the centre of the landscaping.

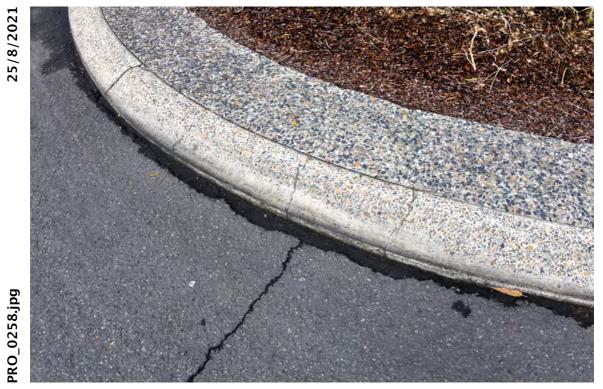
Roundabout at the northern end of the Boulevard. Heading clockwise around the centre of the roundabout. Eastern side. Cracked kerb.

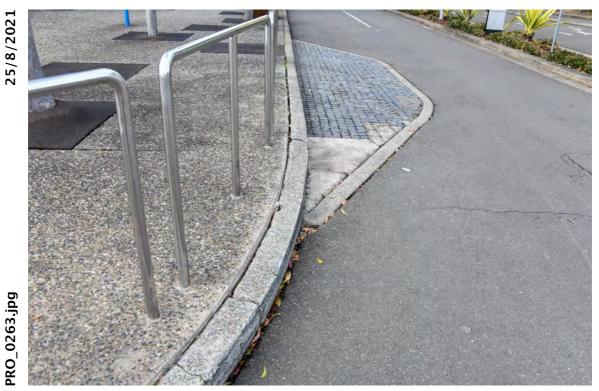
Eastern side of the Boulevard. Heading south from the roundabout at the northern end of the Boulevard. Eastern side of the road. Damaged kerb.

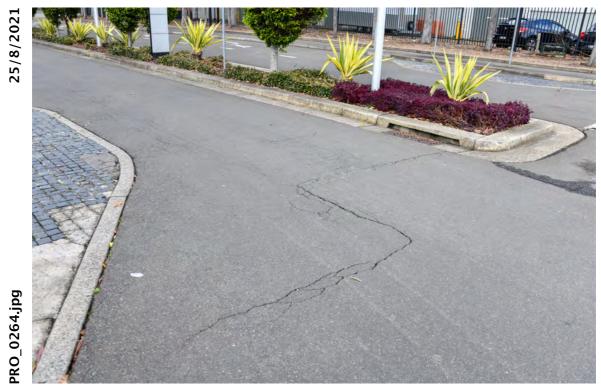
Eastern side of the Boulevard. Heading south from the roundabout at the northern end of the Boulevard. Eastern side of the road. Cracked road paving.

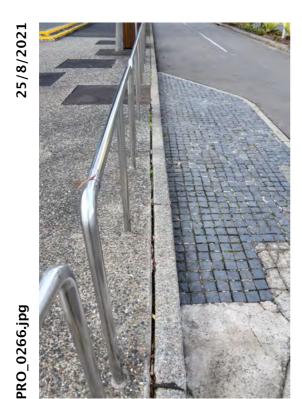
Eastern side of the Boulevard. Heading south from the roundabout at the northern end of the Boulevard. Eastern side of the road. Cobbled paving. Movement to the kerb.

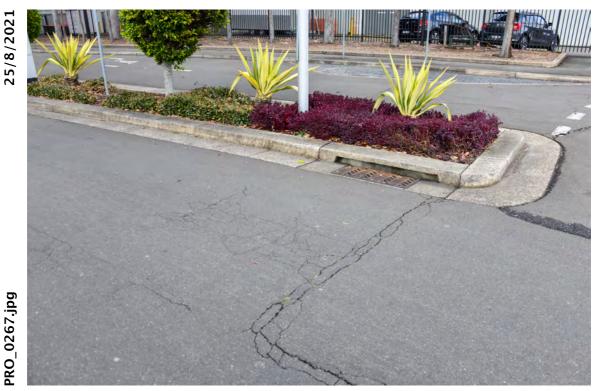
Eastern side of the Boulevard. Heading south from the roundabout at the northern end of the Boulevard. Eastern side of the road. Cracked road paving.

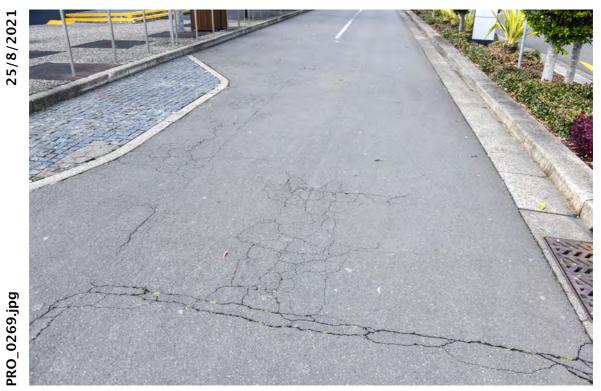
Eastern side of the Boulevard. Heading south from the roundabout at the northern end of the Boulevard. Eastern side of the road. Cracked road paving.

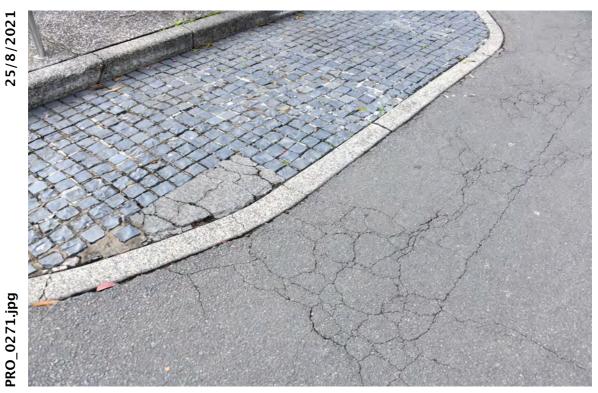
Eastern side of the Boulevard. Heading south from the roundabout at the northern end of the Boulevard. Eastern side of the road. Area of the cobbled paving. Cracked paving.

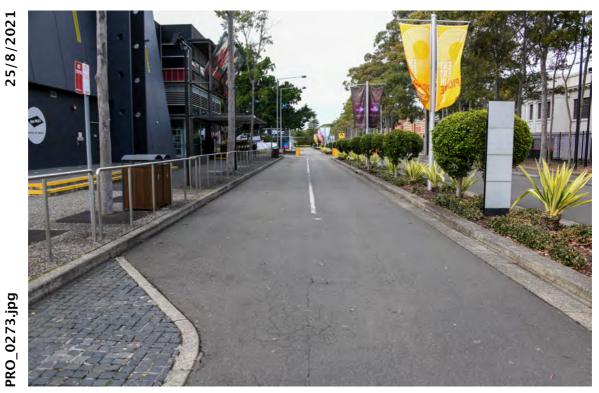
Eastern side of the Boulevard. Heading south from the roundabout at the northern end of the Boulevard. Eastern side of the road. Area of the cobbled paving. Cracked paving.

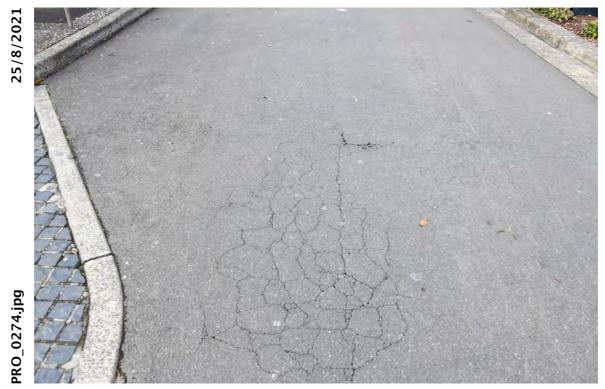
Eastern side of the Boulevard. Heading south from the roundabout at the northern end of the Boulevard. Eastern side of the road. Area of the cobbled paving. Cracked paving.

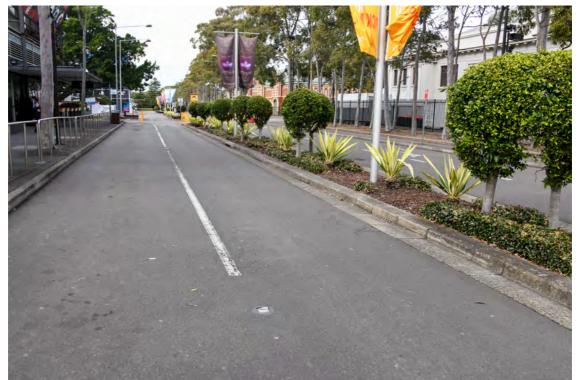
Eastern side of the Boulevard. Area opposite 'The Hordern Pavilion'. Area approaching the intersection with Park Road. Heading south. Cracked road paving.

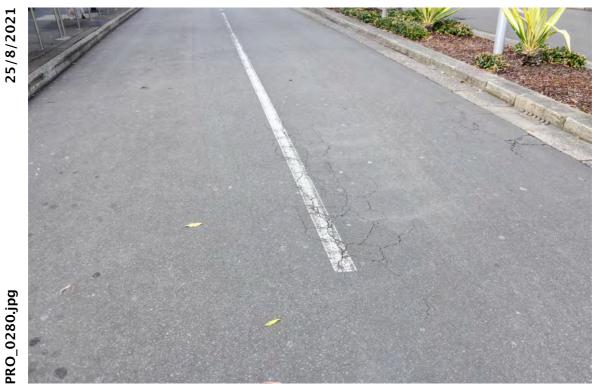
Eastern side of the Boulevard. Area opposite 'The Hordern Pavilion'. Area approaching the intersection with Park Road. Heading south. Cracked paving.

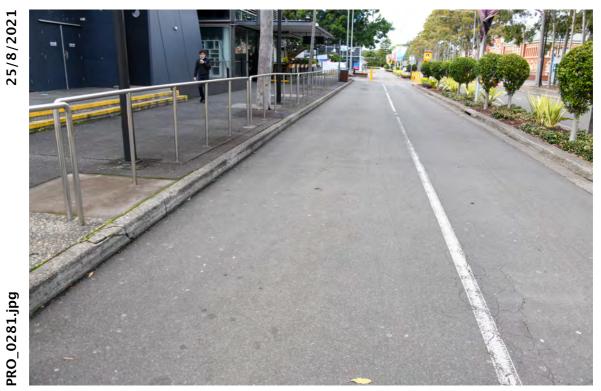
Eastern side of the Boulevard. Area opposite 'The Hordern Pavilion'. Area approaching the intersection with Park Road. Heading south. Cracked paving.

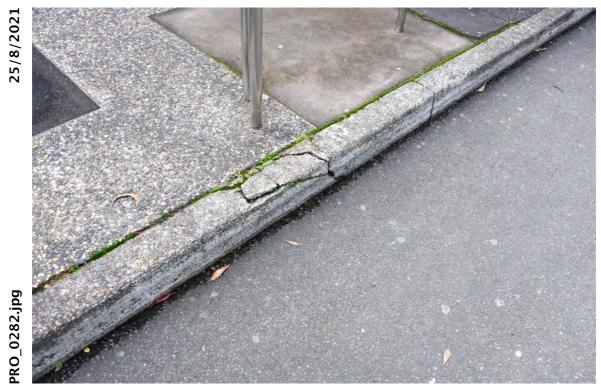
Eastern side of the Boulevard. Area opposite 'The Hordern Pavilion'. Area approaching the intersection with Park Road. Heading south. Cracked kerb.

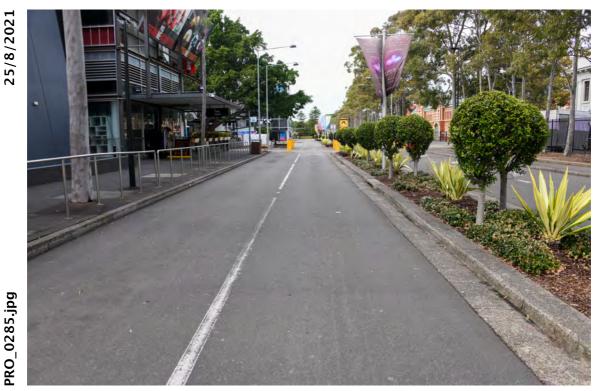
Eastern side of the Boulevard. Area opposite 'The Hordern Pavilion'. Area approaching the intersection with Park Road. Heading south. Cracked paving adjacent to the median strip.

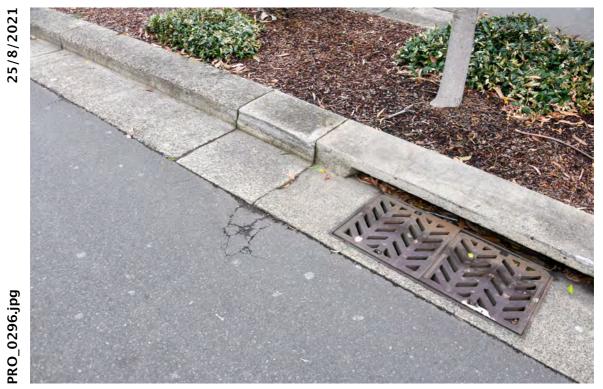
Eastern side of the Boulevard. Area opposite 'The Hordern Pavilion'. Area approaching the intersection with Park Road. Heading south. Storm water drain in the median strip. Cracked adjacent paving.

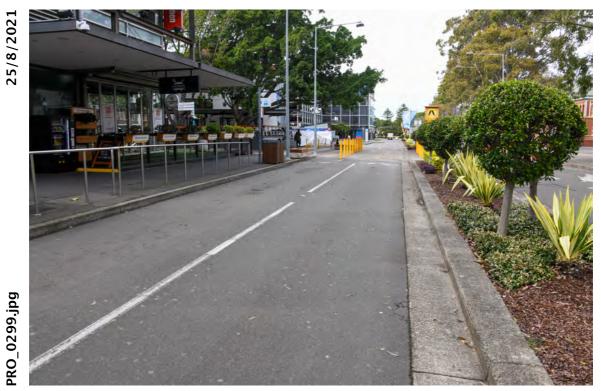
Eastern side of the Boulevard. Area opposite 'The Hordern Pavilion'. Area approaching the intersection with Park Road. Heading south. Flagpole on the median strip. Loose cover plate.

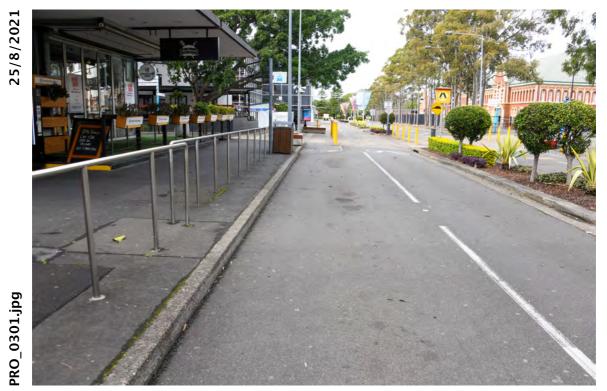
Eastern side of the Boulevard. Area opposite 'The Hordern Pavilion'. Area approaching the intersection with Park Road. Heading south. Cracked paving adjacent to the gutter.

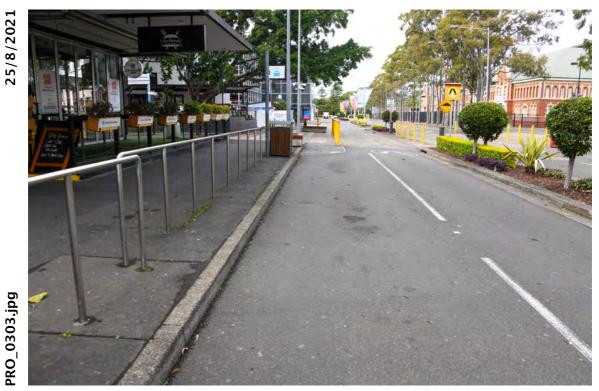
Eastern side of the Boulevard. Area opposite 'The Hordern Pavilion'. Area approaching the intersection with Park Road. Heading south. Indentation in the balustrade.

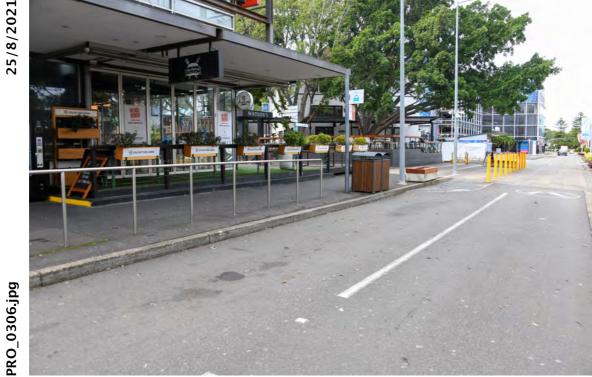
Eastern side of the Boulevard. Area opposite 'The Hordern Pavilion'. Area approaching the intersection with Park Road. Heading south. Cracked paving adjacent to the median strip.

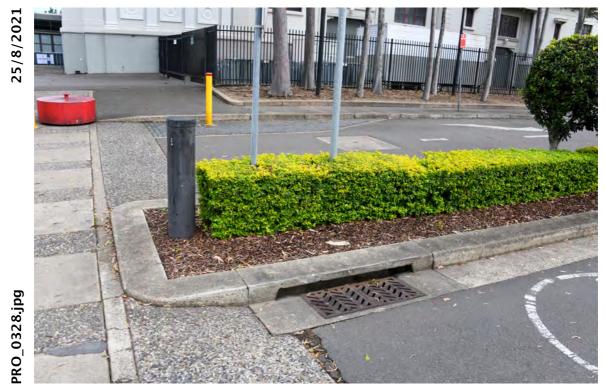
Eastern side of the Boulevard. Area opposite 'The Hordern Pavilion'. Area of the pedestrian crossing. Heading south. Cracked paving.

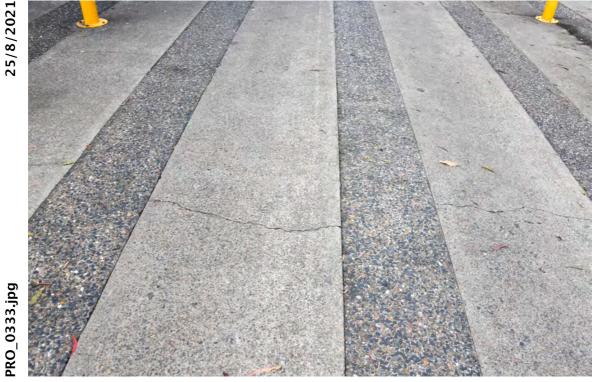
Eastern side of the Boulevard. Area opposite 'The Hordern Pavilion'. Area of the pedestrian crossing. Heading south. Cracked paving.
