Royal Hall of Industries - Moore Park

Sydney Swans HQ & Community Centre

<u>Dilapidation</u> <u>Addendum</u> Report - Errol Flynn Blvd

25th August 2021

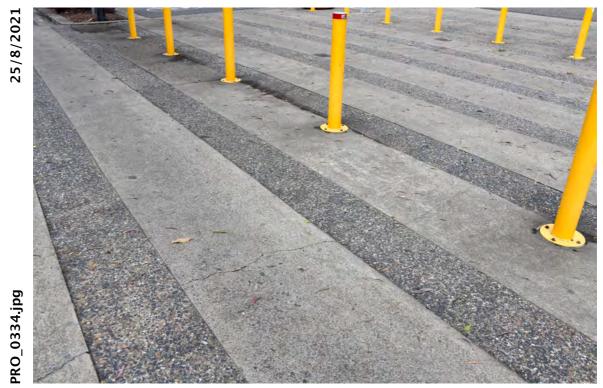
Eastern side of the Boulevard. Area opposite 'The Hordern Pavilion'. Area of the pedestrian crossing. Heading south. Cracked paving.

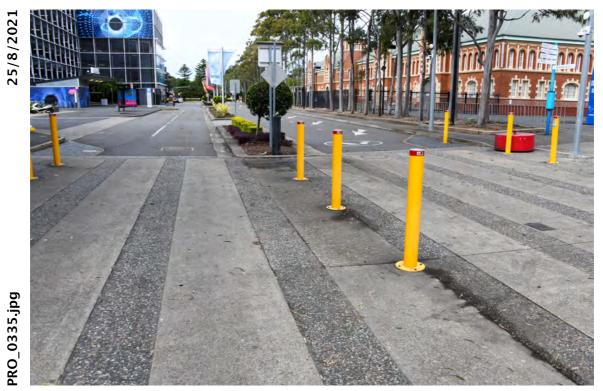
Eastern side of the Boulevard. Area opposite 'The Hordern Pavilion'. Area of the pedestrian crossing. Heading south. Cracked paving.

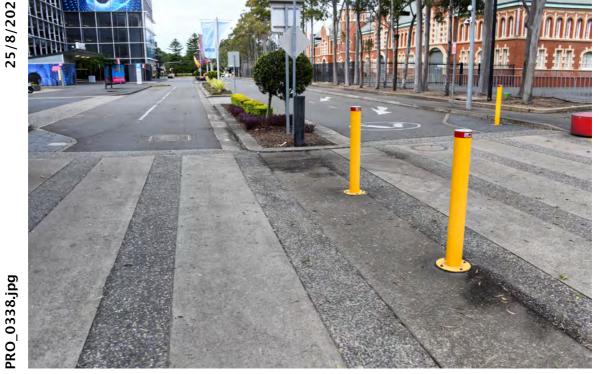
Eastern side of the Boulevard. Area opposite 'The Hordern Pavilion'. Area of the pedestrian crossing. Heading south. Chipped paving.

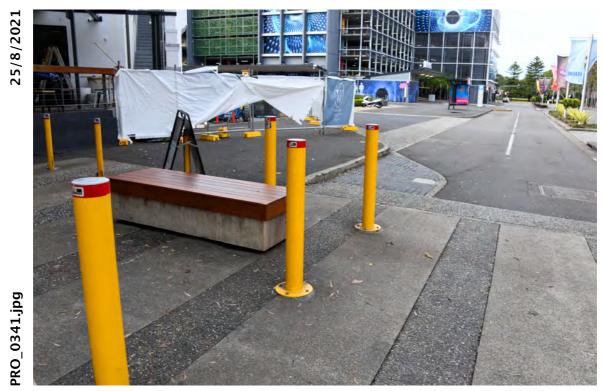
Eastern side of the Boulevard. Area opposite 'The Hordern Pavilion'. Area of the pedestrian crossing. Heading south. Bollards. Cracked adjacent paving.

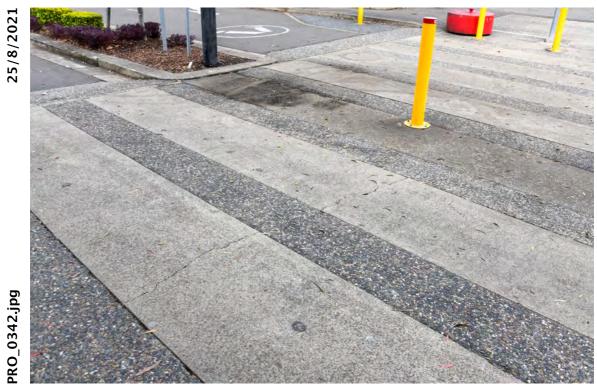
Eastern side of the Boulevard. Area opposite 'The Hordern Pavilion'. Area of the pedestrian crossing. Heading south. Cracked paving.

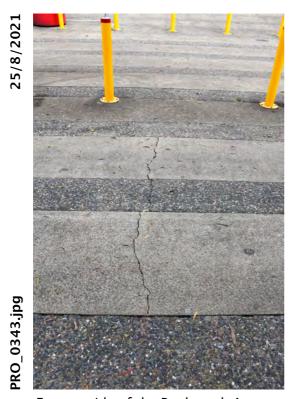
Eastern side of the Boulevard. Area opposite 'The Hordern Pavilion'. Area of the pedestrian crossing. Heading south. Cracked paving.

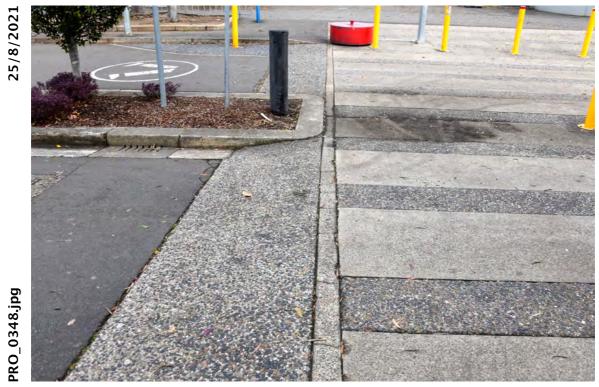
Eastern side of the Boulevard. Area opposite the area between 'The Hordern Pavilion' and 'The Royal Hall of Industries'. Area of the pedestrian crossing. Heading south. Cracked paving.

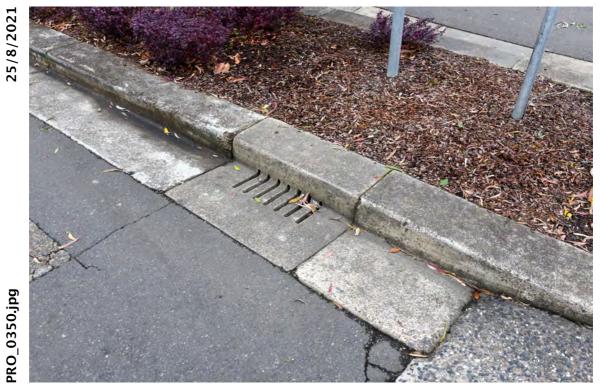
Eastern side of the Boulevard. Area opposite the area between 'The Hordern Pavilion' and 'The Royal Hall of Industries'. Area of the pedestrian crossing. Heading south. Storm water drain in the median strip.

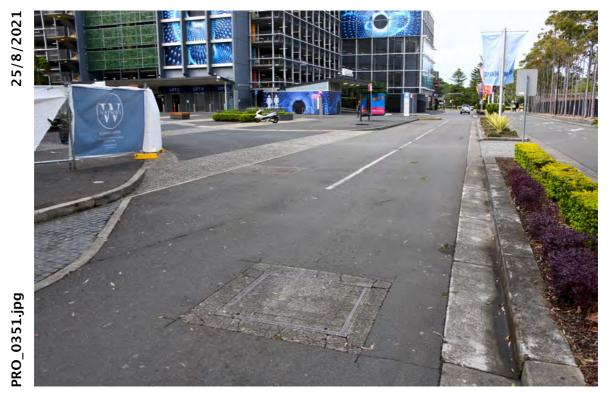
Eastern side of the Boulevard. Area opposite the area between 'The Hordern Pavilion' and 'The Royal Hall of Industries'. Area of the pedestrian crossing. Heading south. Lid to the services pit in the road.

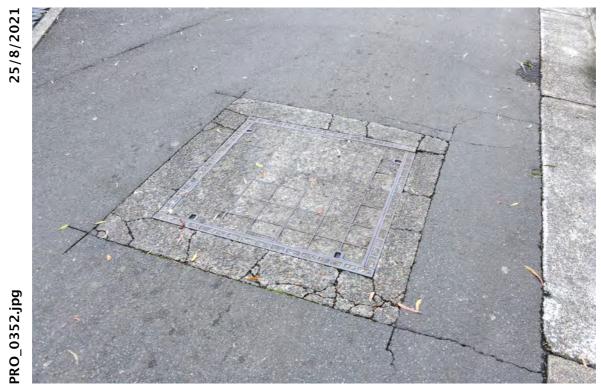
Eastern side of the Boulevard. Area opposite the area between 'The Hordern Pavilion' and 'The Royal Hall of Industries'. Area of the pedestrian crossing. Heading south. Lid to the services pit in the road. Cracked surrounding paving.

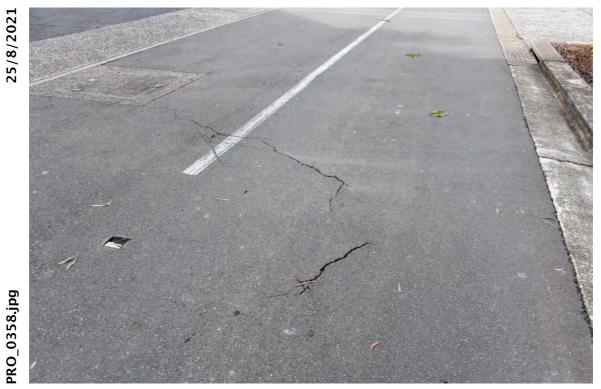
Eastern side of the Boulevard. Area opposite the area between 'The Hordern Pavilion' and 'The Royal Hall of Industries'. Intersection with Park Road. Cracked road paving.

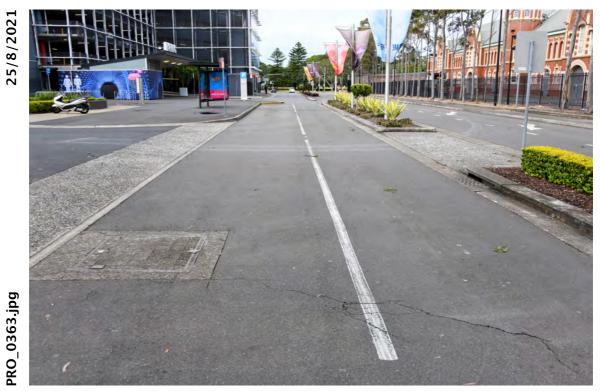
Eastern side of the Boulevard. Area opposite the area between 'The Hordern Pavilion' and 'The Royal Hall of Industries'. Intersection with Park Road. Cracked road paving.

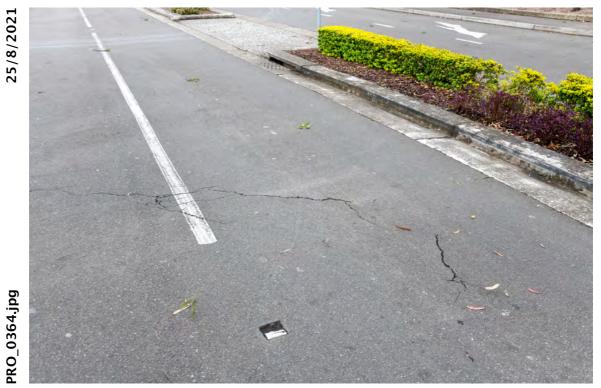
Eastern side of the Boulevard. Area opposite the area between 'The Hordern Pavilion' and 'The Royal Hall of Industries'. Intersection with Park Road. Cracked road paving.

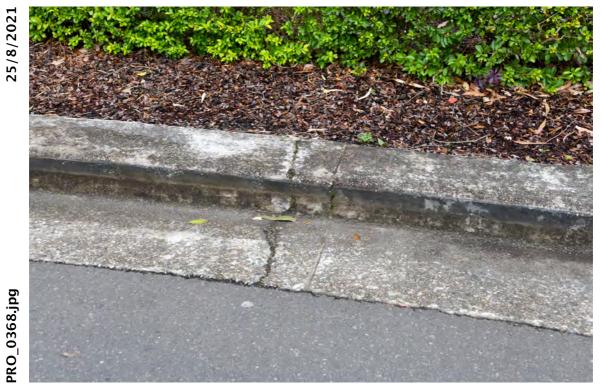
Eastern side of the Boulevard. Area opposite the area between 'The Hordern Pavilion' and 'The Royal Hall of Industries'. Intersection with Park Road. Cracked median strip kerb and gutter.

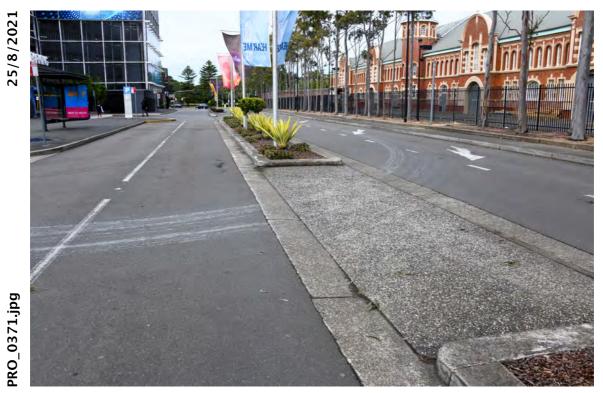
Eastern side of the Boulevard. Area opposite the area between 'The Hordern Pavilion' and 'The Royal Hall of Industries'. Intersection with Park Road. Gap in the median strip.

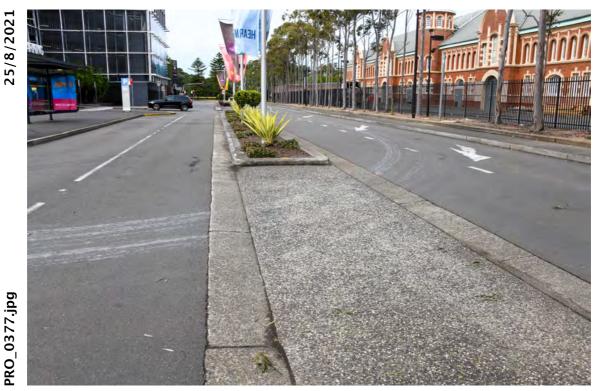
Eastern side of the Boulevard. Area opposite the area between 'The Hordern Pavilion' and 'The Royal Hall of Industries'. Intersection with Park Road. Heading south. Gap in the median strip.

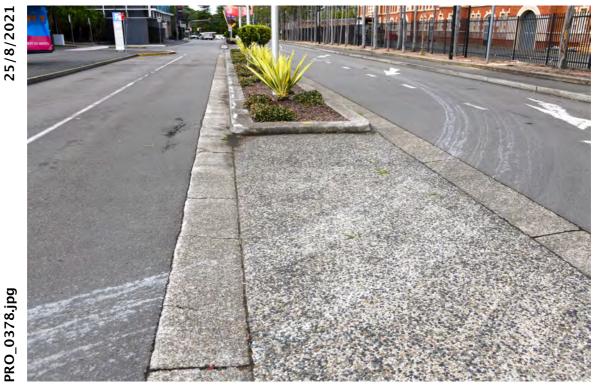
Eastern side of the Boulevard. Area opposite the area between 'The Hordern Pavilion' and 'The Royal Hall of Industries'. Intersection with Park Road. Heading south. Gap in the median strip.

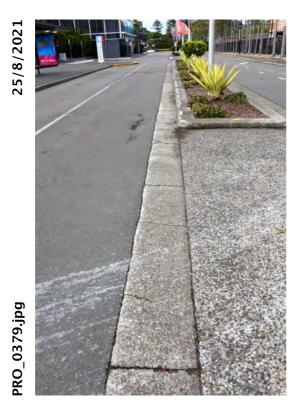
Eastern side of the Boulevard. Area opposite the area between 'The Hordern Pavilion' and 'The Royal Hall of Industries'. Intersection with Park Road. Heading south. Gap in the median strip.

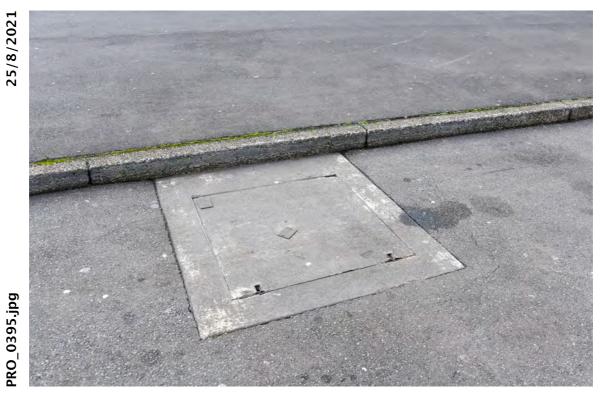
Eastern side of the Boulevard. Area opposite the 'The Royal Hall of Industries'. Area approaching the entry / exit to the 'Wilson Car Park'. Heading south. Lid to a services pit in the road.

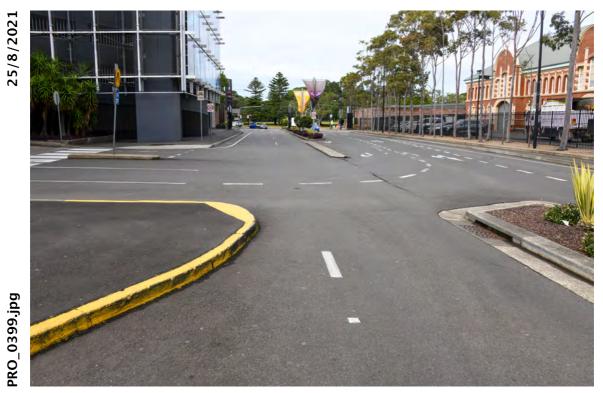
Eastern side of the Boulevard. Area opposite the 'The Royal Hall of Industries'. Area approaching the entry / exit to the 'Wilson Car Park'. Heading south along the kerb and gutter.

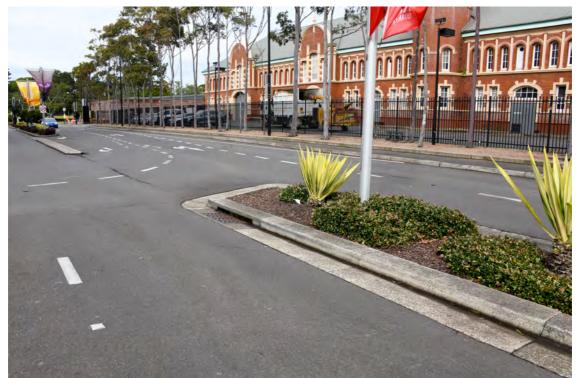
Eastern side of the Boulevard. Area opposite the 'The Royal Hall of Industries'. Area approaching the entry / exit to the 'Wilson Car Park'. Heading south along the median strip.

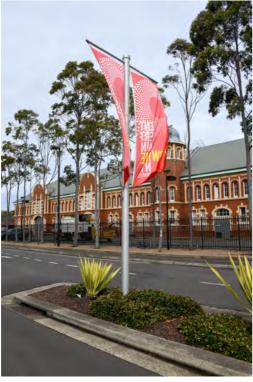
PRO_0401.jpg

Eastern side of the Boulevard. Area opposite the 'The Royal Hall of Industries'. Area approaching the entry / exit to the 'Wilson Car Park'. Heading south along the median strip. Flag pole.

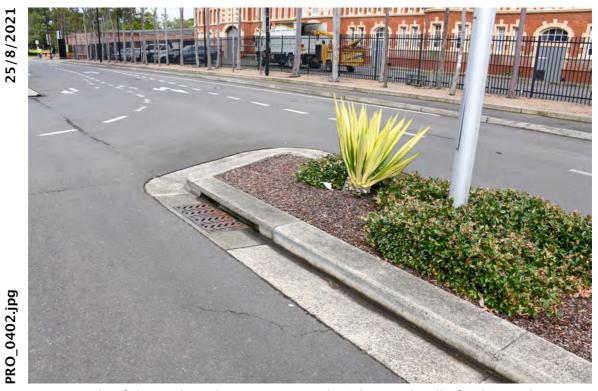
Eastern side of the Boulevard. Area opposite the 'The Royal Hall of Industries'. Area approaching the entry / exit to the 'Wilson Car Park'. Heading south along the median strip. Cracked adjacent paving.

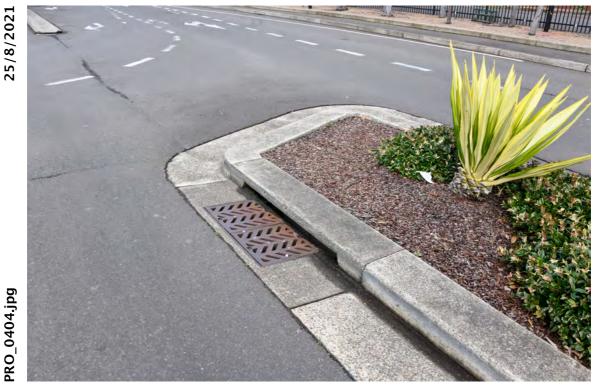
Eastern side of the Boulevard. Area opposite the 'The Royal Hall of Industries'. Area approaching the entry / exit to the 'Wilson Car Park'. Heading south along the median strip. Storm water drain.

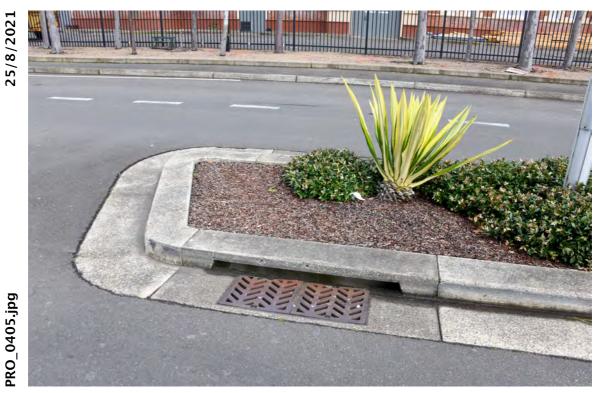
Eastern side of the Boulevard. Area opposite the 'The Royal Hall of Industries'. Area approaching the entry / exit to the 'Wilson Car Park'. Heading south along the median strip. Storm water drain.

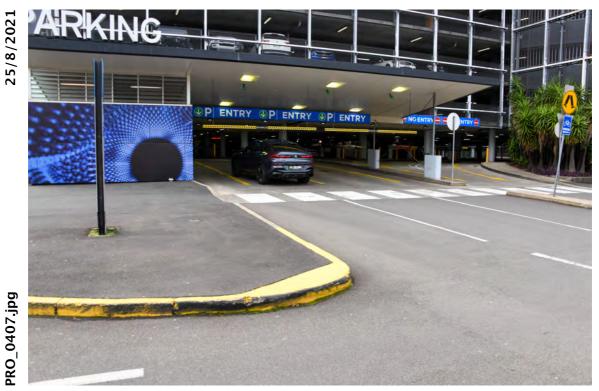
Eastern side of the Boulevard. Area opposite the 'The Royal Hall of Industries'. Area of the entry / exit to the 'Wilson Car Park'. Heading south.

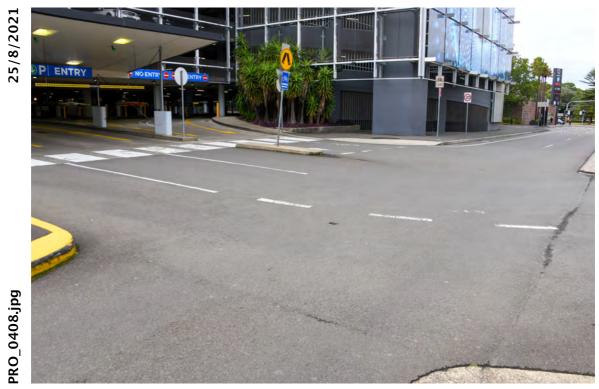
Eastern side of the Boulevard. Area opposite the 'The Royal Hall of Industries'. Area of the entry / exit to the 'Wilson Car Park'. Heading south.

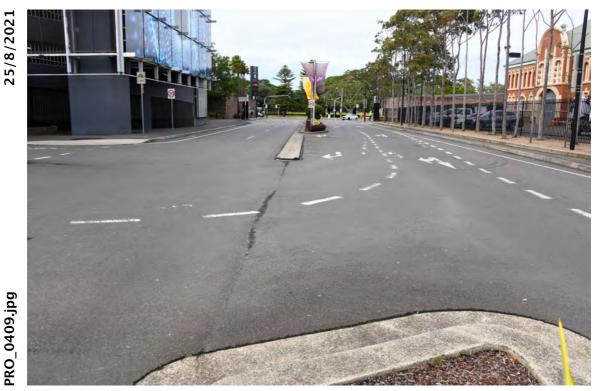
Eastern side of the Boulevard. Area opposite the 'The Royal Hall of Industries'. Area of the entry / exit to the 'Wilson Car Park'. Heading south.

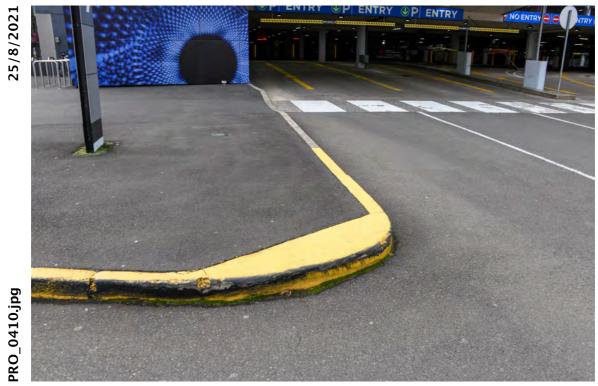
Eastern side of the Boulevard. Area opposite the 'The Royal Hall of Industries'. Area of the entry / exit to the 'Wilson Car Park'. Heading south. Chipped yellow painted kerb.

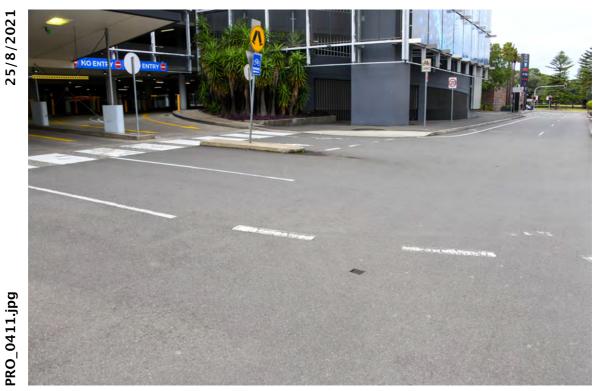
Eastern side of the Boulevard. Area opposite the 'The Royal Hall of Industries'. Area of the entry / exit to the 'Wilson Car Park'. Heading south.

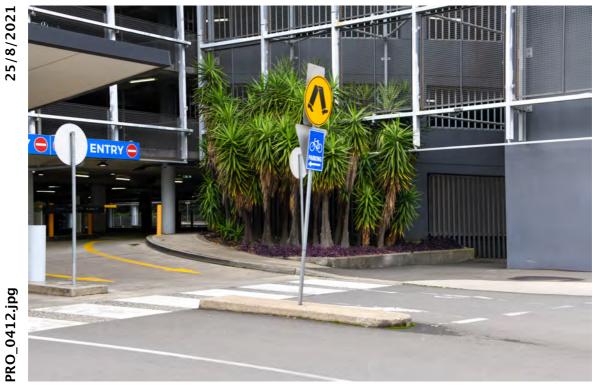
Eastern side of the Boulevard. Area opposite the 'The Royal Hall of Industries'. Area of the entry / exit to the 'Wilson Car Park'. Heading south. Lean on the street sign.

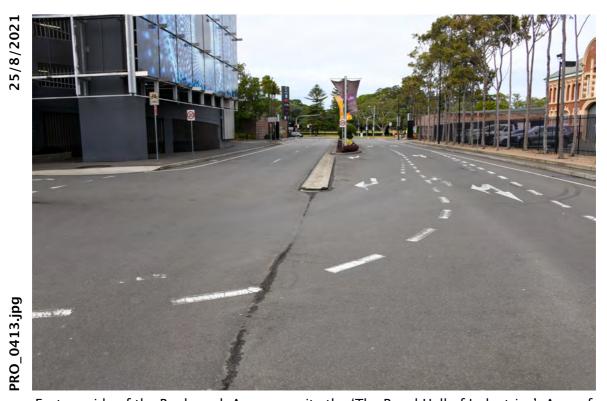
PRO_0414.jpg

Eastern side of the Boulevard. Area opposite the 'The Royal Hall of Industries'. Area of the entry / exit to the 'Wilson Car Park'. Heading south.

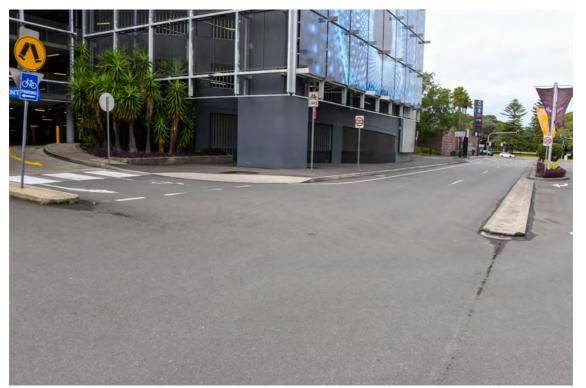
Eastern side of the Boulevard. Area opposite the 'The Royal Hall of Industries'. Area of the entry / exit to the 'Wilson Car Park'. Heading south.

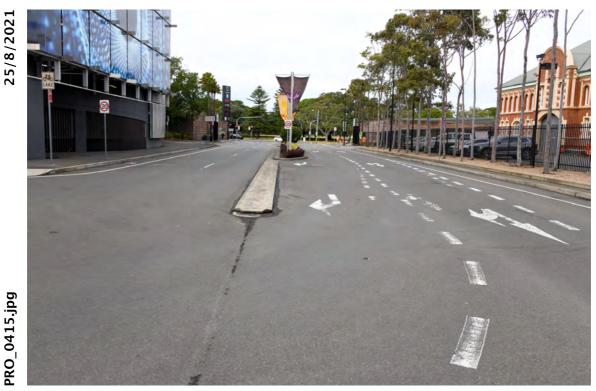
PRO_0416.jpg

Eastern side of the Boulevard. Area opposite the 'The Royal Hall of Industries'. Area of the entry / exit to the 'Wilson Car Park'. Heading south.

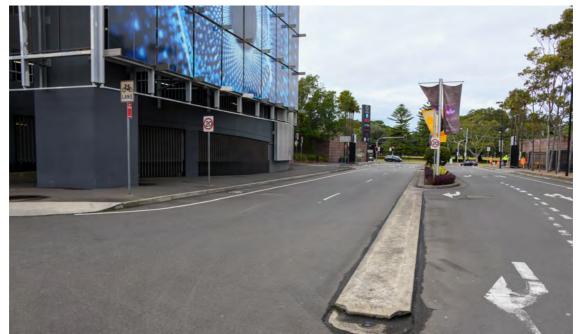
Eastern side of the Boulevard. Area opposite the 'The Royal Hall of Industries'. Area of the entry / exit to the 'Wilson Car Park'. Heading south. Chipped northern end of the median strip.

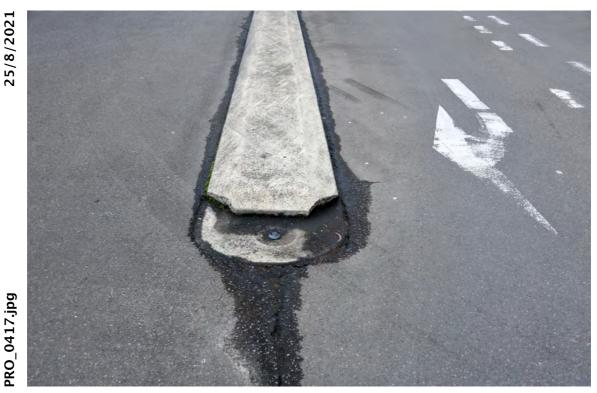
Eastern side of the Boulevard. Area opposite the 'The Royal Hall of Industries'. Area of the entry / exit to the 'Wilson Car Park'. Heading south. Chipped northern end of the median strip.

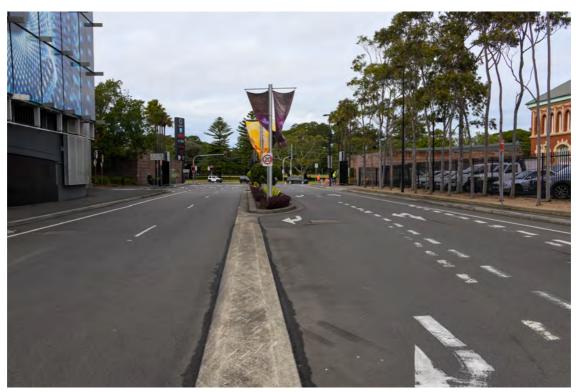
Eastern side of the Boulevard. Area opposite the 'The Royal Hall of Industries'. Area of the entry / exit to the 'Wilson Car Park'. Heading south along the median strip.

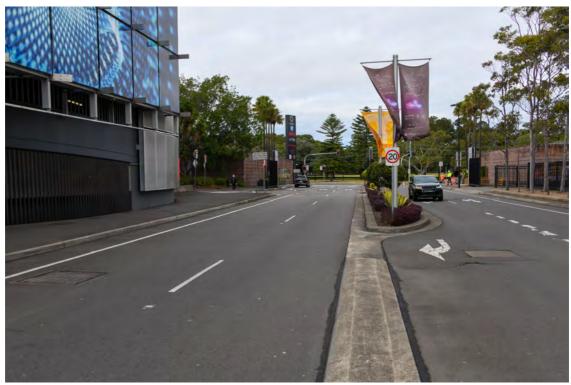
PRO_0419.jpg

Eastern side of the Boulevard. Area opposite the 'The Royal Hall of Industries' and adjacent to the 'Wilson Car Park'. Heading south along the median strip.

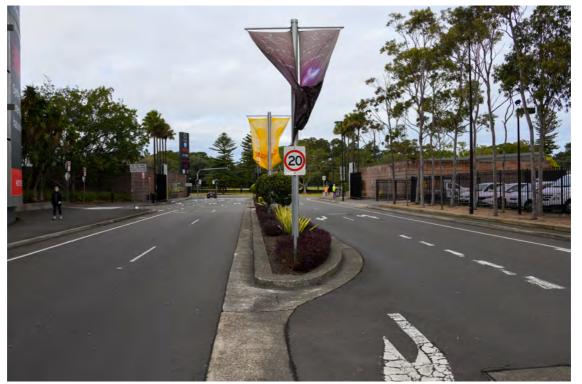
Eastern side of the Boulevard. Area opposite the 'The Royal Hall of Industries' and adjacent to the 'Wilson Car Park'. Heading south along the median strip.
