## **Report on Geotechnical Investigation**

**Proposed Residential Development  
65 Muston Street, Mosman**

**Prepared for Prosker Property Pty Ltd**

**Project 236982.00**

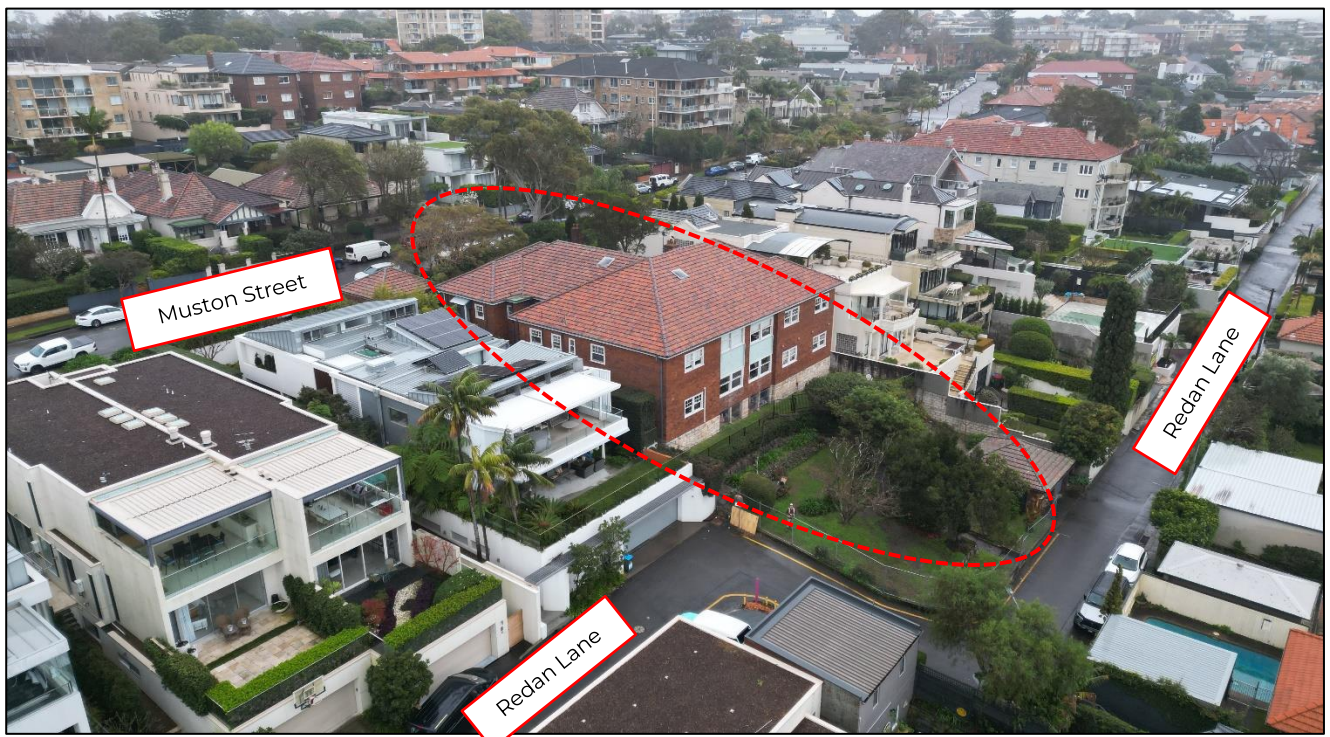
**Figure 1: Drone photo of the site looking north-west (photo taken on 7 August 2025)**

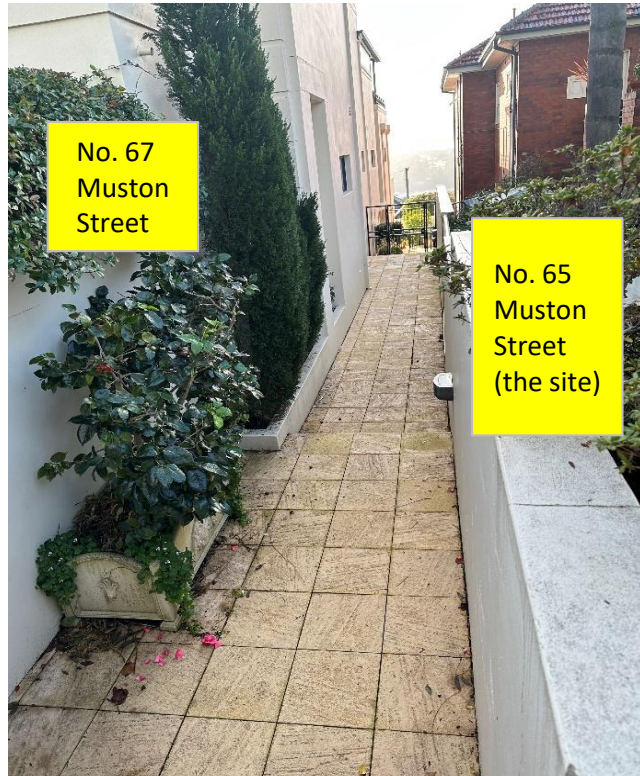
Muston Street. At their closest points, the buildings situated to the north and south of the site are both built to within about 1.5 m of the common boundaries (refer Plate 1, Photo 1 and Photo 2).

Photo 1: Photo looking east down the common northern boundary

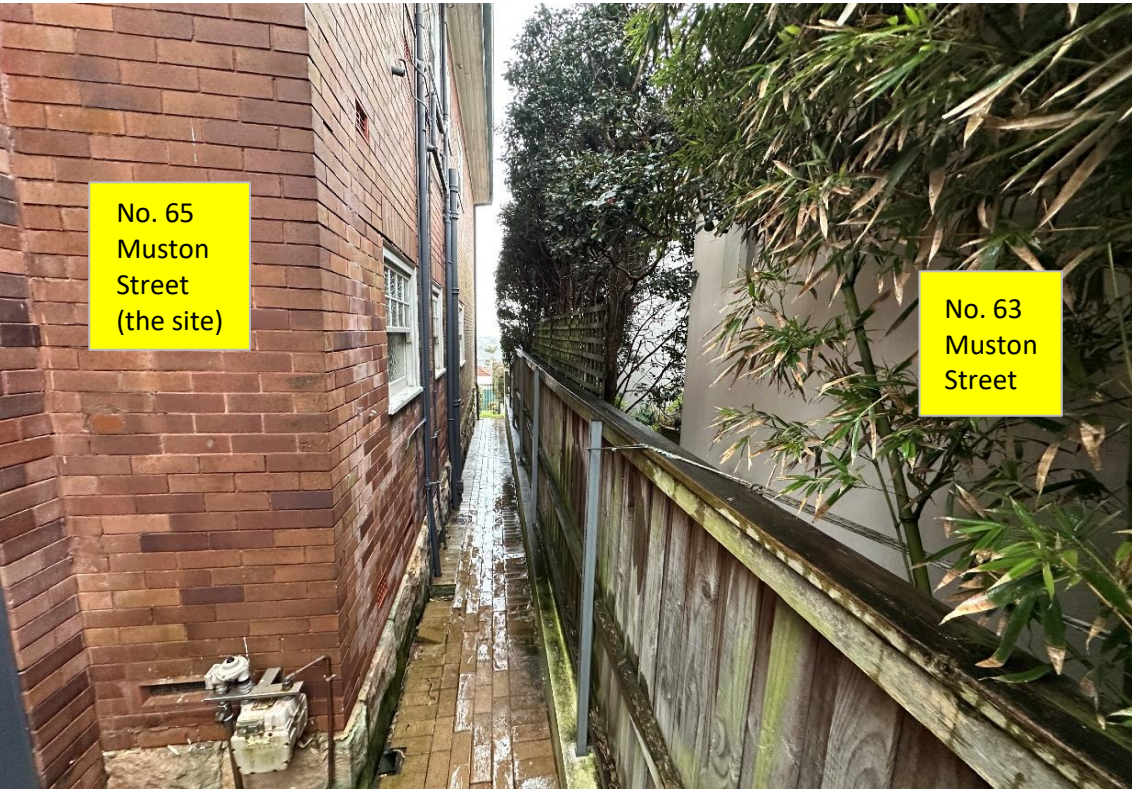
Photo 2: Photo looking east down the common southern boundary

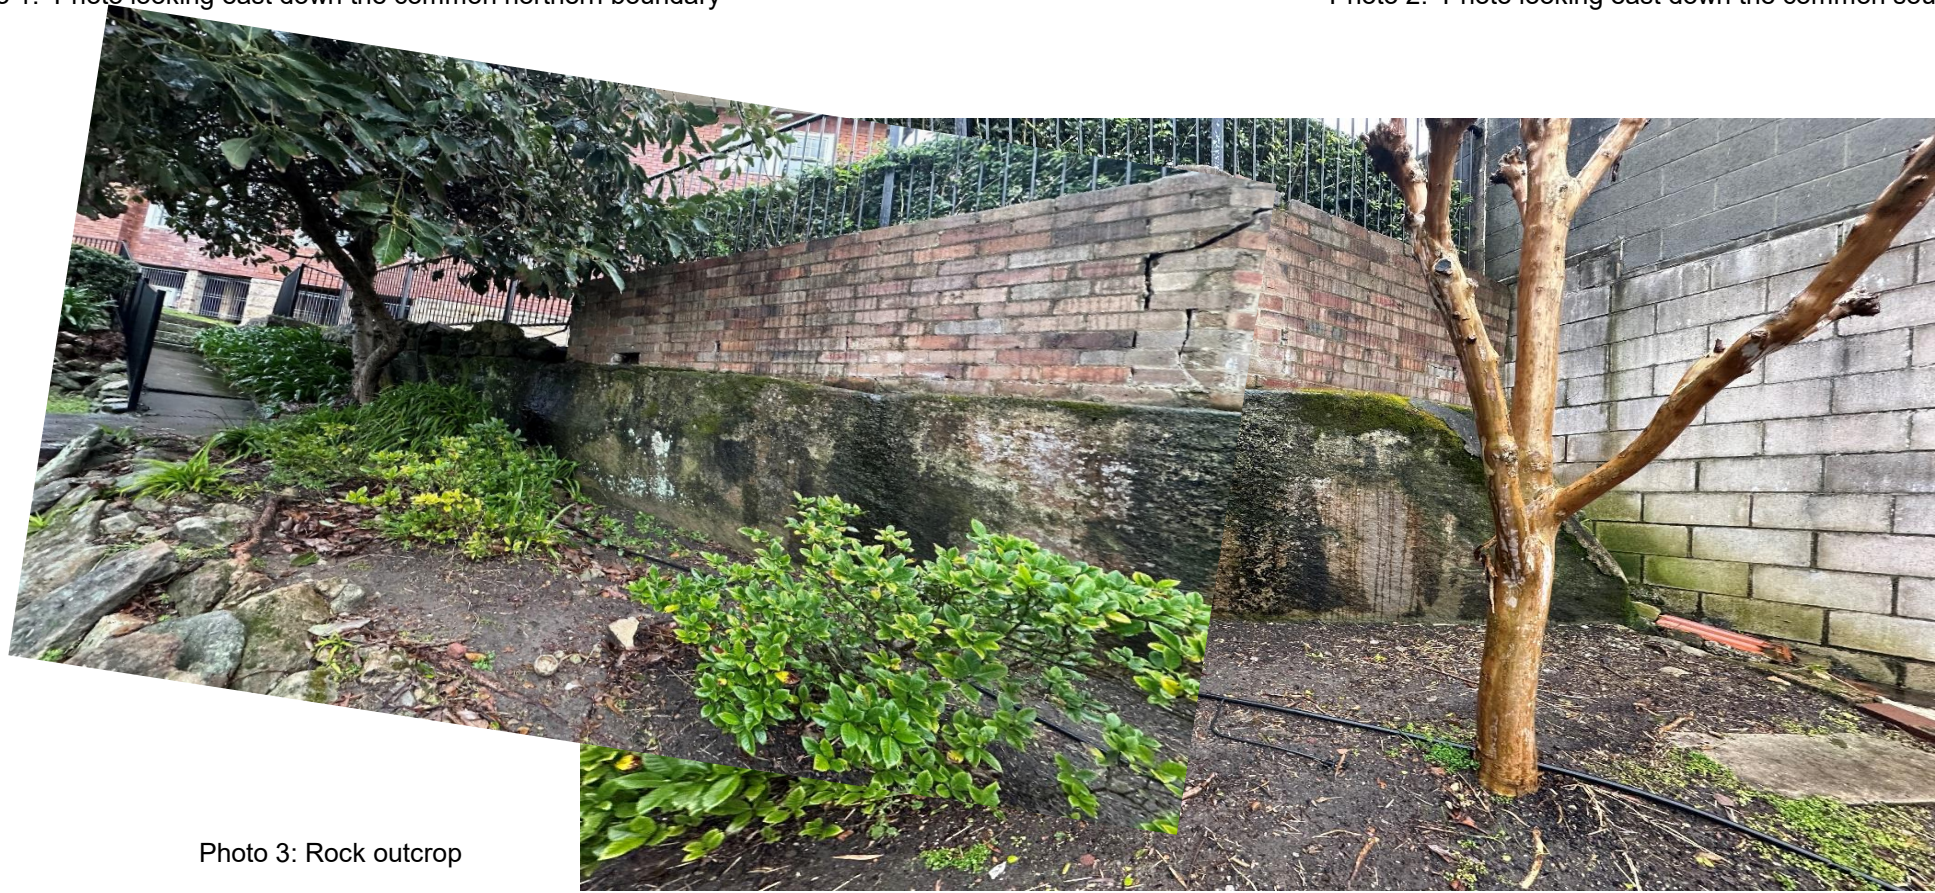
- Rock outcrop comprising medium strength, moderately to slightly weathered sandstone located between the building and the garage on Redan Lane as a sub-vertical step/ledge that trends approximately north-northeast/south-southwest and is about 15 m long and up to 1.3 m high (refer Plate 1, Photo 3);

Photo 3: Rock outcrop

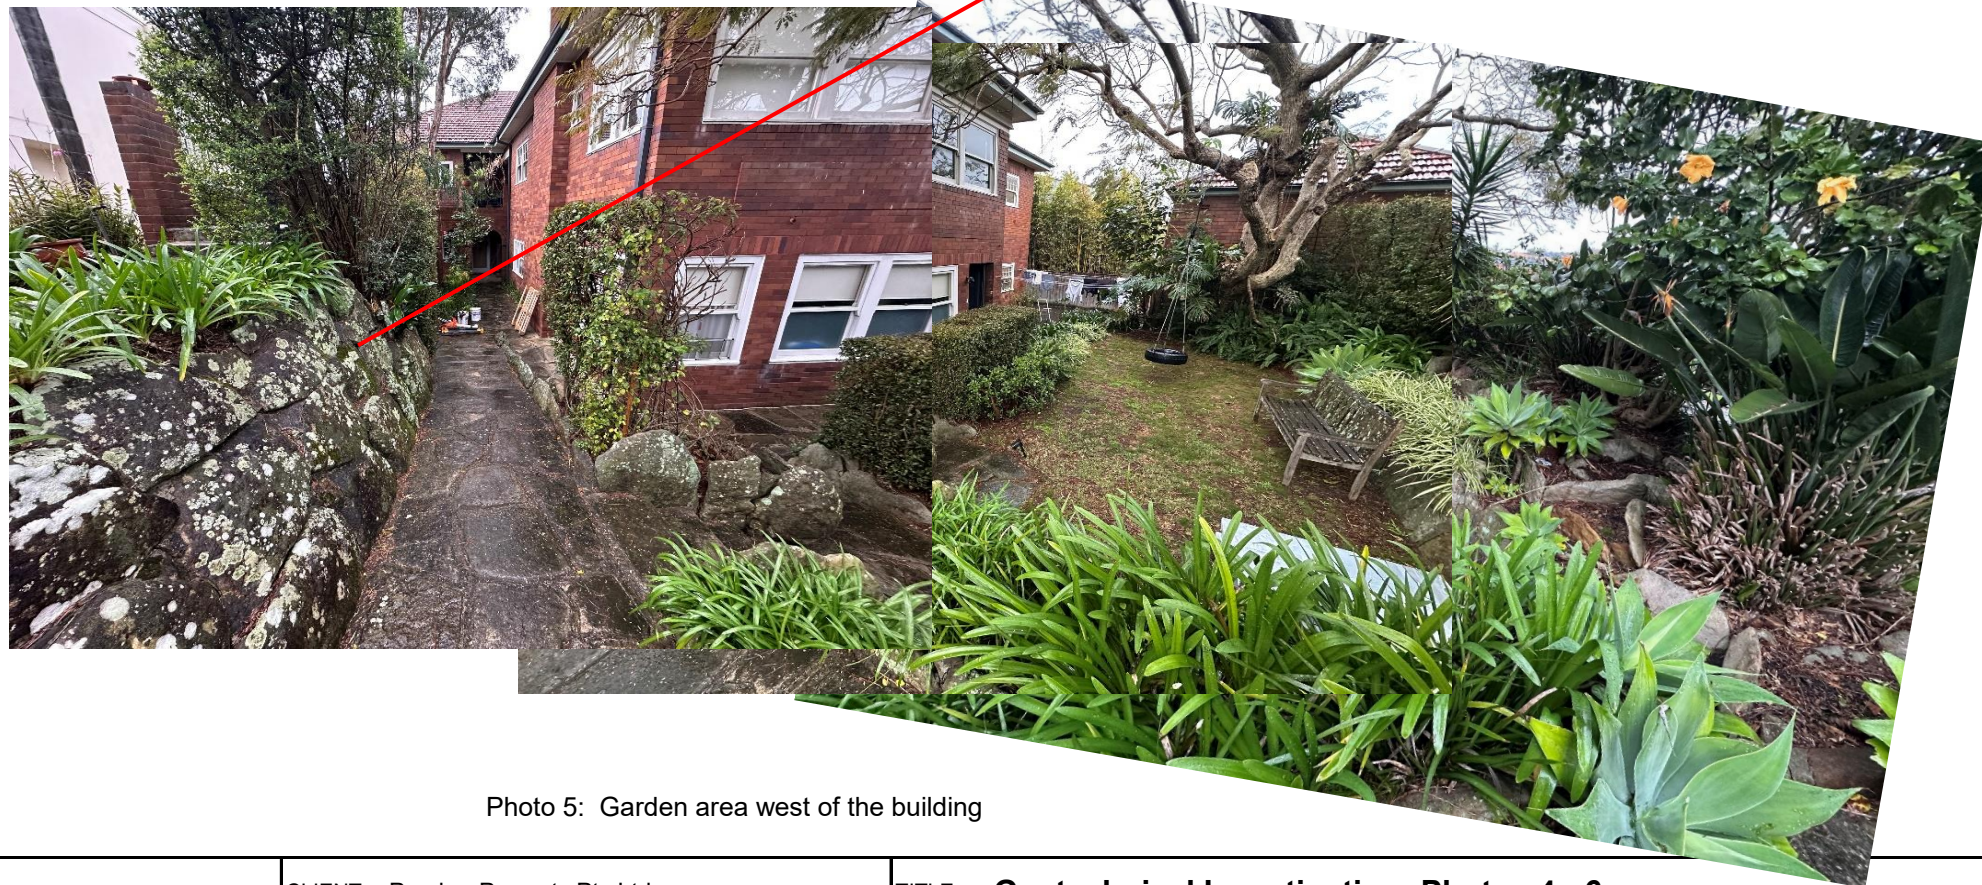
Photo 5: Garden area west of the building

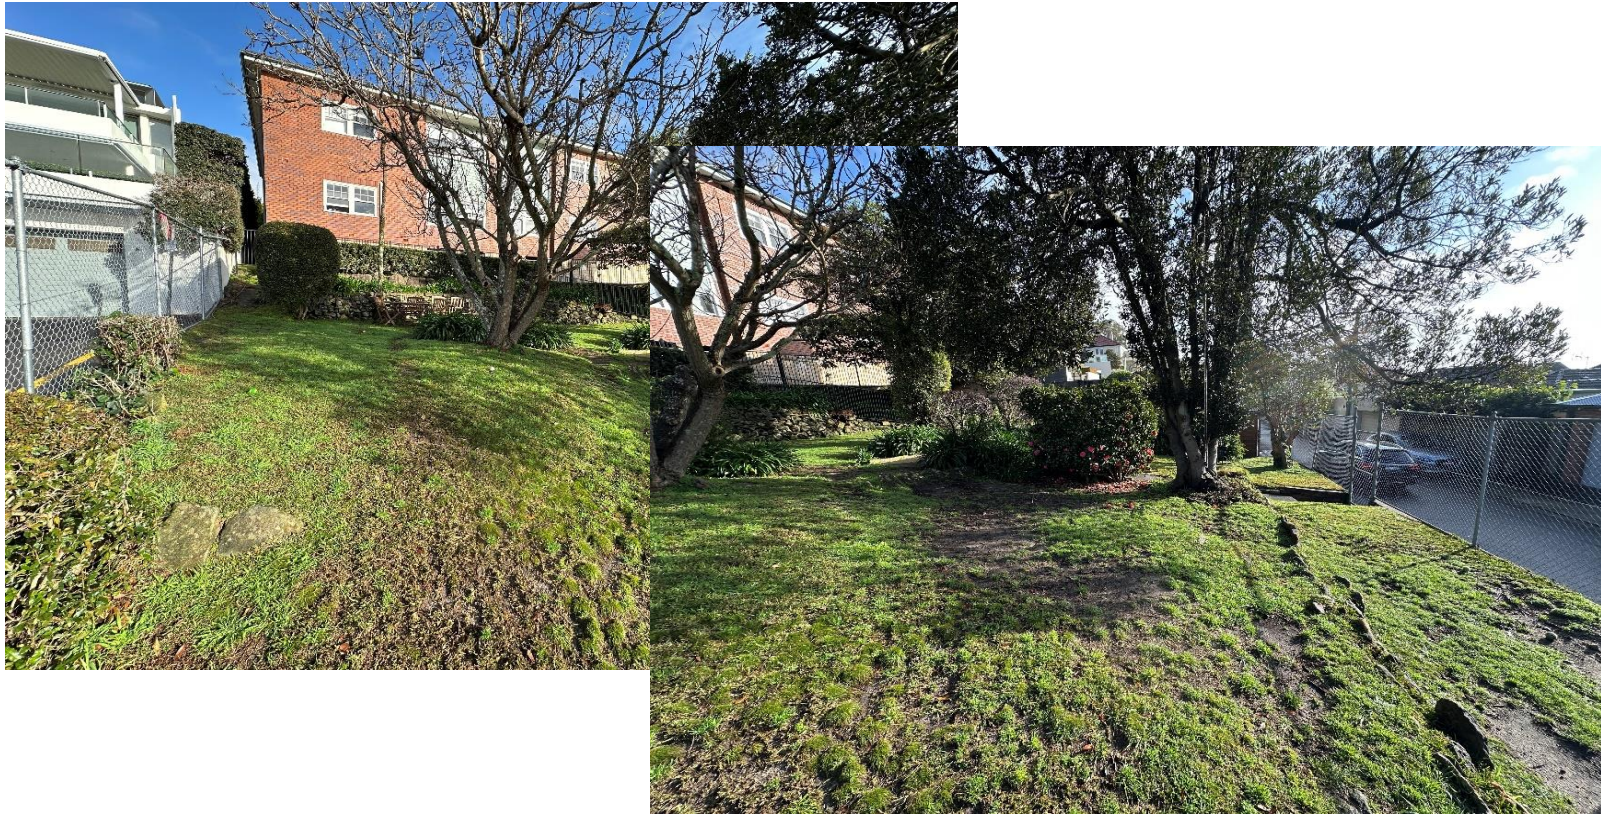
The site is currently occupied by a two-storey brick and tile apartment building with a two-car garage on Muston Street (including a communal laundry underneath) and a two-car garage on Redan Lane. Pavements constructed of concrete and sandstone blocks surround the building and there are low height retaining walls that support garden beds on the western side of the building (refer Plate 2, Photo 5). An open grass covered slope is located on the eastern side of the building (refer Plate 3, Photo 7).

Photo 7: Lawn area east of the building
