Appendix C – Technical reports on the condition of existing Windsor Bridge

**B 415 Windsor Bridge
Follow-up Inspection
15.6.2011**

U/W Bridge Inspection

B 415 Windsor Bridge over Hawkesbury River

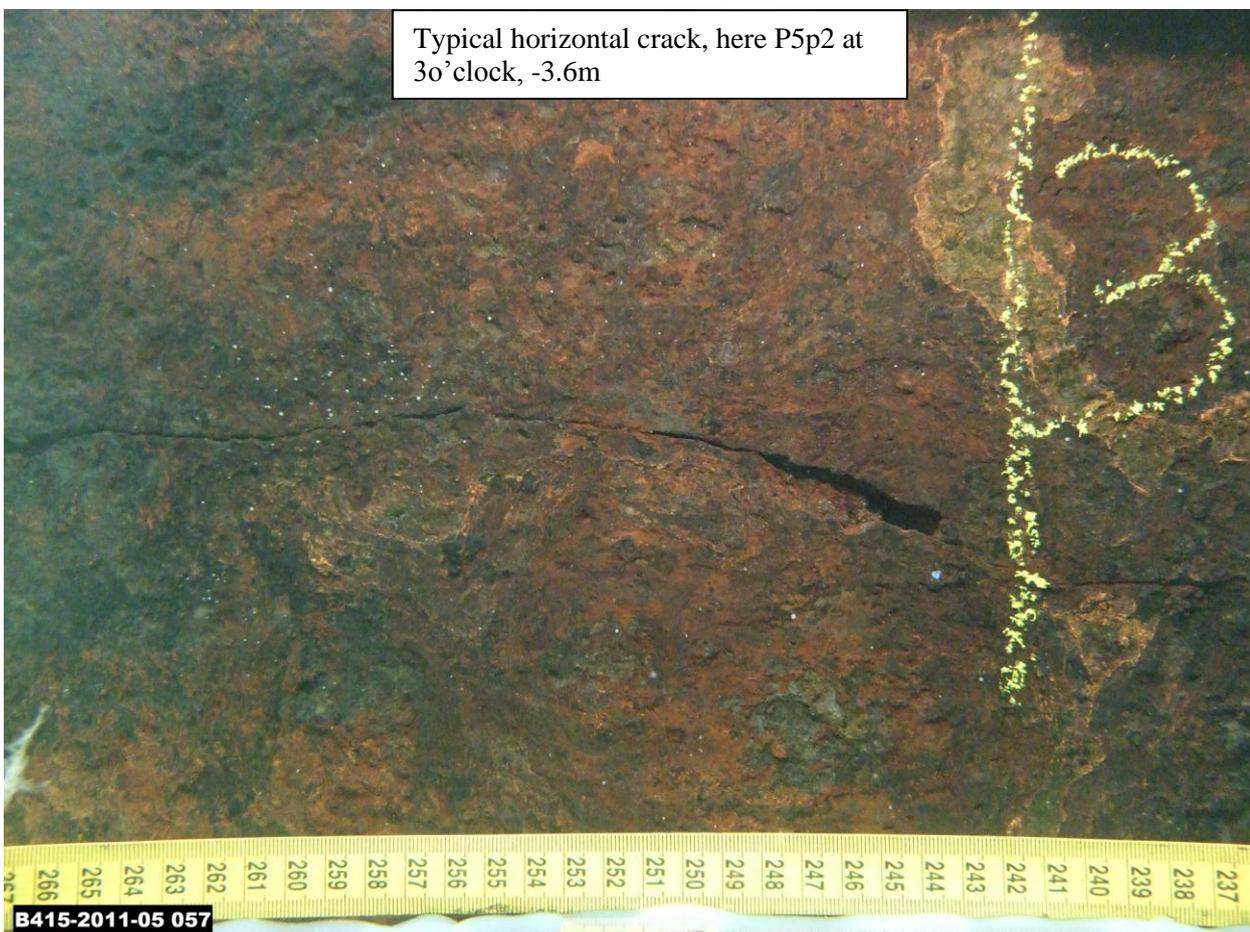
All inspected below water surfaces of the cast iron caissons of this bridge appeared heavily built up with nodules of about 30 to 50mm diameter, up to 50mm high and all covered with a thin layer (up to 20mm) of marine growth. After removing/cleaning the surface layer (some marine growth and a carbonised, black and rusty layer up to 30mm thick), an even graphitised layer about 5-15mm thickness (and up to 20mm in isolated areas) is covering most areas of the underwater surfaces that were investigated and inspected. Near Bed Level the noduling is less pronounced and graphitisation appears to be much thinner. (less than 3 mm)

The 17 Core samples that were taken appear to confirm this "global" graphitisation pattern. Core samples were handed to Fred Salome (CTI Consultants) for analysis.

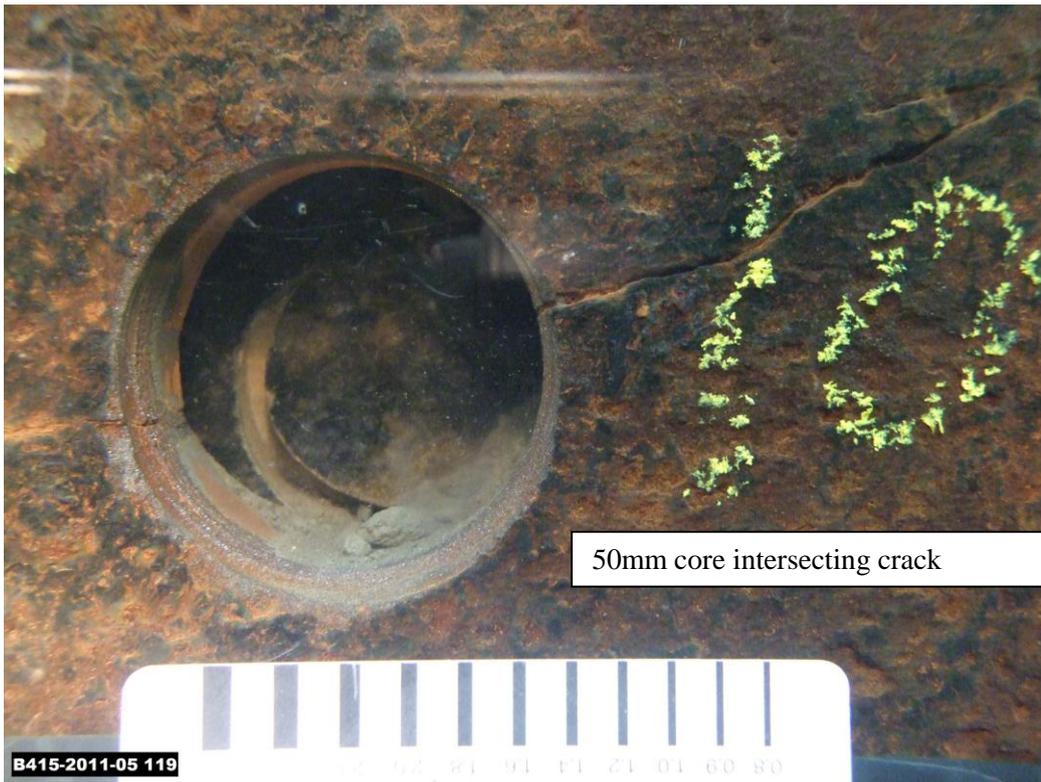
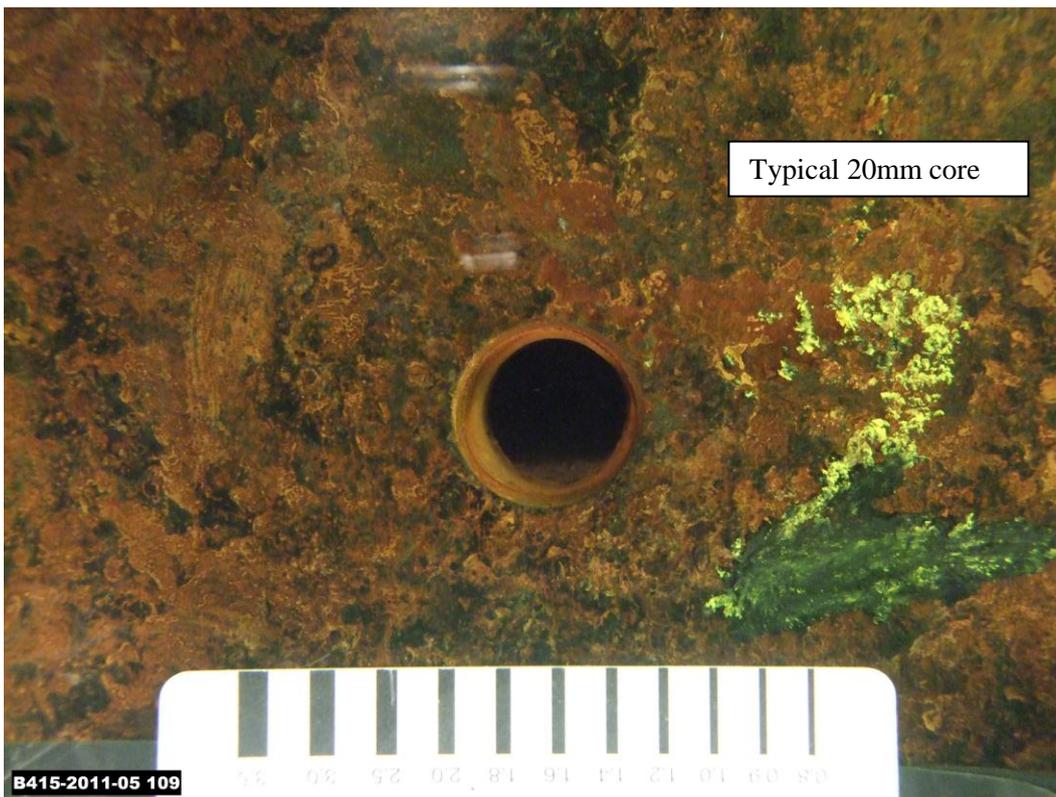
Pile Cleaning – (B350 / clause 4.5.1)

Full HP water cleaning on 14 piles of Piers 2 to 8 was carried out. A High-Pressure Water Unit with on site water extraction and adjusted, moderate nozzle pressure of approximately 200 bar, EWP at turbo nozzle approx 280-300 bar with angle of attack of approx. 35-45 degrees was used for better efficiency than hand tools. The cleaning system delivers a clean surface with all marine growth and most carbonisation removed for ease of caisson inspection. Please note that minimal graphitised material only is removed in this process.

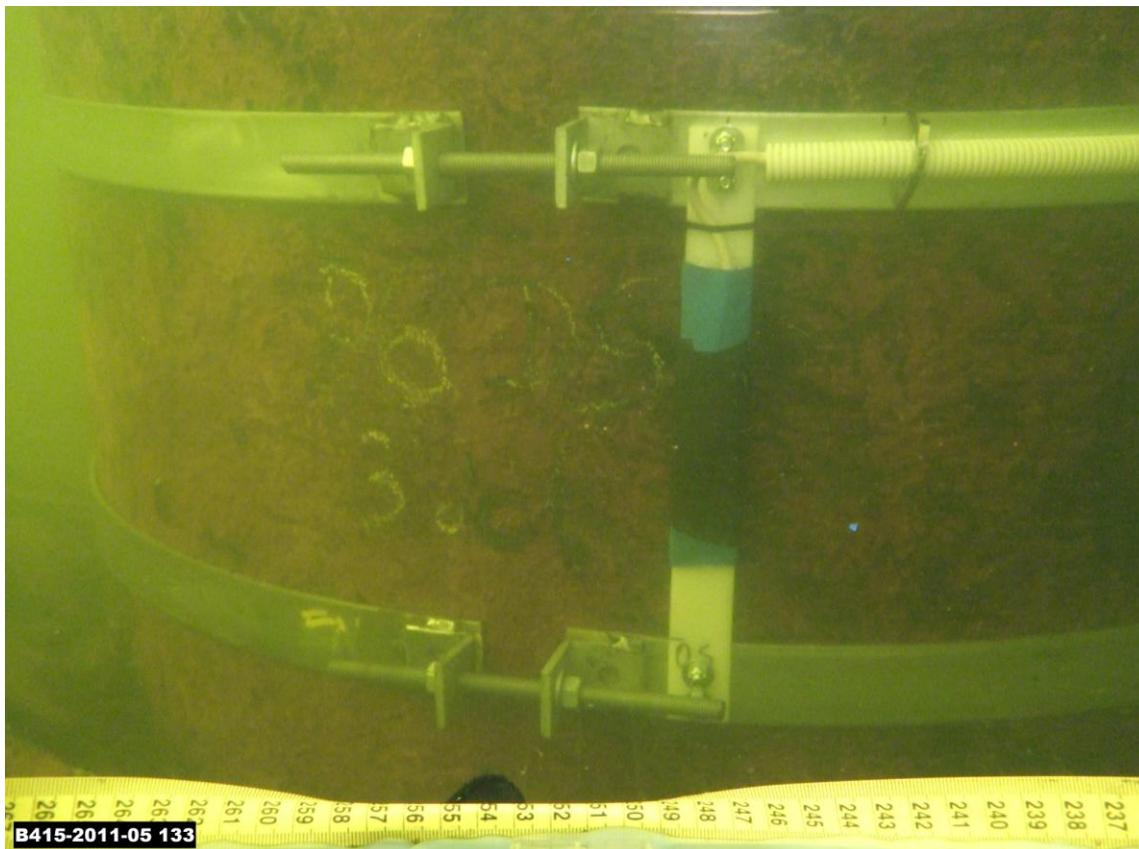
P6p1: -7.14m to top of band

P6p2: -6.45m to top of band

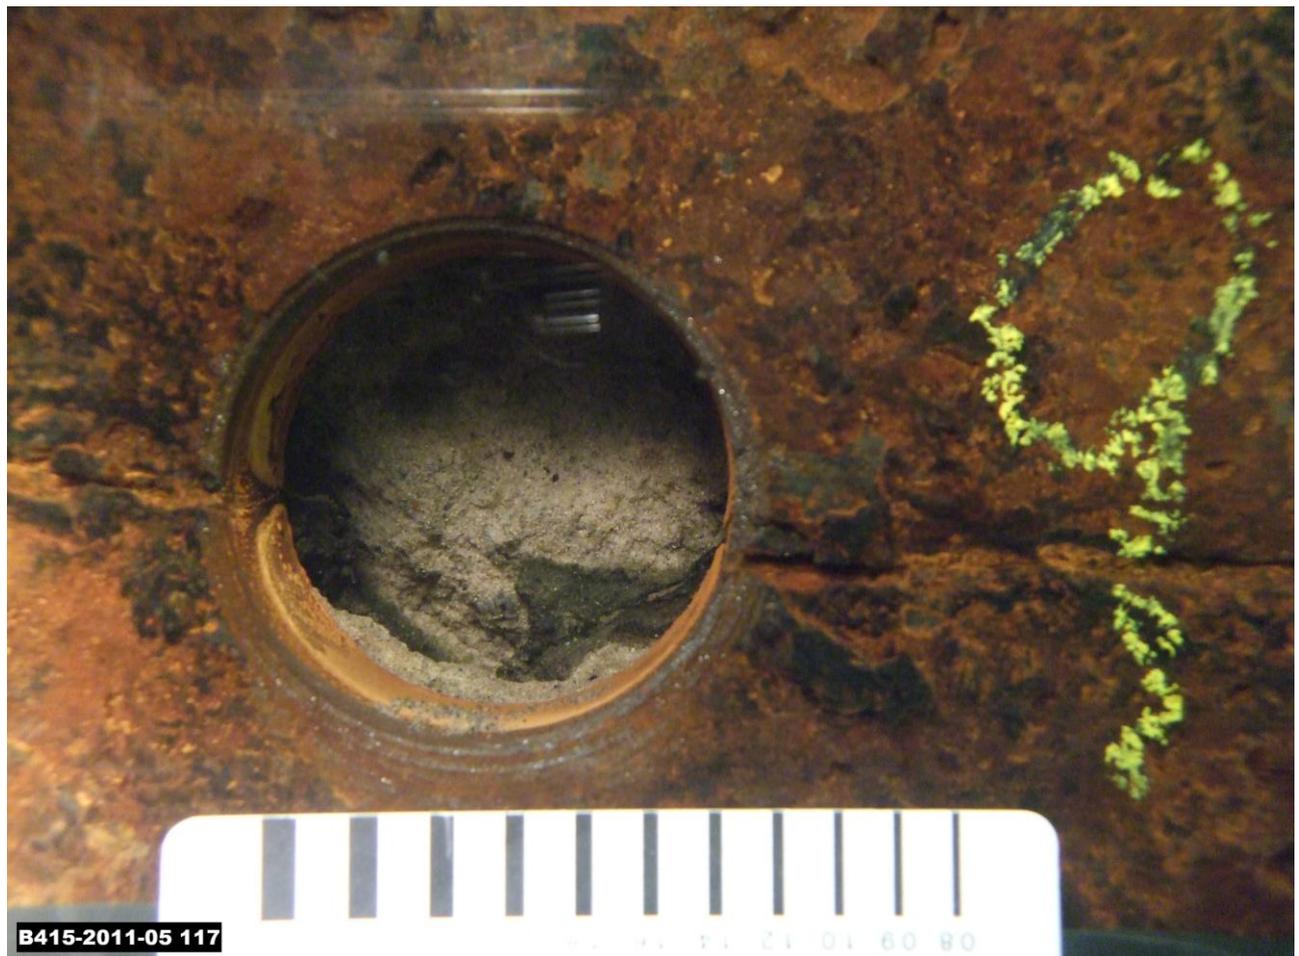
All core holes were photographed and the pictures are contained in the attached Folder "B415 Core holes".

Core Hole Repairs: (B350 / clauses 7.3.3, 7.4)
Principal ordered for the core holes not to be repaired.
