Bridge over Hawkesbury River at Windsor Load Testing

Test Report

Graphitisation Investigation

Windsor Bridge

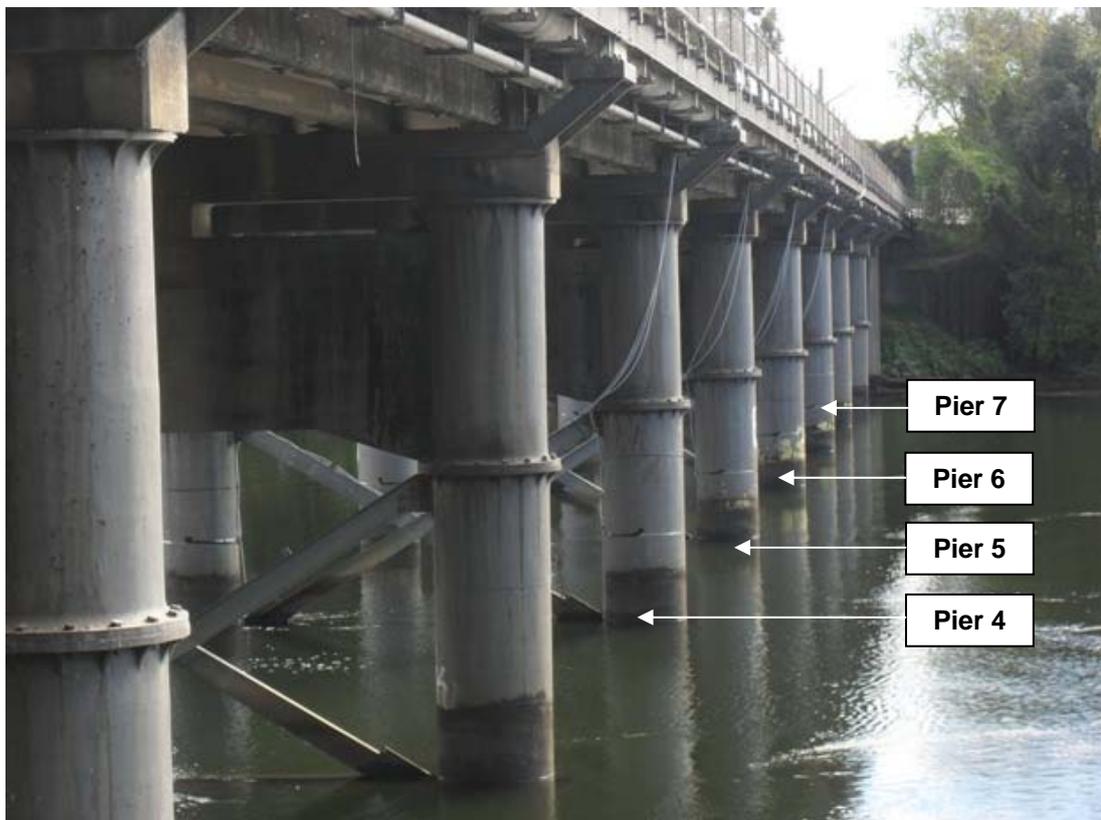
Figure 1-1. RTA Bridge – Windsor Bridge Piers

The Reinforced Concrete (RC) Beam Bridge consists of eleven spans and was built in 1931. 10 sets of 3'6" diameter wrought iron piers extend to the river bed. Figure 1-1 shows the instrumented piers.

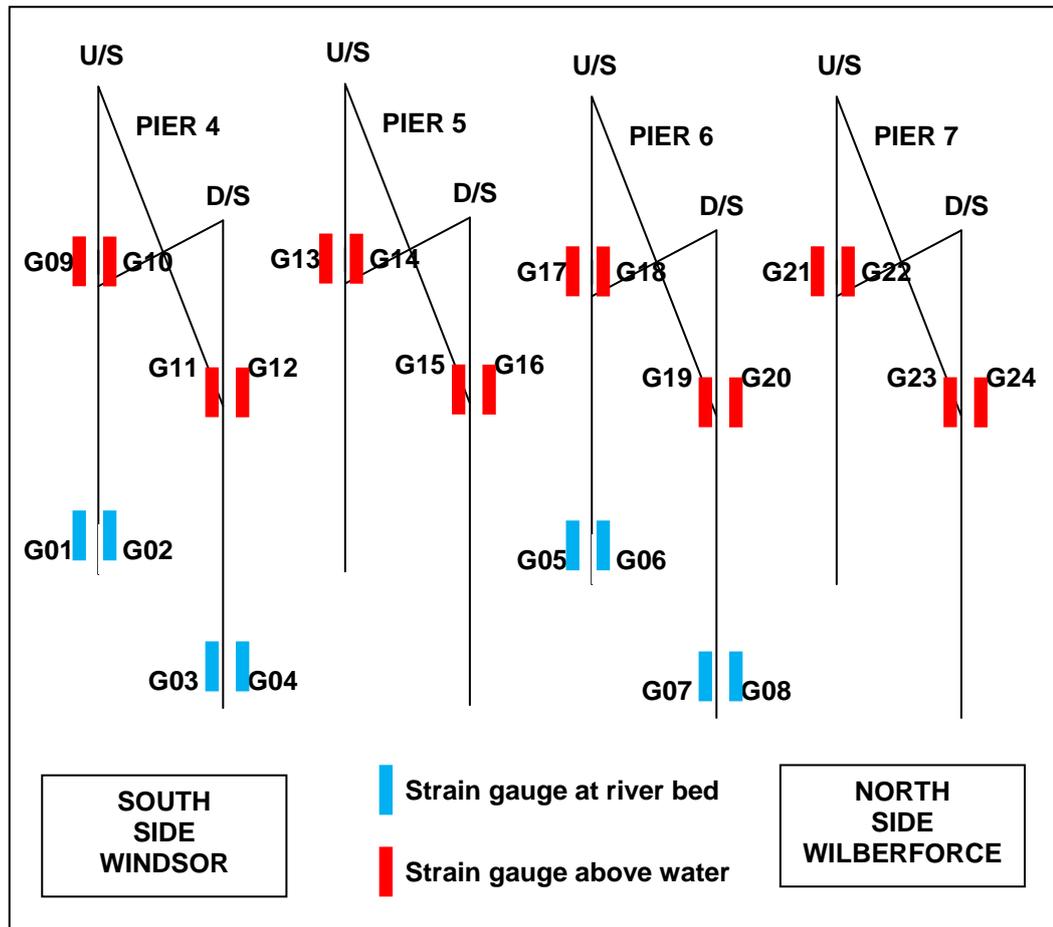
Figure 2-1. Instrumentation Layout

Figure 2-1 below shows the numbering conventions for the installed strain gauges at piers 4 to 7.

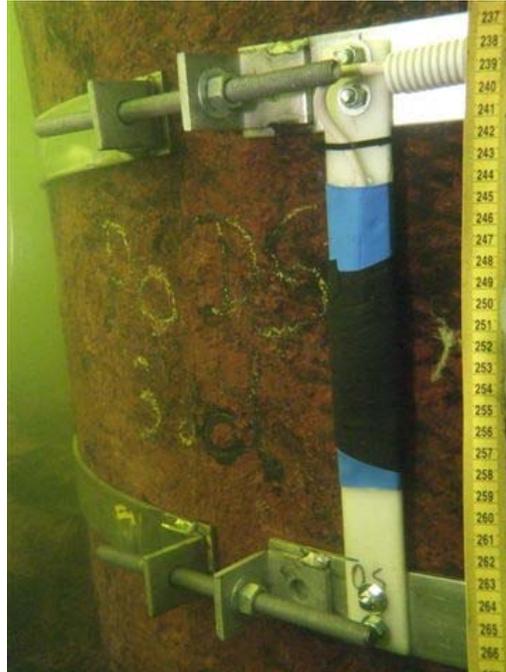
Figure 2-2. Instrumentation – Strap-On Gauge

- Strap-On Strain Gauges – 8 off, 300mm gauge length, 350 ohm full bridge strain sensing elements fastened between two 50x5mm flat bar rings. Installed by CDS Pty Ltd. Straps were initially manufactured to a circumference of 3730mm whereas the actual pier circumference was 3370mm. On-site modifications took place resulting in the strain elements now aligning 180mm to the outboard side on the centreline.
- Foil Strain Gauges – 16 off, TML WFCA-6 120 ohm half bridge gauges.

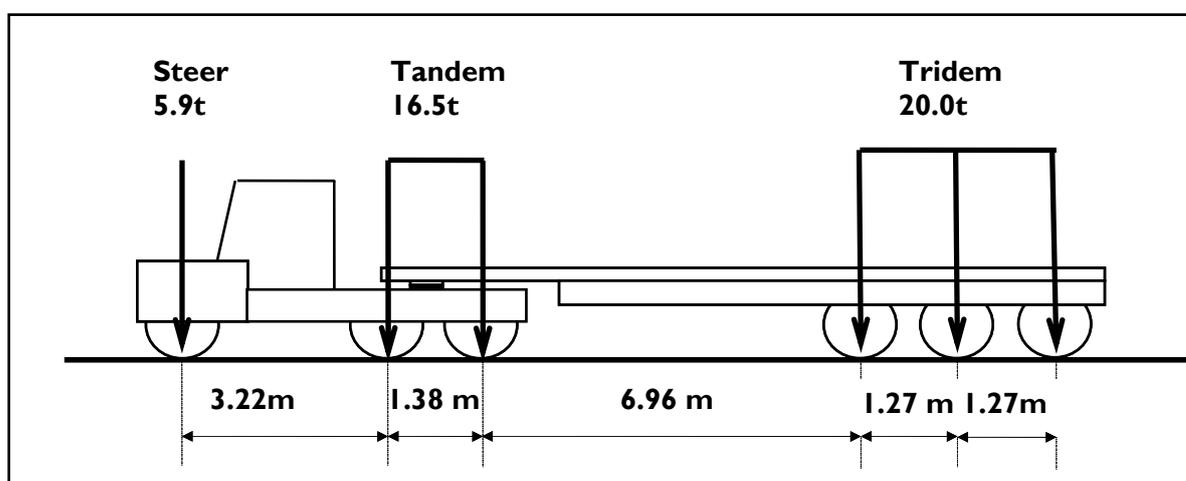
Figure 3-1. RTA Test Vehicle

The planned load testing was conducted by using an RTA dedicated test vehicle as shown in Figure 3-1.

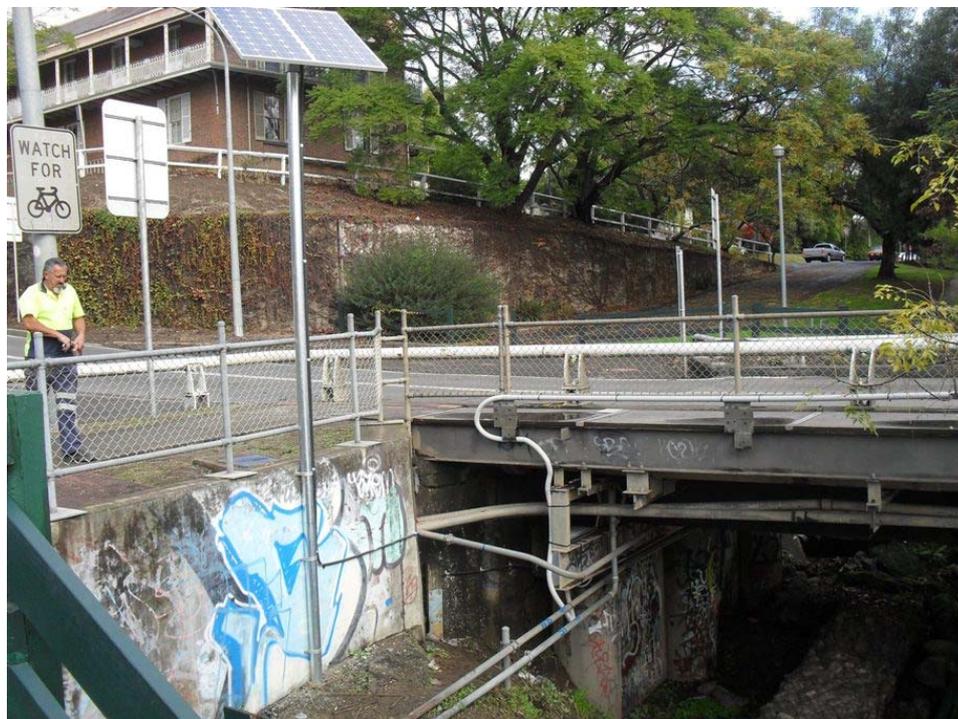
Figure 5-1. Data Acquisition Location

National Instruments hardware acquired all channels at a sampling frequency of 2000Hz. This data was then re-sampled to 200Hz employing appropriate anti-aliasing filters. Labview software was used for data processing. Figure 5-1 shows the location of the hardware.

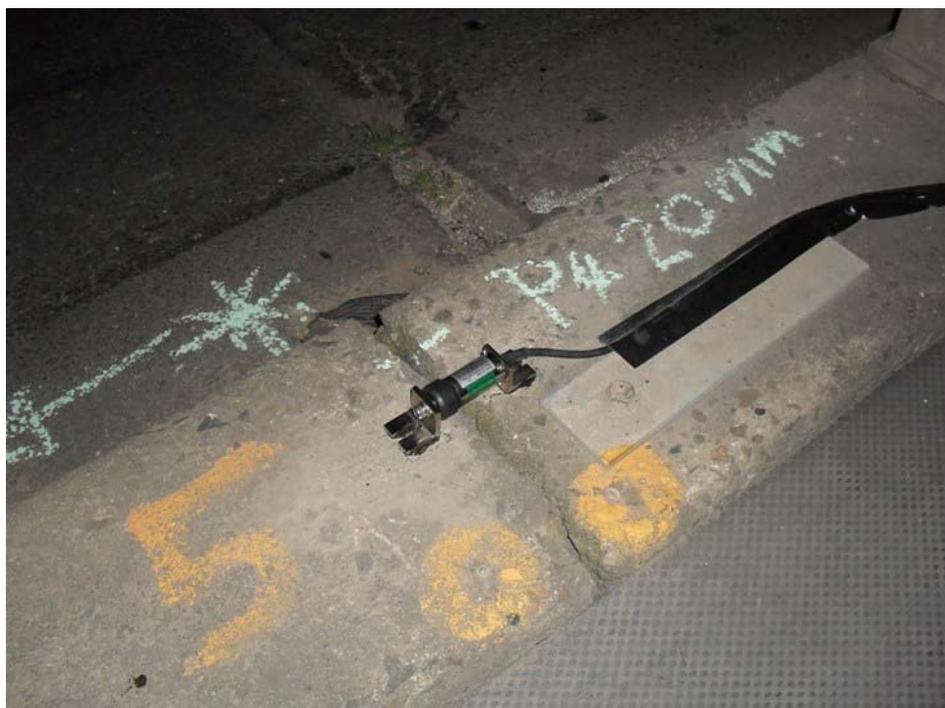
Figure 5-4. Expansion Joint DDT

For the period of the static testing a dynamic displacement transducer was installed at the Pier 4 expansion joint. The sensor was mounted on the downstream kerb as shown in photo Figure 5-4.

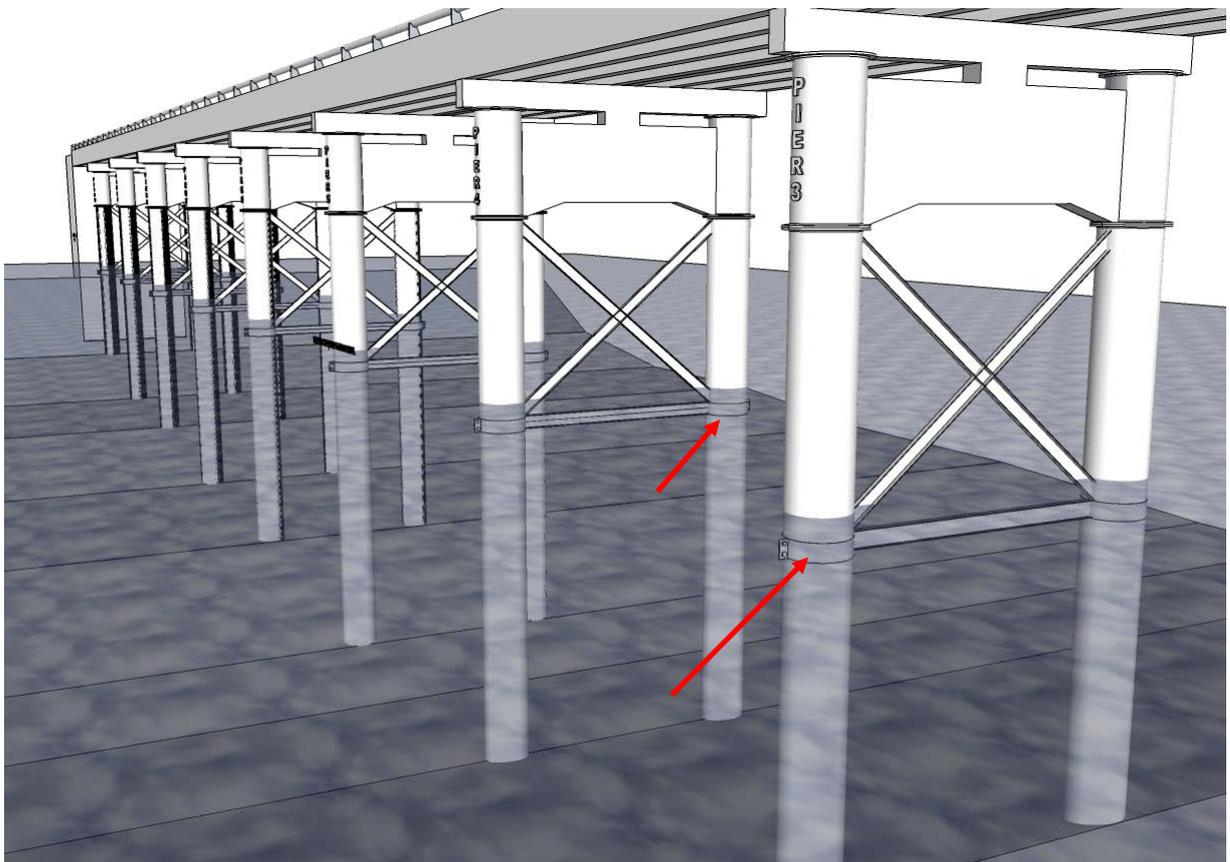
Figure 1 Sketch Showing General Arrangement of Piers

There is diagonal bracing in the atmospheric zone with a tie-beam located at approximately the low water mark, as indicated in Figure 1. The tidal range is of the order of 1 metre.

Note that the cross bracing at present is fixed to the columns by means of cleats at the top, with the cleats having been riveted onto the cast iron columns. However at the base, the bracing is secured by means of collars clamped around the columns, at the bottom of the tidal range (see arrows in Figure 1).

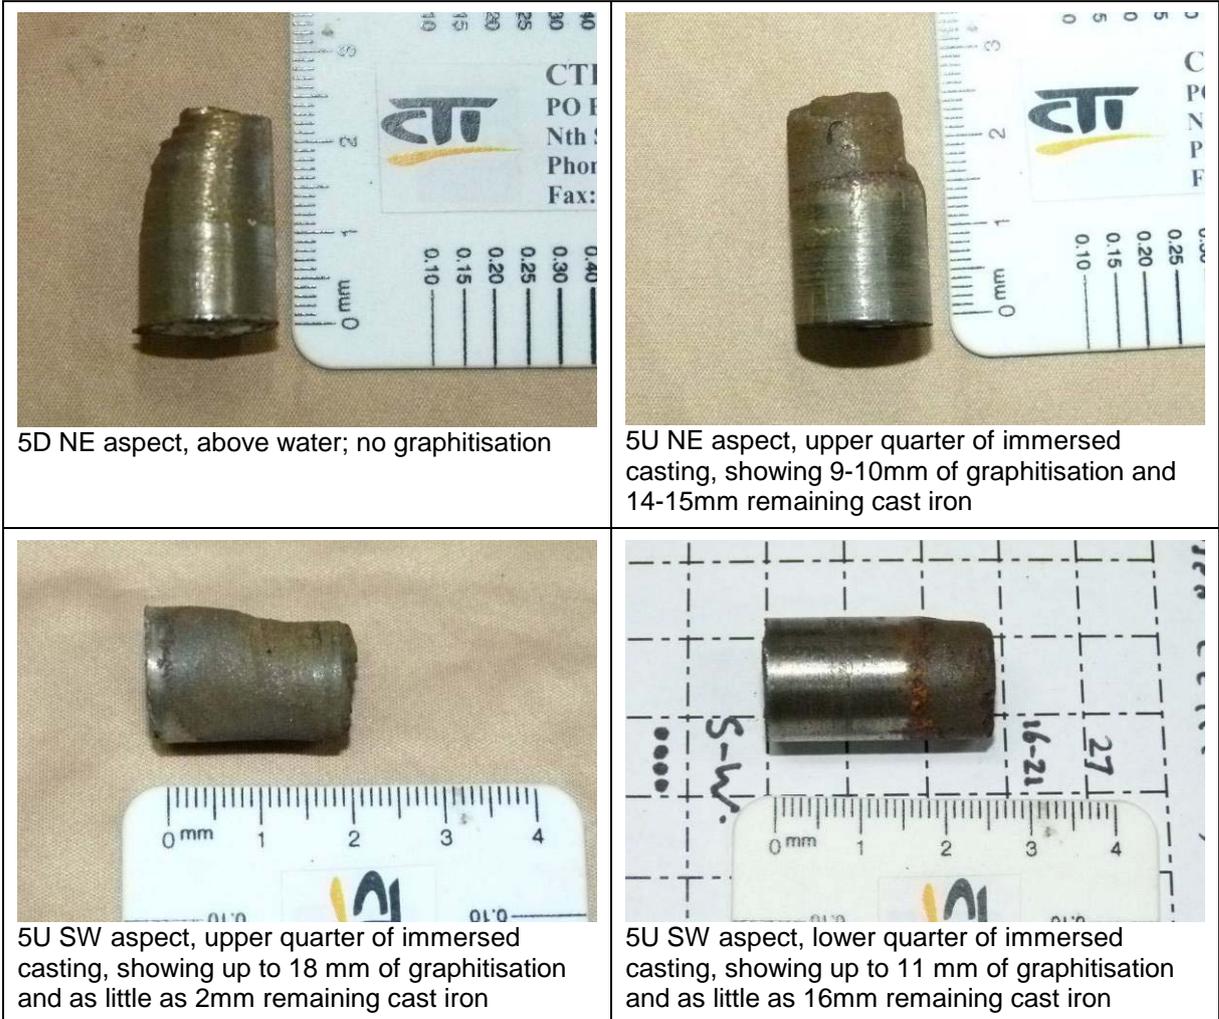
Typical appearance of cores is illustrated in the following photographs.
