Pacific Highway Upgrade: Woolgoolga to Ballina, Sections 1 and 2

Microbat and Nest box Monitoring –
Operational Phase, (2020-2021)

Sandpiper Ecological

8 November 2021

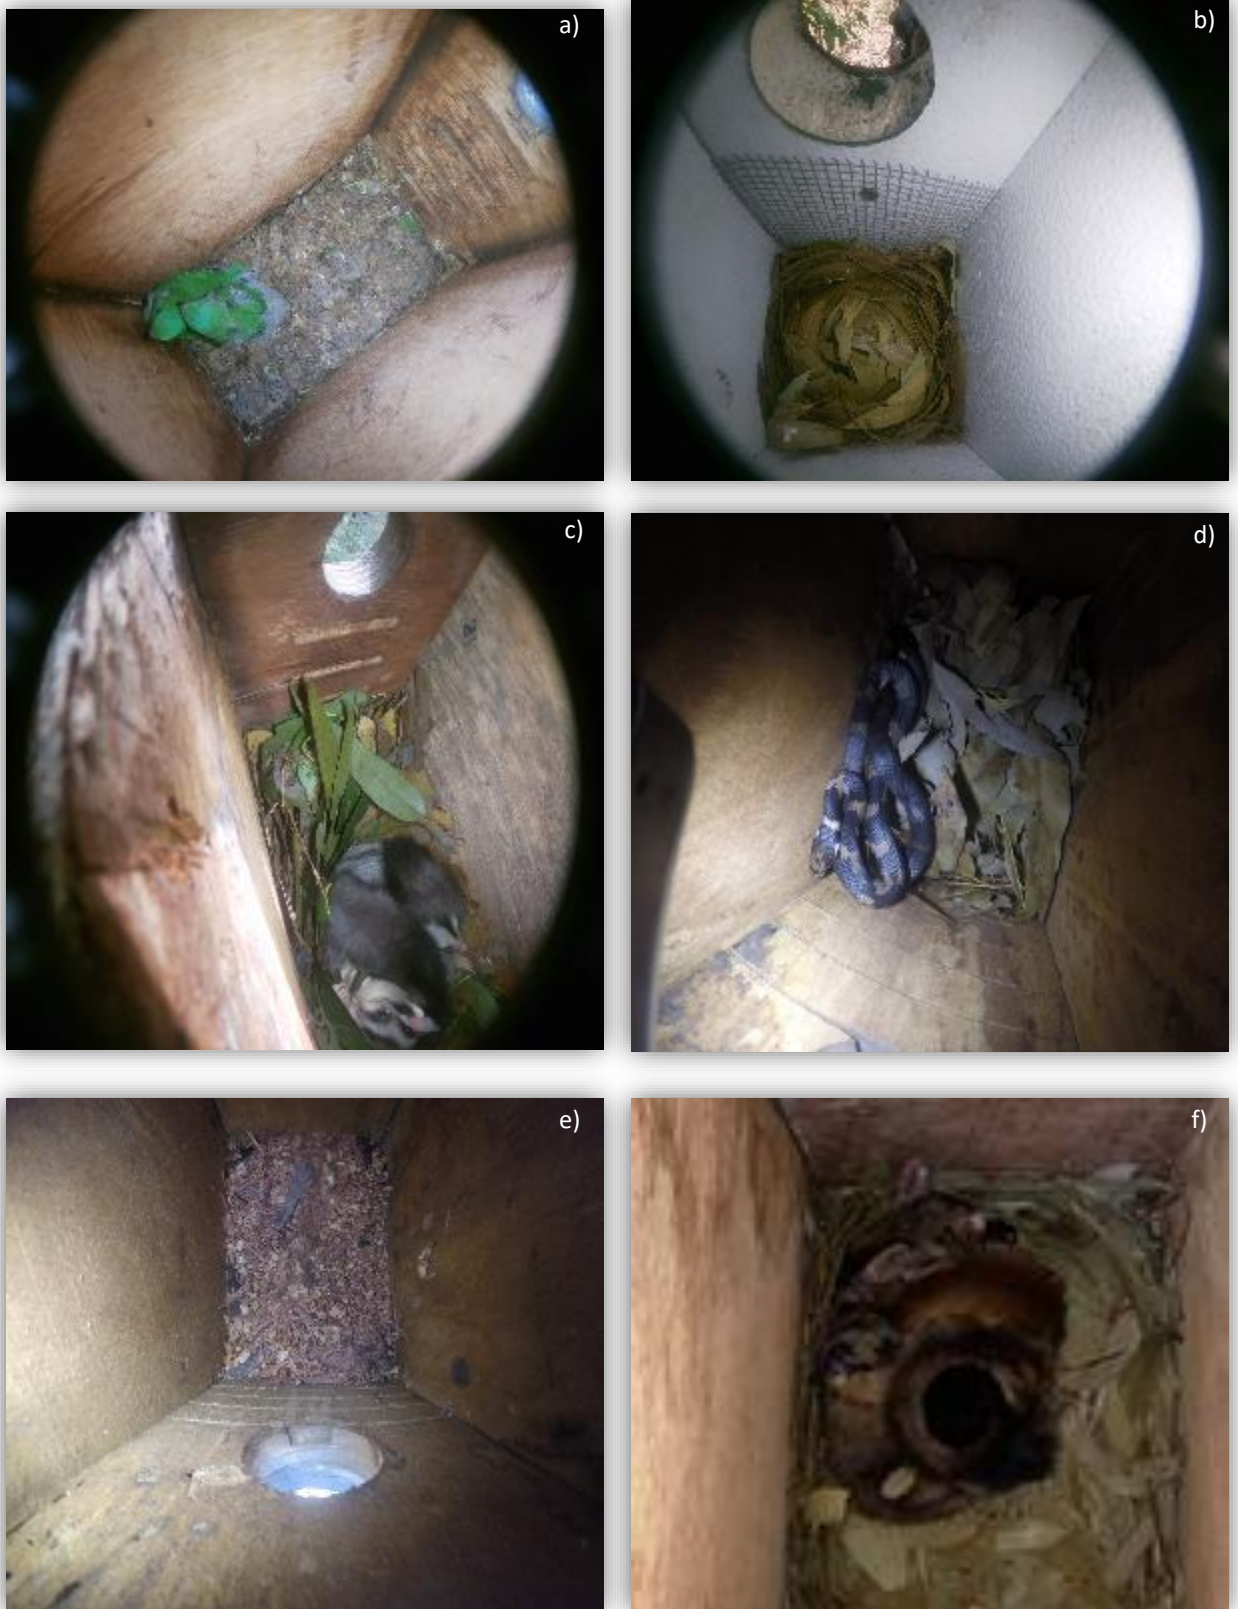
Notably, four threatened species were recorded, including squirrel glider, yellow-bellied glider, brush-tailed phascogale and Stephens' banded snake (Table 6). Squirrel glider (see plate 1) were recorded occupying five and four nest boxes in spring and autumn respectively in section 1 and two boxes during spring and autumn in section 2 (Table 6). An adult and juvenile yellow-bellied glider were recorded using a plywood large parrot box in spring 2020 (remnant leaf nest remained during autumn inspection) and an aluminum large parrot box in autumn 2021 (Table 6, Appendix B, Table B1 and B2). Probable evidence of use by brush-tailed phascogale (indicated by scat deposits amongst shredded bark see plate 1) was recorded in a nest box in section 1 during autumn 2021 and nine and six nest boxes in spring and autumn respectively in section 2 (Table 6). A Stephens' banded snake was recorded using a small parrot box in section 2 during spring 2020 (Table 6).

Plate 1: Fauna recorded during the spring 2020 and autumn 2021 nest box inspections. (a) Scaly-breasted lorikeet chicks, (b) Typical small petaurid (sugar or squirrel glider) leaf nest, (c) Squirrel gliders (n=2) in a small glider box in section 2, (d) Stephens' banded snake recorded in a parrot/lorikeet box in section 2, (e) scat and shredded bark in a scansorial box indicating a probable brush-tailed phascogale record, and (f) two yellow-bellied gliders using a plywood large parrot box in section 2.
