Woolgoolga to Ballina Pacific Highway upgrade

**Sections 3-11 Microbat Monitoring
Annual Report 2018**

W2B Sections 3 – 11 Microbat Management Plan 2018 Annual Monitoring Report

Pacific Complete

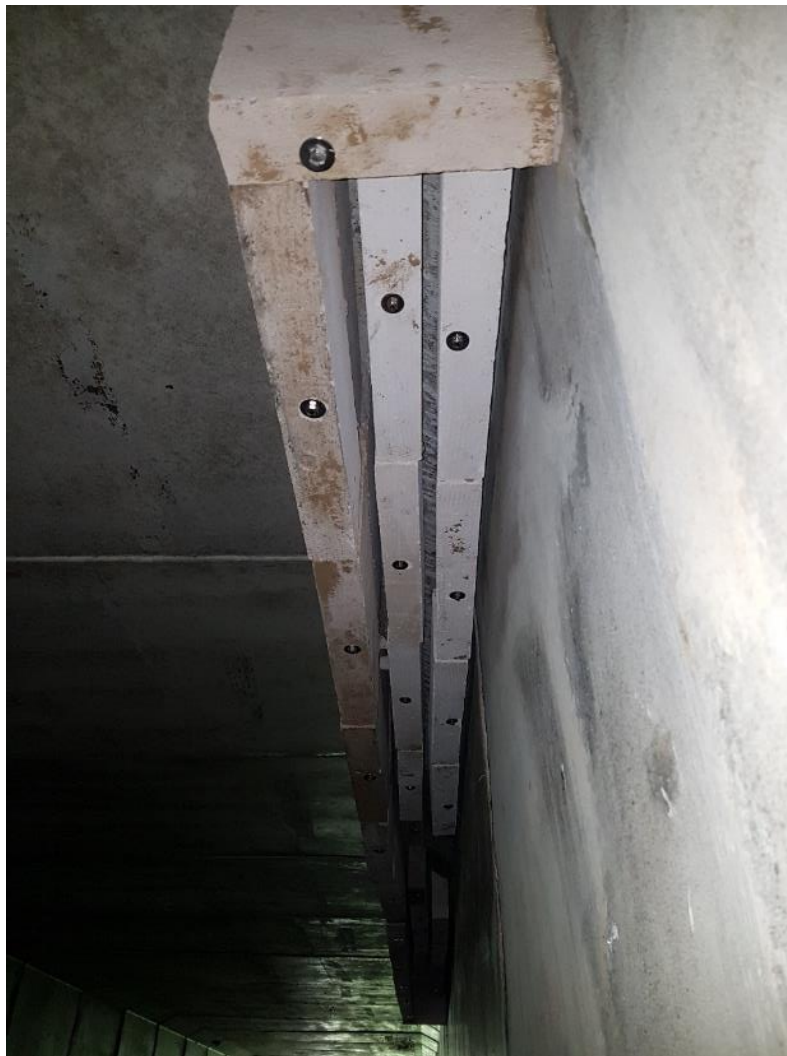
The Bebo Arch was occupied each year between late February/March and September by overwintering Little Bent-winged (and occasionally Large Bent-winged) Bats. Timing of works at this structure were scheduled to avoid the overwintering period for Bent-winged Bats and structure removal was not scheduled to occur until 2019. For this reason, exclusion was not undertaken at the Bebo Arch during 2018. In conjunction with the removal of the Bebo Arch, a prototype Bent-winged Bat box was planned to be installed in a nearby culvert at CH 31400 (Figure 10) to provide permanent cave-dwelling habitat for Bent-winged Bats.

Figure 10: Bent-winged Bat box designed to accommodate up to 2000 Bent-winged Bats, installed in a box culvert at Glenugie CH 31400.

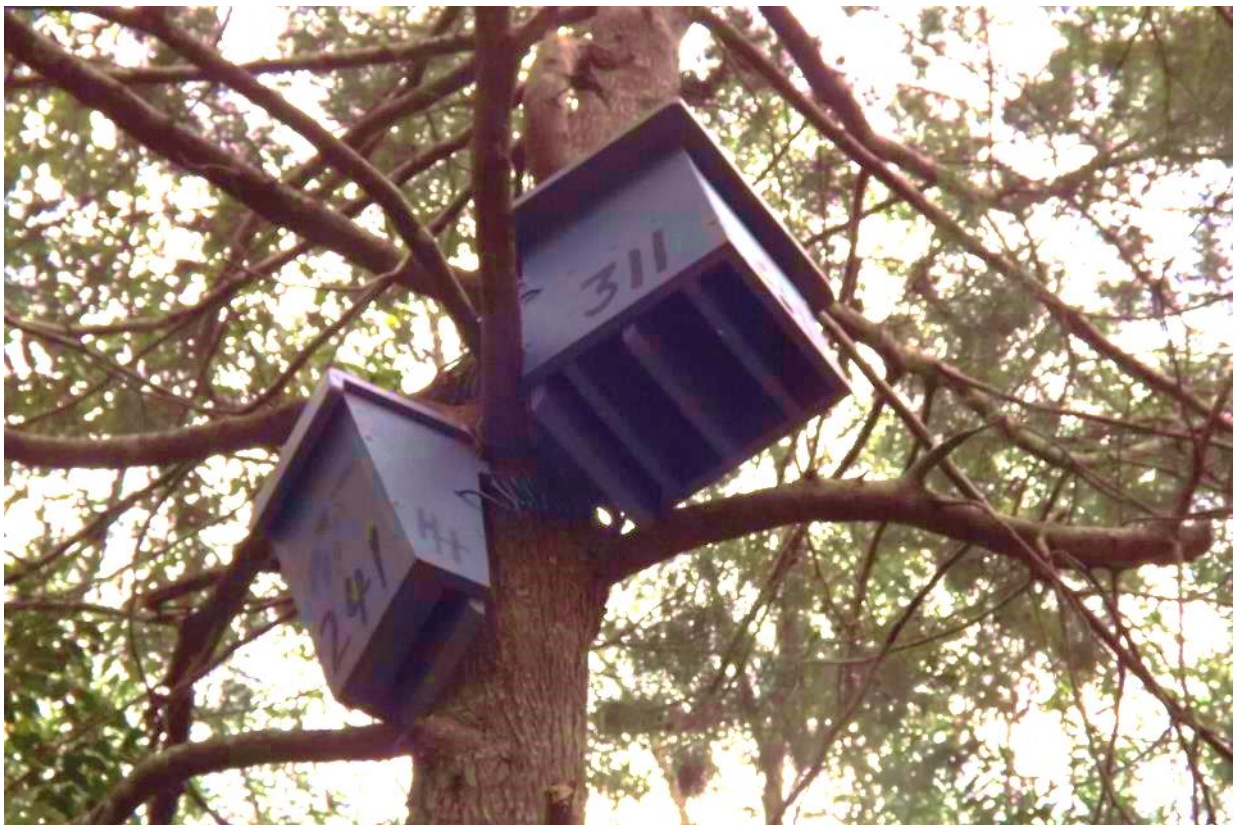
Figure 12: A single chamber bat box (LHS) and a four-chambered bat box (RHS) constructed from Cyplas (recycled plastic) in a tree adjacent to the impacted structures in Section 4, Maclean cut.

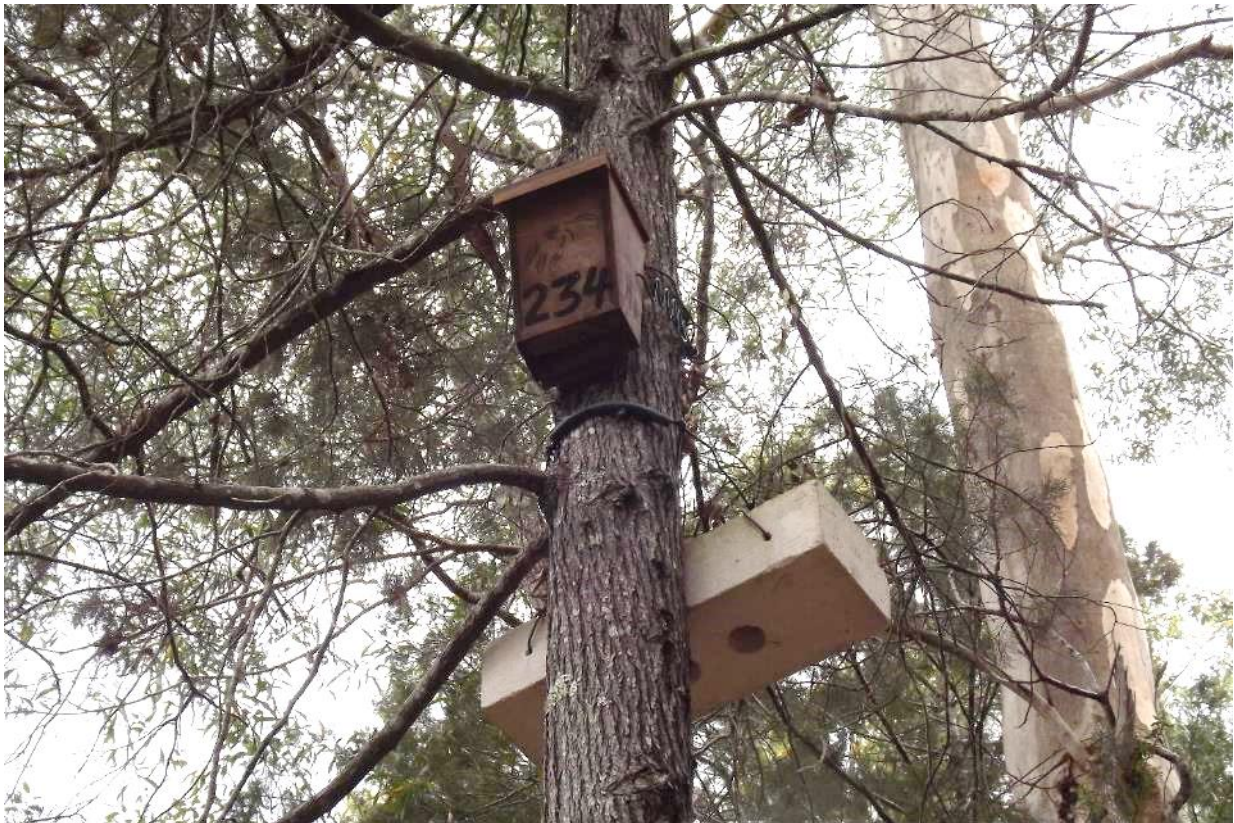
Figure 13: A single chamber timber bat box (upper feature) and a Hebel bat box with four core holes (lower feature behind tree trunk) installed in a tree adjacent to impacted structures in Section 4, Maclean cut.

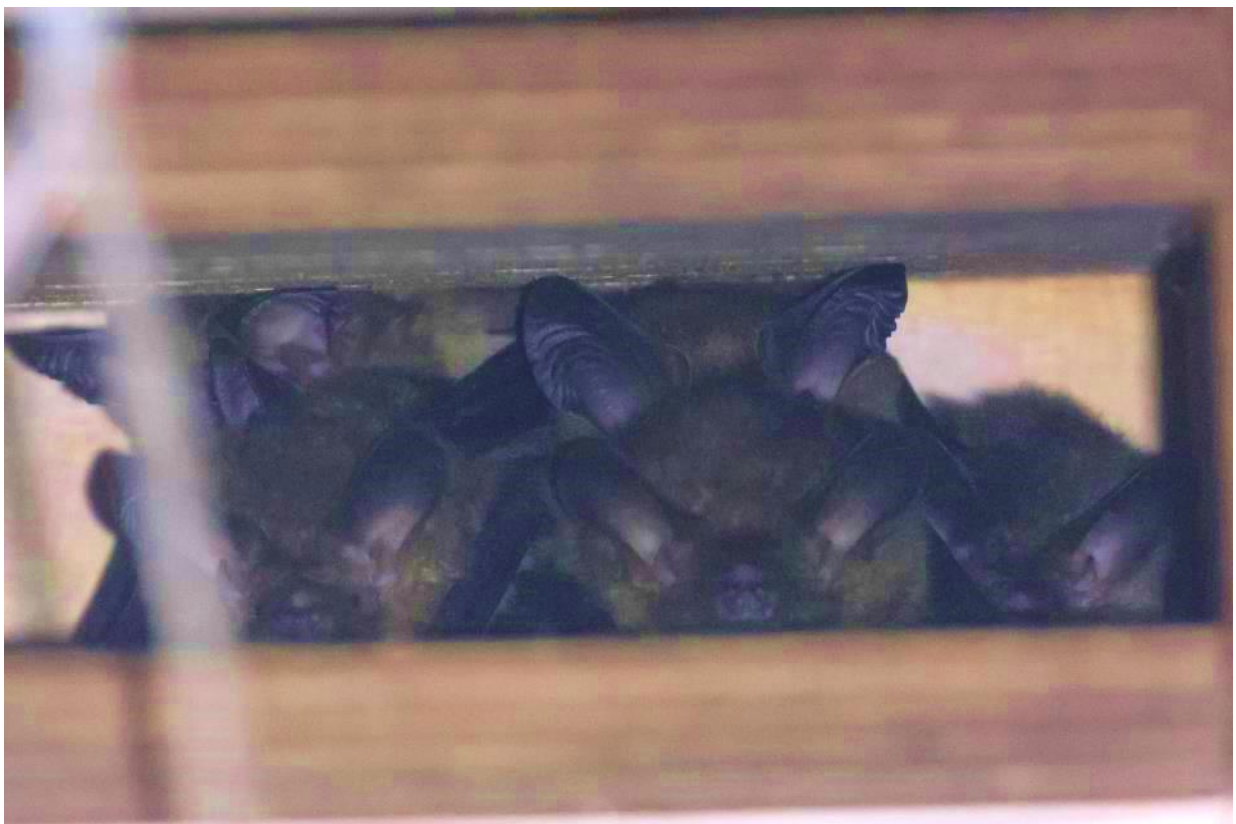
Figure 16: *Nyctophilus gouldi* (Gould's Long-eared Bat) recorded in a timber bat box in June 2018 along Tabbimoble Creek.

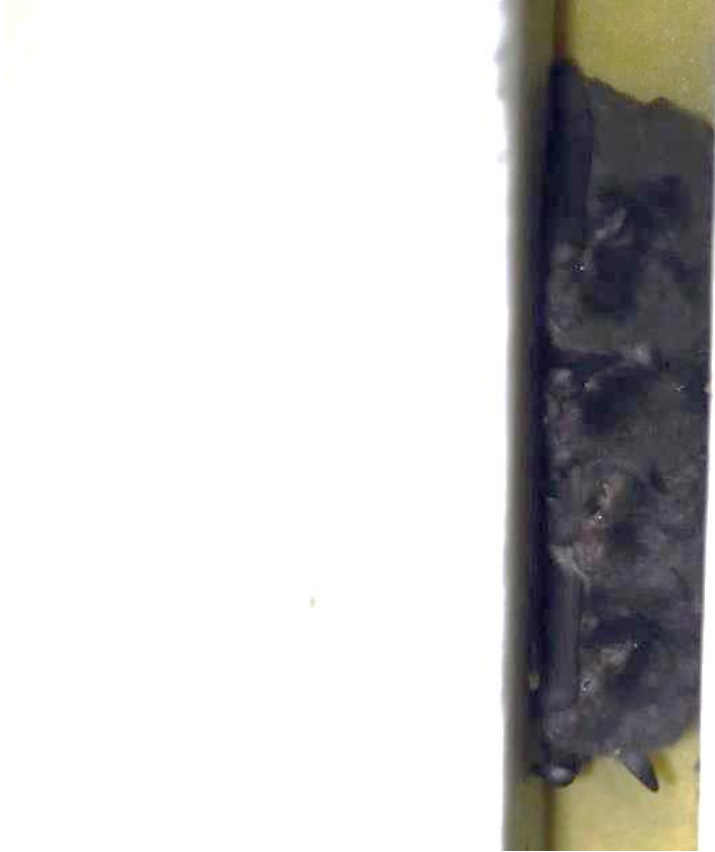
The numbers of Southern Myotis present at Serpentine Creek appears to have remained relatively stable throughout the monitoring period with less than 15 Southern Myotis present at any one time (Figure 18). Once again, there was a decrease in numbers to only 3 Southern Myotis recorded during the Sept 2018 monitoring event which coincided with a period of active construction adjacent to the site.

Figure 18: Three Southern Myotis roosting in an expansion joint beneath the existing Serpentine Creek Pacific Highway Bridge, March 2017.

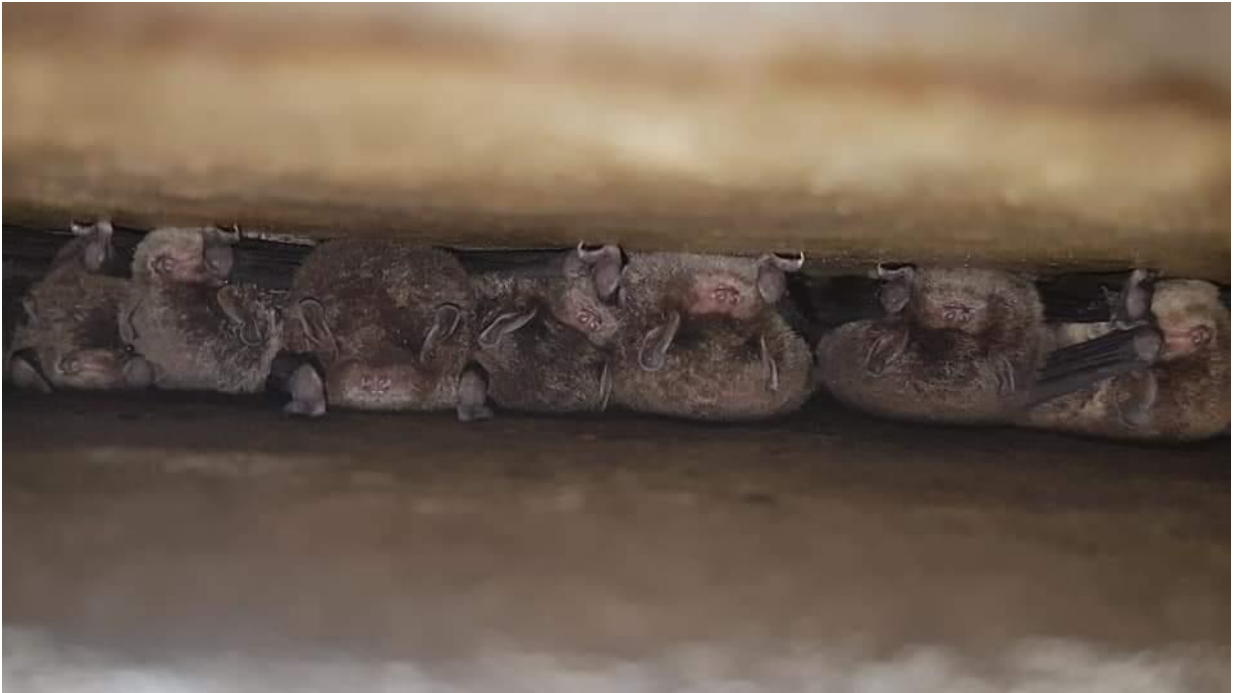
Figure 19: Little Bent-winged Bats roosting within an expansion joint under Tabbimoble Creek Bridge,
