Woolgoolga to Ballina Pacific Highway upgrade

Threatened Rainforest Communities and Rainforest Plants Monitoring Program Annual Report 2019

Construction Phase Report

Woolgoolga to Ballina Pacific Highway Upgrade, Sections 10 & 11, Threatened Rainforest Communities and Rainforest Plants, Annual Monitoring Report # 3 (2019)

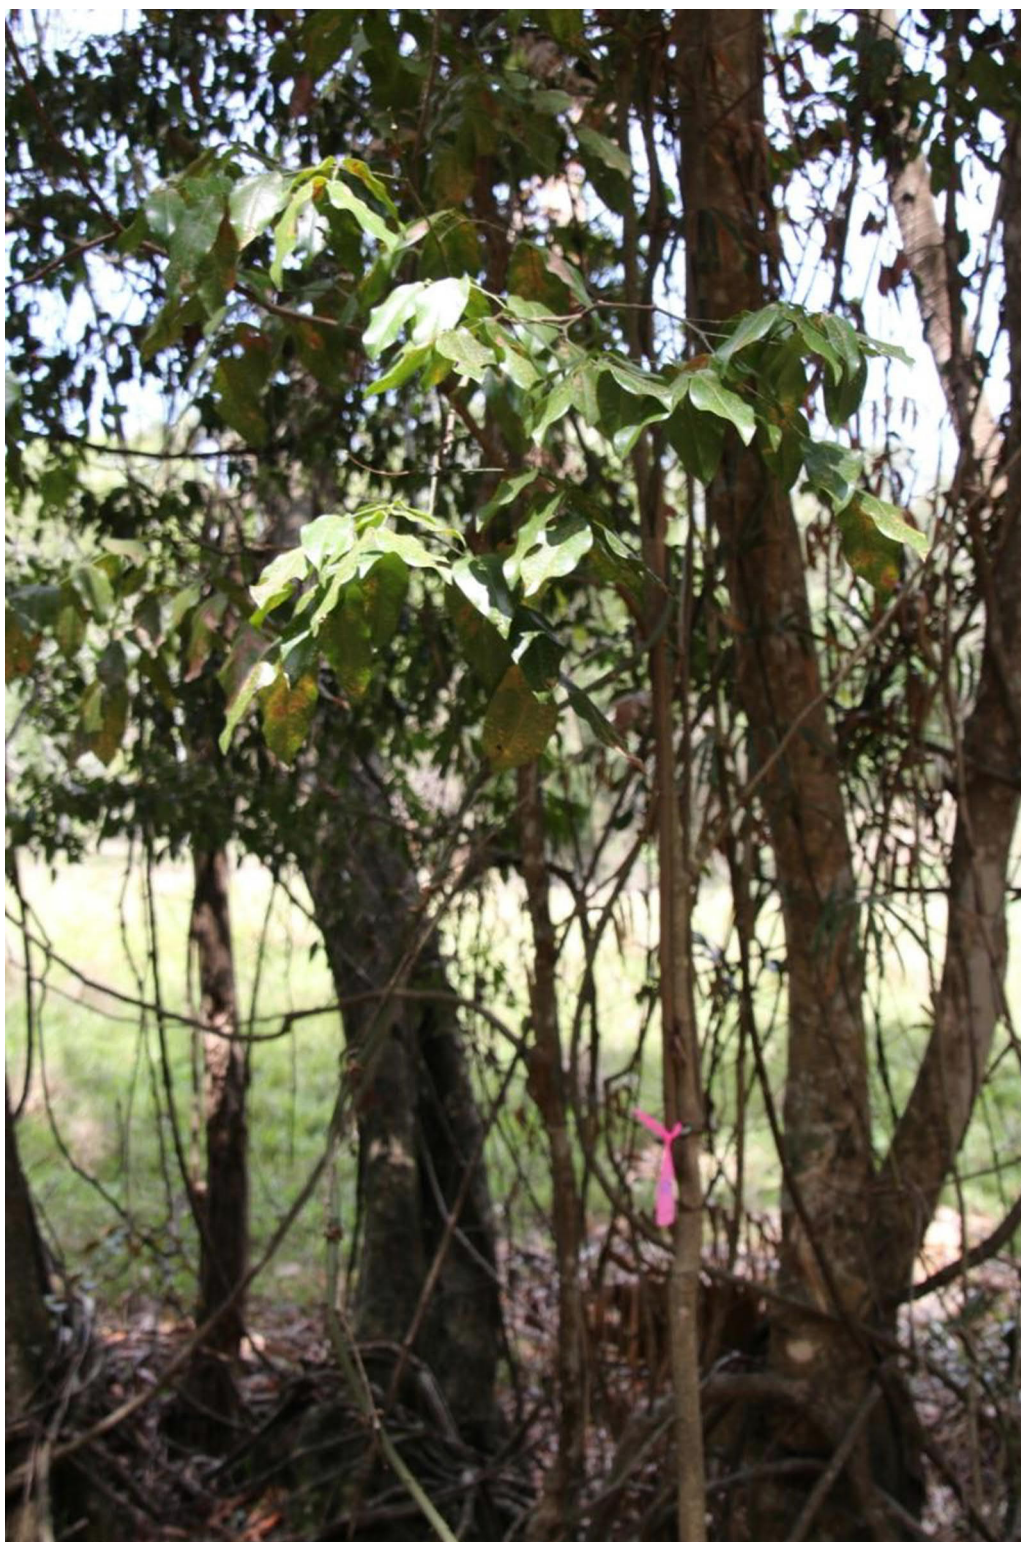
Plate 1: White Laceflower (*Archidendron hendersonii*) no. 73 near Plot 6. Showing no ill effects of the drought.

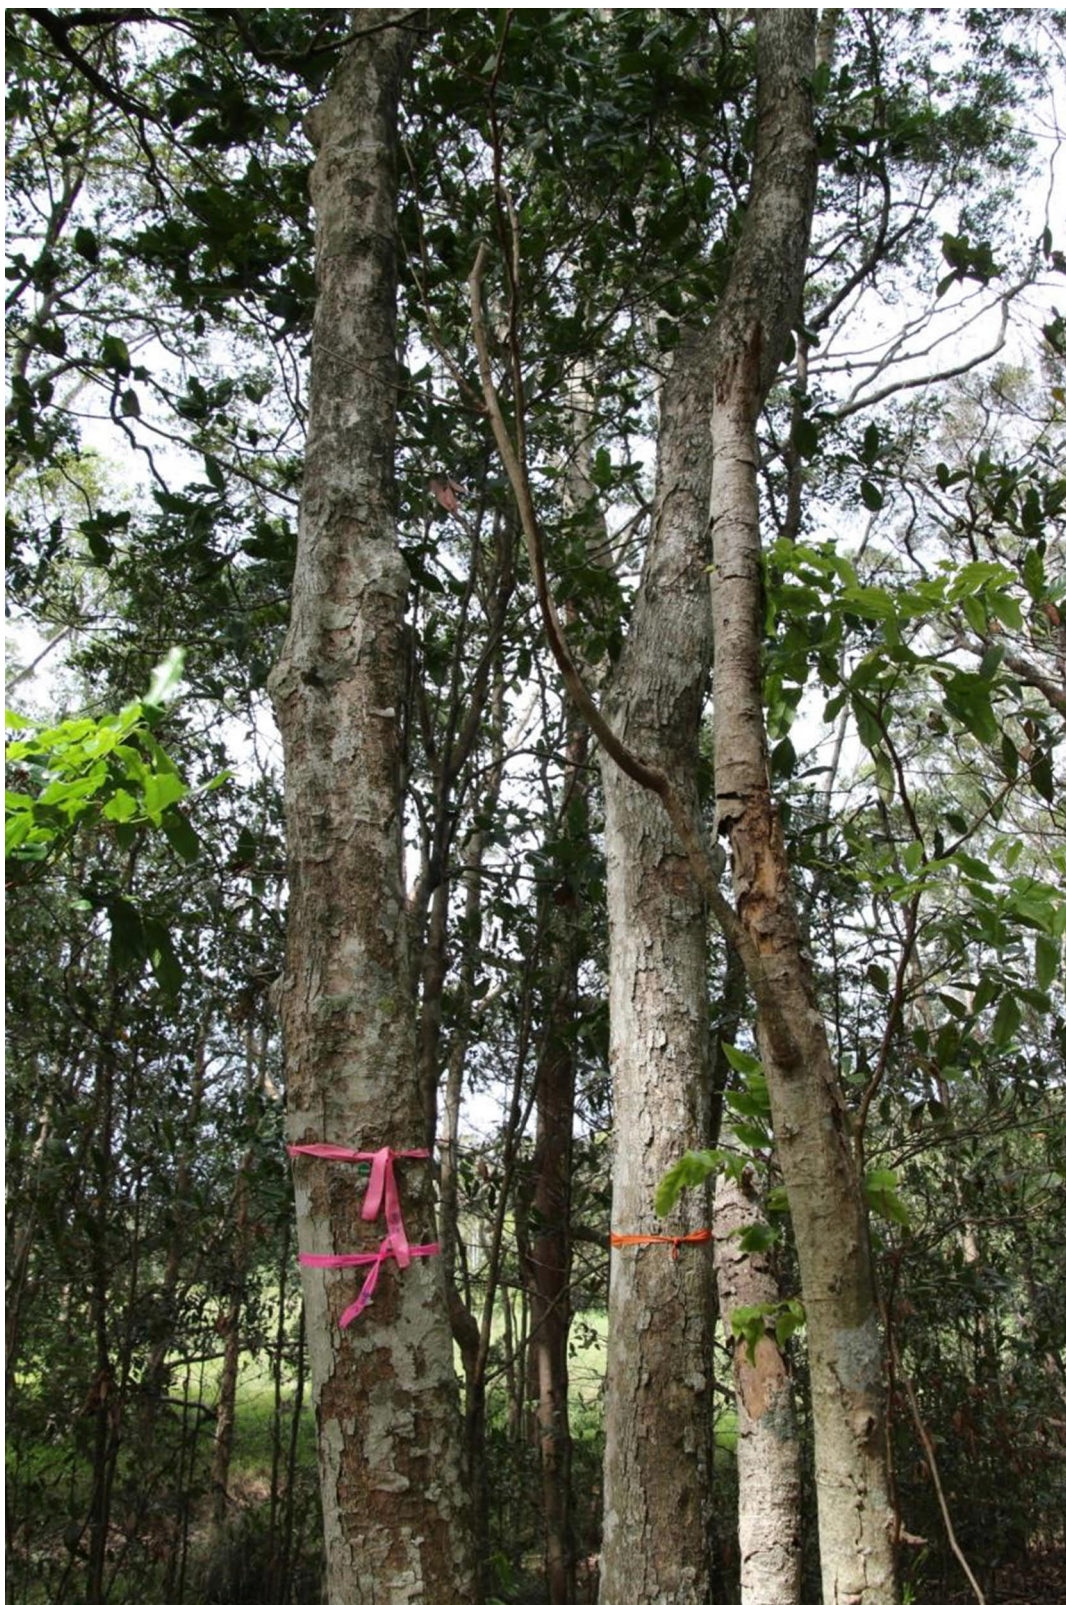
Plate 3: White Laceflower (*Archidendron hendersonii*) no. 73 near Plot 6. Showing no ill effects of the drought.

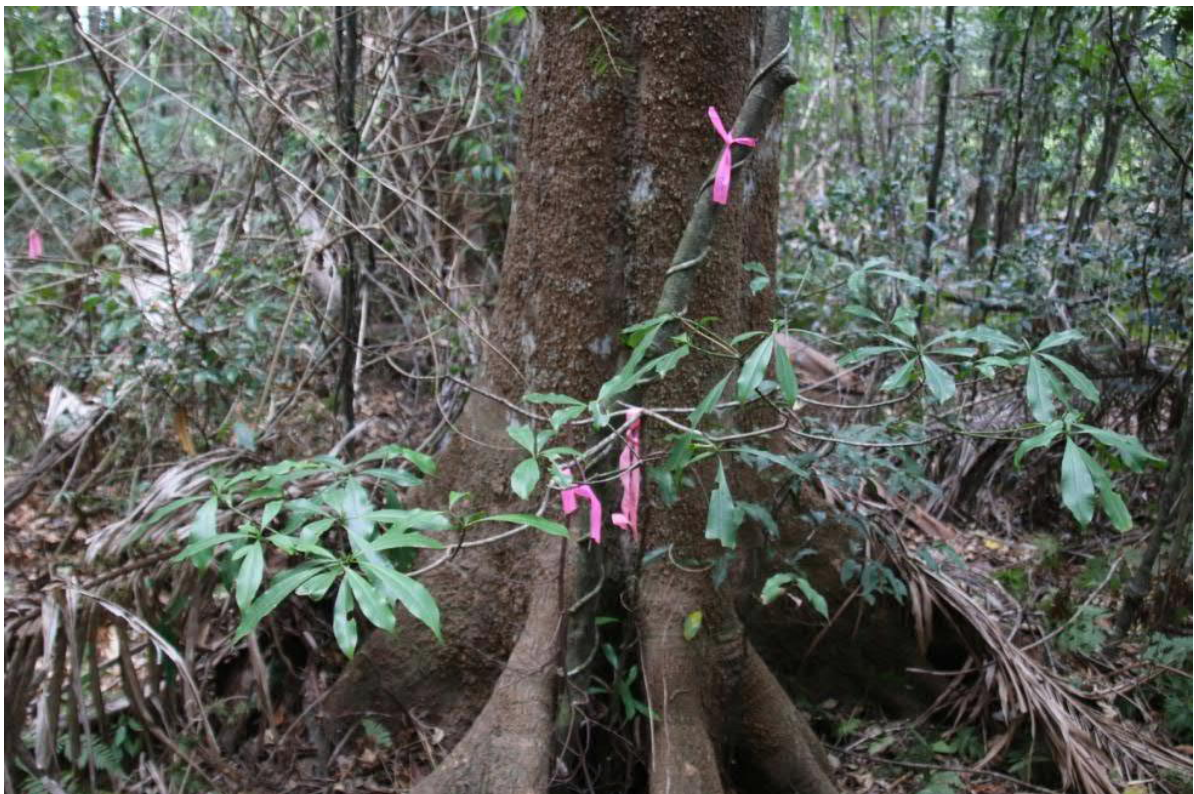
Plate 7: -Southern Ochrosia (*Ochrosia moorei*) – leaves low down and thinner grey main stem going up. Showing no ill effects of drought.

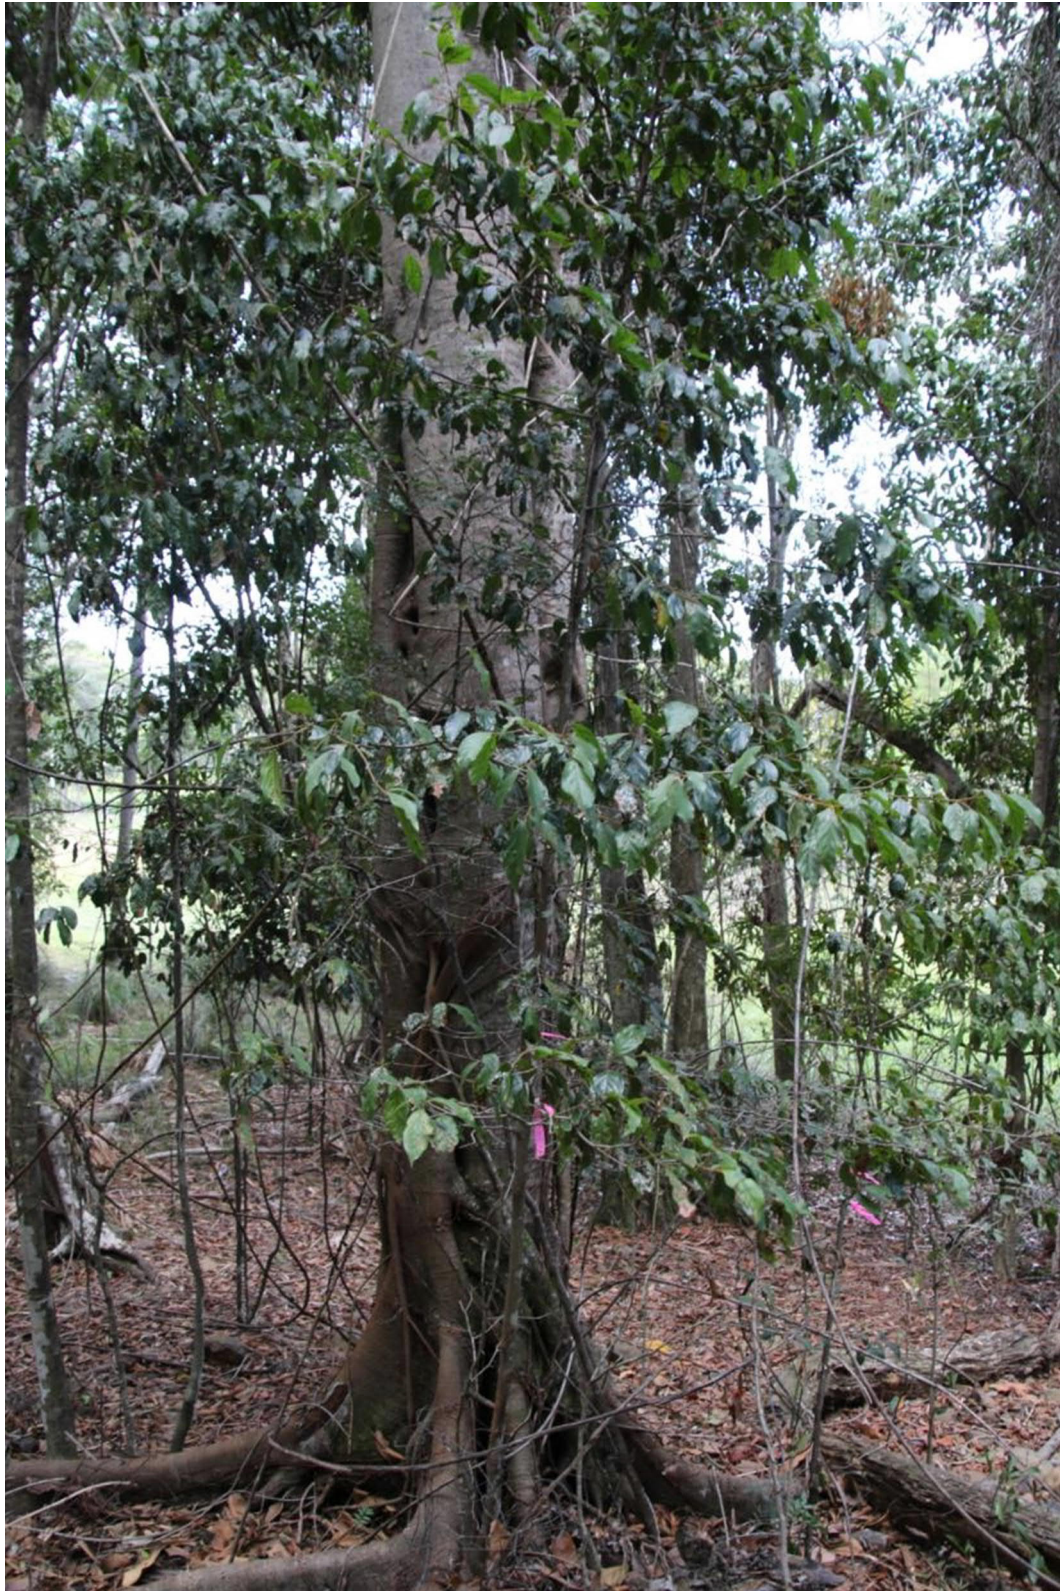
Plate 8: Rusty Green-leaved Rose Walnut (*Endiandra muelleri* subsp. *bracteata*) no.35 near Plot 6. The thinner main stem in front of buttressed, larger tree. Showing no ill effects of the drought.

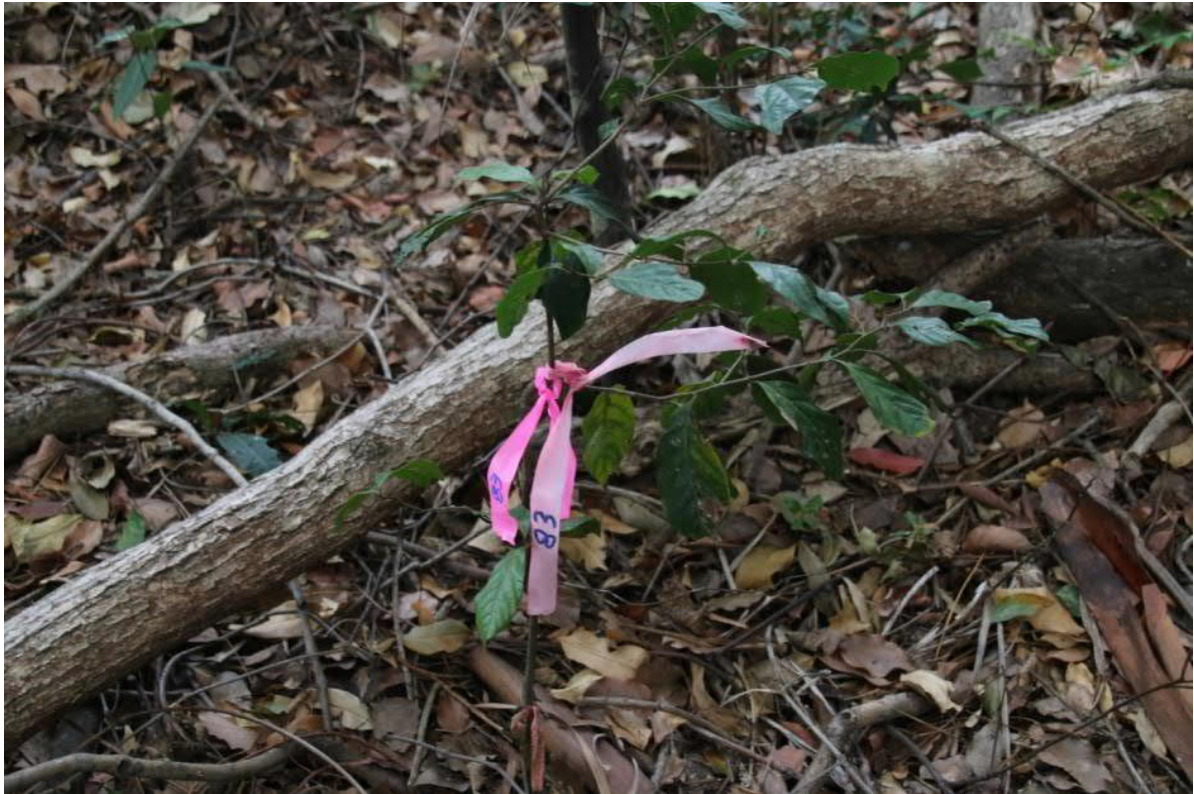
Plate 9: Rusty Green-leaved Rose Walnut (*Endiandra muelleri* subsp. *bracteata*) no.83 near Plot 2. A small juvenile plant showing no ill effects from the drought.

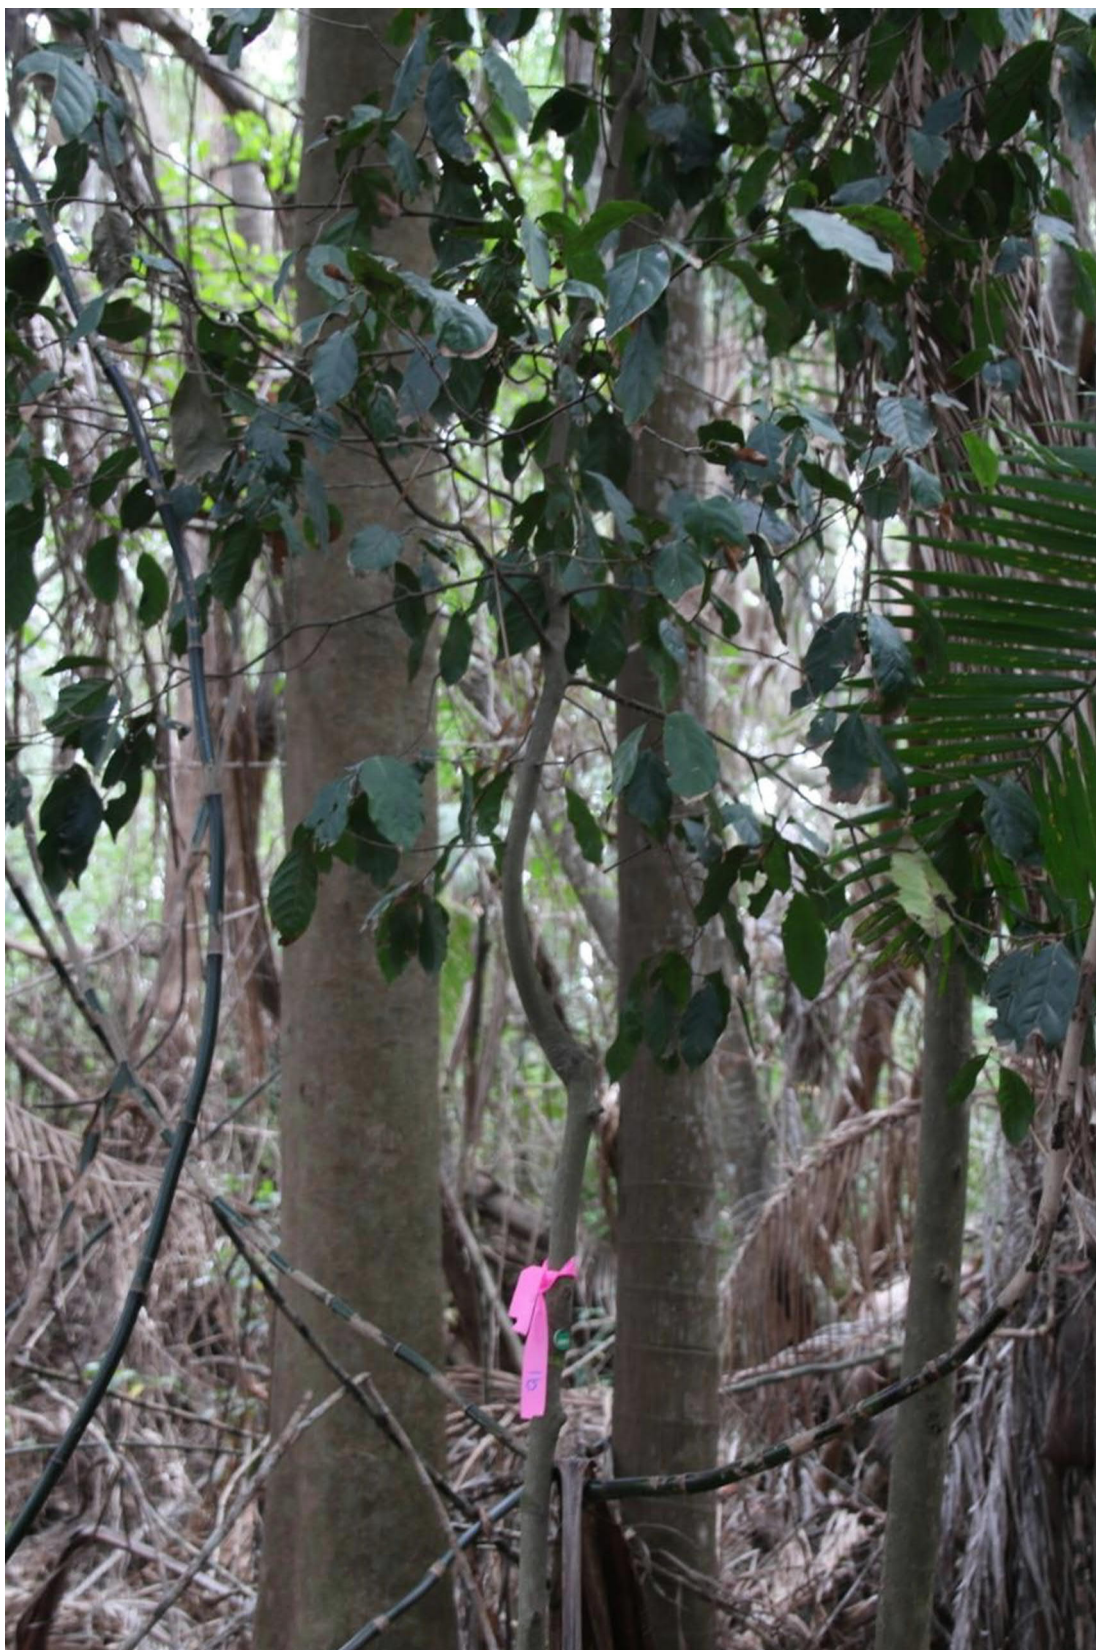
Plate 11: Rusty Green-leaved Rose Walnut (*Endiandra muelleri* subsp. *bracteata*) no.91 near Plot 2. Small tree showing no ill effects from the drought.

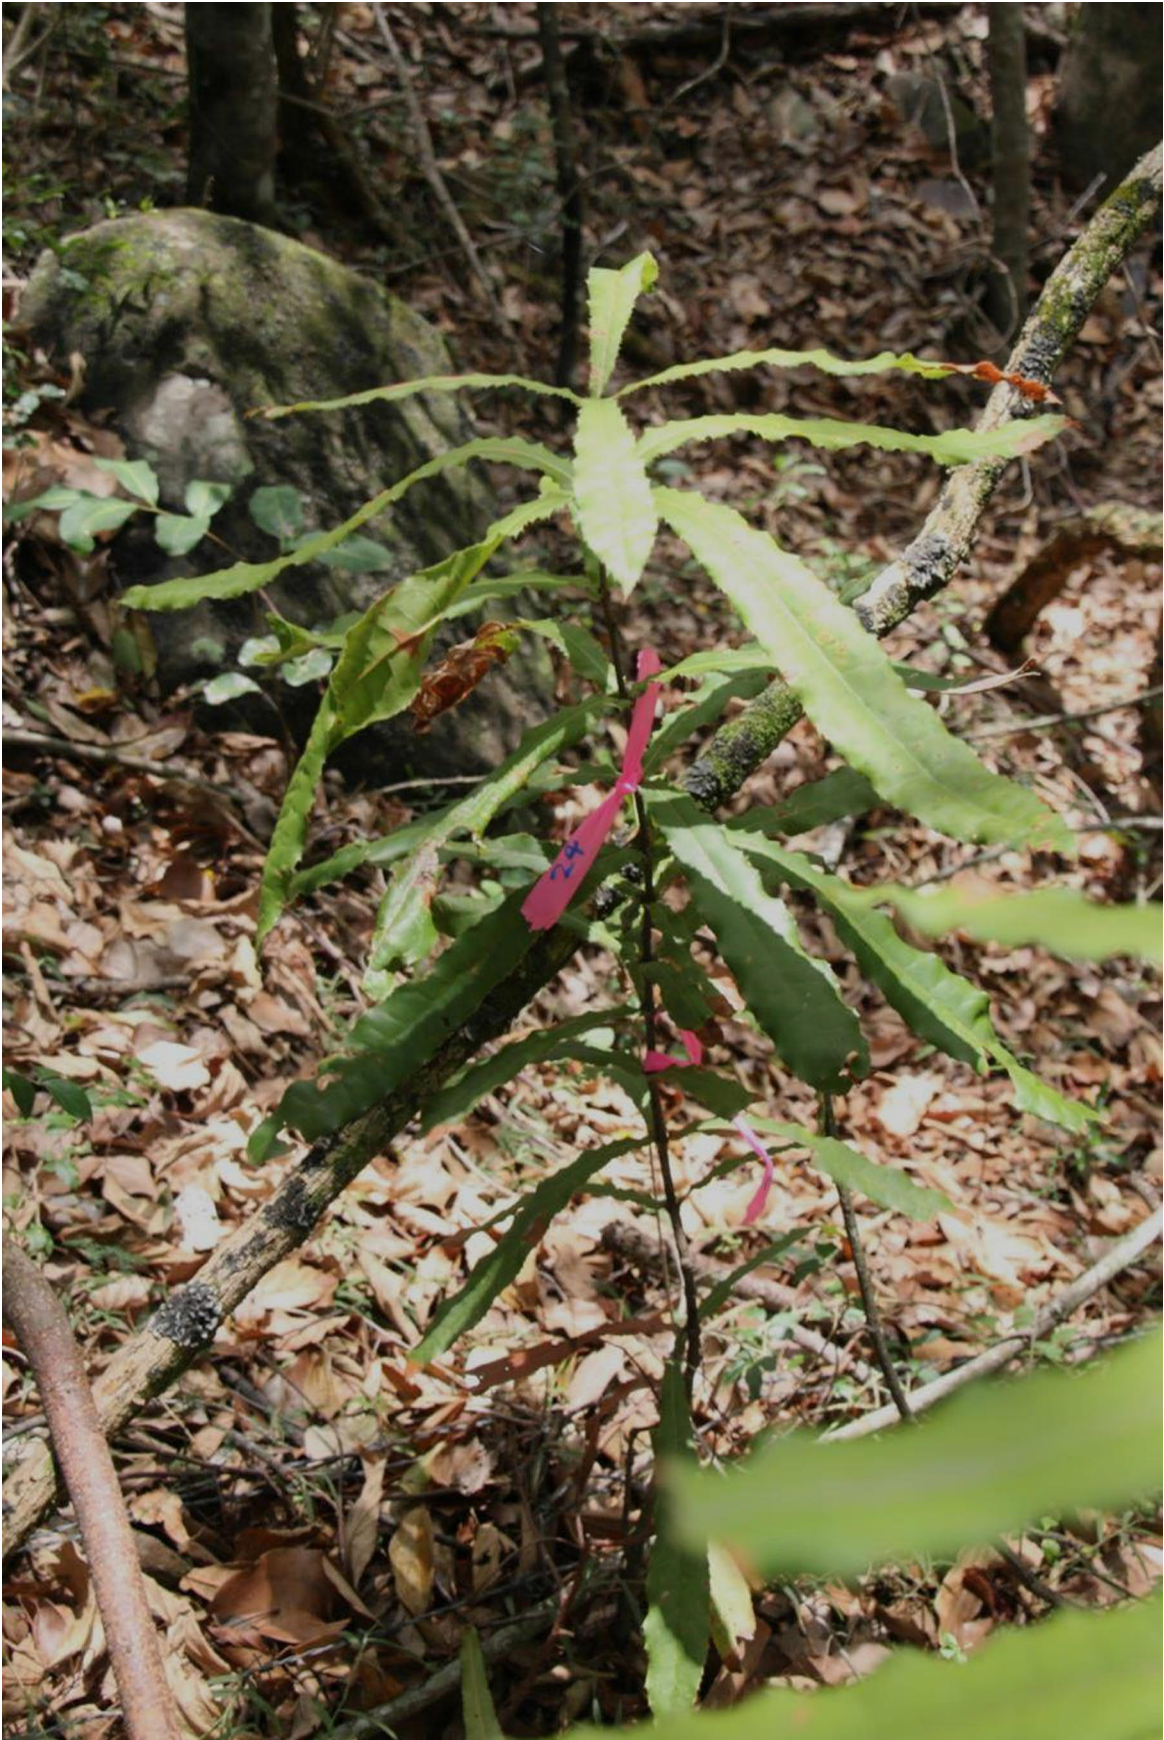
Plate 13: Rough-shelled Bush Nut (*Macadamia tetraphylla*) no.24 near Plot 13. A small juvenile plant showing no ill effects of the drought.

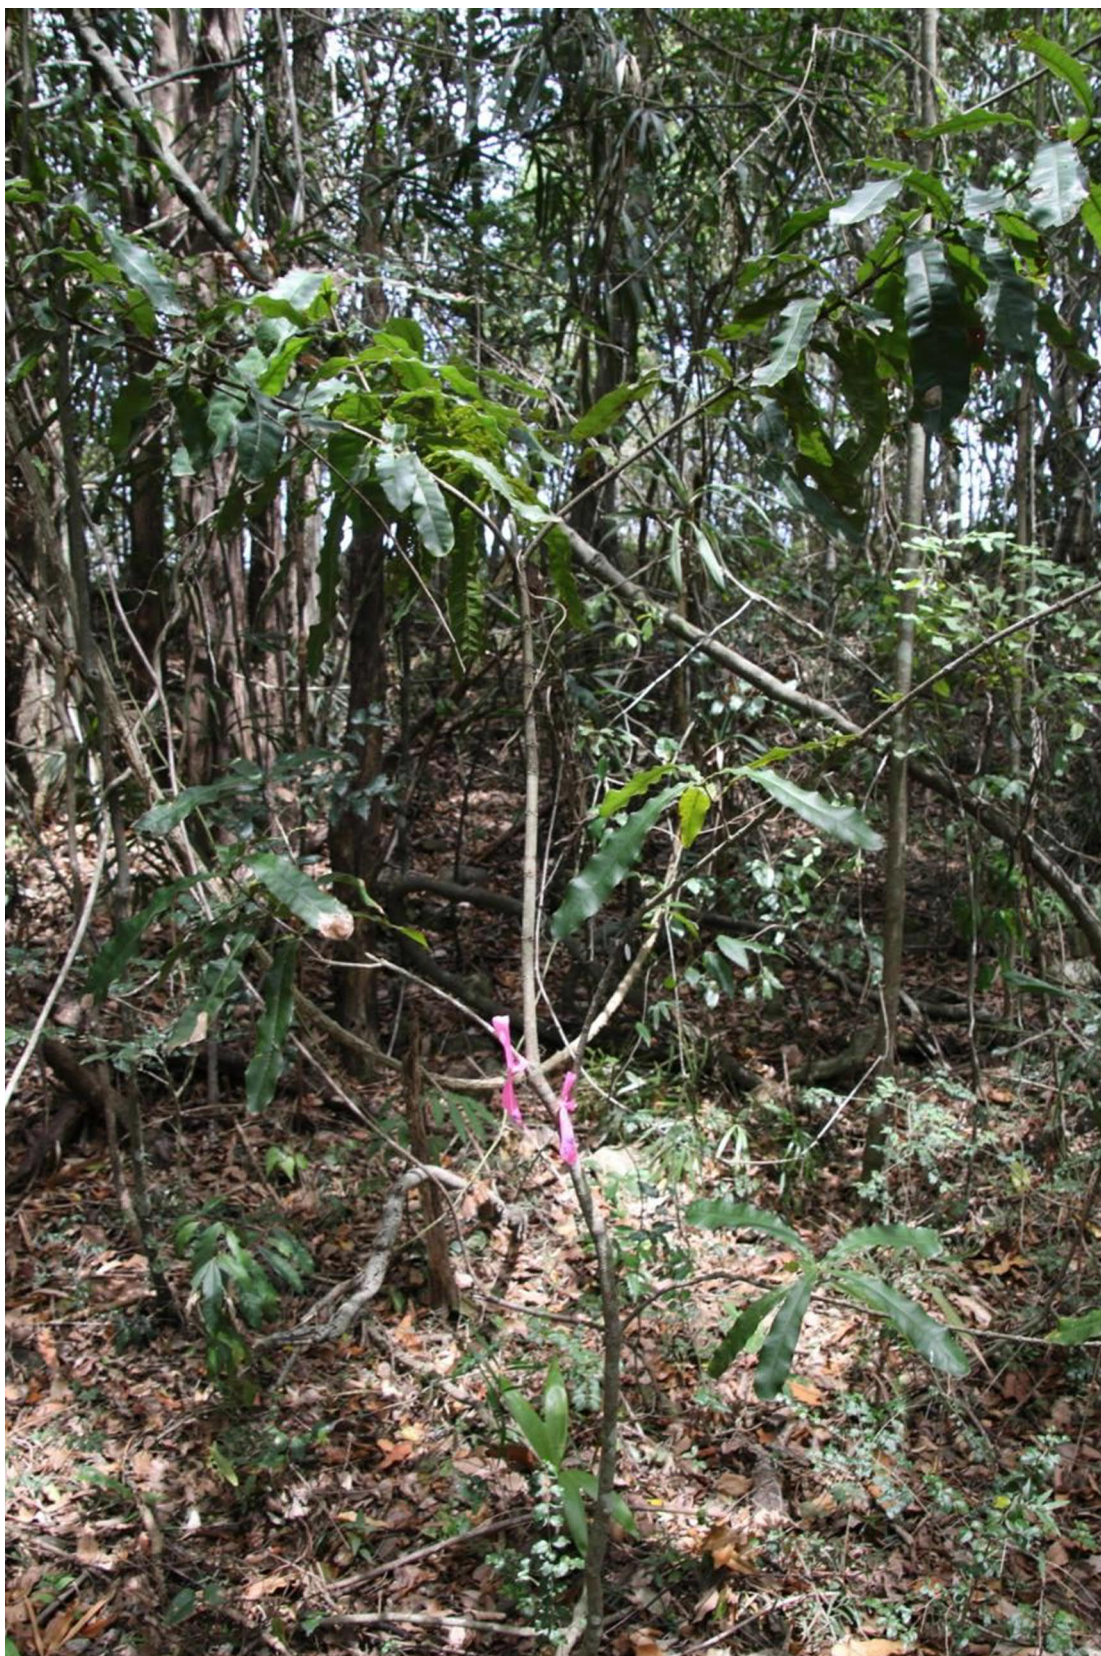
Plate 14: Rough-shelled Bush Nut (*Macadamia tetraphylla*) no. 72 near Plot 6. A small tree showing no ill effects of the drought.

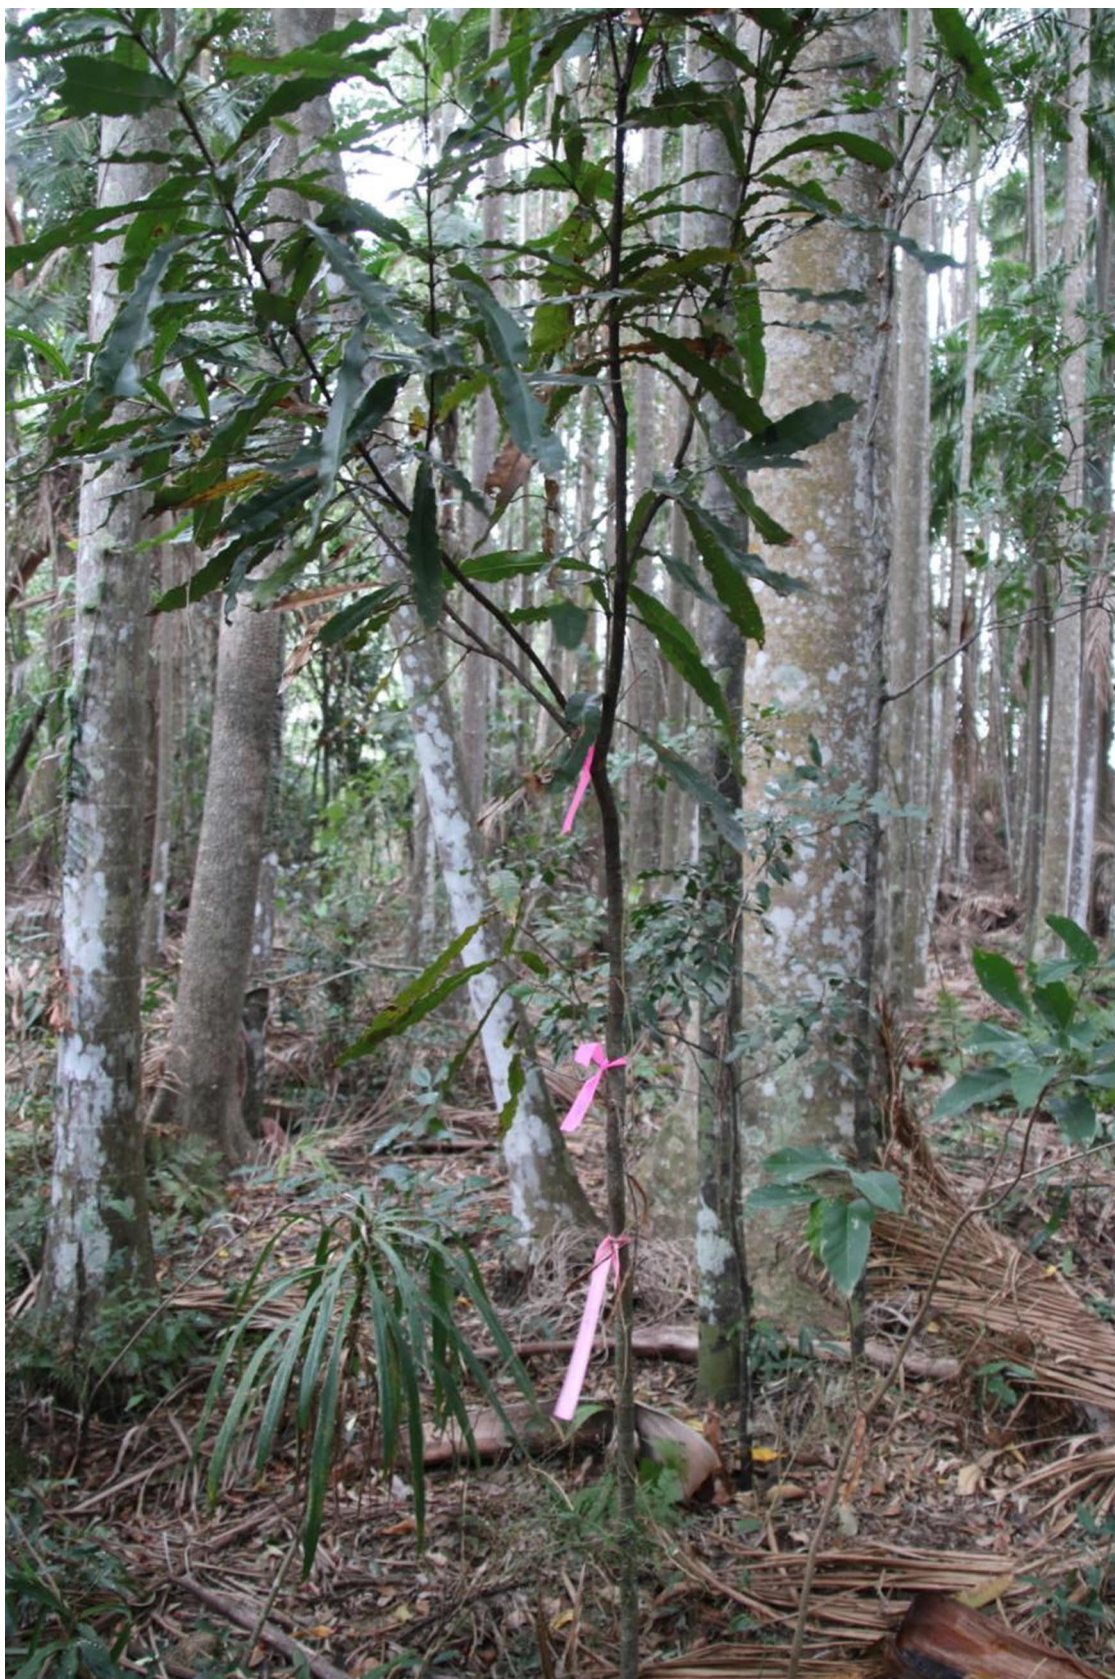
Plate 14: Rough-shelled Bush Nut (*Macadamia tetraphylla*) no. 45 near Plot 3. A small tree showing no ill effects of the drought.

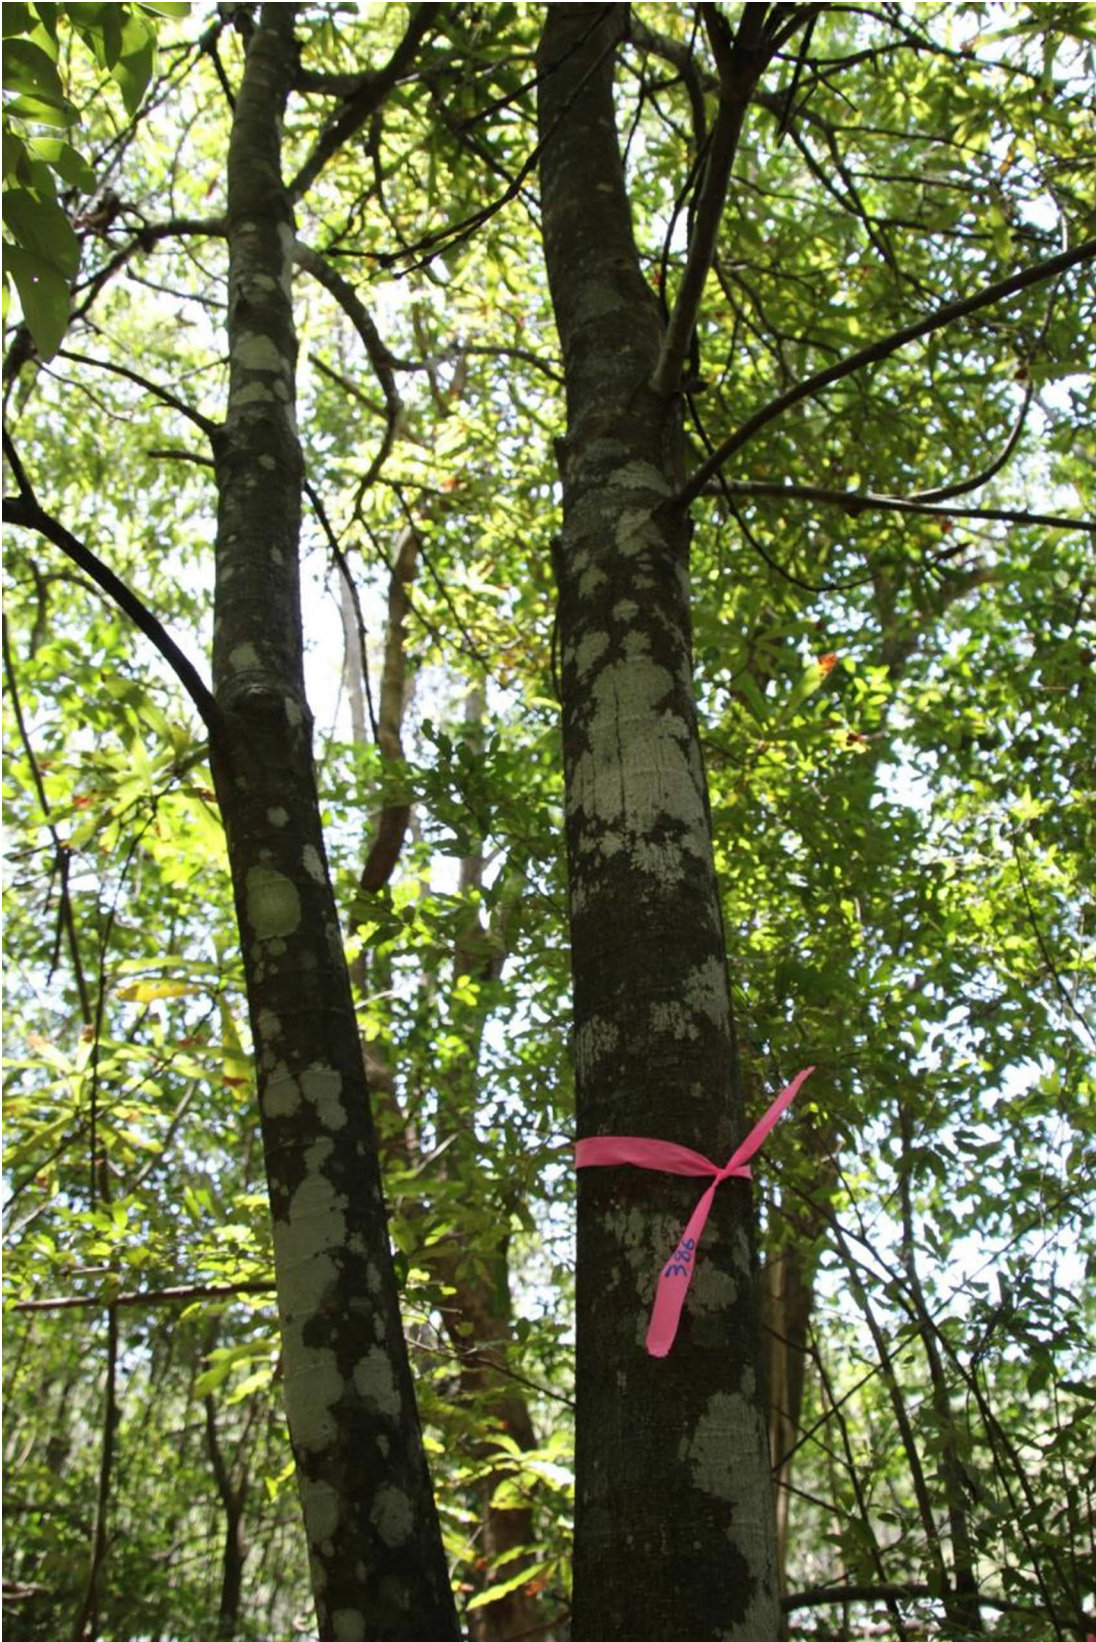
Plate 15: Rough-shelled Bush Nut (*Macadamia tetraphylla*) no. 386 near Plot 4. A mature tree showing no ill effects of the drought.

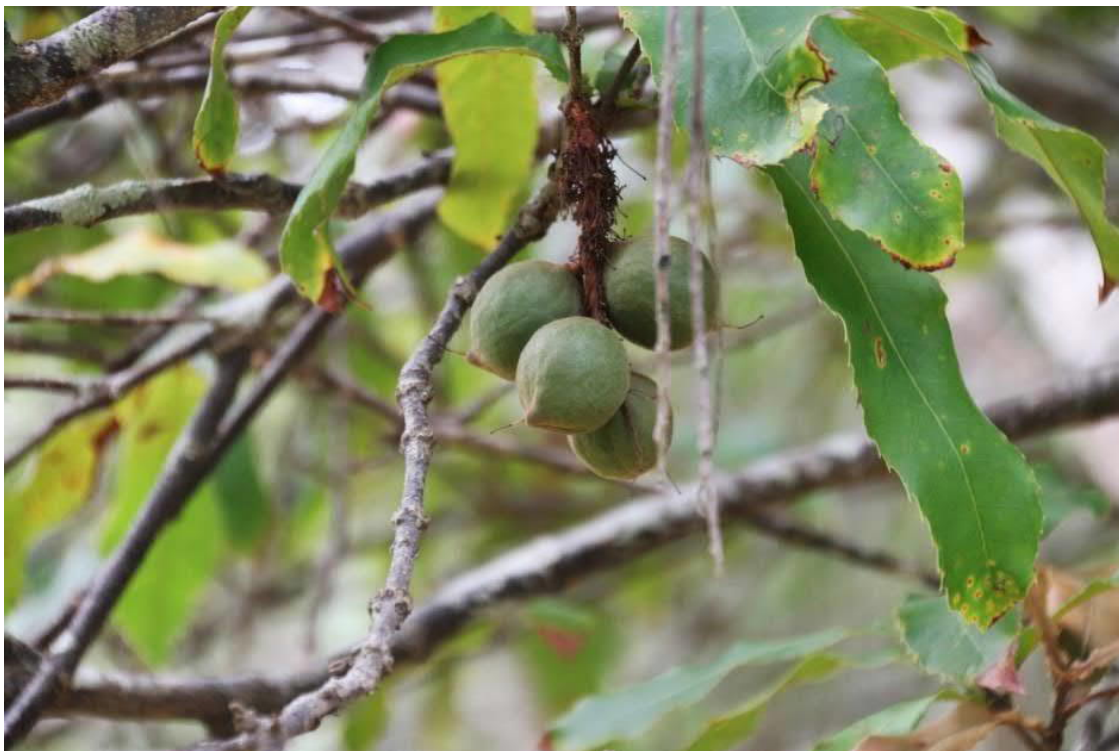
Plate 17: Rough-shelled Bush Nut (*Macadamia tetraphylla*) no. 166 near Plot 10. Small numbers of seed were present on larger macadamia including this multi-stemmed tree near the one above in Plate 16.
