Woolgoolga to Ballina Pacific Highway upgrade

**Construction Monitoring of In-situ
Threatened Flora (non-rainforest flora)**

Annual Report 2017-18

In-situ Threatened Flora (non-rainforest flora) Annual Monitoring Report 2017

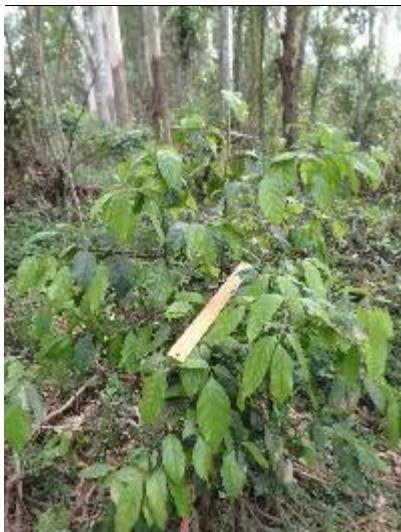
The single individual *E. muelleri* subsp. *bracteata* at Site Emb-4.1 (chainage: 81700) is in excellent health and has grown around 60 centimetres since pre-construction surveys (refer to Photograph 13 and 14). Insect activity on shrub has been observed, including caterpillar, moth and ant and aphids. Leaf insect damage has been noted but hasn't caused detrimental harm to plant. Weed ground cover has increased by 20% to nearly half the plot since pre-construction surveys with an increase in cover of the climber weed *Aristolochia elegans* which was observed growing on *E. muelleri* subsp. *bracteata* in autumn 2017. Increases in weed abundance is unrelated to the project, but may cause harm to plant in future if not controlled.

Photograph 13: *E. muelleri* subsp. *bracteata* at in-situ site Emb-4.1 showing new growth in February 2017

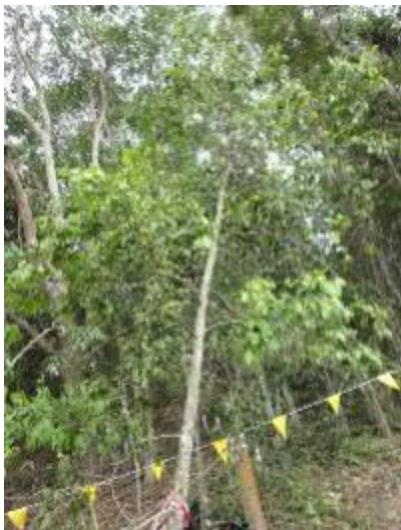
The small tree at Site Emb-4.2 (chainage: 80700) has had continuous new shoot growth on lower and upper branches but has not grown in height with visual crown dieback and moderate dieback of upper branches in spring 2017 (refer to Photograph 15 and 16). Site Emb-4.2 has had no increase in weed cover, but weed species numbers have increased inside the plot, particularly at the lower end around the individual *E. muelleri* subsp. *bracteata* where the site had been cleared to allow for the new embankment. There is potential for future weed invasion and spread.

Photograph 15: *E. muelleri* subsp. *bracteata* at in-situ site Emb-4.2 showing new growth in February 2017

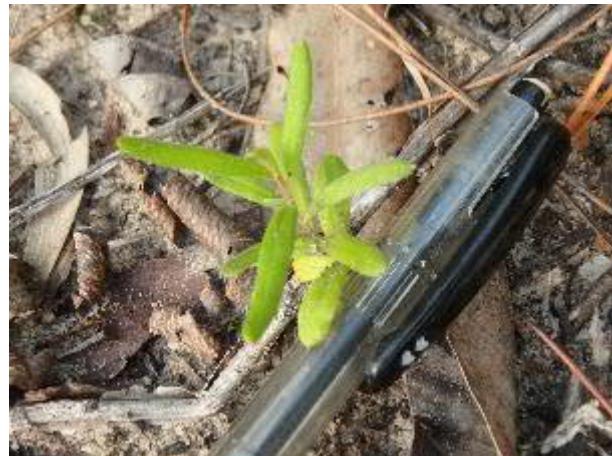
G. quadricauda was found to benefit from a reduced canopy cover and ground disturbance at Site Gq-3.1 where increased sunlight and bare ground allowed for suitable recruitment conditions. Over the Year 1 construction phase, an additional 14 *G. quadricauda* seedlings in-situ were observed. The control site only recorded three

Photograph 18: In-situ G. quadricauda seedling (autumn 2017)

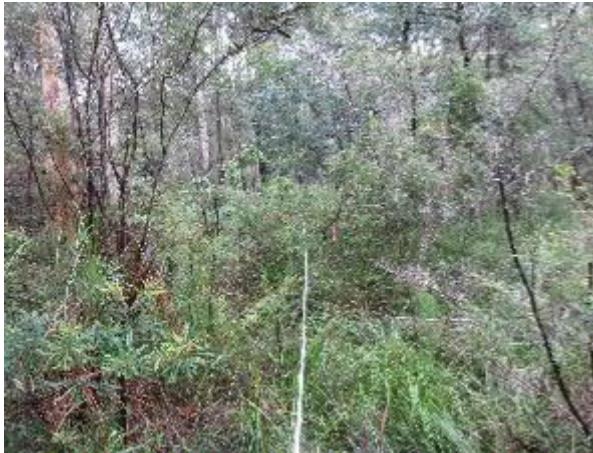
In-situ Site Li-3.1 was directly impacted by detailed design work prior to summer surveys resulting in clearing of 85% of habitat in site. Widespread dieback of *L. incisa* was evident within plot where canopy cover was reduced by habitat clearing (refer to Photograph 19 and 20). Continued monitoring has found the species recovering with new fronds observed in autumn and winter as well as fertile fronds observed in spring. Some fronds are covered with semi-vertically placed geo-fabric on exclusion fencing, this will be monitored closely and should be reviewed. An excavator was observed operating on edge of Site Li-3.1 during spring surveys and the site is expected to have future impacts as part of a proposed sedimentation basin. This site also had 15 clumps of *L. incisa* translocated in December 2016 which may incorporate part of the mean cover loss (0.95%/m²).

Photograph 19: Pre-construction in-situ Site Li-3.1 showing intact habitat (May 2014)

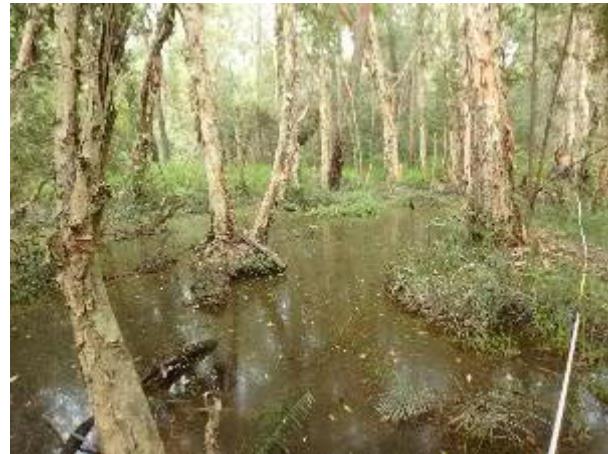
Heavy cattle pugging has continued at Site Mt-3.2 affecting small areas of *M. triglochinoides* in shallow muddy locations of plot. *M. triglochinoides* growing in deeper pools remain unaffected by local land use change. Heavy rainfall during autumn surveys caused high surface water flow laden with sediment from project and associated land. Water from the project was observed being pumped into native vegetation habitat 500 metres upstream of the *M. triglochinoides* population. The water level at this site has remained high with dirty water but *M. triglochinoides* has recovered (refer to Photograph 21). Natural flooding also occurred at control Site Mt-C3.1 causing a temporary reduction. Water had some minor sediment likely from nearby farmland but retained typical tannins in water (refer to Photograph 22).

Photograph 22: Natural flood event at control Site Mt-C3.1 showing typical flooded habitat (May 2017)

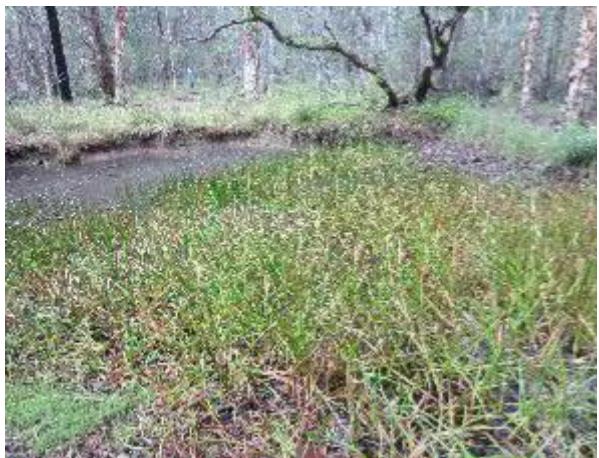
Survey observations and photographic evidence at Site Mt-7.2 suggests inadvertent indirect impacts to *M. triglochinoides* by the project where 92% of the population had been lost outside the project boundary. Very high above average rainfall (total of 740.2 mm at Woodburn) was recorded during March 2017 causing a major flood event at Tabbimobile creek and bridge overflows. Of this, 298.4 mm was recorded in one day on the 31st March. Deposited sediment and gravel transported by flood waters were observed within the habitat of *M. triglochinoides* during May surveys. This was aligned with a major decline in mean plant cover of 0.09% per metre square in plot compared to an estimated plant cover of 13% per metre square in plot in the pre-construction phase (refer to Photograph 23 and 24). These impacts are also likely associated with a slight

Photograph 23: Pre-construction phase at in-situ Site Mt-7.2 showing healthy population of *M. triglochinoides* (May 2014)

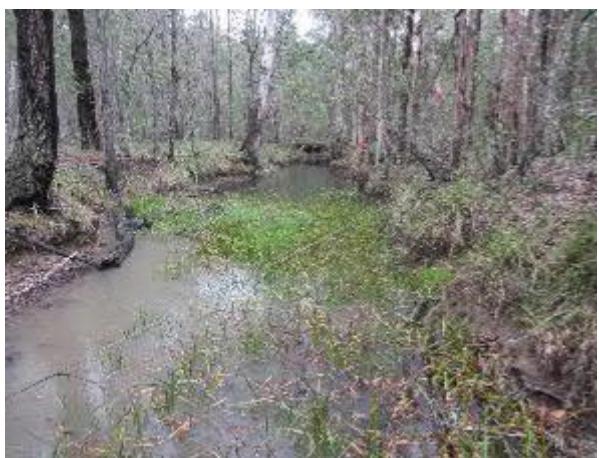
reduction in plant cover at Site Mt-7.3 in the same waterway (Tabbimobile overflow No 1) inside the clearing boundary. (refer to Photograph 25 and 26). Natural impacts from fire and multiple flood events during the construction phase are expected to have caused a decline in plant cover at Site Mt-7.1.

Photograph 25: Pre-construction phase at in-situ Site Mt-7.3 showing healthy population of *M. triglochinoides* (May 2014)
