## 6 Maritime archaeological investigations and assessment

## 6.3 Results and assessment

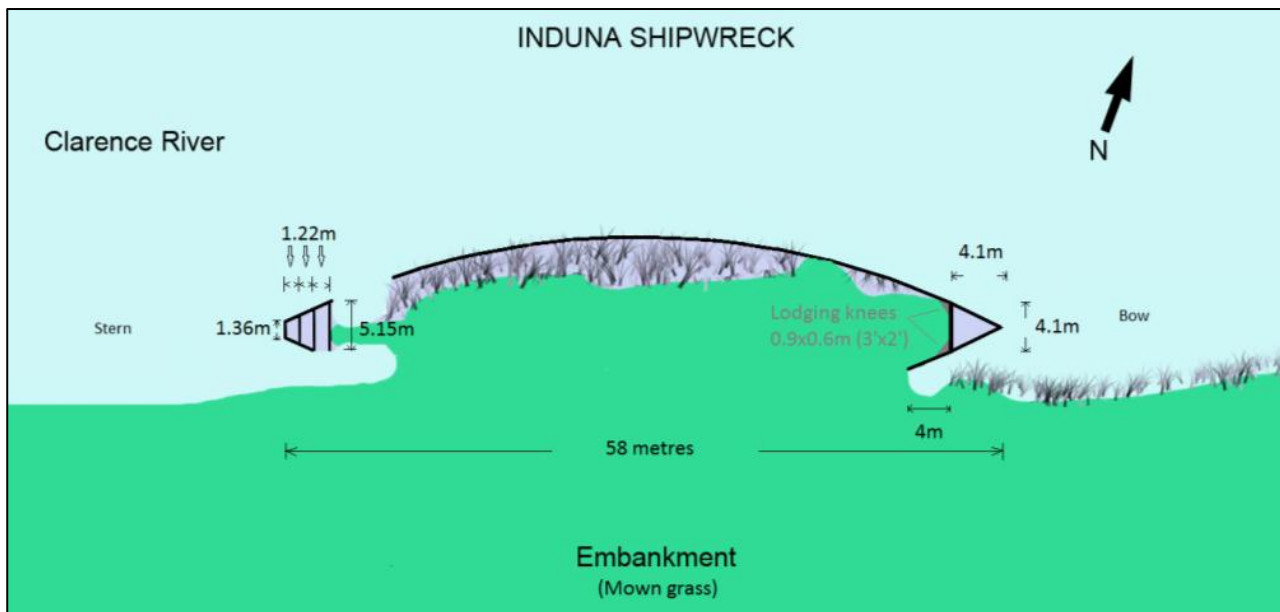
Plate 60: Site Plan of the SS *Induna* (FMW29) (Source: Comber Consultants)

The lower hull of the *SS Induna* is clear of the seabed. Due to the confined space, safety concerns and limited visibility, the full extent of the hull clearance could not be established but, based on observations at the bow and stern and the limit of torch light penetration at mid-ships, the clearance appears to be about at least as far as the keel (see Plate 58 and Plate 61). The submerged bow and stern sections of the port hull were in good condition. Amidships, however, there were six large openings between the hull frames and above the turn of the bilge. Each opening is about 1 metres in height and 0.7 metres in width. This appears to be the result of natural corrosion of the hull plating in an oxygenated area that is periodically exposed to wetting and drying.

Immediately in front of the stern post is remnant tar/pitch which lies between the stern post and a 1650 millimetres frame. In front of this frame can be seen the rear extremity of the concrete ballast that was introduced for the vessel's rail ferry work. The wreckage itself has survived the regular flooding of the river and appears relatively stable. The submerged hull plates and frames remain relatively sound and there are no signs of loose plating or frames that could indicate potential for imminent collapse. At water level, the hull plating and longitudinal frames just forward of the stern assembly are no longer present but the lower frames and keel appear to be intact and the stern remains in alignment with the bow. The underwater survey revealed that almost the entire port side of the hull is supported by water rather than the river bed sediment.
