# **The Northern Road – Mersey Road, Bringelly to Glenmore Parkway, Glenmore Park**

## **Environmental Representative Monthly Report**

**October 2020**

**Doc no. 18008-RP-MR-028-TNR 4,5,6 Monthly Report\_October 2020 \_0**

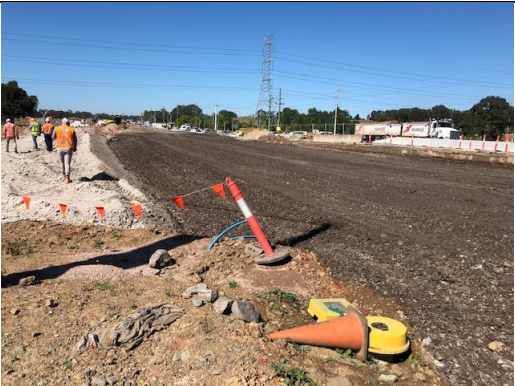
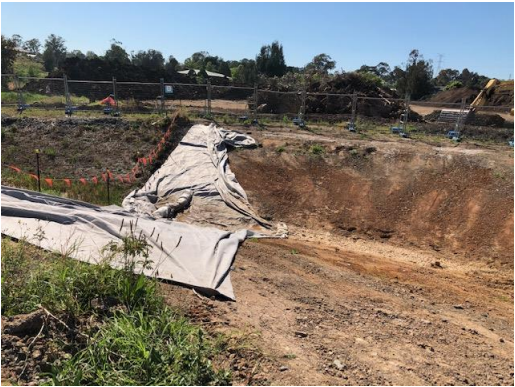
4	South of P12 gate	<p>Works in progress - New table drain has been cut to lead into the inlet of the main culvert. Drain needs to be lined and complete, or an earth bund installed to hold water back as a matter of priority.</p>	M	Complete drain lining or install bund to hold water back by the end of the week.	16/10/20	<p>Not complete by 16/10 but has been communicated and could be actioned over the weekend.</p> <p>Sandbags available on site to create quick bund if needed.</p>

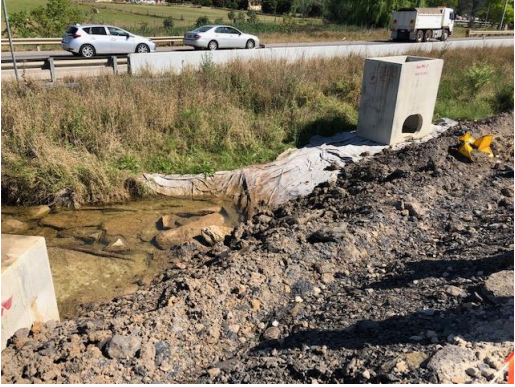
6	P12 – main retention dam	<p>Works in progress - Drain from the outlet of the retention dam is currently being constructed.</p>

M	Continue to make this drain construction a priority to get finished prior to rainfall. Where it cannot be finished prior to rainfall, install temporary controls to minimise the amount of potential dirty water being discharged into the vegetated drain downstream.	16/10/20	Noted. Progress has been made this week to dig the fish passage. Further work to install temporary controls has been communicated with the site Foreman.

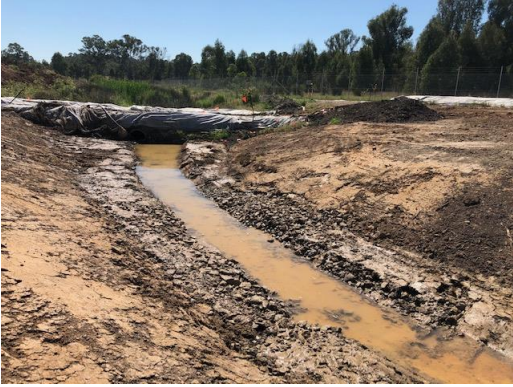
7	Median inlet of triple cell pipe culvert	<p>Works in progress – currently filling median at inlet of pipes to create a stable base. Once complete, the clean water path needs to be reinstated prior to the weekend.</p>

M	Reinstate clean water path from the existing culvert through the new triple cell pipe culvert.	16/10/20	The construction team has shaped the inlet and will be finalising to design soon. Water from Bradley street has the ability to be slowed in this area prior to entering the triple cell culvert.
8	N3 Box Culvert	<p>General observation - Southbound side of culvert is currently being constructed. Formwork for base slab currently being installed and being prepared for concrete pour in near future. It is noted that the clean water from this culvert is being accepted in this</p>	N/A	N/A	N/A	Concrete slab has been poured. An outlet to join the water from the culvert to the existing clean water diversion will occur in due course.

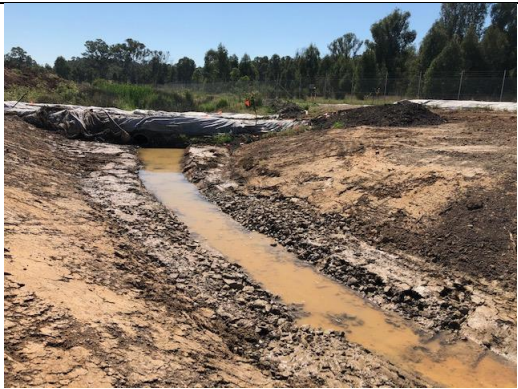
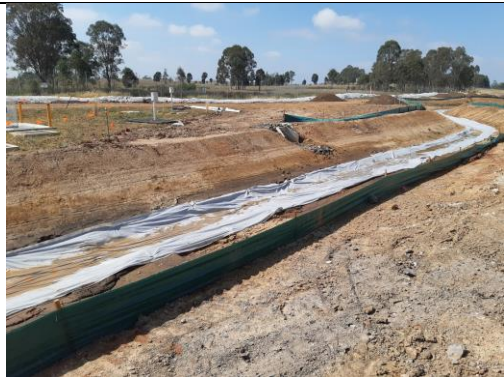
1	Culvert north of Gate N2	Inlet area of culvert needs some work prior to the forecast rainfall.	M	Tidy controls at the inlet of the culvert and ensure water is passed through controls before entering the lined inlet area.	23/10/20 or prior to rainfall.	Geofabric around inlet has been tidied up before entering lined inlet
---	--------------------------	-----------------------------------------------------------------------	---	-----------------------------------------------------------------------------------------------------------------------------	--------------------------------	-----------------------------------------------------------------------

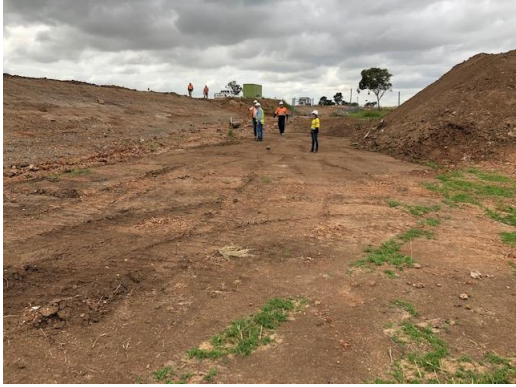
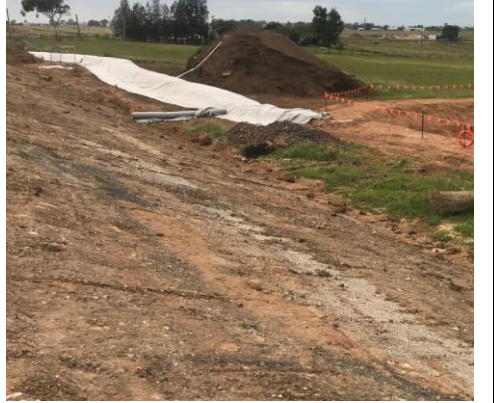
3	Basin near GRS Towing	Basin appears to be nearly at capacity
