The Northern Road – Mersey Road, Bringelly to Glenmore Parkway, Glenmore Park

Environmental Representative Monthly Report

March 2021

Doc no. 18008-RP-MR-033-TNR 4,5,6 Monthly Report_March 2021_0

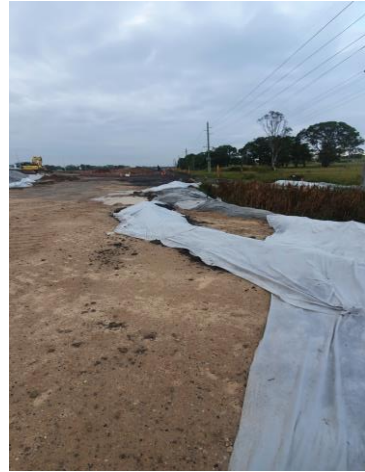
7	P12 Flood overflow culvert	<p>Section of the access road into the compound was observed to be a potential low point where water could escape from access road</p>	L	<p>Install rock bund along the edge of the access track into the compound to provide a sediment control.</p>	11/03/21

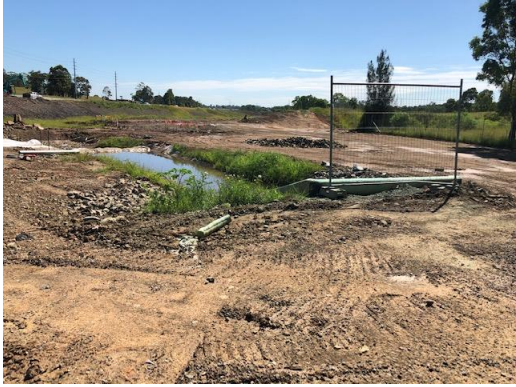
of site water. Completed on the 9 th March 2021.
8	Area to north of DEOH gate/Gate S3	<p>Positive to see the progress in this area. As a short term temporary measure for forecast rain prior to the final landscaping treatment, install sediment fence along the top of the channel and over the top of the culvert to protect drainage line.</p>

L	Install sediment fence along the top of the channel as discussed on site.	11/03/21

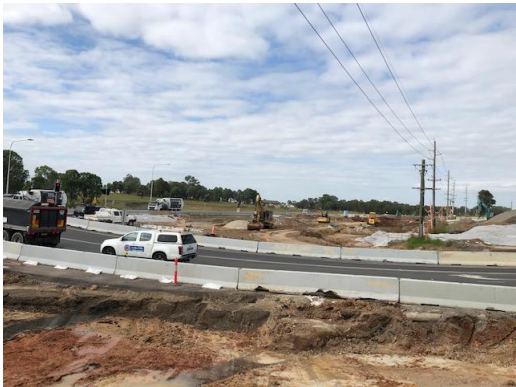
1/4/2021 - Sediment fence has been installed around the pit. The pit is at a low point and will pond water before it can be filtered through the sediment fence and into the culvert. CPB is in the process of reviewing options to stabilise the batter surrounding the pit.
3	Bradley Street	<p>Bradley Street area appeared to perform very well during the rainfall. Some maintenance of controls is required around the clean water path and culvert.</p>

M	Ensure all controls are reinstated and maintained prior to the weekend.	1/03/21

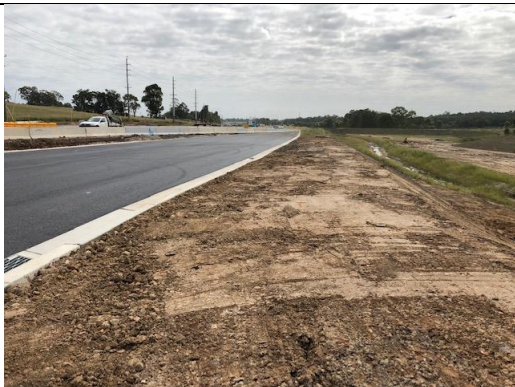
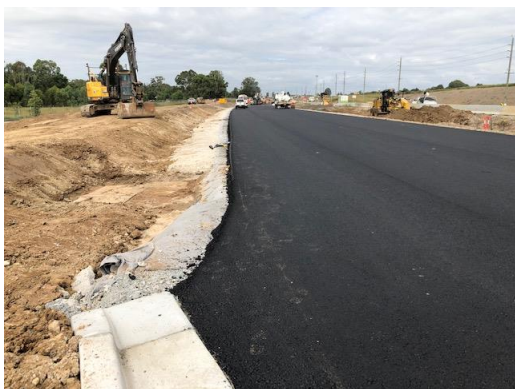
<p>1/4/2021 – Sediment fence at area S3 has been re-erected. Topsoil is being spread today in the areas surrounding the S3 culverts.</p>
6	Area to north of DEOH gate/Gate S3	<p>Positive observation – asphalt is being laid to the north and south of the DEOH gate in preparation for the next traffic switch which is planned for mid-late April.</p>	N/A	N/A	N/A	<p>1/4/2021 - Topsoil is being spread today in the areas surrounding the S3 culverts and on batters in preparation for hydro-mulching to follow.</p>
