The Northern Road – Mersey Road, Bringelly to Glenmore Parkway, Glenmore Park

Environmental Representative Monthly Report

May 2021

Doc no. 18008-RP-MR-035-TNR 4,5,6 Monthly Report_May 2021_0

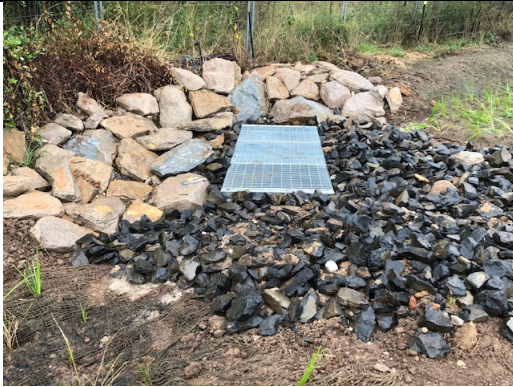
2	Bradley Street	<p>Observed that some of the scour protection rock being placing in the drain has a relatively high content of fines.</p> <p>Rock being placed in clean water areas should be clean and free of fines.</p>	L	Ensure the remainder of the rock being placed in this clean water area is clean and free of fines to minimise the risk of sediment being eroded and transported downstream.	14/05/21	Scour protection rock placement put on hold due to supply issues. Rock will be inspected as it is delivered and/or placed with a shaker bucket.
3	Bradley Street	Positive observation – drainage depression has been topsoiled, lined with jute-mesh, straw bails installed as checks, and sprayed with hydro-mulch. Sediment fence has also been installed on either side of the channel.	N/A	N/A	N/A	N/A

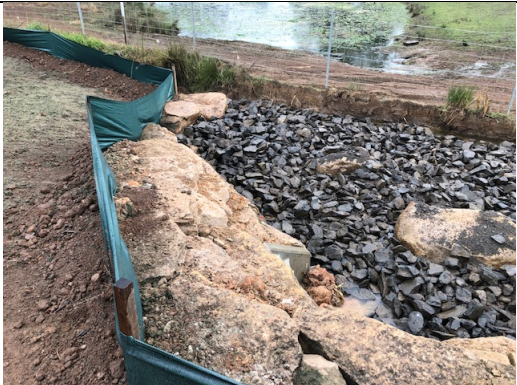
6	Chain-of-Ponds Road	Positive observation – open drains and inlet and out of the culvert on Chai-of-Ponds Road have been finished very well. Looks great!	N/A	N/A	N/A	N/A
