Construction Monitoring Report September 2021 – February 2022

Sydney Metro City & Southwest – Line-wide Works

Contract Number:	C600
Systems Connect Number	N21063
Document number:	SMCSWLWC-SYC-CSW-EM-REP-011744
Revision date:	24/03/2022
Revision:	0

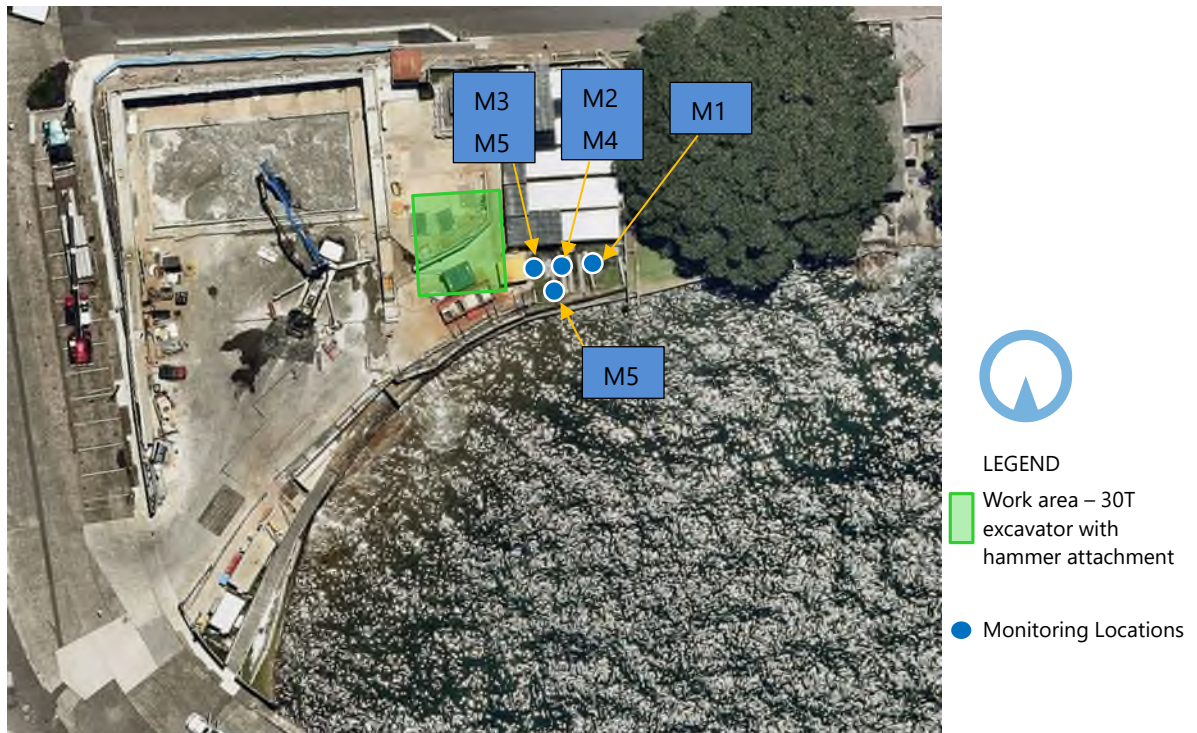
Figure 2-1 - Monitoring locations – Blues Point attended vibration monitoring

Measurement ID	Assessment Point	Date	Time	Measured plant	Approx. distance to measured plant
M1	Blues Point site (Figure 2-1)	03.02.2022	02:27pm – 02:29pm	30T excavator with hammer attachment	7m
M2	Blues Point site (Figure 2-1)	03.02.2022	02:29pm – 02:31pm	30T excavator with hammer attachment	5m
M3	Blues Point site (Figure 2-1)	03.02.2022	02:29pm – 02:31pm	30T excavator with hammer attachment	3m
M4	Blues Point site (Figure 2-1)	03.02.2022	02:40pm – 02:41pm	30T excavator with hammer attachment	4m
M5	Blues Point site (Figure 2-1)	03.02.2022	02:40pm – 02:41pm	30T excavator with hammer attachment	2m

For the remaining concrete removal works within the established minimum working distances, unattended monitoring was conducted. The measurement location of the unattended vibration monitoring is described in Table 4-3 and Figure 2-1.

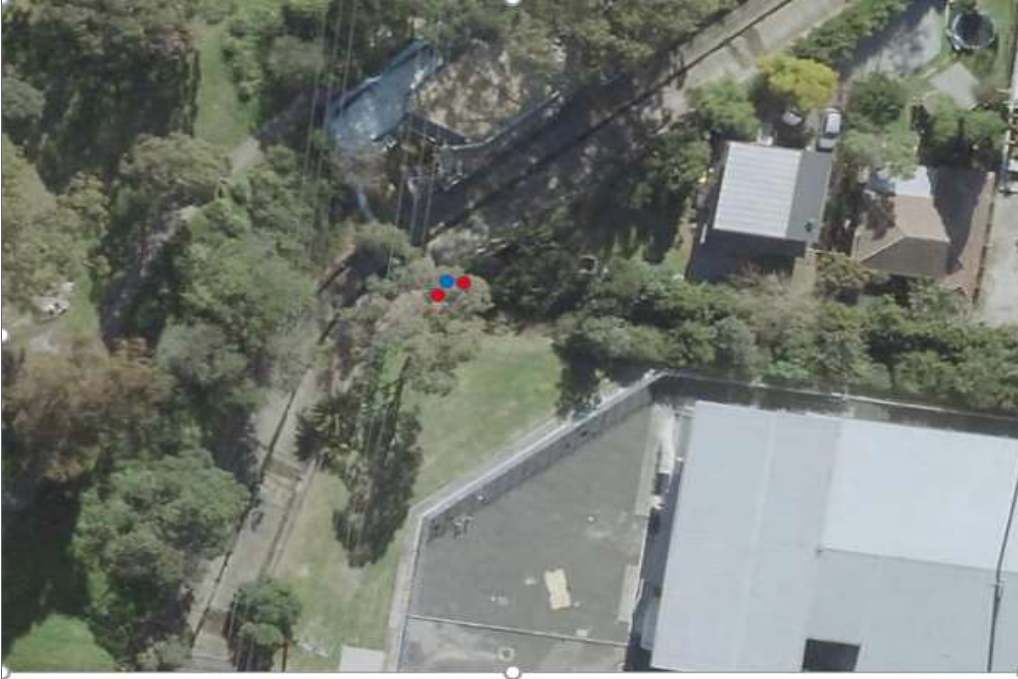
20/09/2021	3:27:00 PM	6.77	0.34	0.76	Auger piling through hard rock at depth
COMPLIANT WITH VIBRATION CRITERIA:			Yes		
MONITORING COMMENTS OR ACTIONS TAKEN TO ADDRESS EXCEEDENCES OF VIBRATION CRITERIA					
No vibration exceedance above the criteria of 10 mm/s during piling works
