# INLAND RAIL – NARRABRI TO NORTH STAR – SSI 7474

## ER MONTHLY REPORT

September | 2022

**Report Name:** Inland Rail N2NS – SSI 7474 – ER Monthly Report – September 2022  
**Project No.:** 136

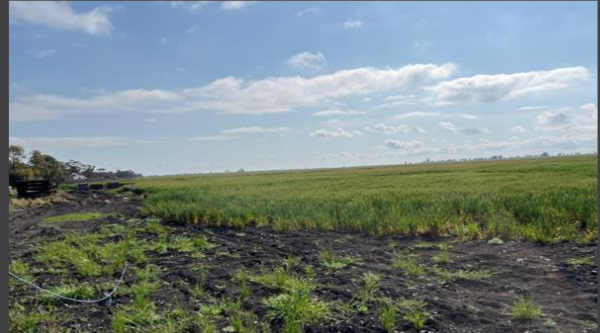
Site rehabilitation – cereal crops growing on previous  
laydown area

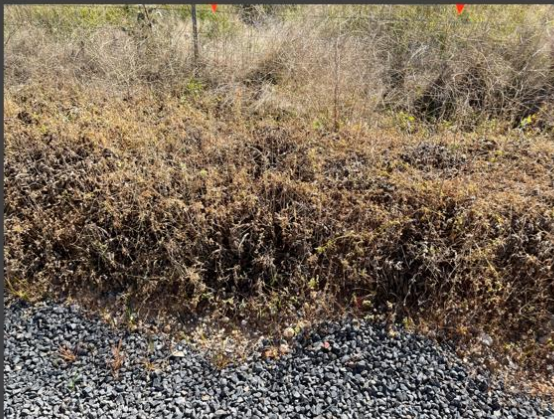
Weed control at Pad 6

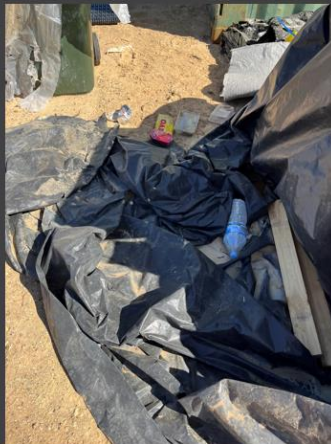
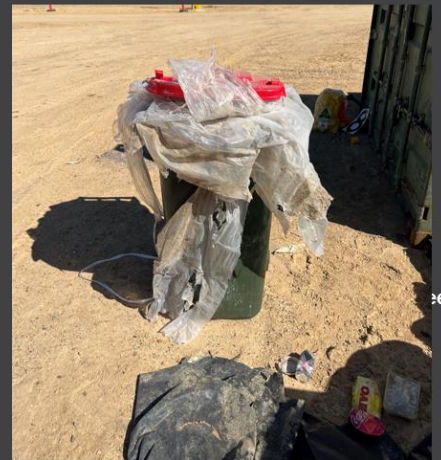
Room for improvement – overflowing bin and poor housekeeping at Pad 6

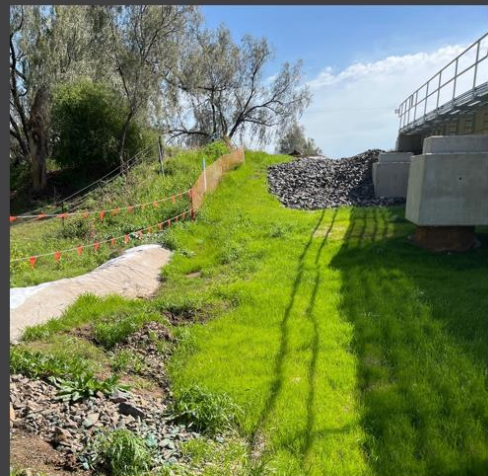
Erosion and sediment controls at Bobbiwa Creek

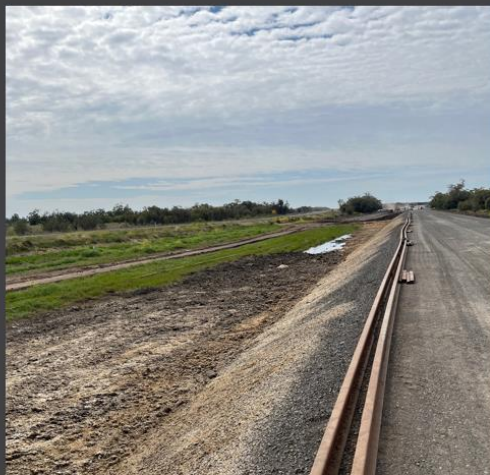
Final profile in Stage 2 – Awaiting Application of hydro mulch

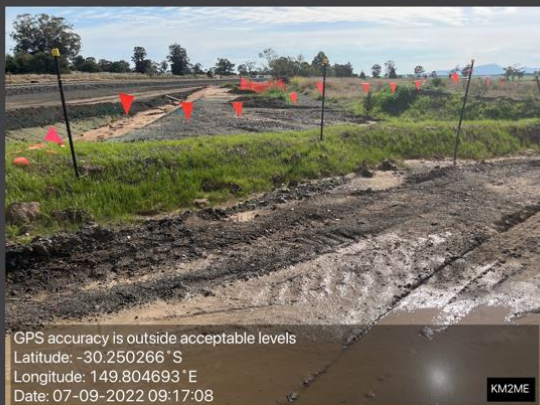
Gate 2b – Temporary soil stabilisation works

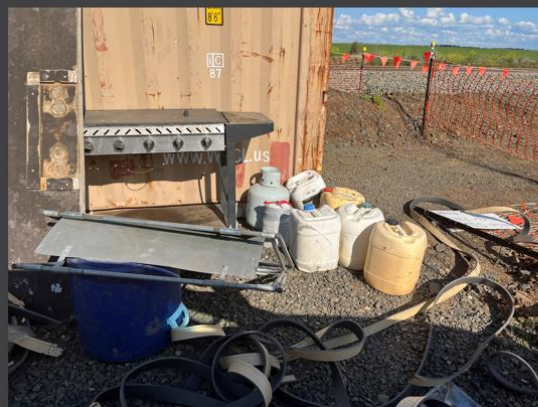
North Star – Housekeeping – Room for improvement

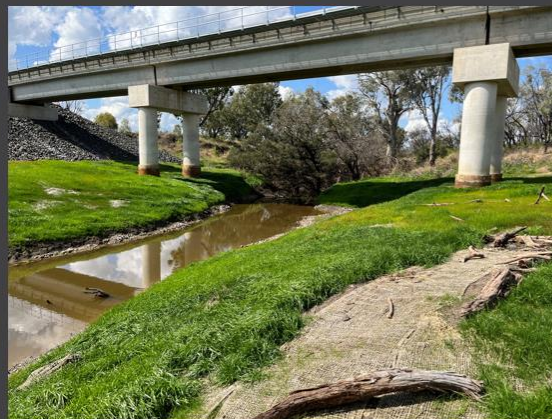
Croppa Creek – Woody debris disburshed throughout riparian zone as part of Creekside rehabilitation works – Note potential for augmentation of riparian zone function by planting trees and tall shrubs close to the creek line

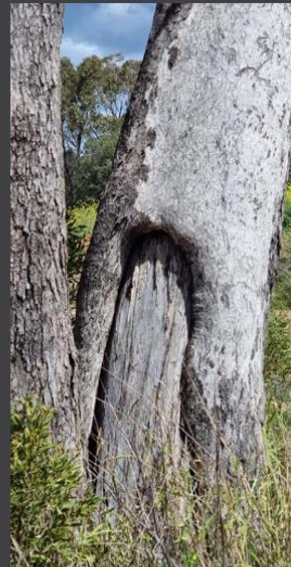
Potential unexpected heritage find near Pad 6

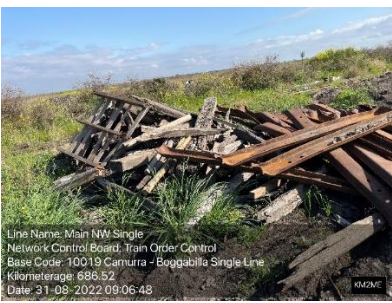
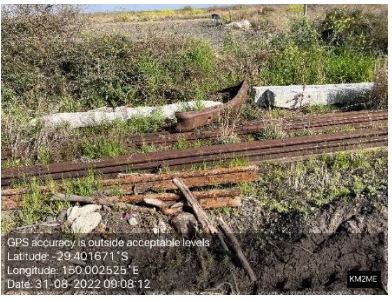
| 220831_4<br>KM 686.52<br>Milguy Laydown | NA | <p>Line Name: Main NW Single<br/>Network Control Board: Train Order Control<br/>Base Code: 10019 Camurra - Boggabilla Single Line<br/>Kilometrage: 686.52<br/>Date: 31-08-2022 09:06:48</p> <p>GPS accuracy is outside acceptable levels<br/>Latitude: -29.401671°S<br/>Longitude: 150.002335°E<br/>Date: 31-08-2022 09:08:12</p> | <p>Milguy Laydown Area</p> <p>Non-segregation of waste material stockpile</p> <p>Waste segregation should occur as soon as possible</p> <p>Note weed growth adjacent to waste stockpile</p> | Medium | Open |

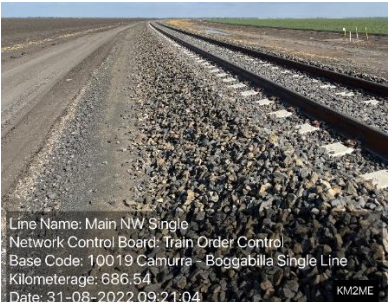
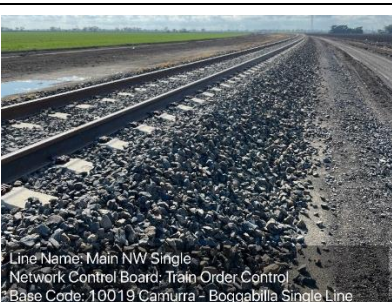
| 220831_6<br>Km 686.54 | NA | <p>Line Name: Main NW Single<br/>Network Control Board: Train Order Control<br/>Base Code: 10019 Camurra - Boggabilla Single Line<br/>Kilometrage: 686.54<br/>Date: 31-08-2022 09:21:04</p> <p>Line Name: Main NW Single<br/>Network Control Board: Train Order Control<br/>Base Code: 10019 Camurra - Boggabilla Single Line<br/>Kilometrage: 686.64<br/>Date: 31-08-2022 09:21:34</p> | <p>Trans4m regeneration killed by overspray from adjoining landholder</p> <p>ARTC in correspondence with managing company in relation to this matter</p> | 0 | Open pending resolution |

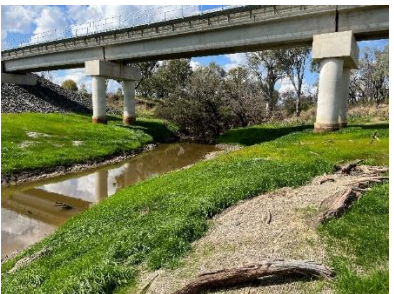
| 220831 -15<br>Croppa Creek | NA | | <p>Contractor is encouraged to establish trees adjacent to the waterway to enhance connectivity of the waterway for aquatic fauna by providing shading over the waterway</p> | <div>0</div> | Open |

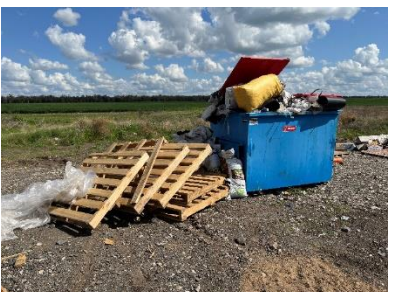
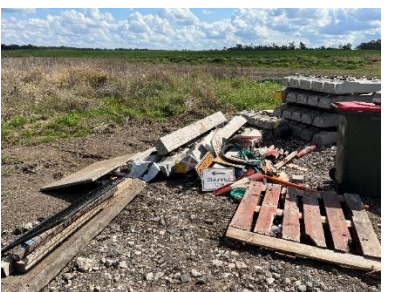
| 220831 -15<br>Croppa Creek Laydown Area | NA | | <p>Waste bin overfull – waste material windblown across neighbouring land</p> <p>Waste needs to be collected ASAP</p> | <div>High</div> | Open |

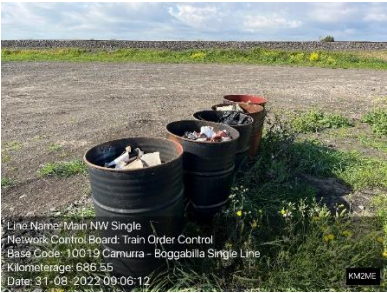
| Unique ID | Document / requirement reference | Requirement | Finding | Action proposed / implemented | Status |
|---|---|---|---|---|---|
| 220831_3<br>Km 686.55<br>Milguy Laydown | NA | | Drums for storage of sleeper jewelry<br><br>Note weed growth adjacent to drums | <br><br>Consider covering drums with lids to prevent entry of water and vermin | Open |

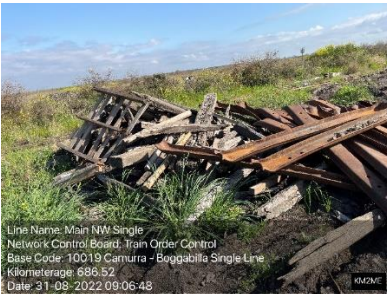
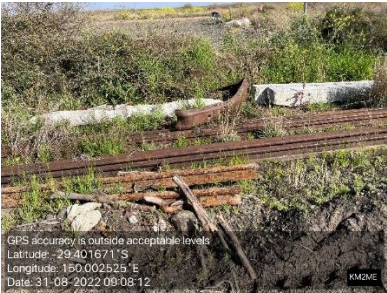
| Unique ID | Document / requirement reference | Requirement | Finding | Action proposed / implemented | Status |
|---|---|---|---|---|---|
| 220831_4<br>KM 686.52<br>Milguy Laydown | NA | <br> | Milguy Laydown Area<br><br>Non-segregation of waste material stockpile<br><br>Waste segregation should occur as soon as possible<br><br>Note weed growth adjacent to waste stockpile | | Open |

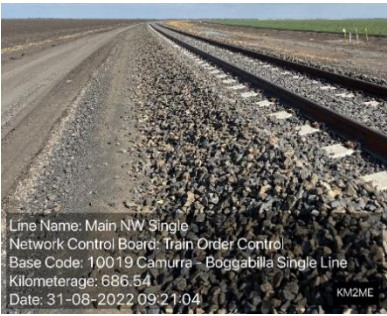
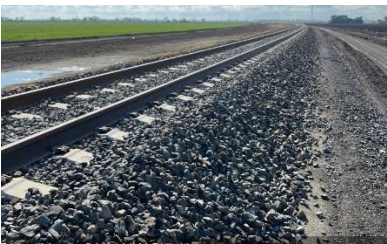
| Unique ID | Document / requirement reference | Requirement | Finding | Action proposed / implemented | Status |
|---|---|---|---|---|---|
| 220831_6<br>Km 686.54 | NA | <br> | Trans4m regeneration killed by overspray from adjoining landholder<br><br>ARTC in correspondence with managing company in relation to this matter | | Open pending resolution |

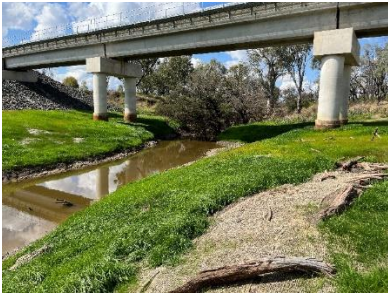
| Unique ID | Document / requirement reference | Requirement | Finding | Action proposed / implemented | Status |
|---|---|---|---|---|---|
| 220831 -15<br>Croppa Creek | NA | | Contractor is encouraged to establish trees adjacent to the waterway to enhance connectivity of the waterway for aquatic fauna by providing shading over the waterway | | Open |

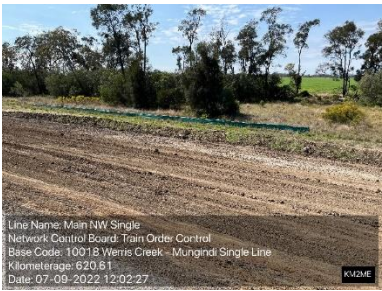
| Unique ID | Document / requirement reference | Requirement | Finding | Action proposed / implemented | Status |
|---|---|---|---|---|---|
| 220907_7<br><br>Km 620.61<br><br>North of Penneys Rd | NA | <p>Line Name: Main NW Single<br/>Network Control Board: Train Order Control<br/>Base Code: 10018 Werris Creek - Mungindi Single Line<br/>Kilometrage: 620.61<br/>Date: 07-09-2022 12:02:27</p> | Skink hotel – One of three in the general location.<br><br>To be inspected and consideration given to removal if no longer serving a purpose | On | Open pending inspection and decision re removal or retention |

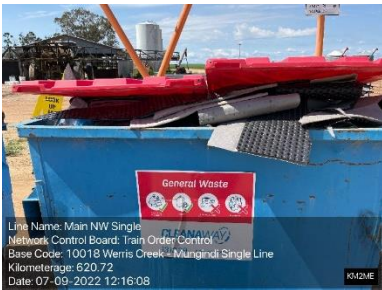
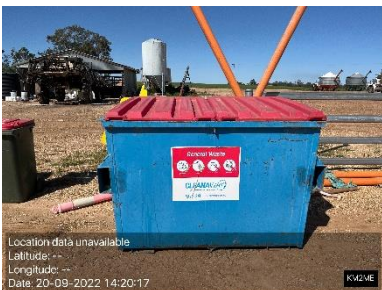
| Unique ID | Document / requirement reference | Requirement | Finding | Action proposed / implemented | Status |
|---|---|---|---|---|---|
| 220907_8<br><br>Km 620.72<br><br>Pad 6 | NA | <p>Line Name: Main NW Single<br/>Network Control Board: Train Order Control<br/>Base Code: 10018 Werris Creek - Mungindi Single Line<br/>Kilometrage: 620.72<br/>Date: 07-09-2022 12:16:08</p> <p>Location data unavailable<br/>Latitude: --<br/>Longitude: --<br/>Date: 20-09-2022 14:20:17</p> | Waste bins overfull – to be emptied as soon as possible<br><br><br><br><br><br><br><br><br><br>Bin has been emptied | High | Open pending removal of waste<br><br><br><br><br><br><br>Closed |

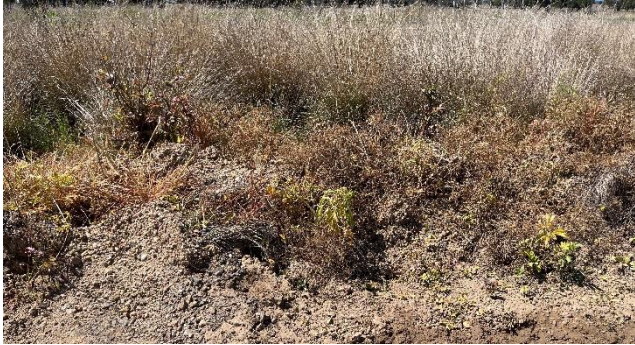
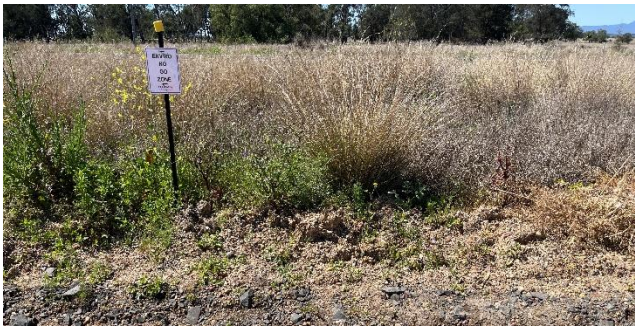
| Unique ID | Photo | Finding | Priority | Status |
|---|---|---|---|---|
| 220920_6<br>Km 596.60 | <br> | Evidence of recent weed spraying beginning to take effect | <br><br>Example of good practice | No further action required |

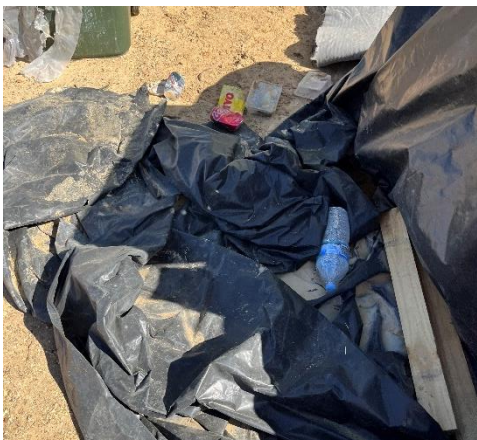
| Unique ID | Photo | Finding | Priority | Status |
|---|---|---|---|---|
| 220920_11<br>Pad 6 | <br> | Waste bin overflowing with sub-standard house keeping | Medium | Open pending clean up and emptying of bin |
