Tree Impact Assessment Report

City and Southwest Metro Station Upgrade Works Package 5 & 6

P5 Document No. SMCSWSW5-DEW-WEC-EM-REP-000542

P6 Document No. SMCSWSW6-DEW-WEC-EM-REP-000632

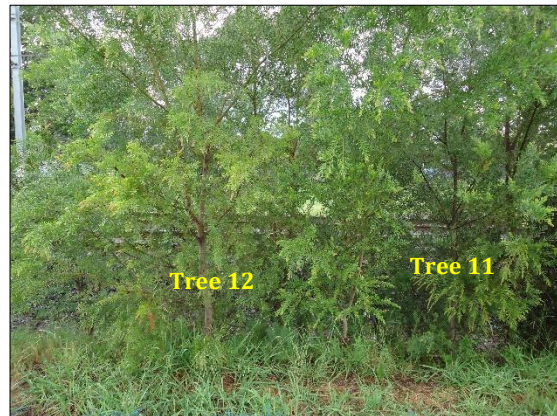
Photograph 9: Trees 11 and 12 *Acacia* sp (Wattle) to be removed for MSB works.

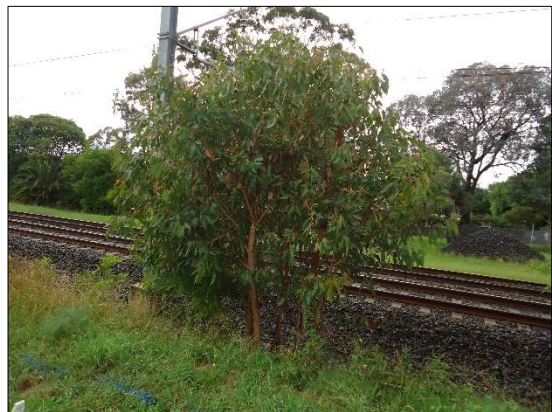
Photograph 10: Tree 13 *Eucalyptus robusta* (Swamp Mahogany) to be removed to accommodate the new sewer alignment.

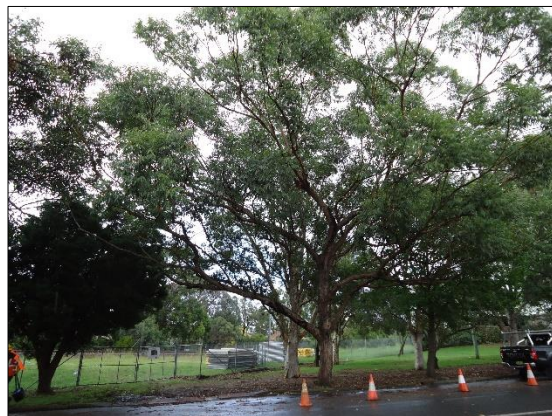
Photograph 11: Tree 14 *Eucalyptus robusta* (Swamp Mahogany) located within road reserve to be selectively pruned for site access clearances.

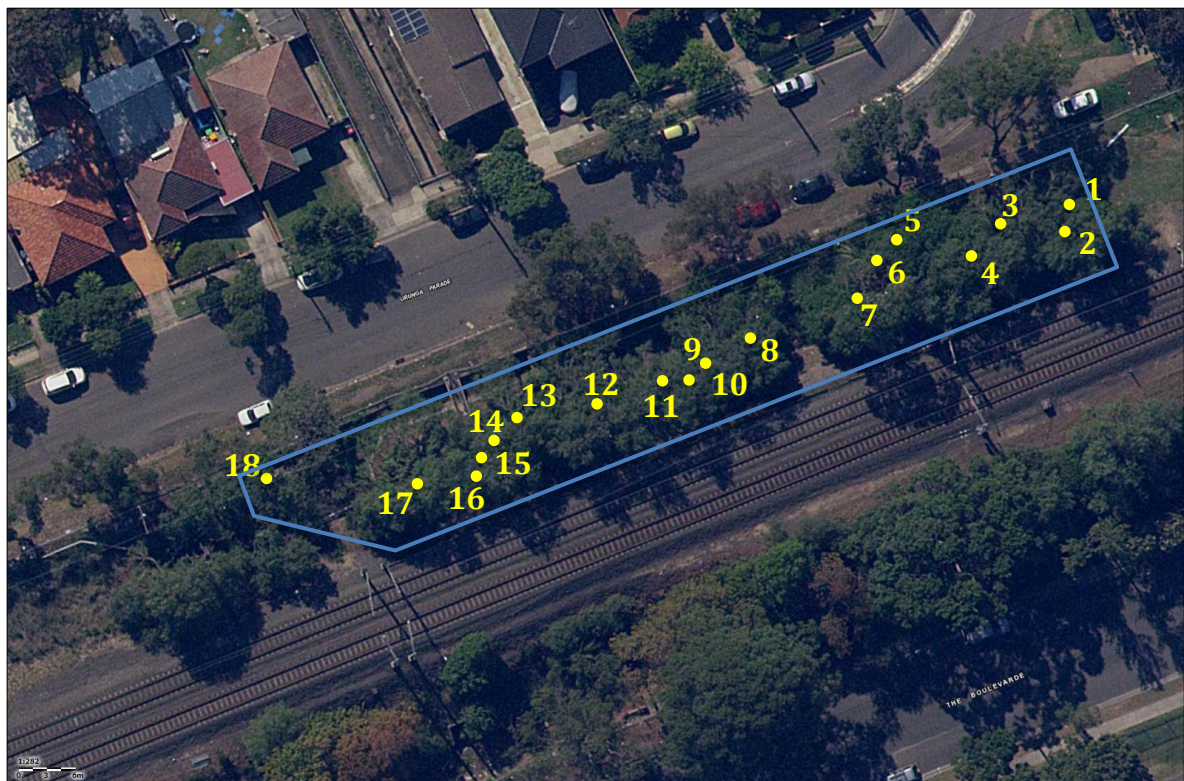
The additional tree removals where there is a direct design clash and 100% encroachment into the TPZ and SRZ consist of seventeen *Schinus molle* (Peppercorn Tree), one *Eucalyptus scoparia* (Wallangarra White Gum) which constitute the significant trees within the site. Understory plants totaling sixty-two individual specimens were also identified. All trees are located along the rail embankment adjacent Urunga Parade. Image 1 shows the area of assessment and approximate locations of significant trees (trees 1-18). The Peppercorn trees are typically arranged in a line suggesting a landscape planting. The Wallangarra White Gum is likely to be a self-seeded specimen.

Image 1: Aerial image showing the proposed vegetation clearance area (blue outline) and approximate locations of significant trees (1 to 18).

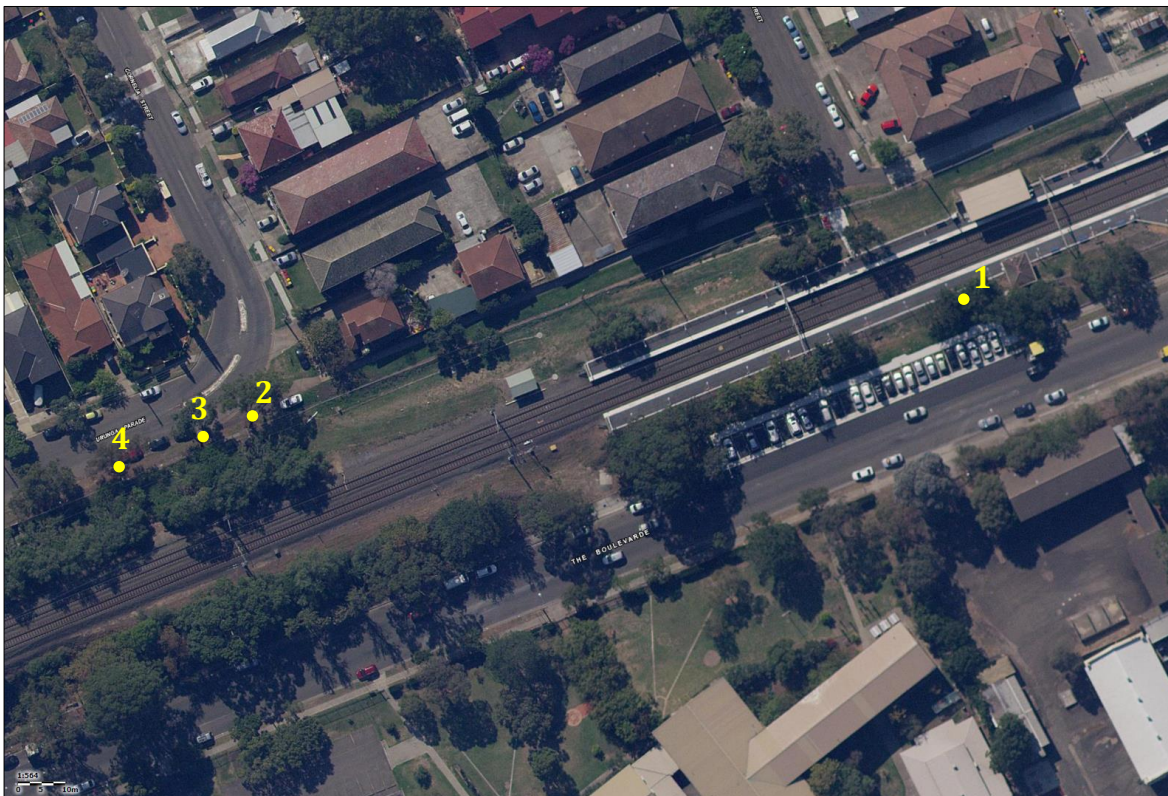
The Wallangarra White Gum (tree 4) is listed as Endangered under the Biodiversity Conservation Act 2016 and Vulnerable under the Environmental Protection Biodiversity Conservation Act 1999. However, the subject specimen is located outside of its naturally occurring range and appears to have been planted as part of the streetscape.

Image 1: Aerial image of Wiley Park Station Station showing the location of additional trees to be removed.

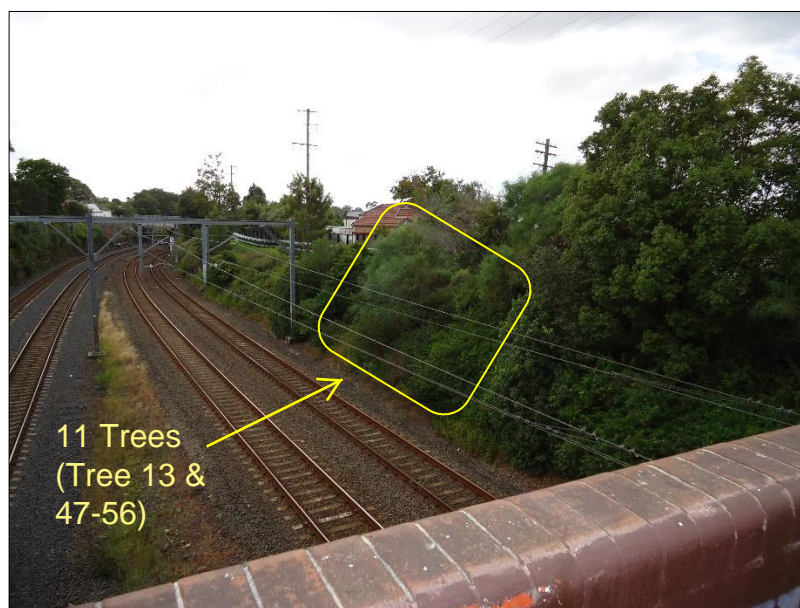
Woody vegetation located along the rail embankment was identified for removal to align the new GST. No access was gained to the rail corridor to assess the vegetation, but it has been confirmed in consultation with the project Ecologist to consist of; one *Pittosporum undulatum* (Sweet Pittosporum) tree 13, seven *Acacia saligna* (Golden Wreath Wattle) trees 47 to 53, one *Grevillea* sp (Grevillea), tree 54 and two *Yucca* sp (Yucca) trees 55 and 56. The vegetation is considered to have a short useful life expectancy and low landscape significance given its location within the rail corridor. Image 3 shows the approximate area to be cleared.

Image 3: Approximate area of woody vegetation along the rail embankment to be cleared to align the new GST.

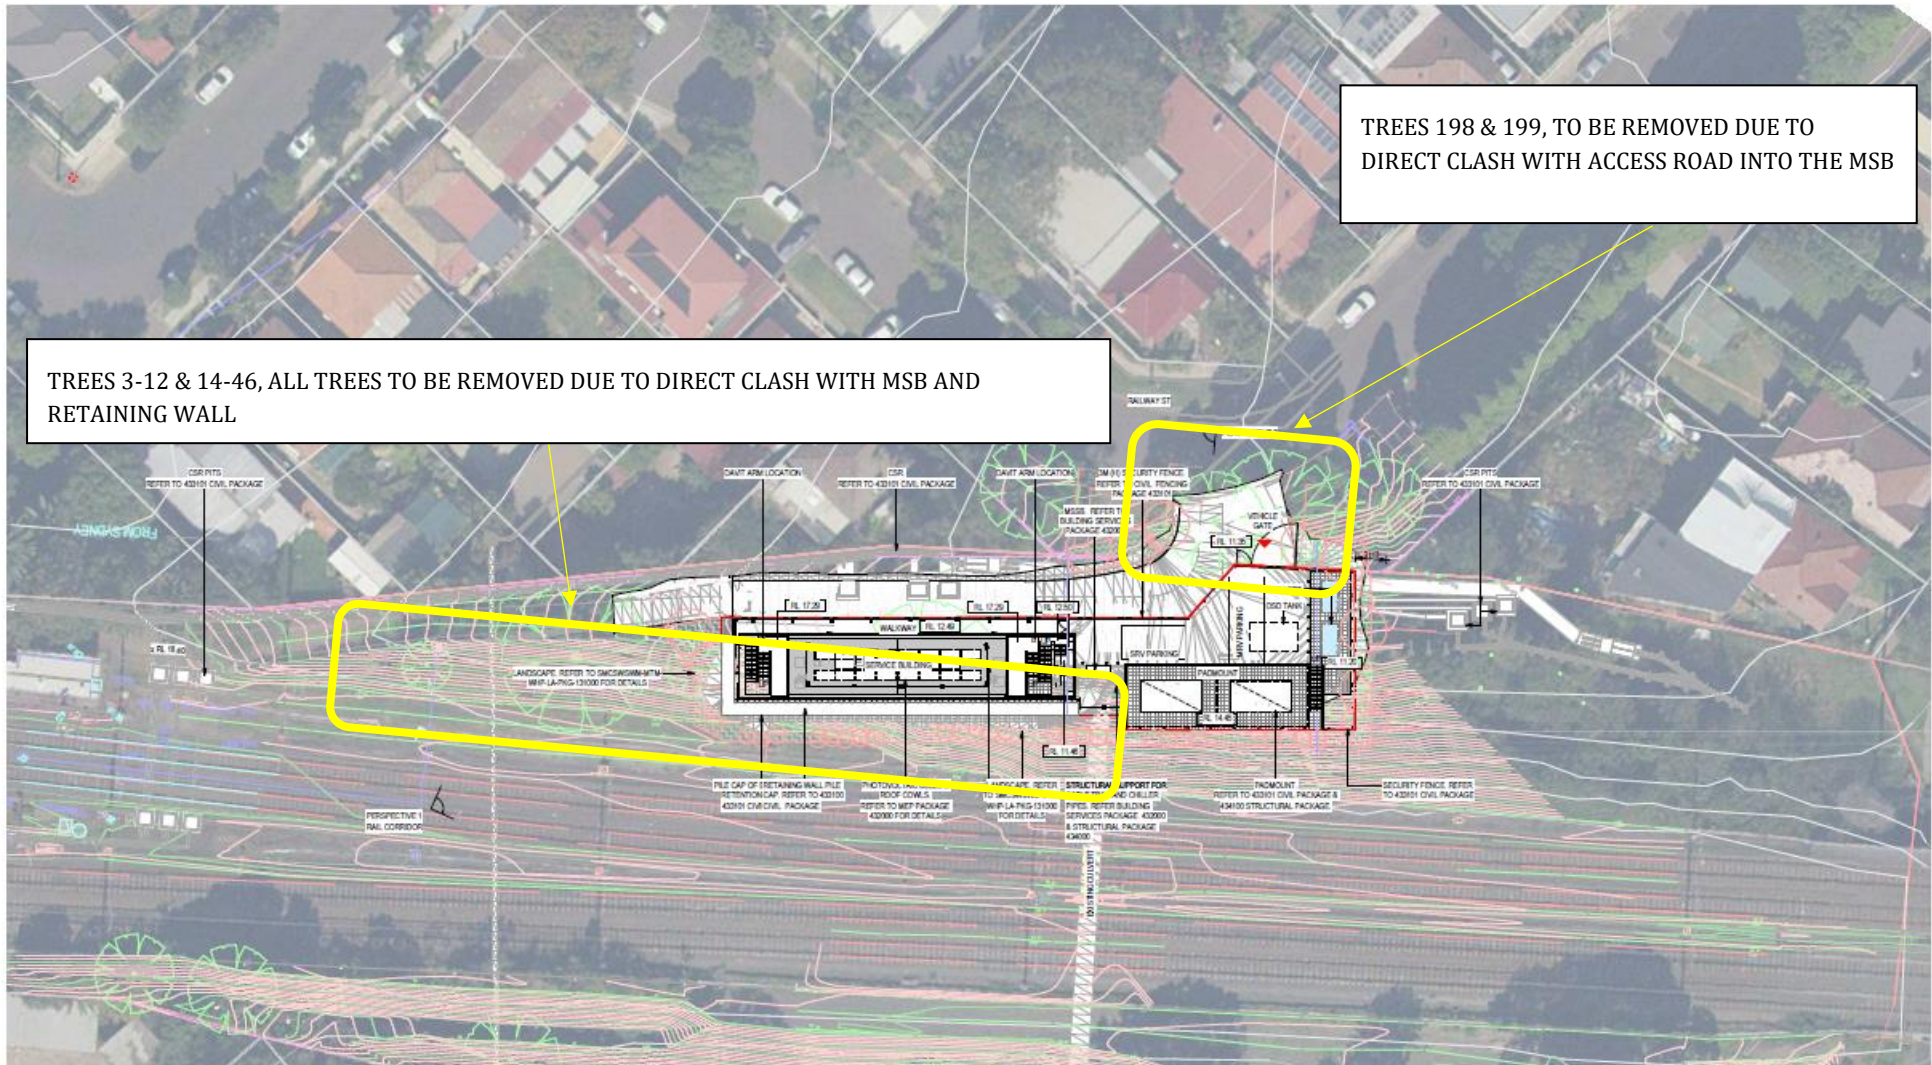
TREES 198 & 199, TO BE REMOVED DUE TO DIRECT CLASH WITH ACCESS ROAD INTO THE MSB

TREES 3-12 & 14-46, ALL TREES TO BE REMOVED DUE TO DIRECT CLASH WITH MSB AND RETAINING WALL

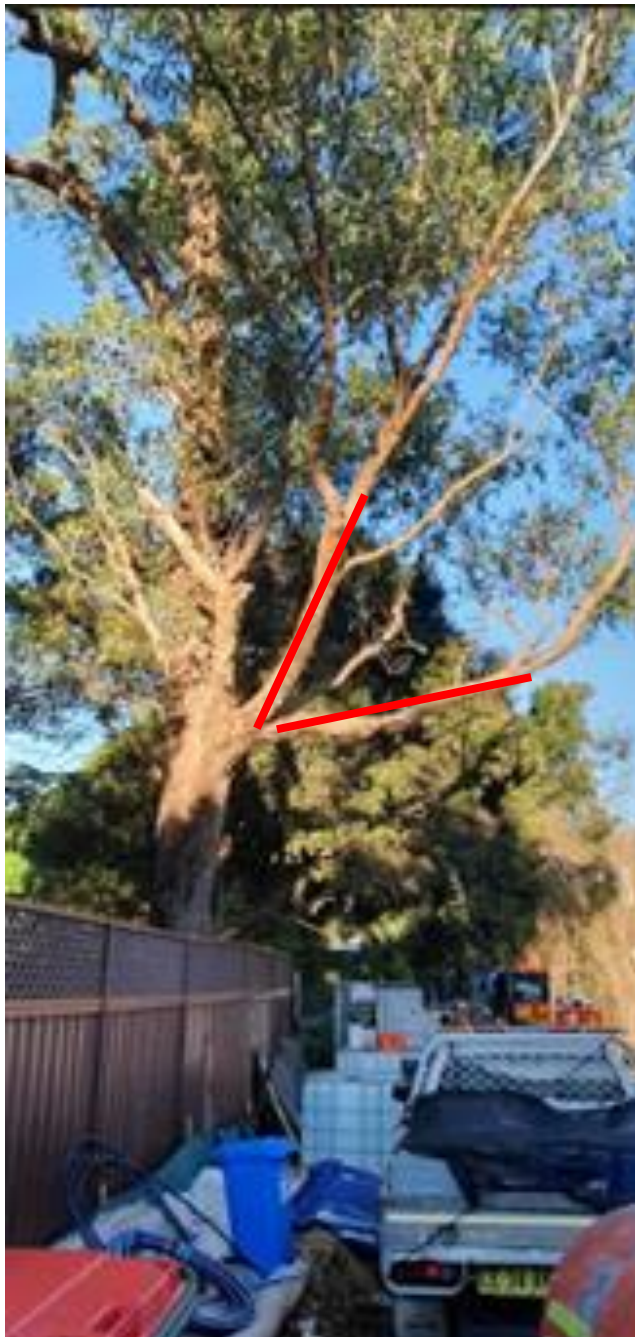
3.2 TREE 2 – GUM TREE (*UNIDENTIFIED EUCALYPTUS SP.*) SEE FIGURE 3

Branch No #	Branch / Stem Height	Branch / Stem Diameter	Branch Order	Pruning Class	Canopy Percentage
1	4.4m	180mm	2 nd	7.2.4, Selective	8%
2	4.5m	180mm	2 nd	7.2.4, Selective	9%

Figure 3: Limbs to be pruned marked in red.

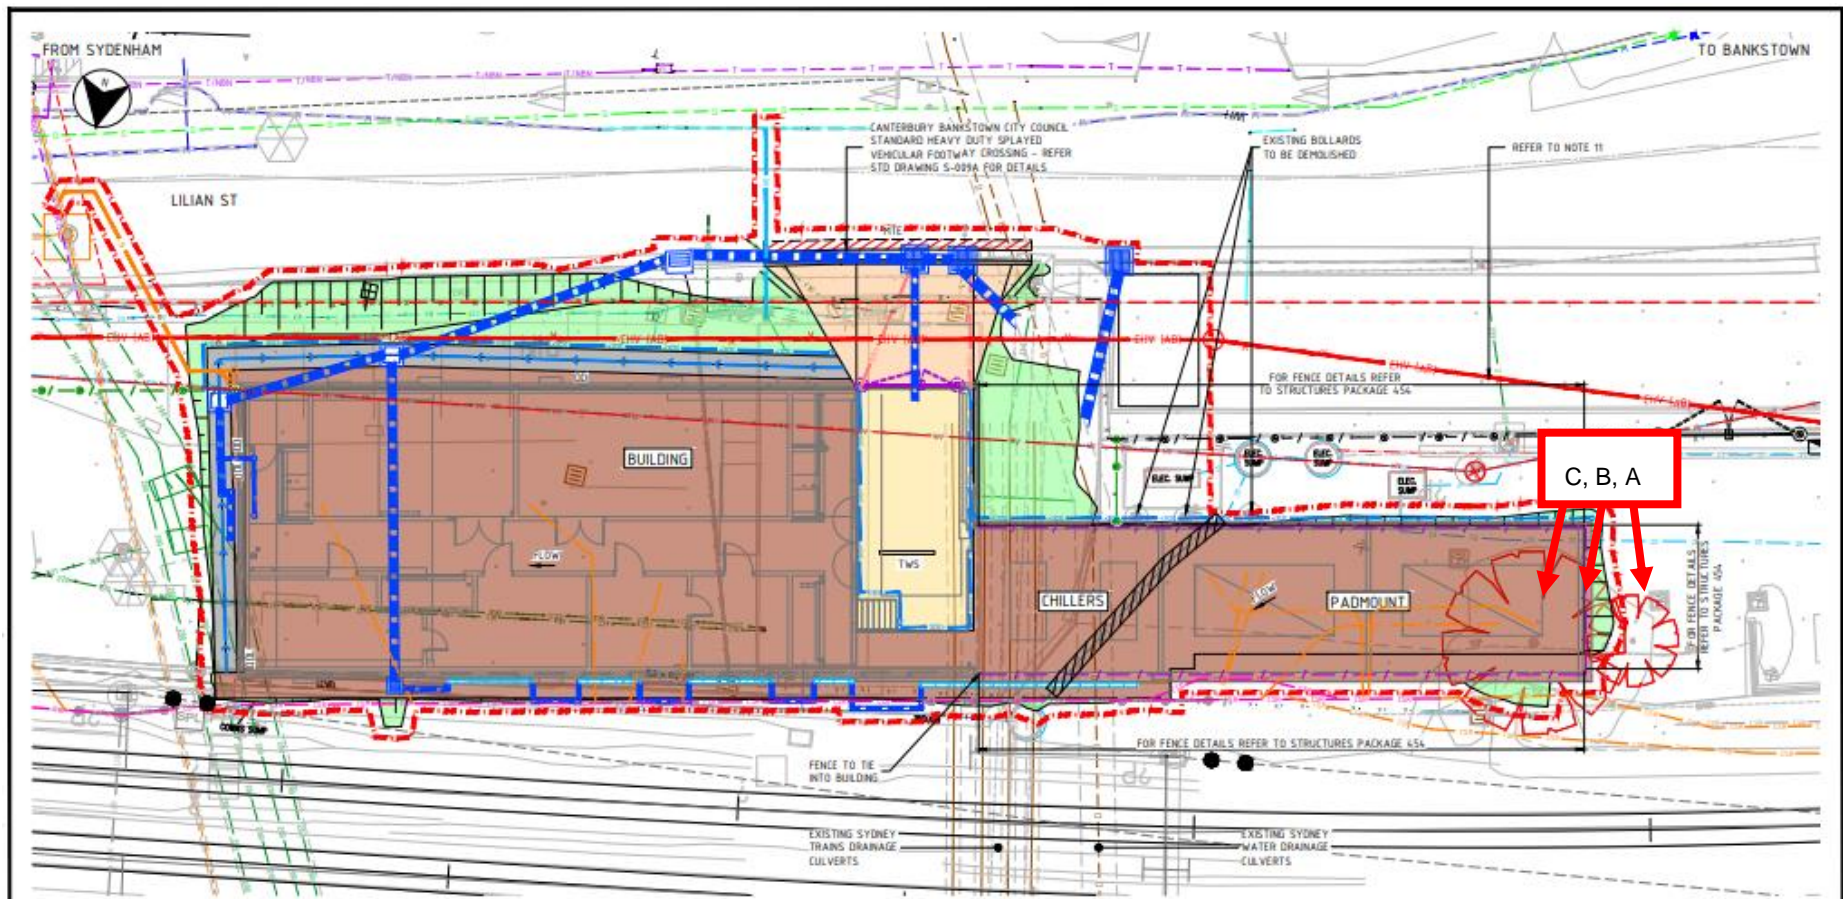
C, B, A

Trees A, Tallowwood and B Brush Box were found to be in good health and condition. They are considered to have a medium useful life expectancy and landscape significance. Tree C Tallowwood was found to have normal vigour and fair condition. Deadwood and canopy dieback was observed within the tree indicating a possible decline in health and condition. As such the tree is considered to have a short useful life expectancy. Image 2 shows the subject trees. The trees provide some screening and relief from the rail corridor and associated infrastructure along Lillian Street.

Image 2: The three additional trees identified for removal as part of the Southwest Metro Package works.

I can confirm that no tree removals were identified within the initial AIA report. Three additional trees located to the rear of the station adjacent the commuter car park off Lillian Street have been identified for removal based on direct design clash and 100% encroachment of TPZ and SRZ. Data for these trees can be found as Appendix 1 of this report. Image 1 shows the location of the additional tree removals.

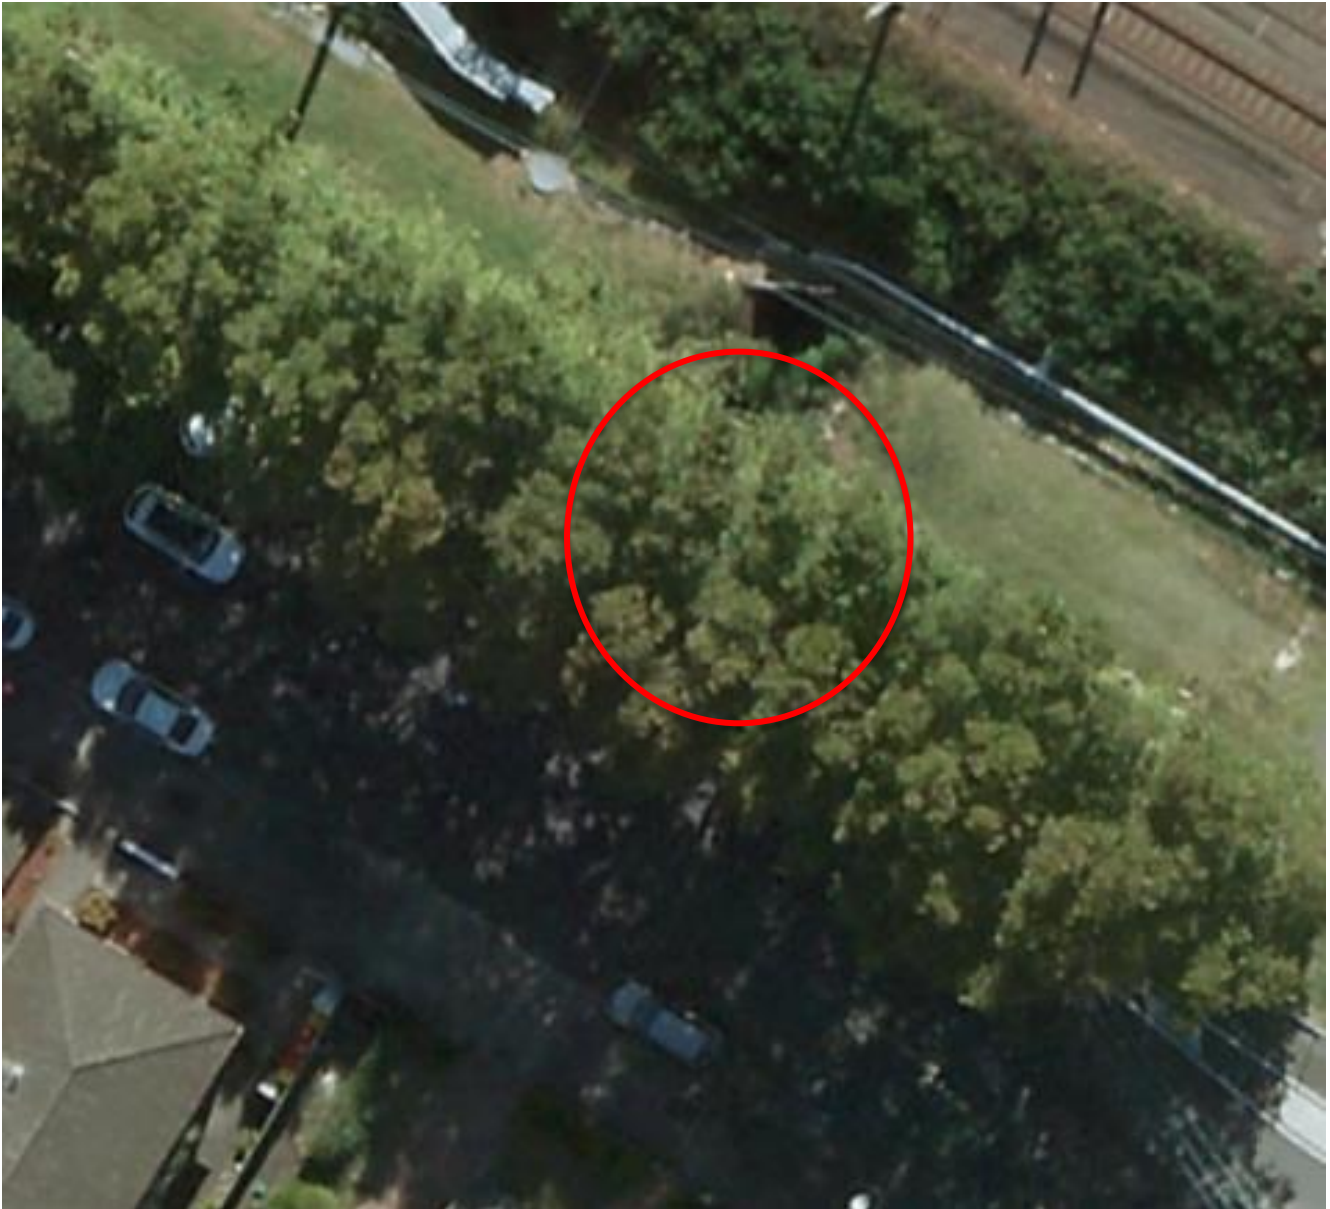
Location of the subject tree (tree 94) circled in red (*Metromap 2021*).

Tree number	Tree name	Tree dimensions				Vigour	Condition	Age class	ULE	Amenity and Visual Value	Native or Exotic	TPZ (m)	SRZ (m)	Comments	Remove or Retain
	Botanical name Common name	Height (m)	Spread (m)	DBH (cm)	DAB (cm)										
94	<i>Platanus x Hybrida</i> London Plane	20	12	100	120	NV	F	M	M	M	E	15	3.57	To be removed due to a clash with the permanent drainage design.	Remove

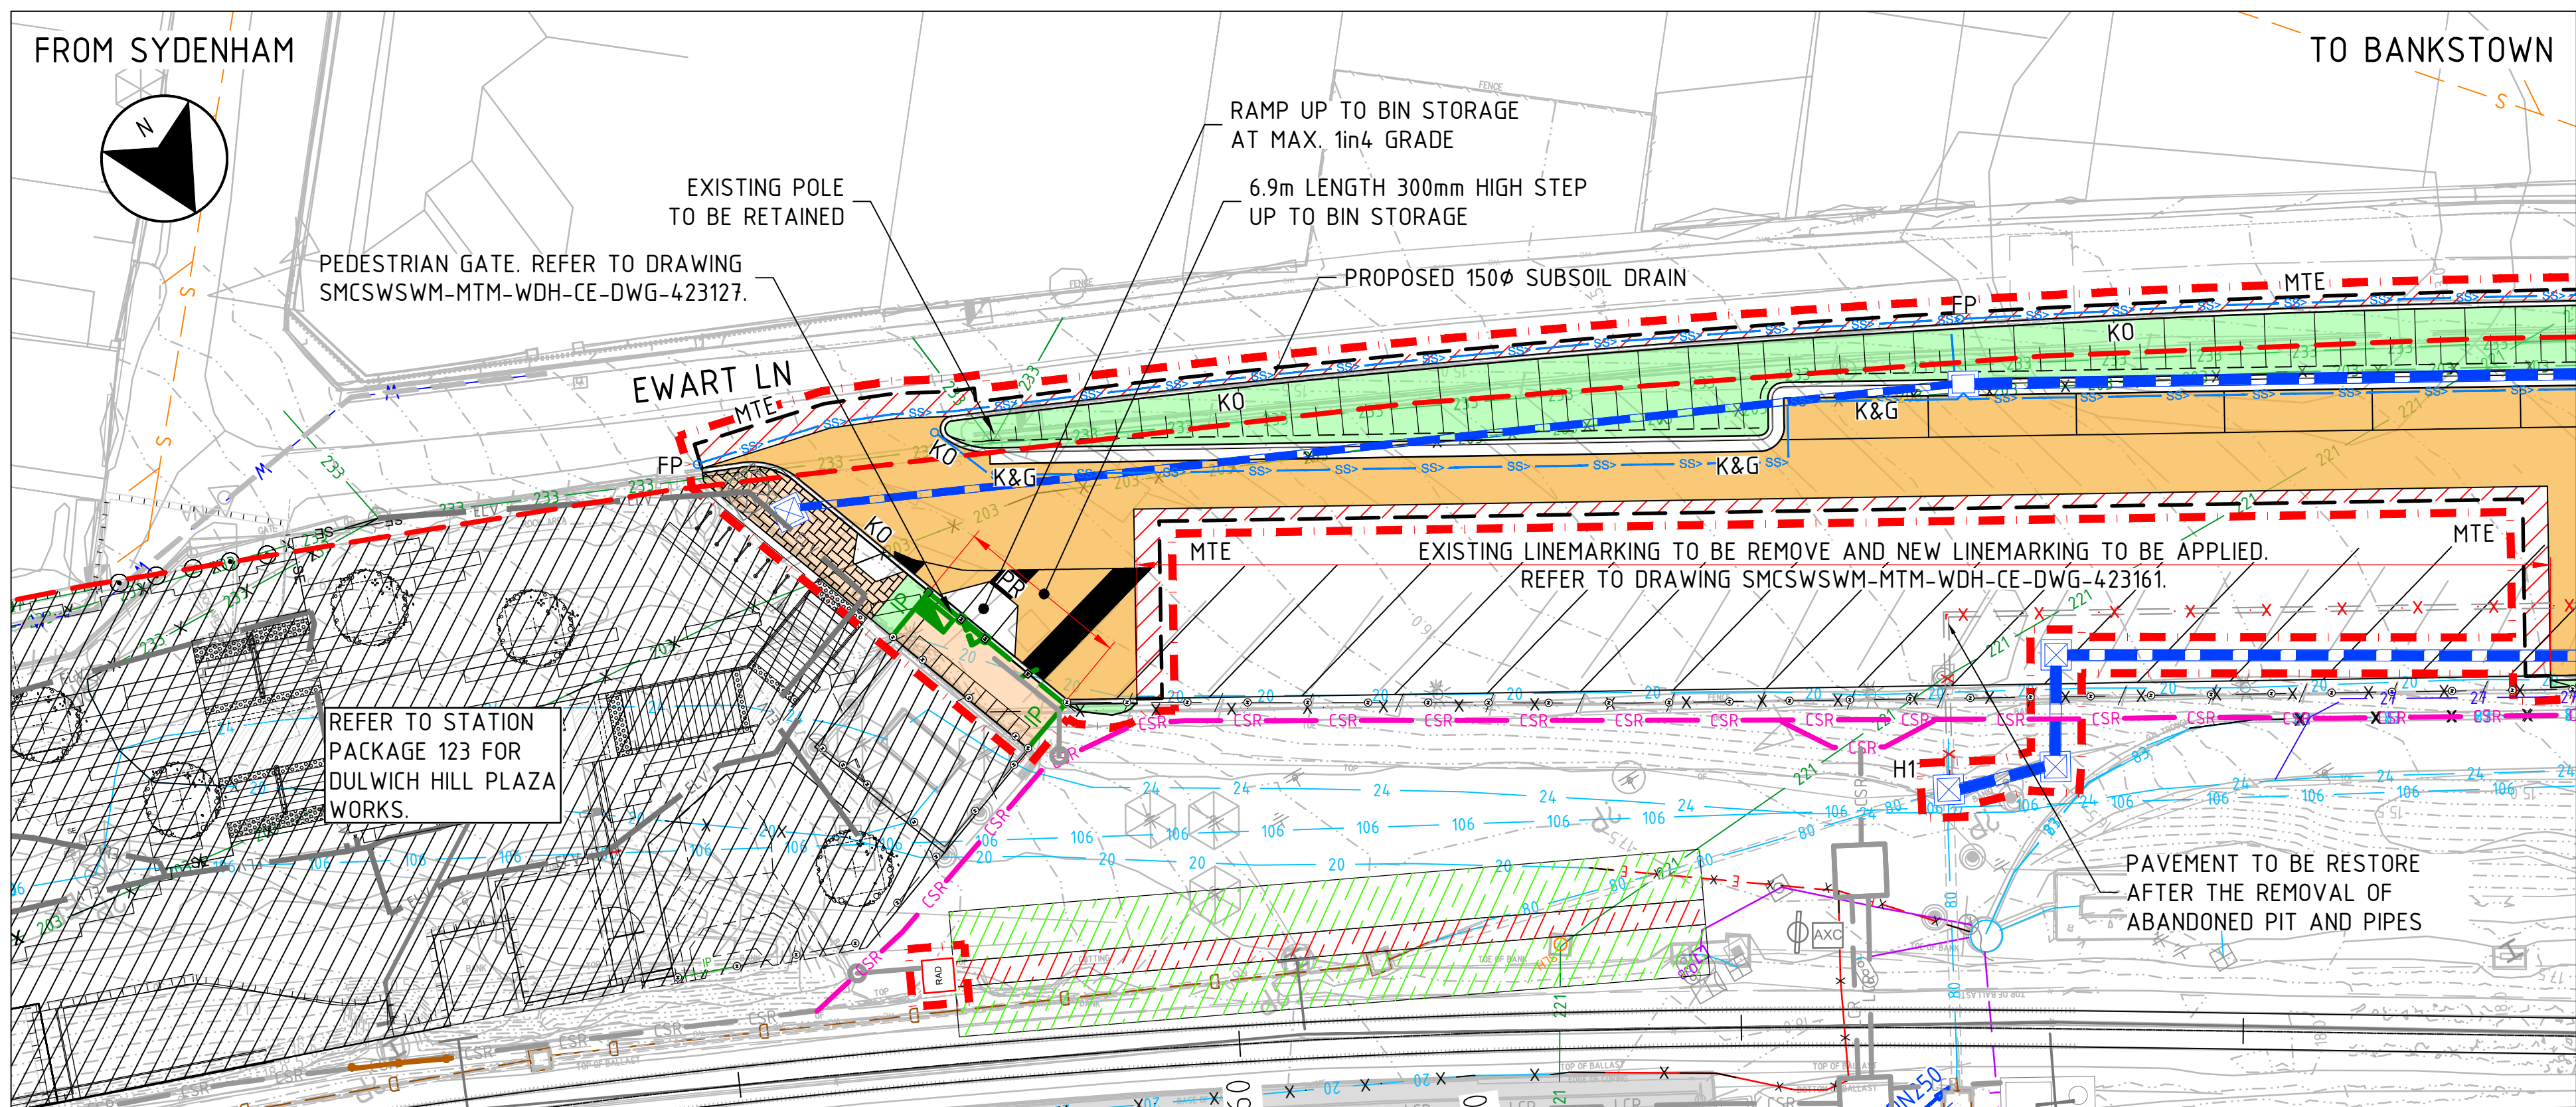
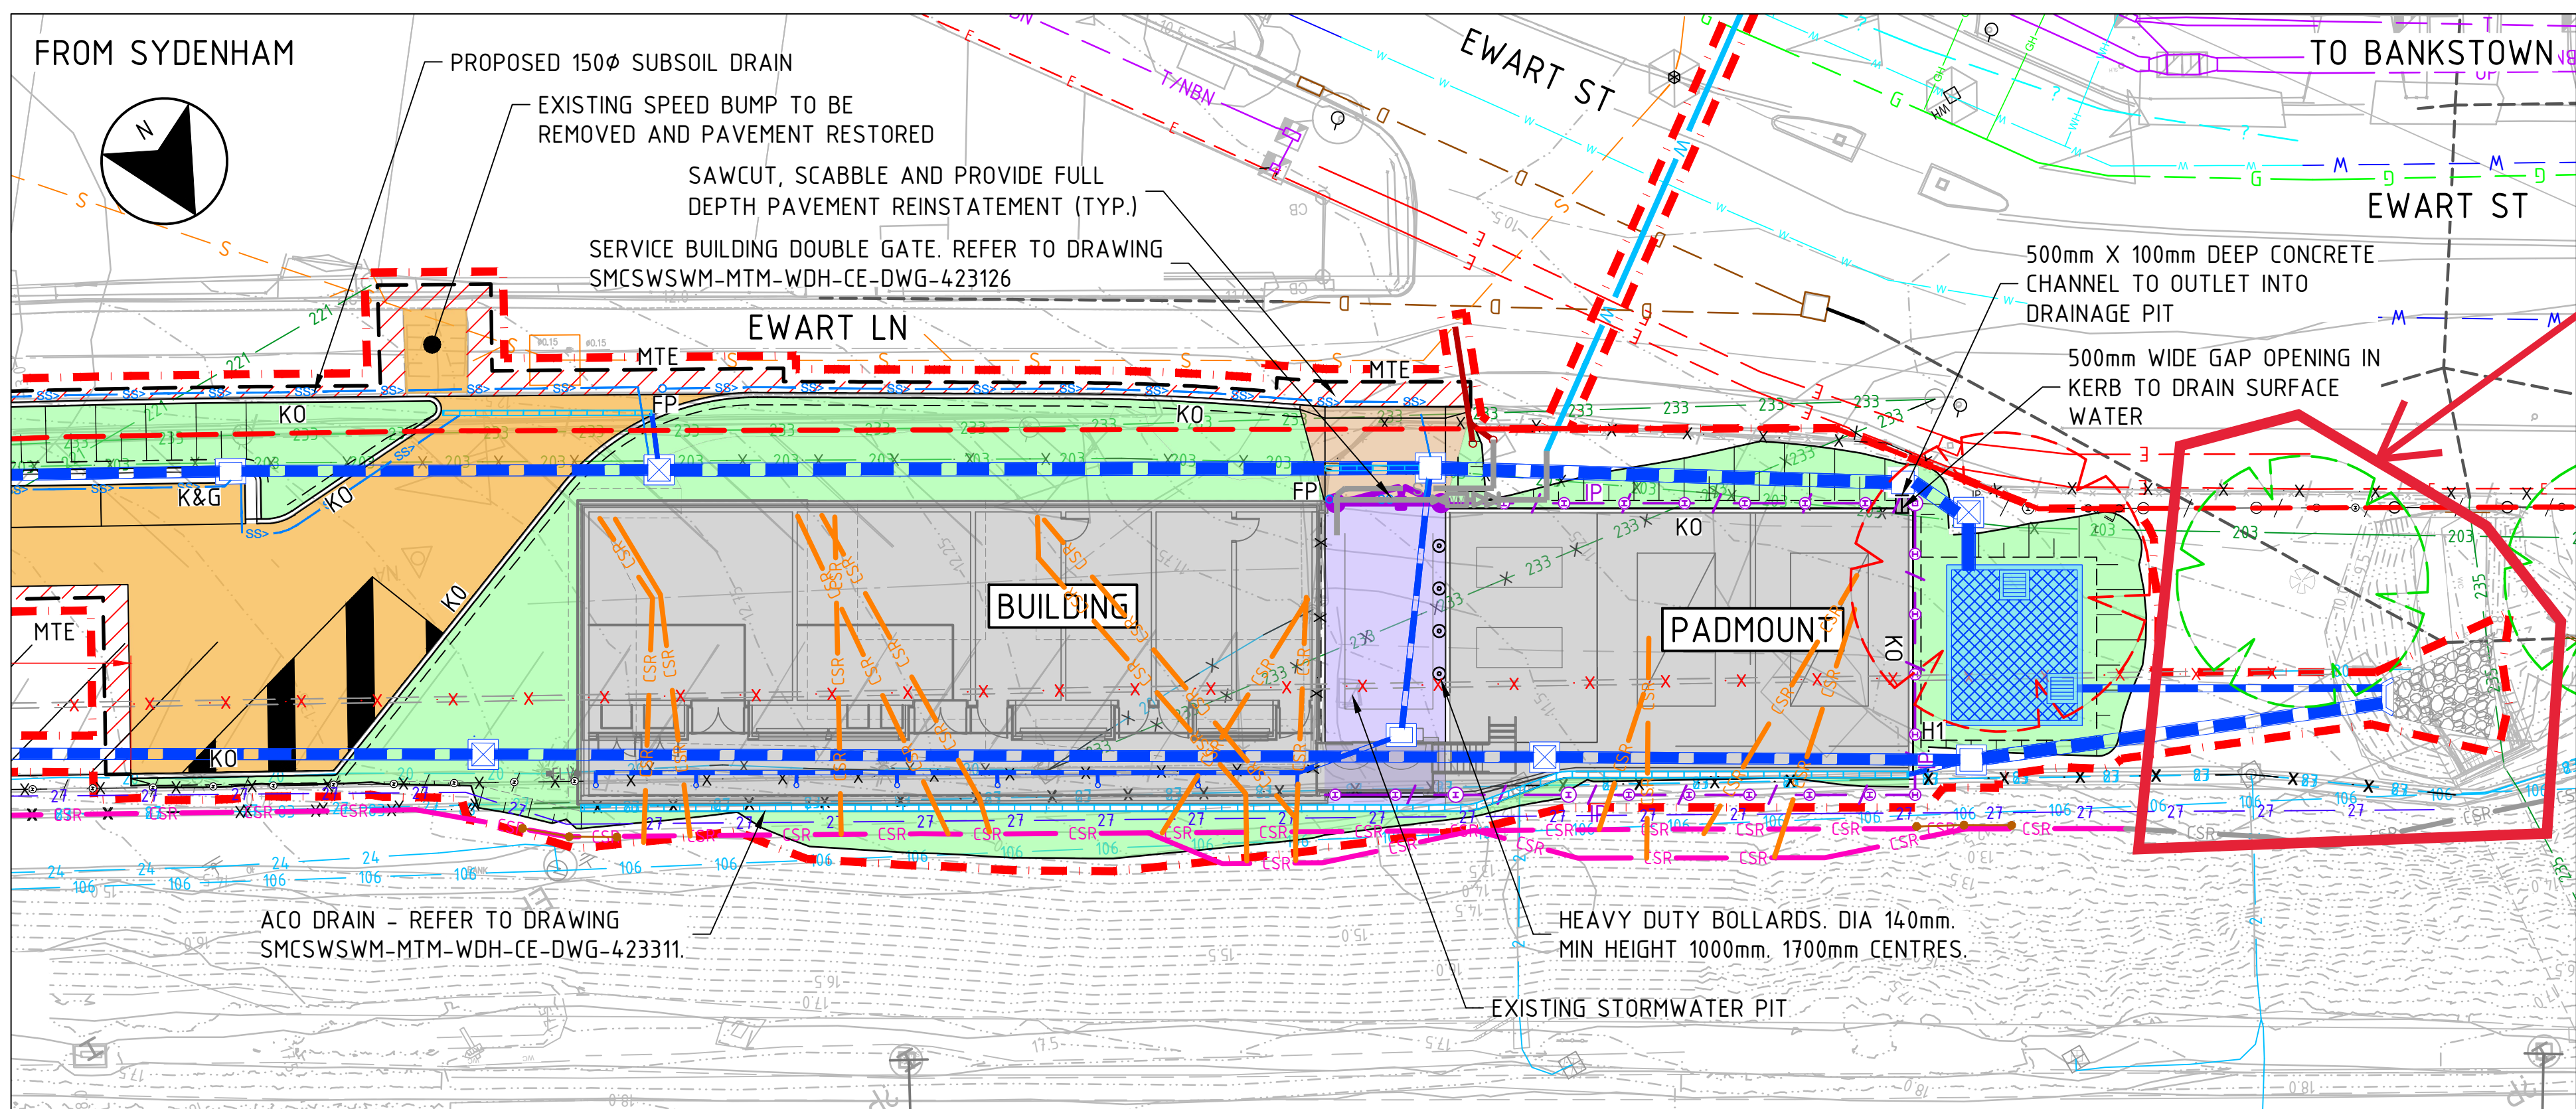
To be cleared due to clash with permanent drainage design. Drainage design indicted by blue and white dotted line.

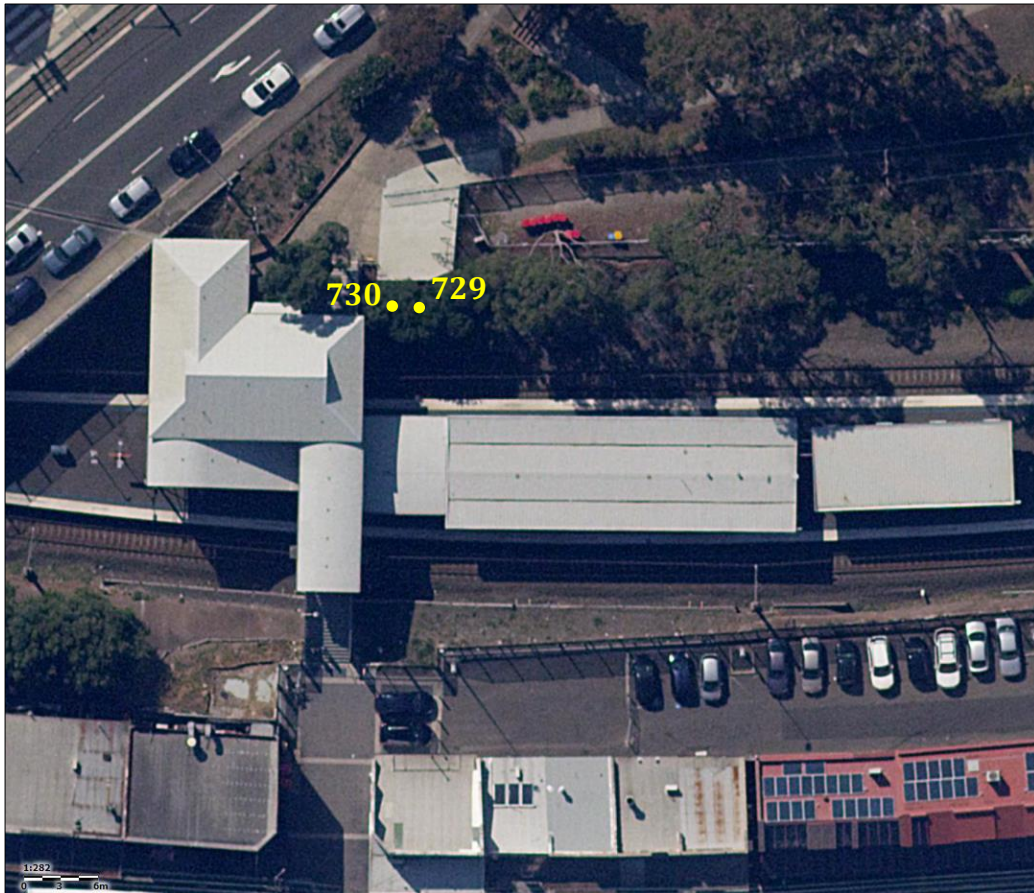
Image 1: Aerial image of Punchbowl Station showing the location of trees 729 and 730.

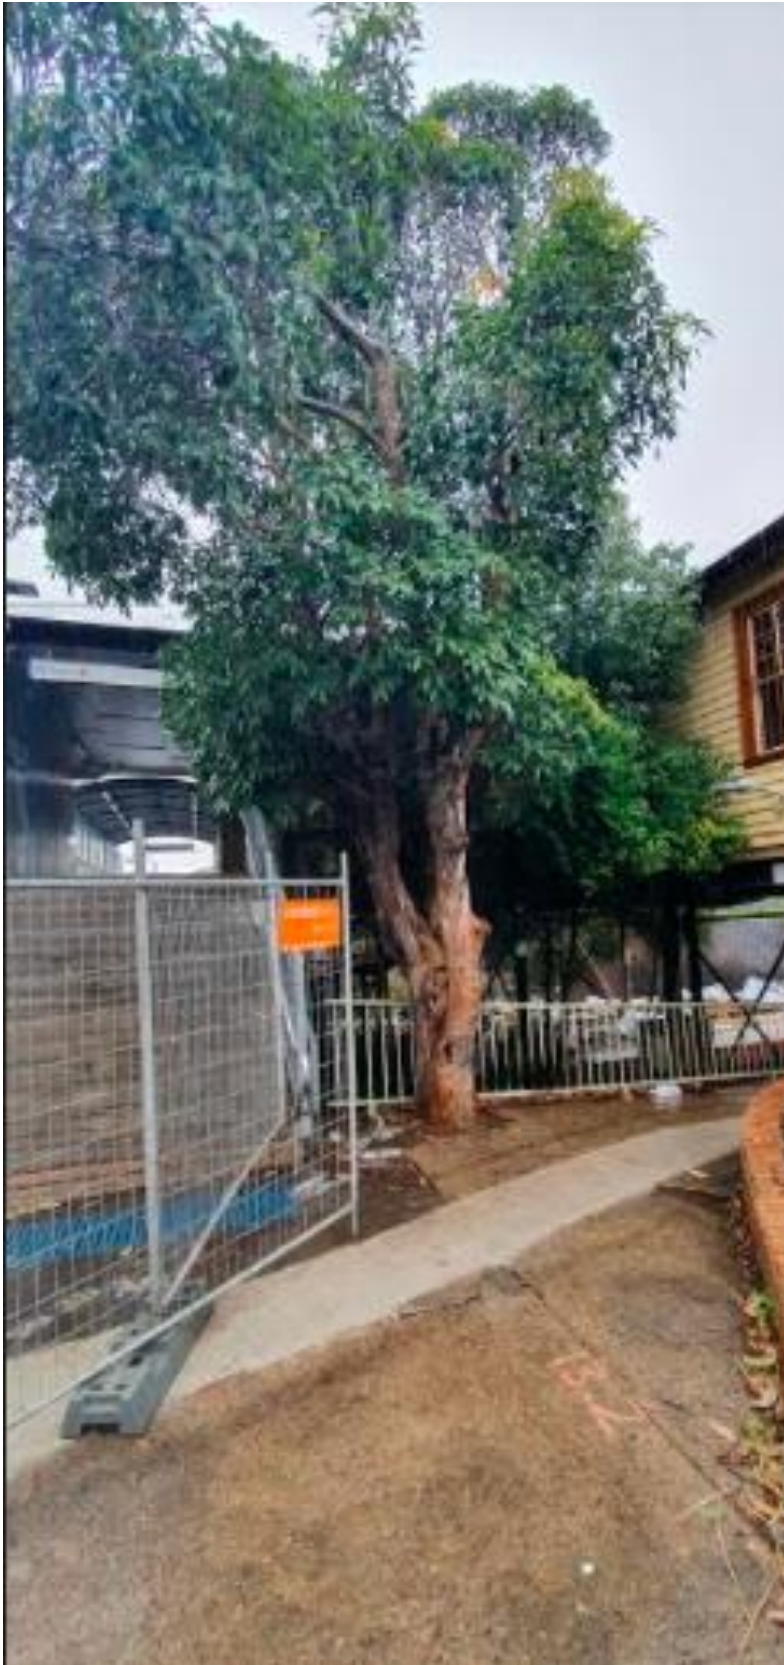
Image of the subject tree taken on the 29th June 2021.
