## Tree Impact Assessment Report

### City and Southwest Metro Station Upgrade Works Package 5 & 6

**Project wide: Hurlstone Park, Wiley Park, Belmore,  
Campsie, Dulwich Hill and Punchbowl**

**P5 Document No. SMCSWSW5-DEW-WEC-EM-REP-000542**

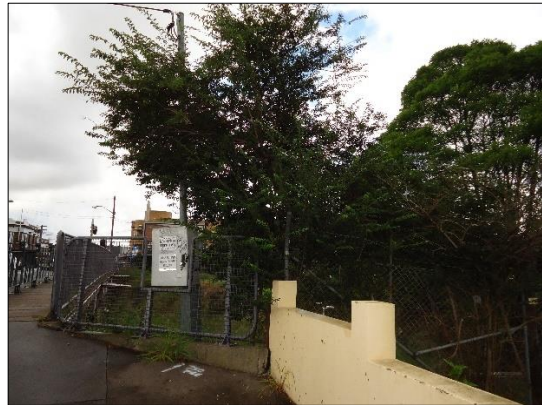
Tree 1 *Ligustrum sinensis* (Small-leafed Privet) is an identified species under the *Biosecurity Act 2015*. A general biosecurity duty exists within NSW to prevent, eliminate or minimise any biosecurity risk. The trees are not representative of a threatened or endangered species or ecological community.

**Photograph 1:** Tree 1 *Ligustrum sinensis* (Small-leaved Privet) to be removed for pilling works adjacent rail bridge.

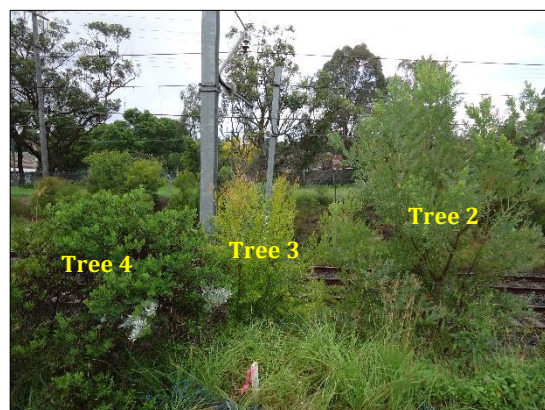
**Photograph 2:** Trees 2 *Acacia* sp (Wattle), 3 *Leptospermum* sp (Tee Tree) and 4 Unknown species to be removed for MSB works.

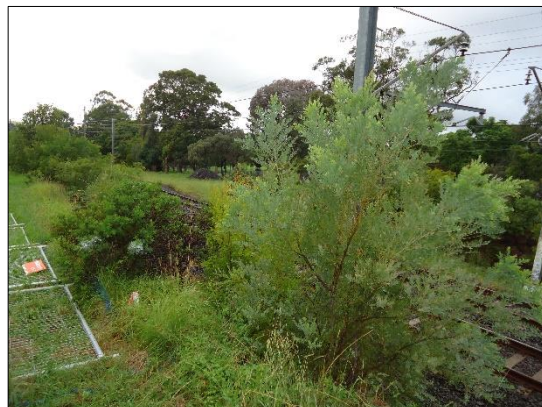
**Photograph 3:** Tree 5 *Acacia* sp (Wattle) to be selectively pruned for clearance along the embankment.

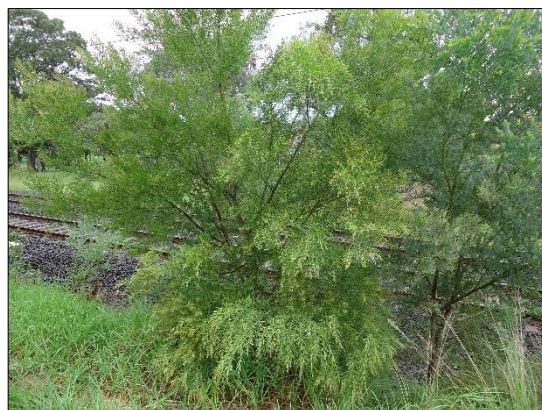
**Photograph 4:** Tree 6 *Acacia* sp (Wattle) to be removed for MSB works.

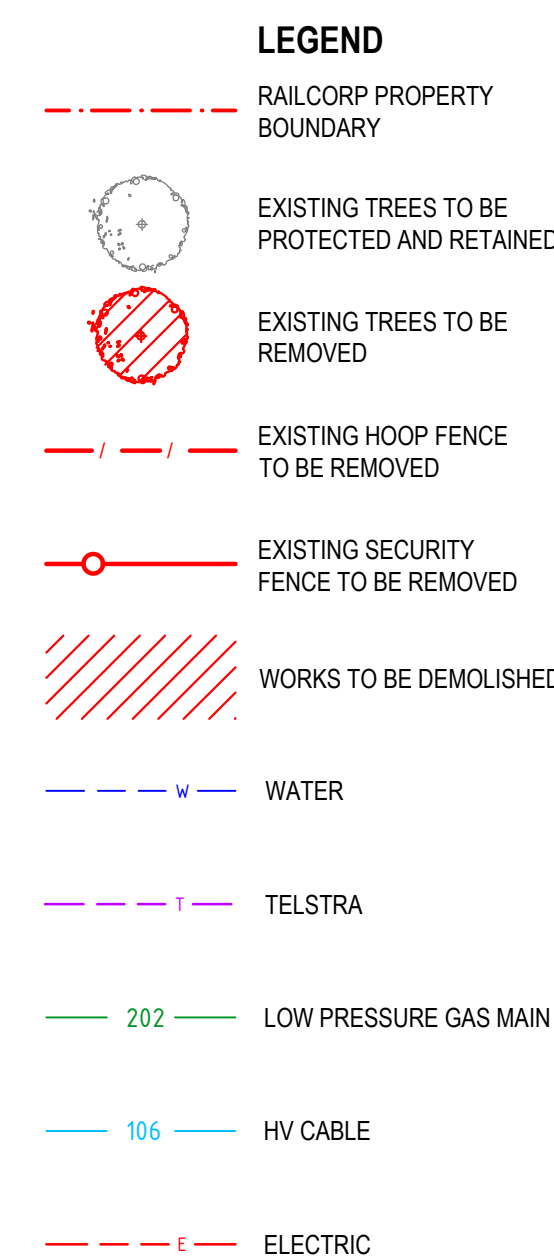
TREE 687, 688, 689, 690 &  
 691 TO BE REMOVED  
 DUE TO DIRECT CLASH  
 WITH PERMANENT  
 PLATFORM SERVICE  
 BUILDING

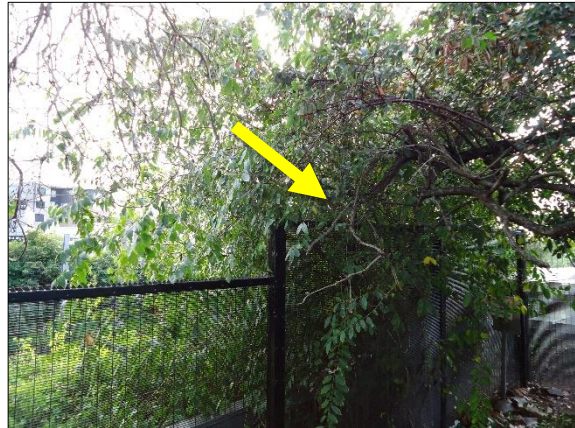
**Photograph 6:** Tree 7 *Celtis sinensis* (Hackberry) located within rail corridor. Tree to be removed to accommodate the new GST alignment.
