# Arboricultural Report: BAC Tree Report

**Site Location:** Southwest Metro -  
Marrickville, Belmore, Wiley Park,  
Punchbowl and Bankstown, NSW

**Prepared for:**  
John Holland Laing O'Rourke

**Prepared by:** Bryce Claassens  
Urban Arbor Pty Ltd  
**Date prepared:** 23 September 2022  
**Ref:** 220923-BAC-AIA  
**Rev:** 1

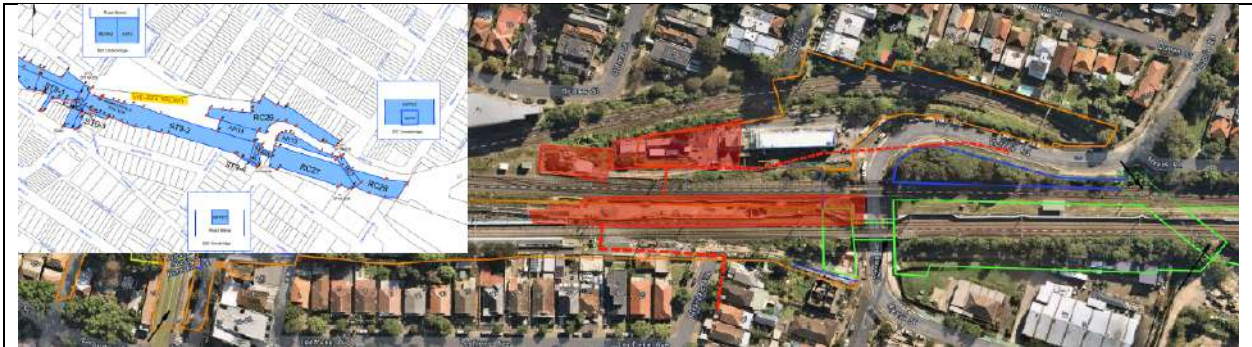
**9.3.1 Victoria Road/Riverdale:** No *vegetation*/tree removal or pruning is required within this area. Removal of insignificant weed species only.

**Image 1: Victoria Road/Riverdale works area from JHLOR.**

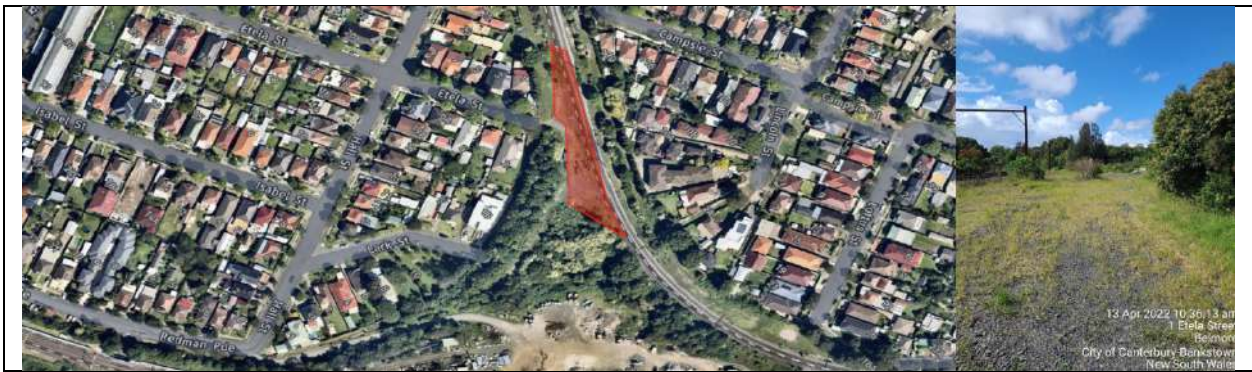
**9.4.1 Elata Street:** No *vegetation*/tree removal or pruning is required within this area. Removal of insignificant weed species only.

**Image 2:** Elata Street works area from JHLOR.

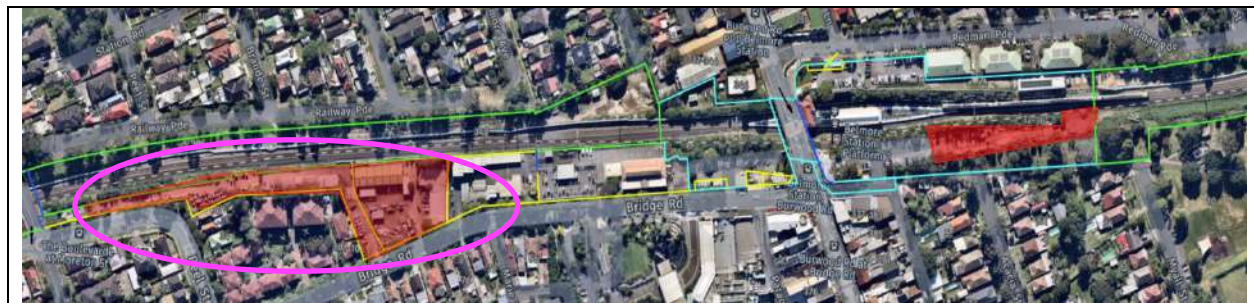
**9.4.2 Bridge Road:** The trees within this area are located adjacent to proposed laydown areas and canopy pruning will be required to allow for the works. The following trees have been identified within this area:

**Image 3:** Bridge Road works area from JHLOR (circled pink).

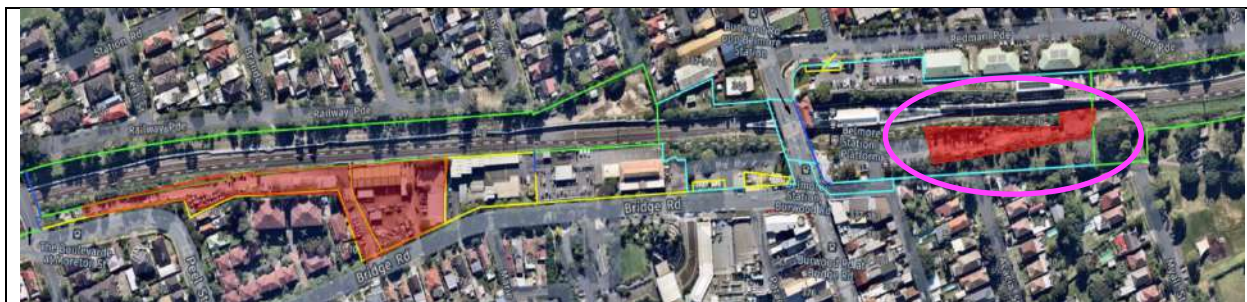
**9.4.3 Belmore Carpark:** No *vegetation/tree* removal or pruning is required within this area. Removal of insignificant weed species only.

**Image 9:** Belmore carpark works area from JHLOR (circled pink).

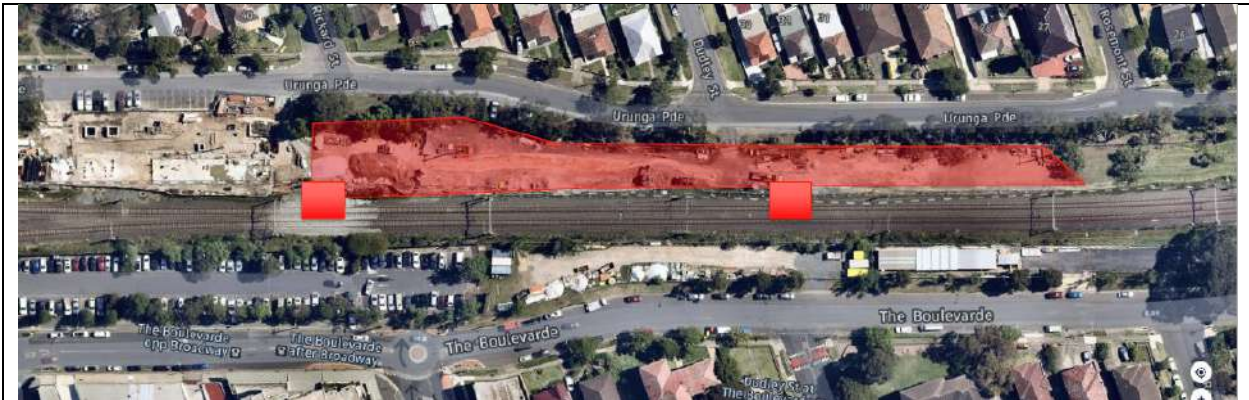
**9.6.2 Urunga Parade:** No *vegetation*/tree removal or pruning is required within this area. Removal of insignificant weed species only.

**Image 16:** Urunga Parade works area from JHLOR.

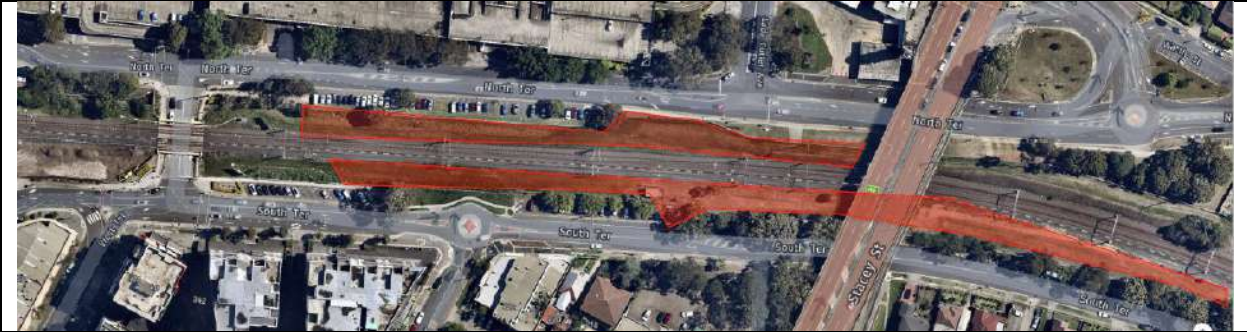
**9.7.2 North Terrace:** No *vegetation*/tree removal or pruning is required within this area. Removal of insignificant weed species only.

**Image 26:** North Terrace works area from JHLOR.

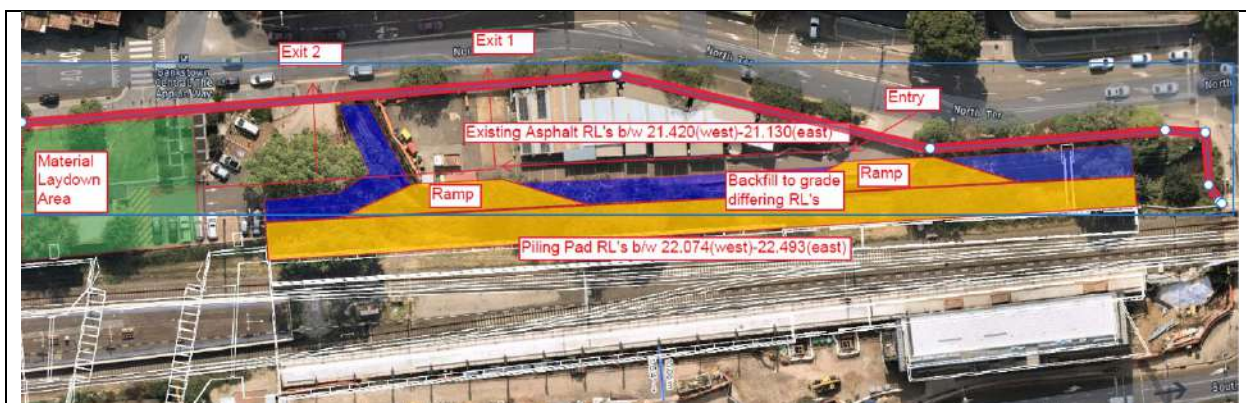
**9.7.3 Bankstown Station:** A combination of tree removal and canopy pruning will be required to accommodate the proposed construction. Tree 1647, 1656, 1671, 1675, 1677, 1678, 1679, 1682, 1683, 1684, 1685, 1686, 1687, 1688, 1689, 1690, 1691, 1692, 1693, 1694, 1696, 1697, 1699, 1700, 1701, 1704, 1705, 1706 and G31 will be in conflict with the works area and are required to be removed. Multiple insignificant weed species will also require removal within this area. Tree 1643 and 1676 will require canopy pruning to allow for access to the works area. The following trees have been identified in this area;

**Image 27:** Bankstown Station works area from JHLOR.
