Preliminary Site
Investigation

Warragamba Dam Raising - proposed construction disturbance areas

Client Reference No. 30013187
Prepared for: WaterNSW
15 July 2022

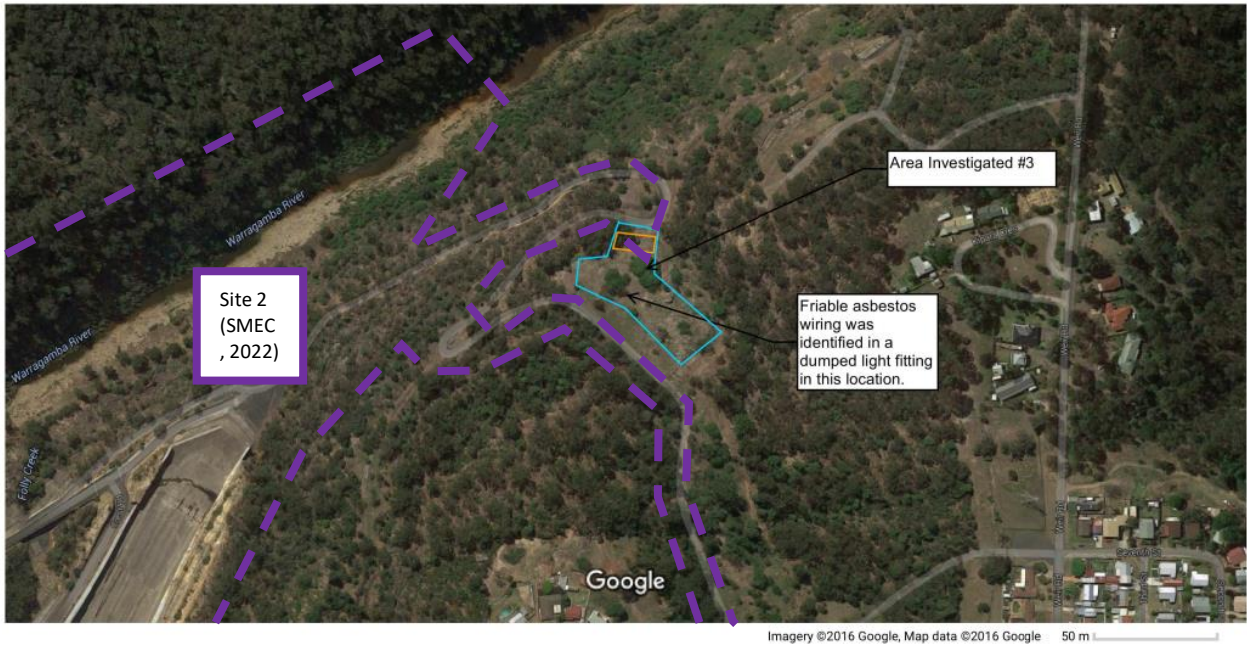
Figure 3-1 Figure extract from Integrated Environmental (2016), demonstrating the areas investigated over 19 and 20 May 2016 (Investigation Areas 1 and 2).

With reference to Figure 3-1 and Figure 3-2 below, 'Area investigated #1', 'Area investigated #2' and 'Area investigated #3' are located immediately outside of Site 2. The report states that areas outside of Area #1, #2 and #3 were not investigated. Approximately 500 fragments of cement sheeting were observed within Area #1 some of which was concluded to have been projected here from an adjacent burn zone. A representative fragment was analysed at a laboratory and shown to comprise chrysotile and amosite asbestos, the fragments were considered to be both non-friable and friable. Greater than 1,000 fragments of ACM (non-friable and friable) were estimated to be present at Area #2 and approximately 30 fragments (friable and non-friable) were observed in Area#3.

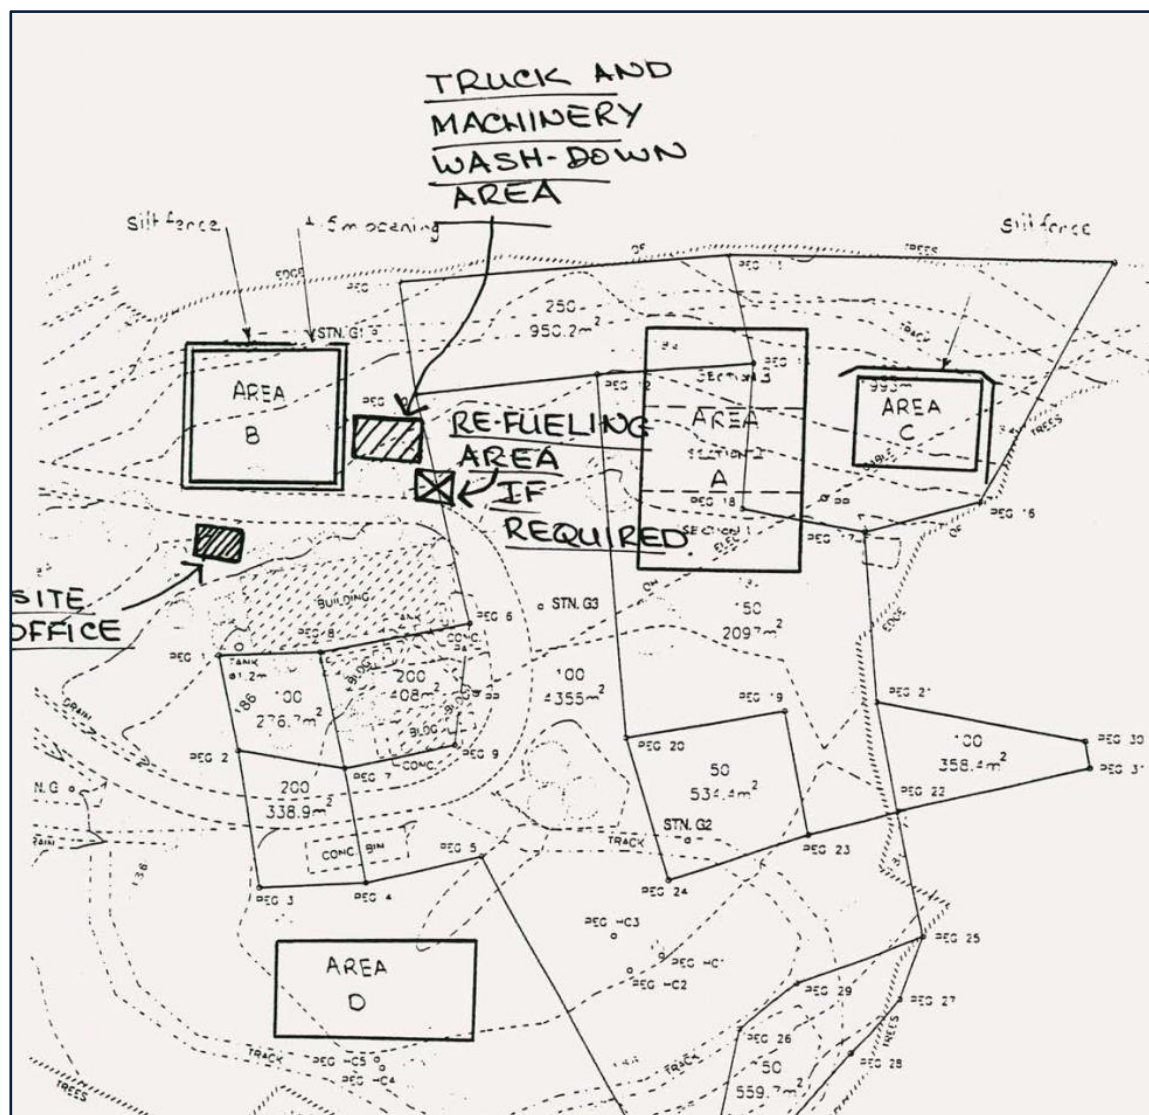
Figure 3-7 (it is unknown what Area A to Area D is referring to (possibly options for the locations of the proposed contamination cell))

This Environmental Management Plan does not generally provide information directly relevant to this assessment but includes several sketches showing 'details of works to be performed'. Several sketches/plans (refer to Figure 3-7 to Figure 3-9 below) show the proposed locations for the truck maintenance area and explosives storage area at Site 1 and the proposed location of the contamination cell at Site 1.
