Report on  
Geotechnical Investigation

Proposed New Maitland Hospital  
Metford Road, Metford

Prepared for  
Health Infrastructure

Project 81719.01  
May 2018

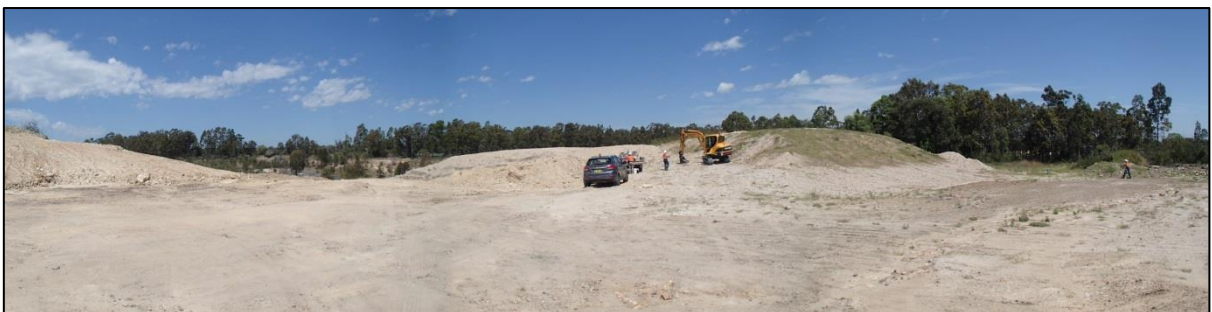
**Figure 6: Looking south from the site boundary, excavator at Pit 301 (2015)**

The north-western area of the site has been highly disturbed as is characterised by bare soil and rock surfaces with numerous stockpiles. It is understood that the majority of the structures for the new hospital will be constructed in this area of the site. The stockpiles are typically about 5 m to 10 m in height above the surrounding ground level. The stockpiled material is variable but predominantly comprised either cohesive soils and ripped bedrock (clay, sandy clay, silty clay and weathered rock); or gravel, chitter (coarse coal reject) and coal.

Surface levels in this area of the site are generally RL 20 m AHD to RL 24 m AHD.

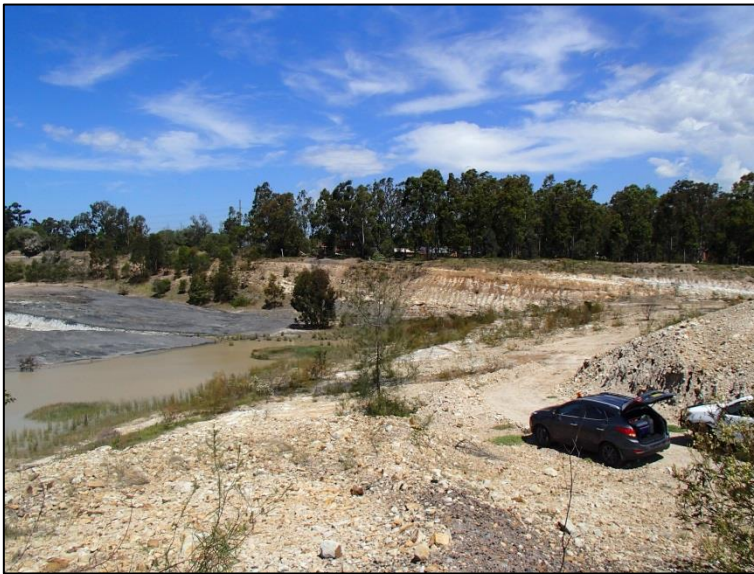
**Figure 10: Looking south from top of a stockpile, carbonaceous stockpiles (left), water body (left), existing quarry cutting (back), stockpile (right) (2015)**

Based on review of available topographic mapping, the surface levels within this area of the site generally range from about 8 m AHD to 12 m AHD, rising to the west, south and east out of the floor of the former quarry.

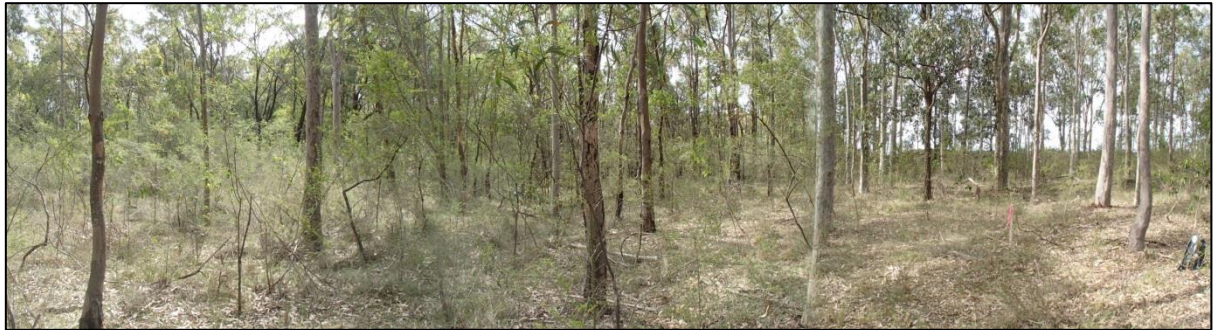
**Figure 13: Existing vegetation at Pit 312 (2015)**

The southern strip of the site, which varies in width of between 40 m to 90 m in width, is located between the former quarry floor and the southern boundary of the site.

This area is generally covered by dense bush (refer Figure 13).

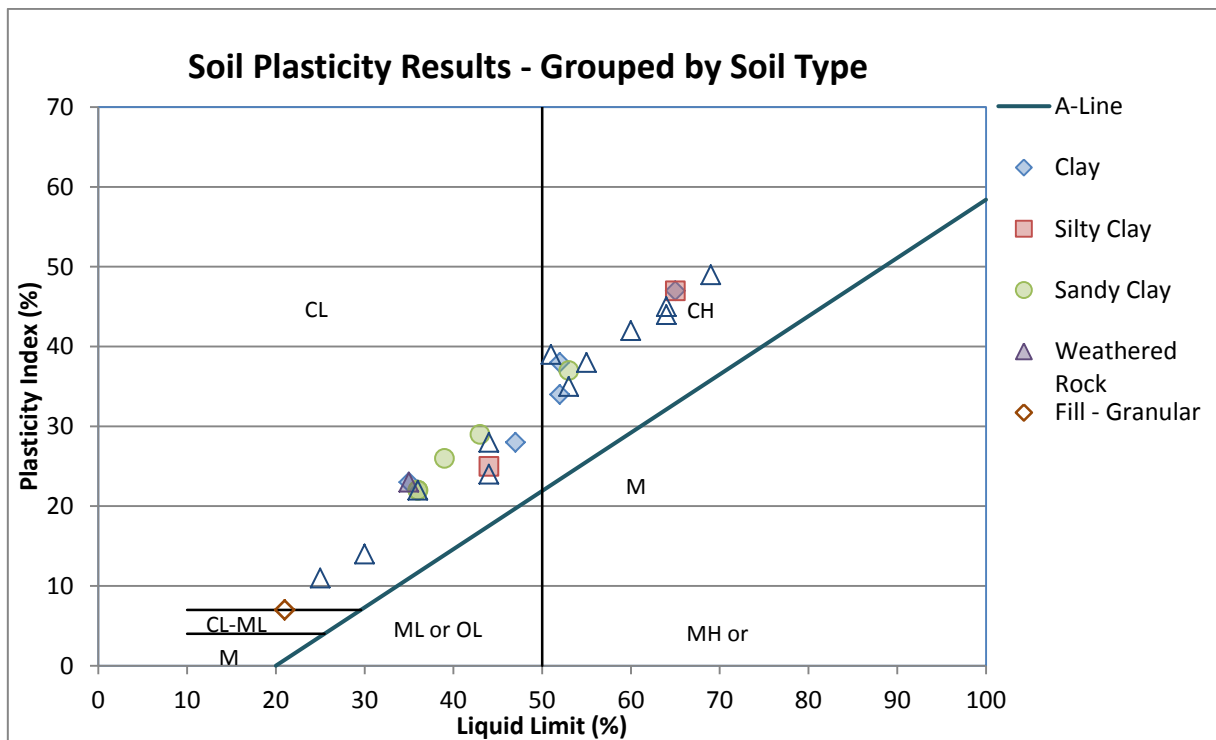
**Figure 23: Chart of Soil Plasticity Tests**

Figures 23 and 24, below, present a graphical summary of soil plasticity and shrink-swell data obtained for soils in the vicinity of the site during the previous investigation by DP (Ref 1).

Laboratory testing on samples retrieved from the current investigation and the information provided above indicate that the clay has a moderate propensity to change in volume with changes with moisture content, as indicated by high shrink-swell values on remoulded samples up to 3.0% and swells of up to 1.2% during soaked CBR testing. The results also indicate that the underlying clays have a moderate potential to soften on exposure to moisture, as indicated by the low soaked CBR values (as low as 5%).

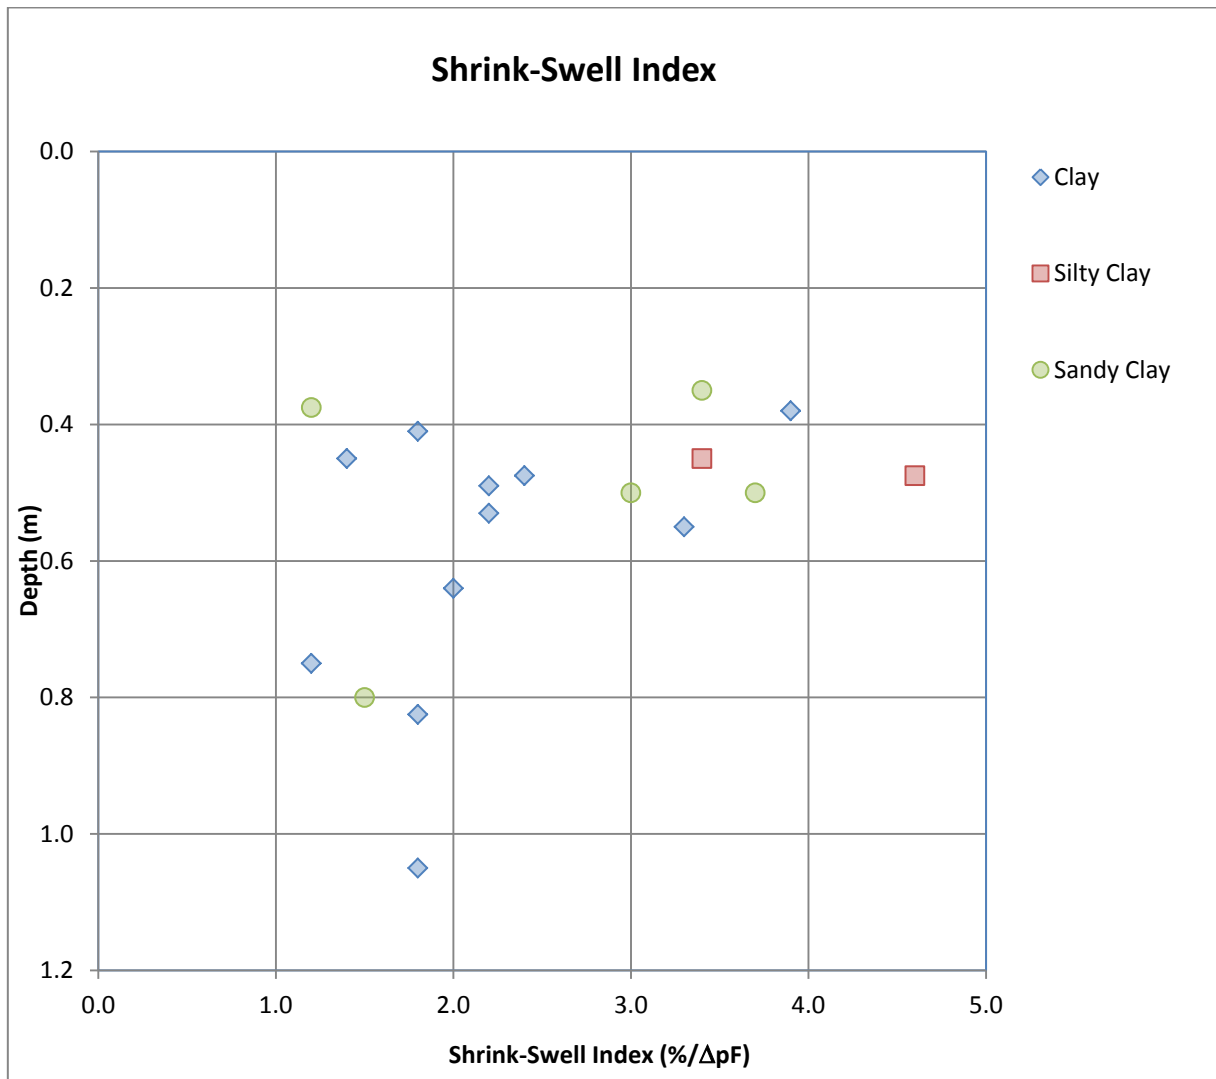
**Figure 24: Chart of Shrink-Swell Index Tests**

Available data on clay reactivity in terms of the shrink-swell index is shown plotted in Figure 24. California bearing ratio (CBR) results are graphed in Figure 29.

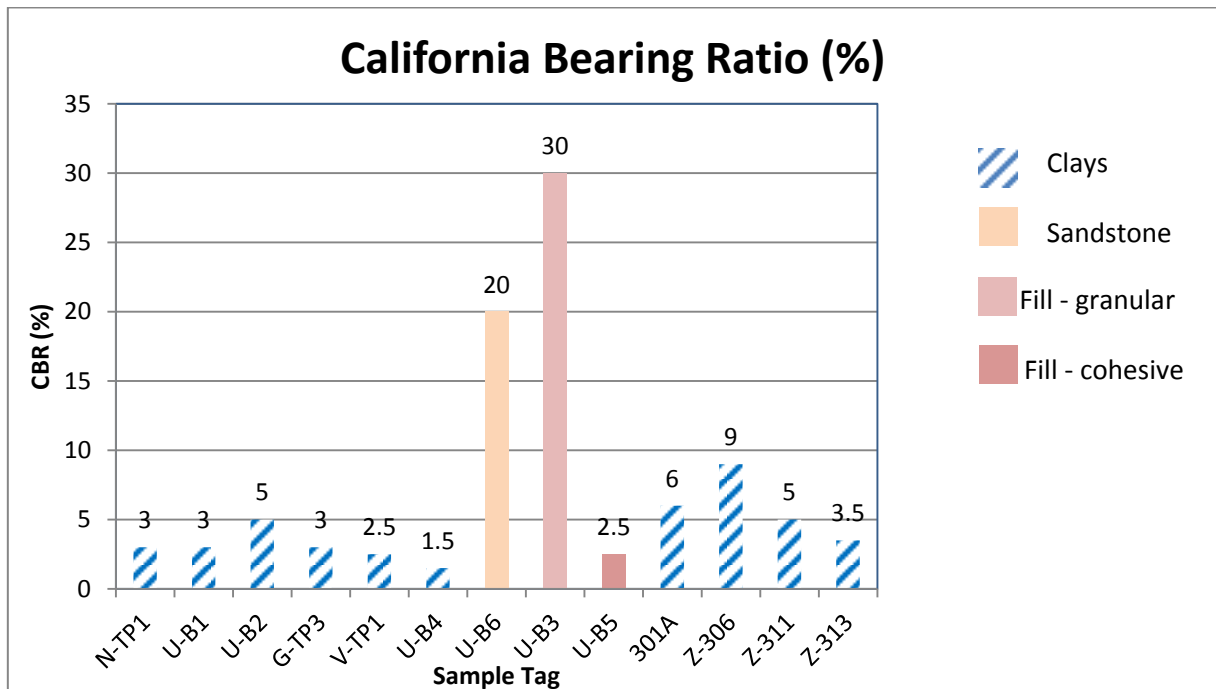
**Figure 29: Graph of CBR Test Results from previous investigation**

Laboratory testing on samples retrieved from the pits indicate a CBR range of about 3% to 9%.

The previous Geotechnical Assessment (Ref 1) suggested a CBR range of 3% to 5%, based on a data assessment of CBR laboratory testing taken at and adjacent to the site, as shown in Figure 29.

As can be seen from Figure 28, for clay soils, CBR values ranging from 1.5% to 5% were returned, which is generally consistent with the results of testing from the present investigation.
