Conceptual site model and risk assessment

Snowy 2.0

Contamination Assessment

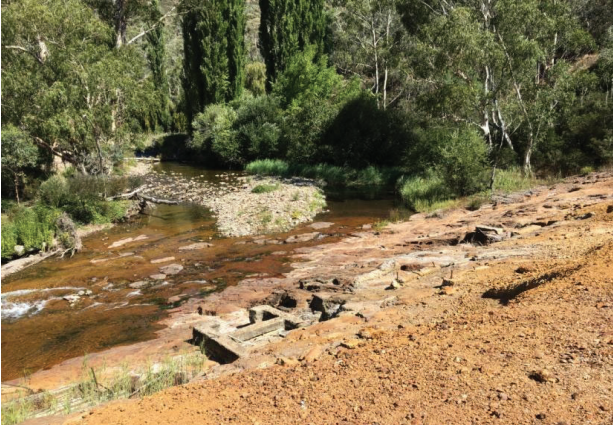
Historical shaft and processing area (facing east) at Lobs Hole

Description	Photo
Historical shaft and processing area at Lobs Hole	 
Rock emplacement at Lobs Hole
