## Snowy 2.0 External Agency Incident Notification Form

| Talbingo Wedgepit Material Placed in Pad 50 - SHL-ENV-INC-002 | |
| Site | Lobs Hole - Pad 50, Main Yard |

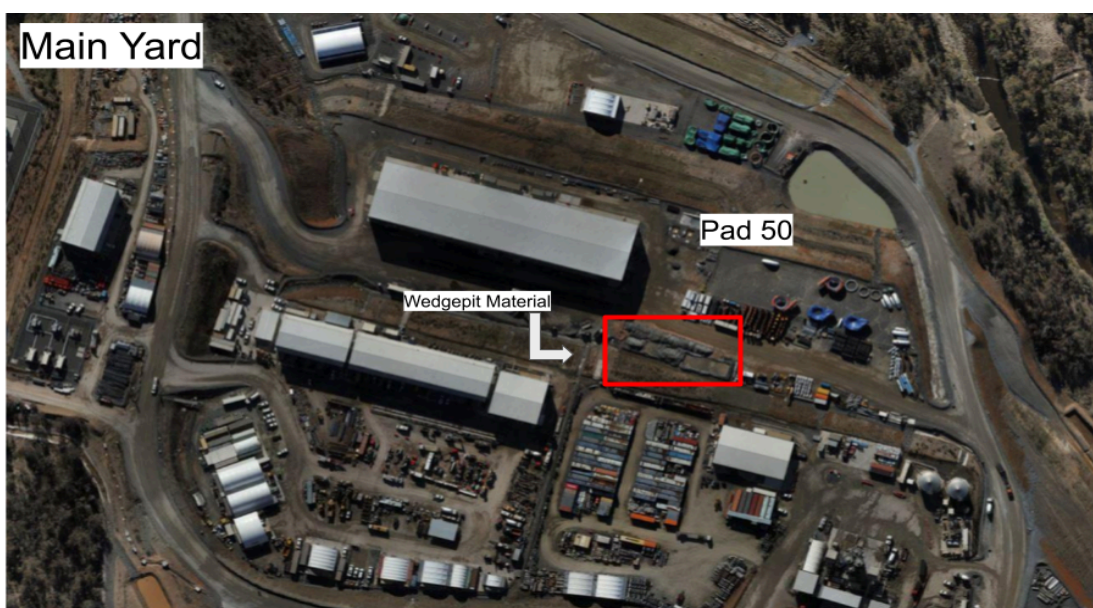
03/07/2024 - At the time of inspection, the FGJV Environment Team observed that solid spoil material blended with sludge was observed to be placed outside the bunded area.

- General location of the incident at Pad50, Main Yard

1. FGJV Environment team to carry out pre & post-rainfall inspections to ensure no run-off from the material
2. Upon receipt of waste classification, material stored at Pad50 to be disposed appropriately offsite.
