# BOTANY RAIL DUPLICATION

Technical Report 5 –  
Contamination  
Assessment

Document No. BRD-G2S-CT-TPP-0001-05\_Contamination  
26 September 2019

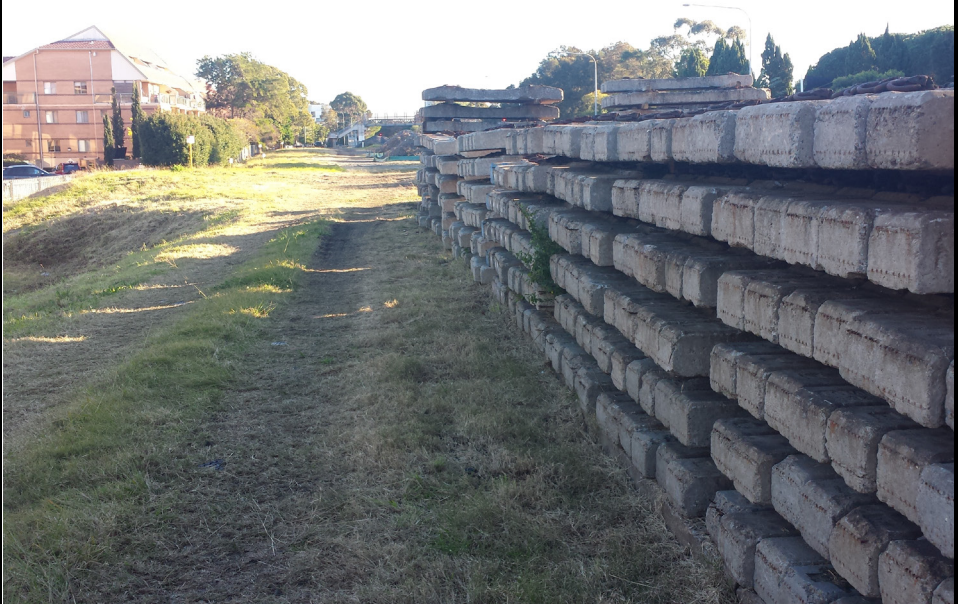
| Photo No. | Date | |
|---|---|---|
| 2 | 06.07.2018 | |

| Photo No. | Date | |
|---|---|---|
| <b>Description</b><br><br>Rail sleeper storage area.<br><br>Chainage 9.700 km (approximate). | | |

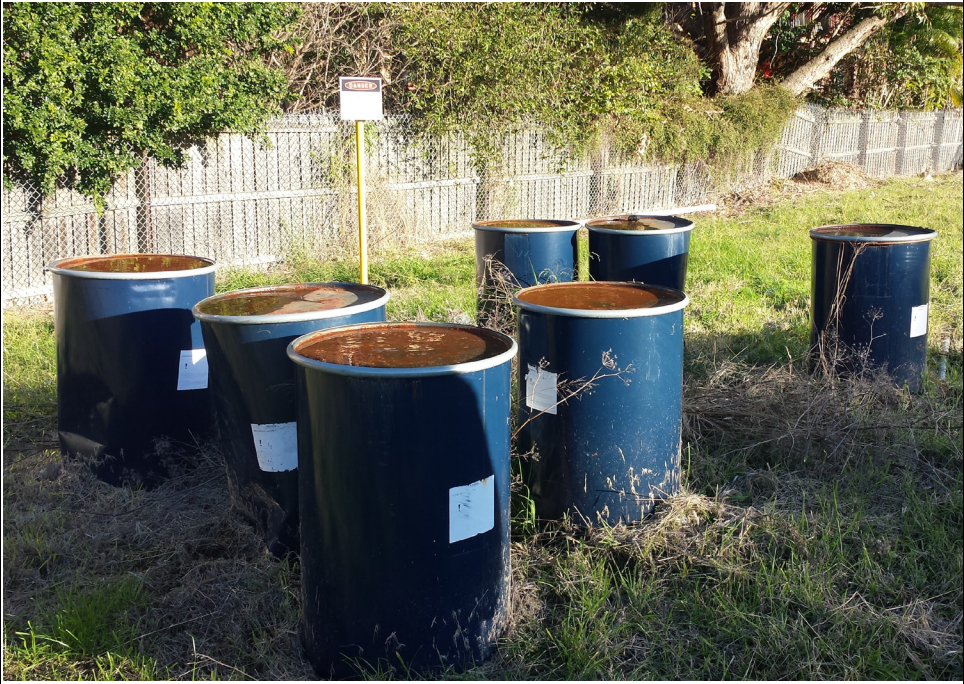
| Photo No. | Date | |
|---|---|---|
| 4 | 06.07.2018 | |

A number of waste drums were also observed about halfway between Page Stephen Bridge and the Banksia Street pedestrian overpass (Photograph 4). The waste drums appeared to contain limestone based fire-resistant sealant. A covered skip bin was also observed near the Banksia Street pedestrian overpass.

| Photo No. | Date | |
|---|---|---|
| <b>Description</b><br><br>Multiple waste drums present, labels indicate they contain a limestone based firecaulk sealant.<br><br>Chainage 9.850 km (approximate). | | |

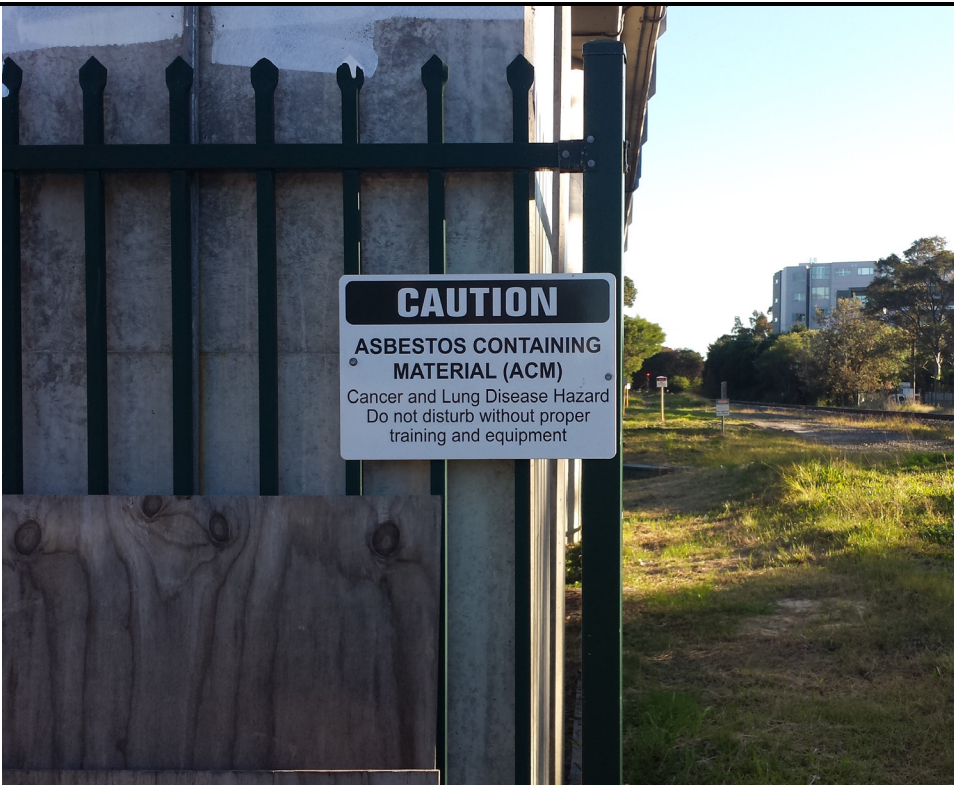
| Photo No. | Date | |
|---|---|---|
| 6 | 06.07.2018 | |

| Photo No. | Date | |
|---|---|---|
| <b>Description</b><br><br>Asbestos Containing Material warning signage noted under the Banksia St Pedestrian Level Crossing.<br><br>Chainage 10.000 km (approximate). | | |

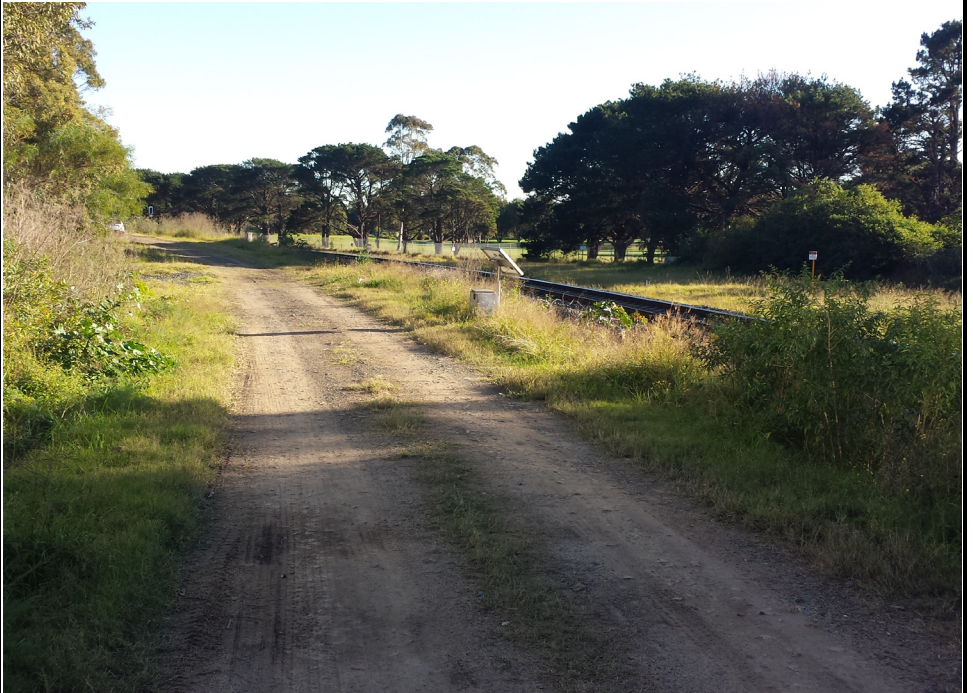
| Photo No. | Date | |
|---|---|---|
| 8 | 06.07.2018 | |

| Photo No. | Date | |
|---|---|---|
| <b>Description</b><br><br>Elevated roadways continues opposite the Eastlake Golf Course.<br><br>Chainage 10.200 km (approximate). | | |

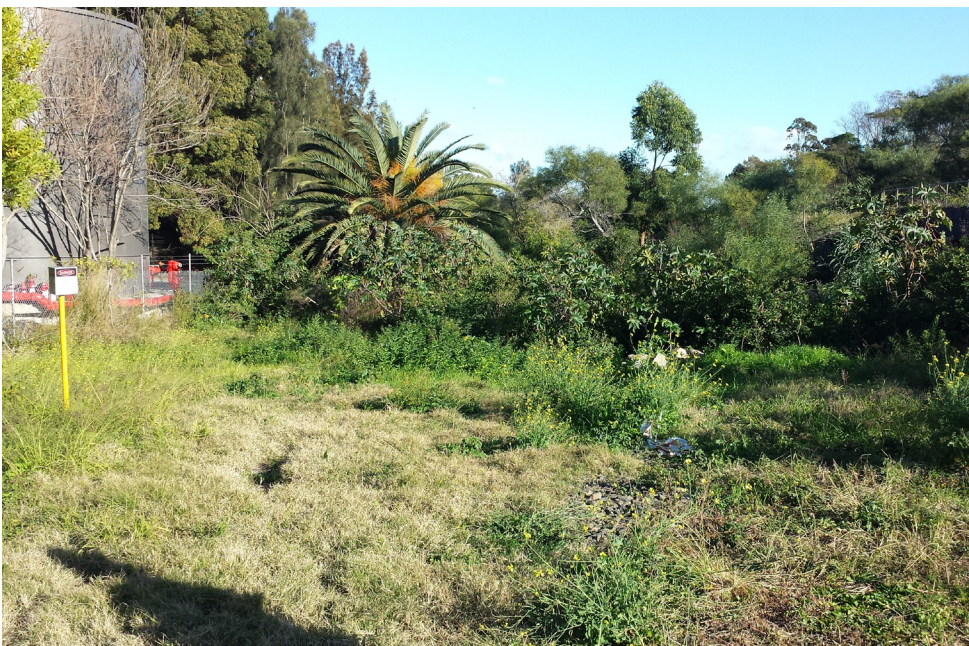
| Photo No. | Date | |
|---|---|---|
| <b>Description</b><br><br>Overgrown vegetation observed surrounding the roadway, particularly in the vicinity of the Mill Stream Bridge.<br><br>Unauthorised to proceed beyond this point due to narrow bridge.<br><br>Chainage 10.900 km (approximate). | | |

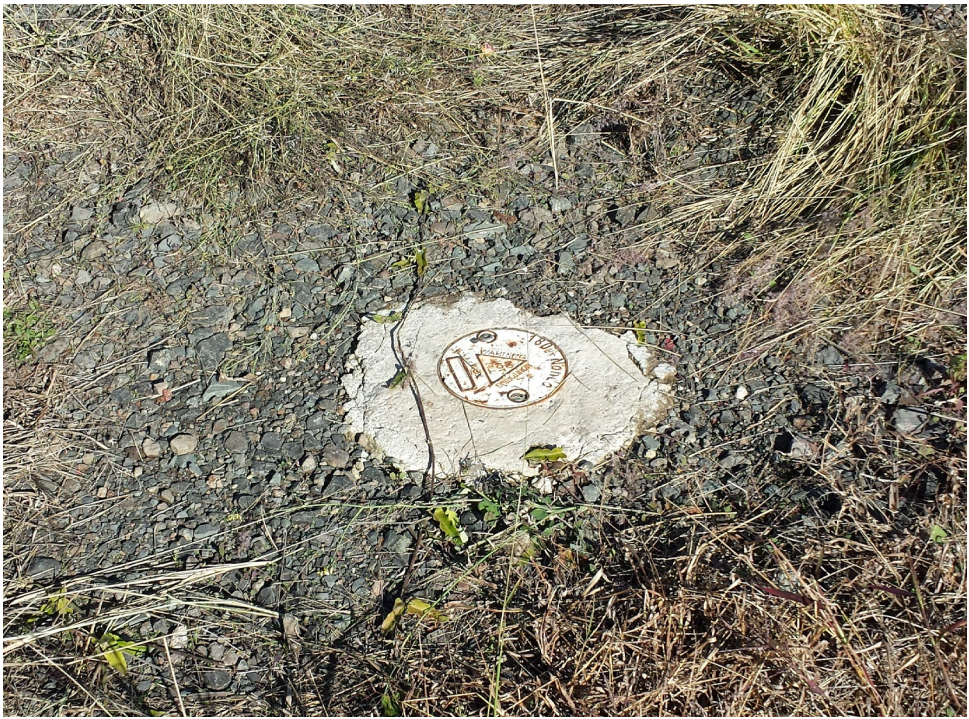
| Photo No. | Date | |
|---|---|---|
| 9 | 06.07.2018 | |

Some construction rubbish was observed in the project site to the west of the tracks within a fenced area near the railway crossing (Photograph 2). A groundwater monitoring well was observed within the rail corridor (Photograph 9). This well does not appear on bore searches.

| Photo No. | Date | |
|---|---|---|
| <b>Description</b><br><br>Groundwater monitoring well observed within the rail corridor.<br><br>Chainage 12.000 km (approximate). | | |

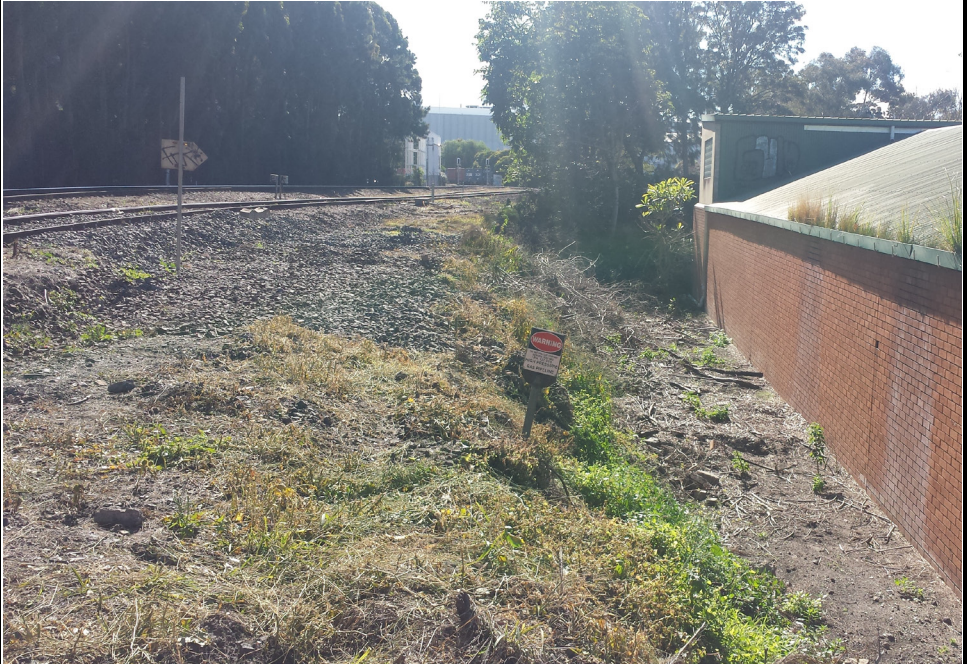
| Photo No. | Date | |
|---|---|---|
| 13 | 06.07.2018 | |

During site inspection on 6 July 2018 several ACM fragments were observed on the project site surface in an area west of Robey Street bridge, adjacent to the wall of an existing building (nominated as AEC2).

| Photo No. | Date | |
|---|---|---|
| <b>Description</b><br><br>View of the rail corridor facing north. Numerous fragments of ACM observed along building wall (right).<br><br>Chainage 12.715 km (approximate). | | |

Several ACM fragments were observed during site inspection on the site surface in an area west of Robey Street Bridge (adjacent to the wall of an existing building). Additional investigation is recommended to further evaluate the risk of potential contamination exposure to workers during construction phase and provide guidance on waste management in the event that excavated materials require off-site disposal or classification for potential reuse.

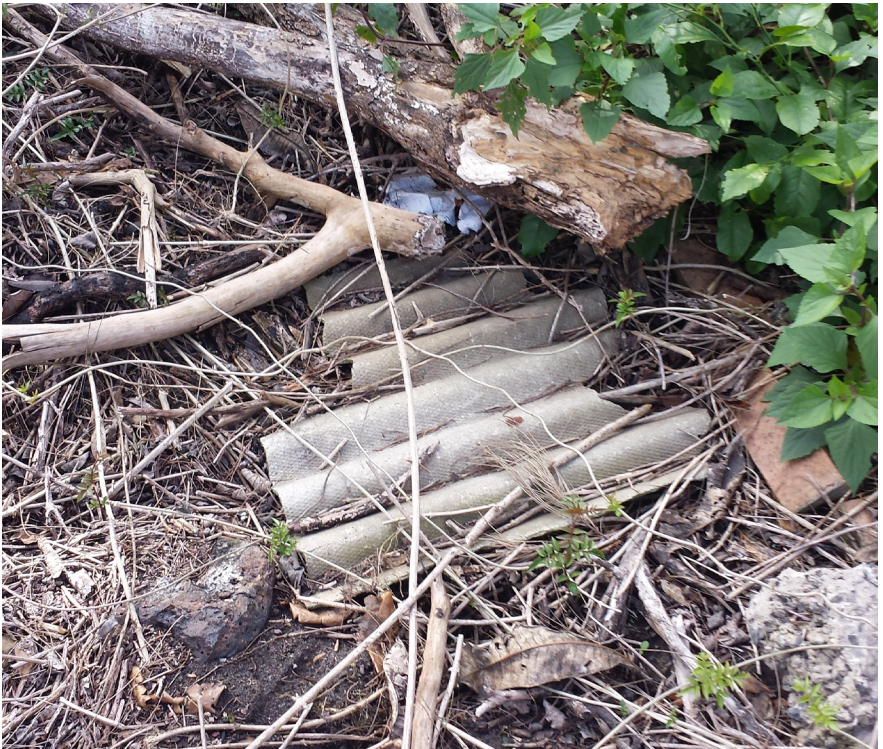
| Photo No. | Date | |
|---|---|---|
| 14 | 06.07.2018 | |

The area north of Robey Street bridge was accessed via a gate off Coleman Street (Photograph 11). This portion of the project site was inspected from the eastern side of the tracks. Two sub-stations were observed along the tracks (Photographs 12 and 21). Several ACM fragments were observed on the floor along the wall of a building within the rail corridor (Photographs 14 and 15). The fragments did not appear to be severely weathered.

| Photo No. | Date | |
|---|---|---|
| <b>Description</b><br><br>Close-up view of ACM sheet observed.<br><br>Chainage 12.735 km (approximate). | | |

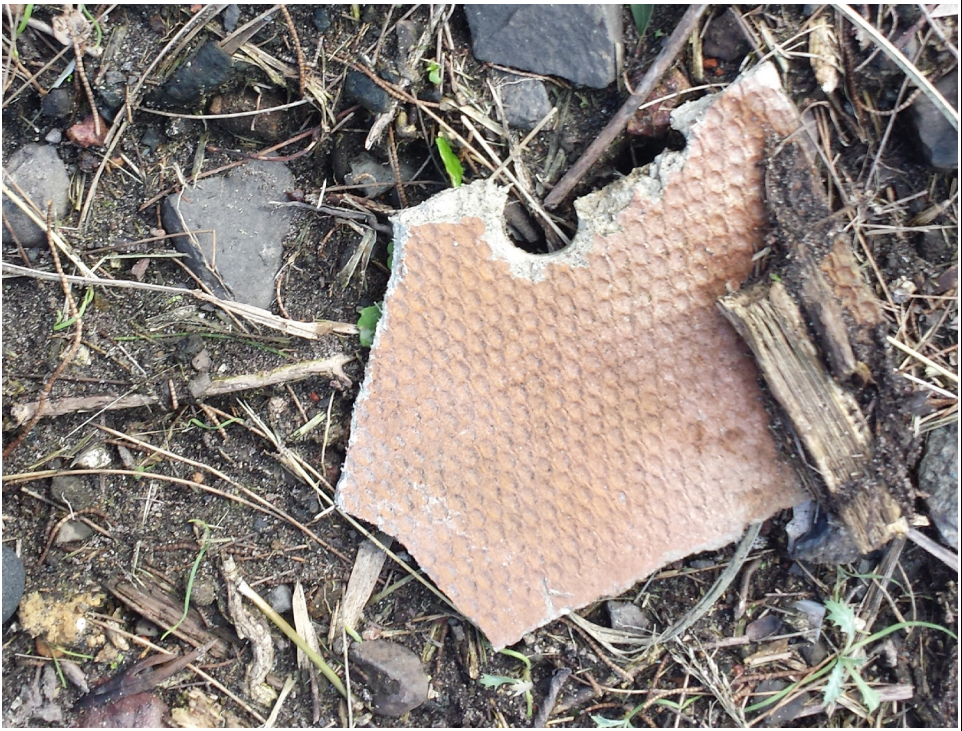
| Photo No. | Date | |
|---|---|---|
| 15 | 06.07.2018 | |

| Photo No. | Date | |
|---|---|---|
| <b>Description</b><br><br>Close-up view of ACM fragment observed.<br><br>Chainage 12.735 km (approximate). | | |

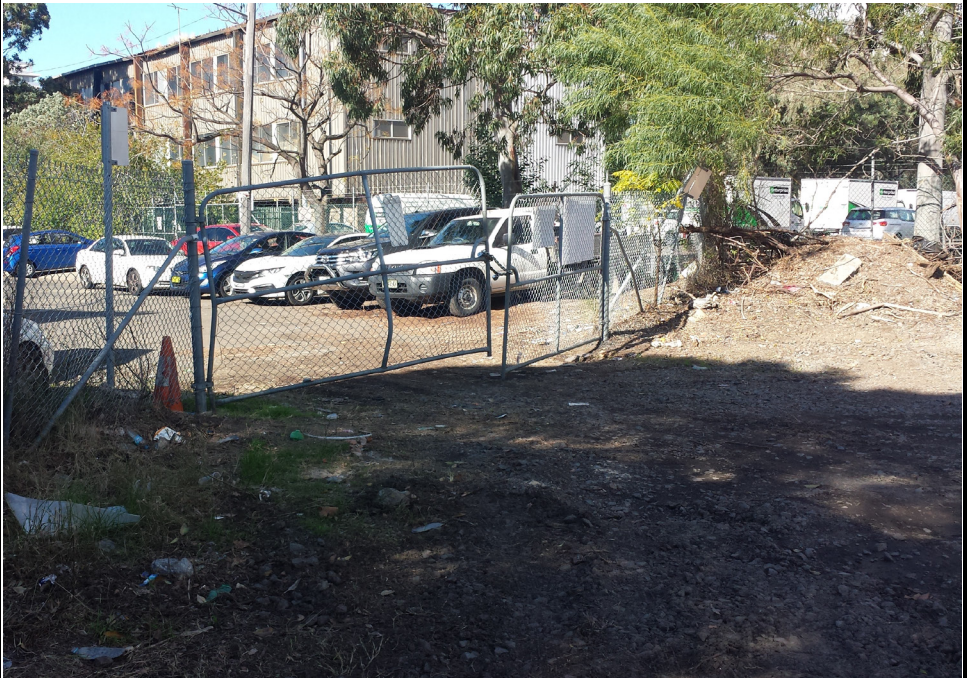
| Photo No. | Date | |
|---|---|---|
| 18 | 06.07.2018 | |

| Photo No. | Date | |
|---|---|---|
| <b>Description</b><br><br>View of the rail corridor access gate on King Street.<br><br>Chainage 12.910 km (approximate). | | |

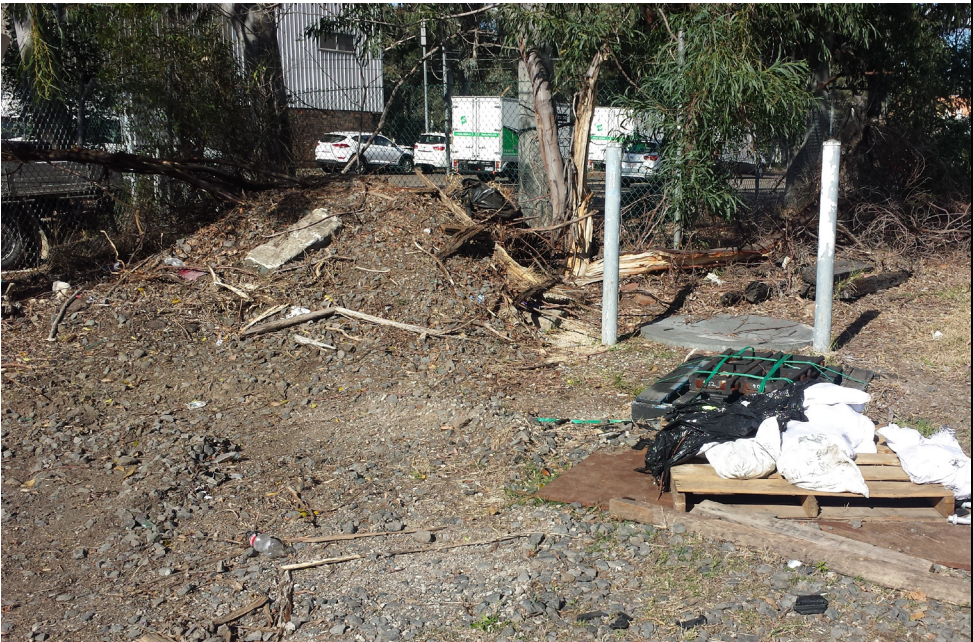
| Photo No. | Date | |
|---|---|---|
| 19 | 06.07.2018 | |

| Photo No. | Date | |
|---|---|---|
| <b>Description</b><br><br>General debris and small uncharacterised stockpile observed.<br><br>Chainage 12.910 km (approximate). | | |

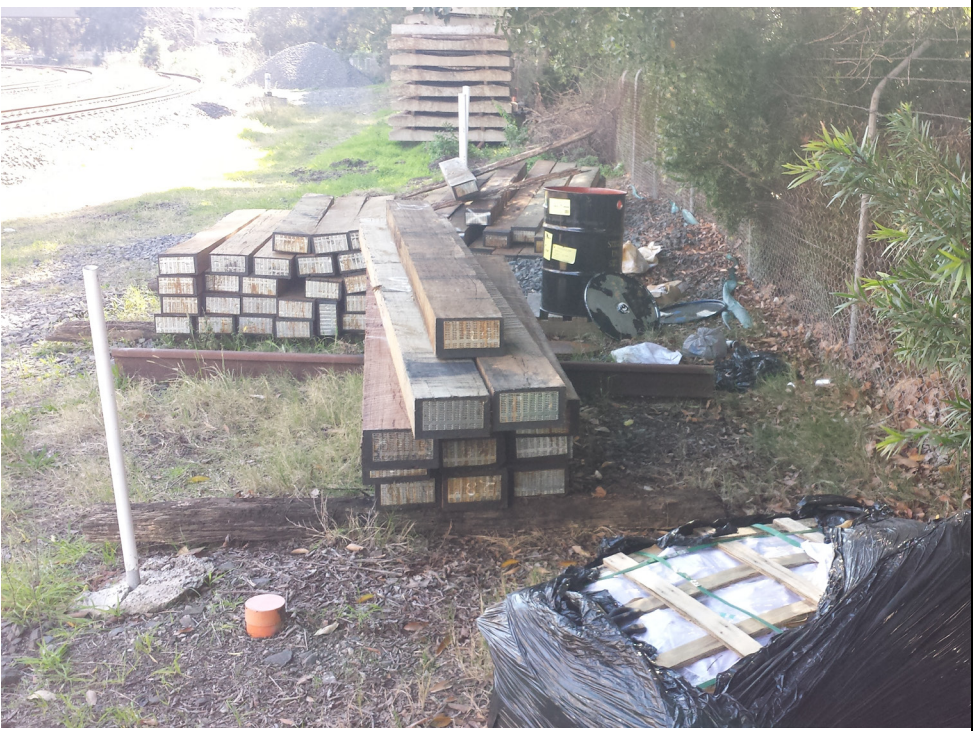
| Photo No. | Date | |
|---|---|---|
| 20 | 06.07.2018 | |

| Photo No. | Date | |
|---|---|---|
| <b>Description</b><br><br>General debris and rail sleepers storage area.<br><br>Chainage 12.950 km (approximate). | | |

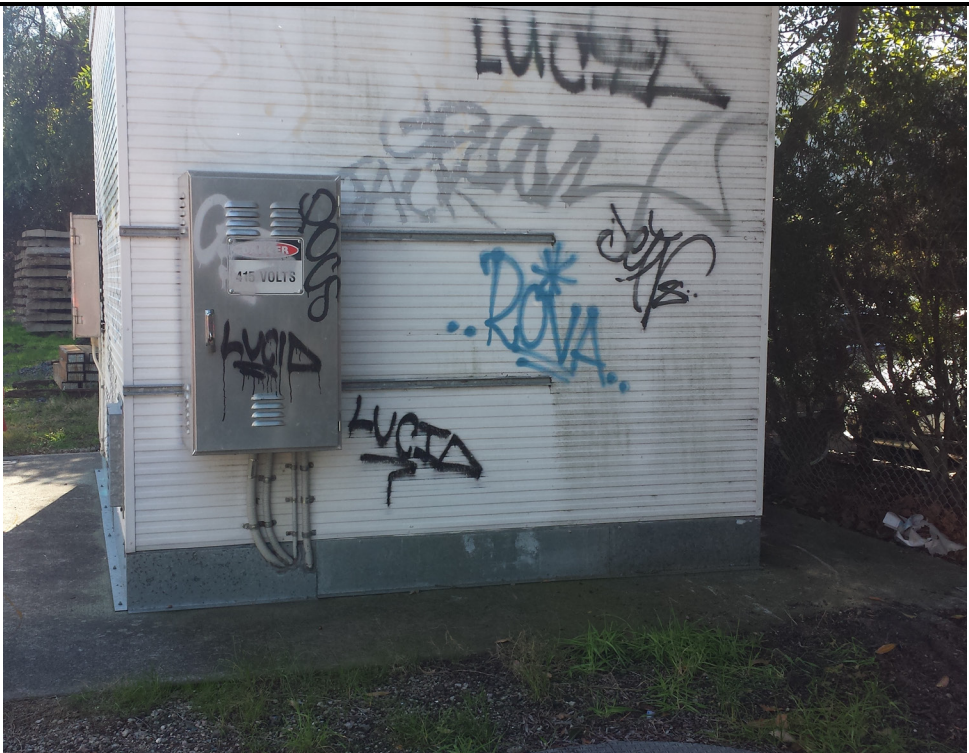
| Photo No. | Date | |
|---|---|---|
| 21 | 06.07.2018 | |

| Photo No. | Date | |
|---|---|---|
| <b>Description</b><br><br>View of electrical substation/maintenance building (2 of 2).<br><br>Chainage 12.975 km (approximate). | | |

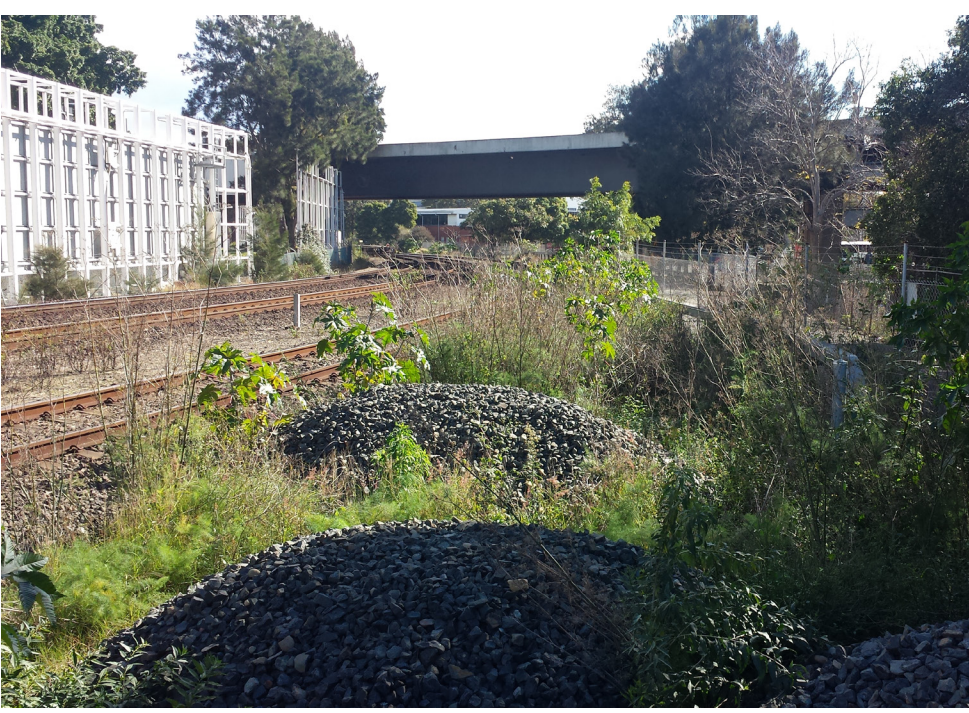
| Photo No. | Date | |
|---|---|---|
| 22 | 06.07.2018 | |

| Photo No. | Date | |
|---|---|---|
| <b>Description</b><br><br>View of Qantas Bridge facing west.<br><br>Unauthorised to proceed beyond this point due to narrow rail corridor.<br><br>Chainage 13.143 km (approximate). | | |
