Report on  
Detailed Geotechnical Investigation

Proposed New Hospital  
Metford Road, Metford

Prepared for  
Multiplex Constructions Pty Ltd

Project 81719.09  
March 2019

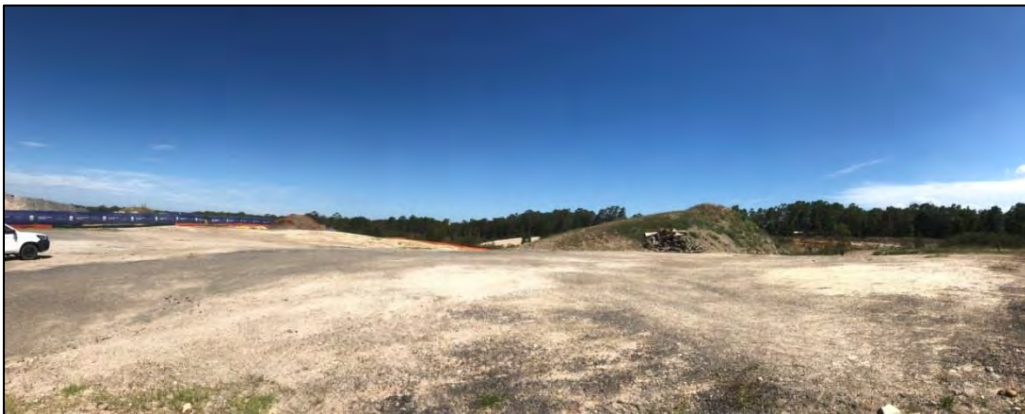
**Figure 3: Looking south from near Bore 3004 towards large stockpile in the central area of the site.**

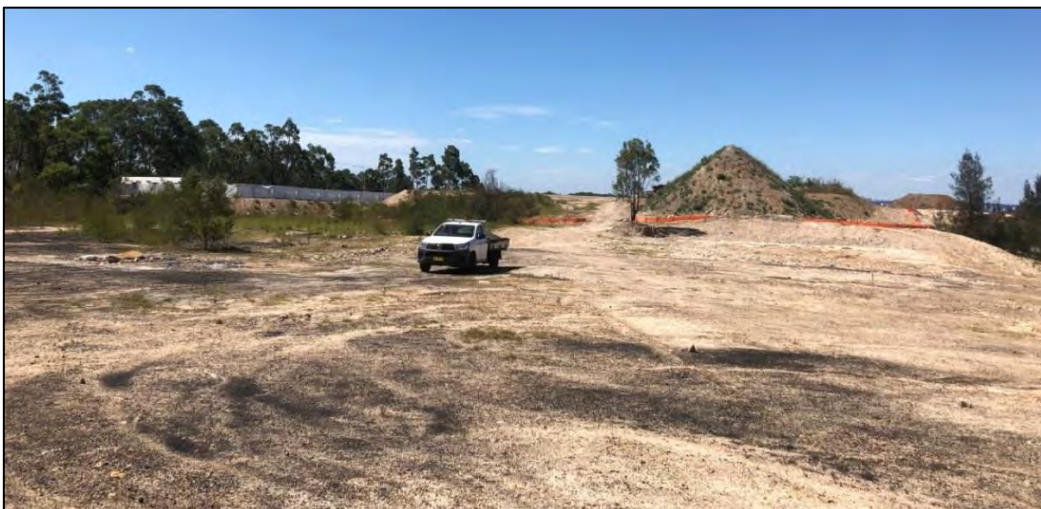
**Figure 4: Looking north east from near pit 4003 towards construction compound (distant left) and large stockpile in the central area of the site (distant right)**

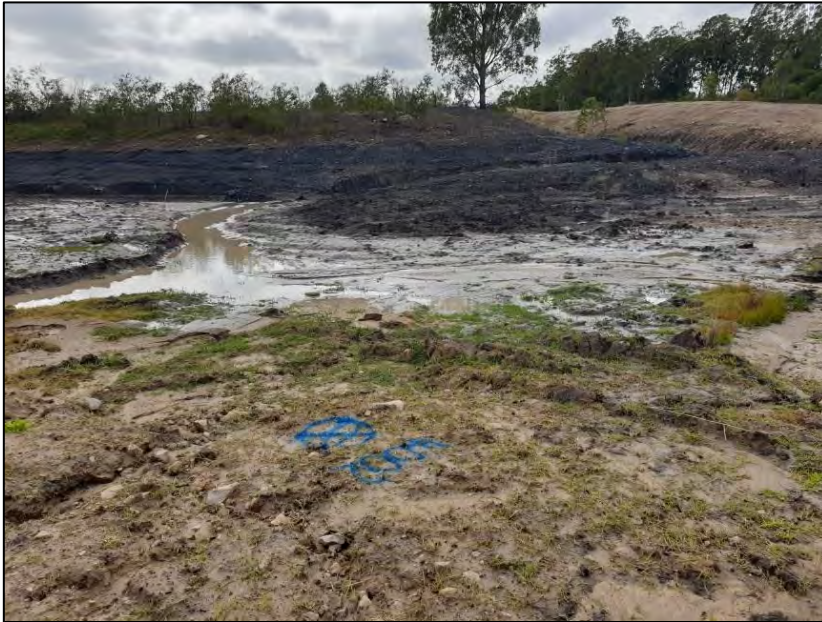
- The lower area of the site, which includes the existing pond and surrounding area is characterised by weak sandy sediments and surface water, with carbonaceous material, including coal exposed in the area to the east (refer Figure 5);

**Figure 5: View of the site near Pit 4002, looking east.**

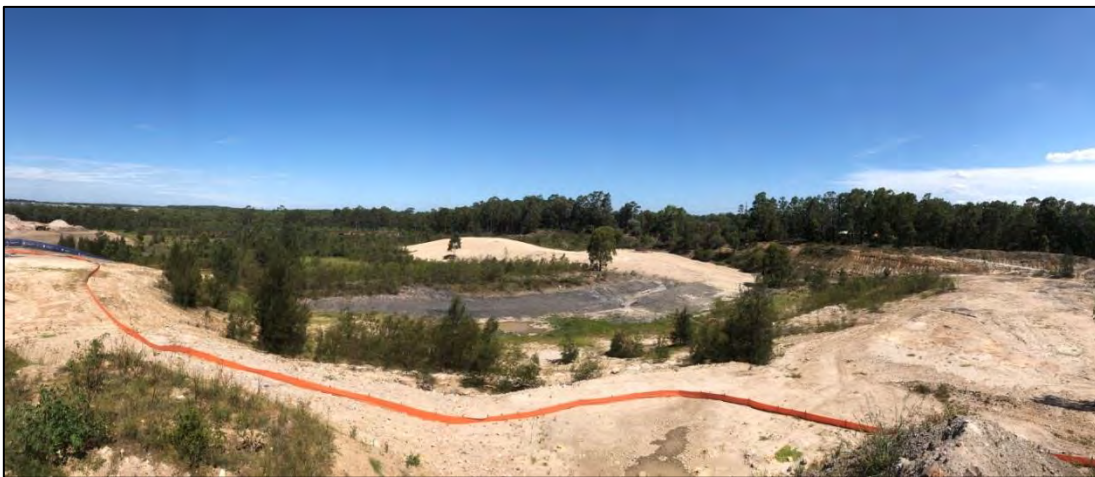
- The remainder of this lower area (beyond the pond) is covered by accumulated sediments and low vegetation; and
- A large capped stockpile of carbonaceous material is present to the east and south-east of the hospital footprint. A proposed car parking area is to be constructed over the existing pond and may encroach on the north-western edge of the stockpile (refer Drawing 1 and Figure 6).

**Figure 6: Looking south-east towards low lying area from large stockpile in central area of the site.**

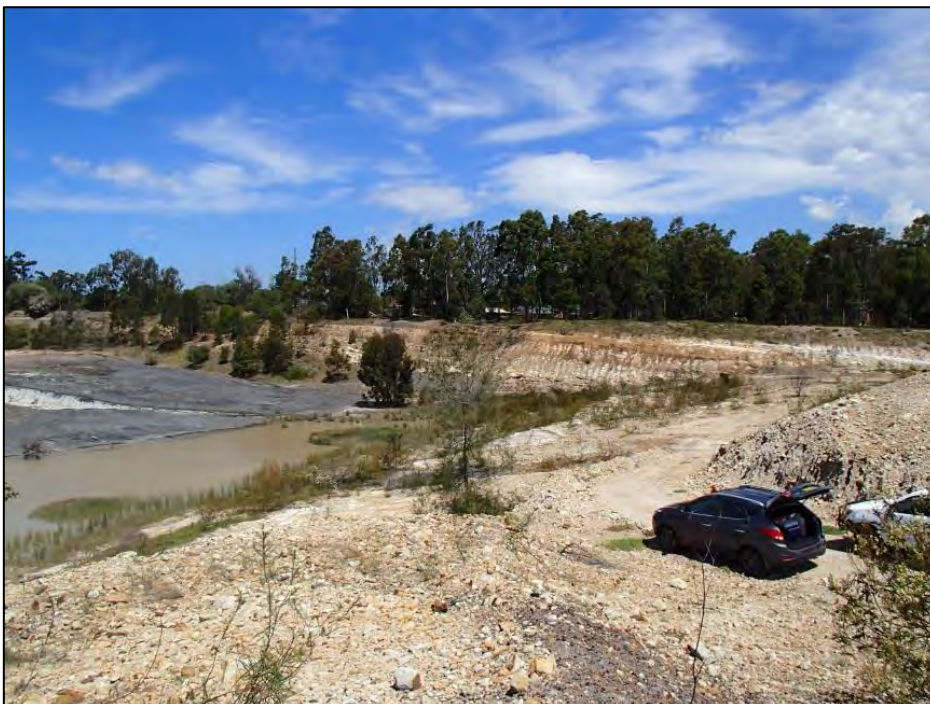
**Figure 8: Looking south from top of a stockpile, carbonaceous stockpiles (left), water body (left), existing quarry cutting (back), stockpile (right) (2015)**

- Coal was observed to be outcropping in excavations around the existing stockpile.

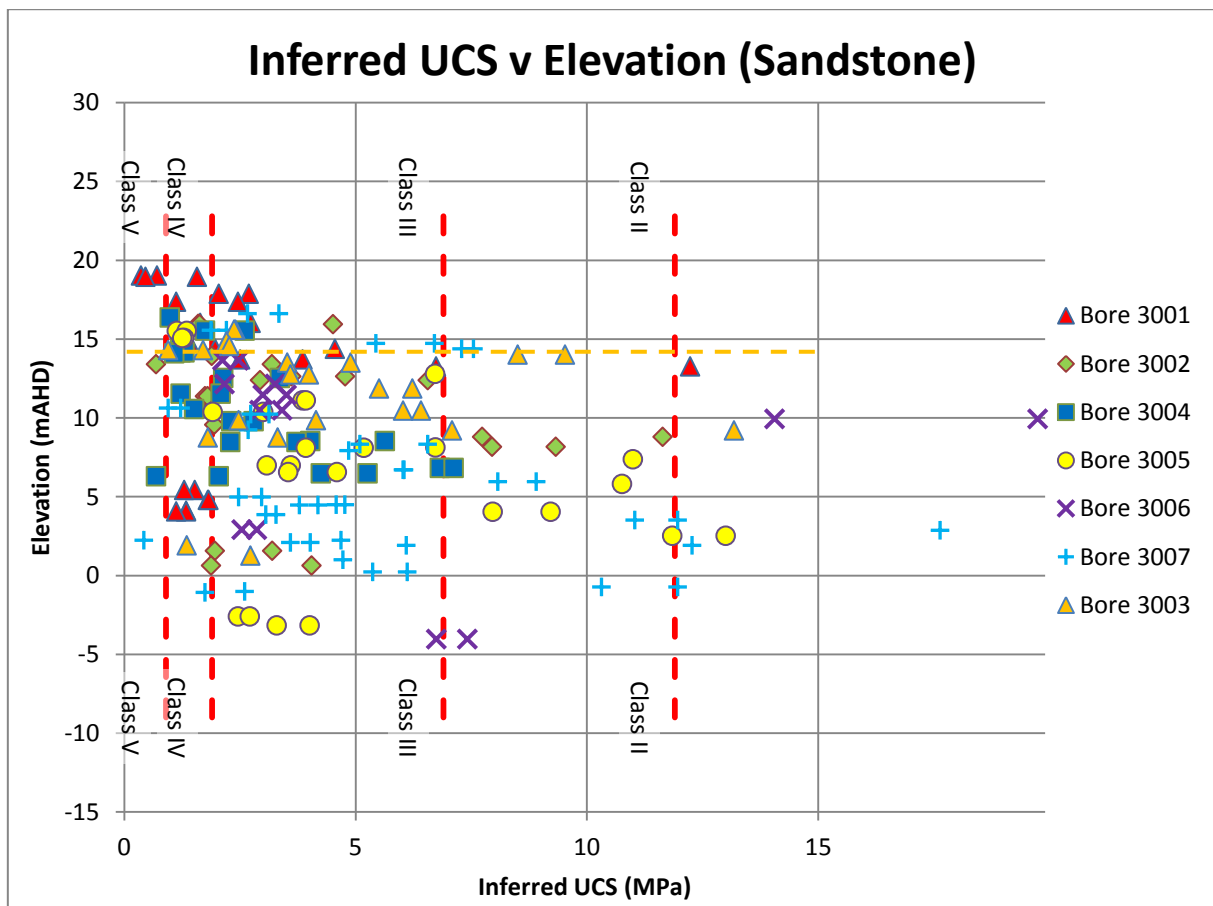
As can be seen in Figure 17 and Figure 18, at the anticipated lower ground floor foundation level (about RL 13.5 m AHD) the anticipated bedrock is either predominantly Class IV sandstone or Class IV/III siltstone. Some areas of the site, however, are likely to expose weaker (Class V) bedrock.

**Figure 17: Inferred UCS against elevation for sandstone units**

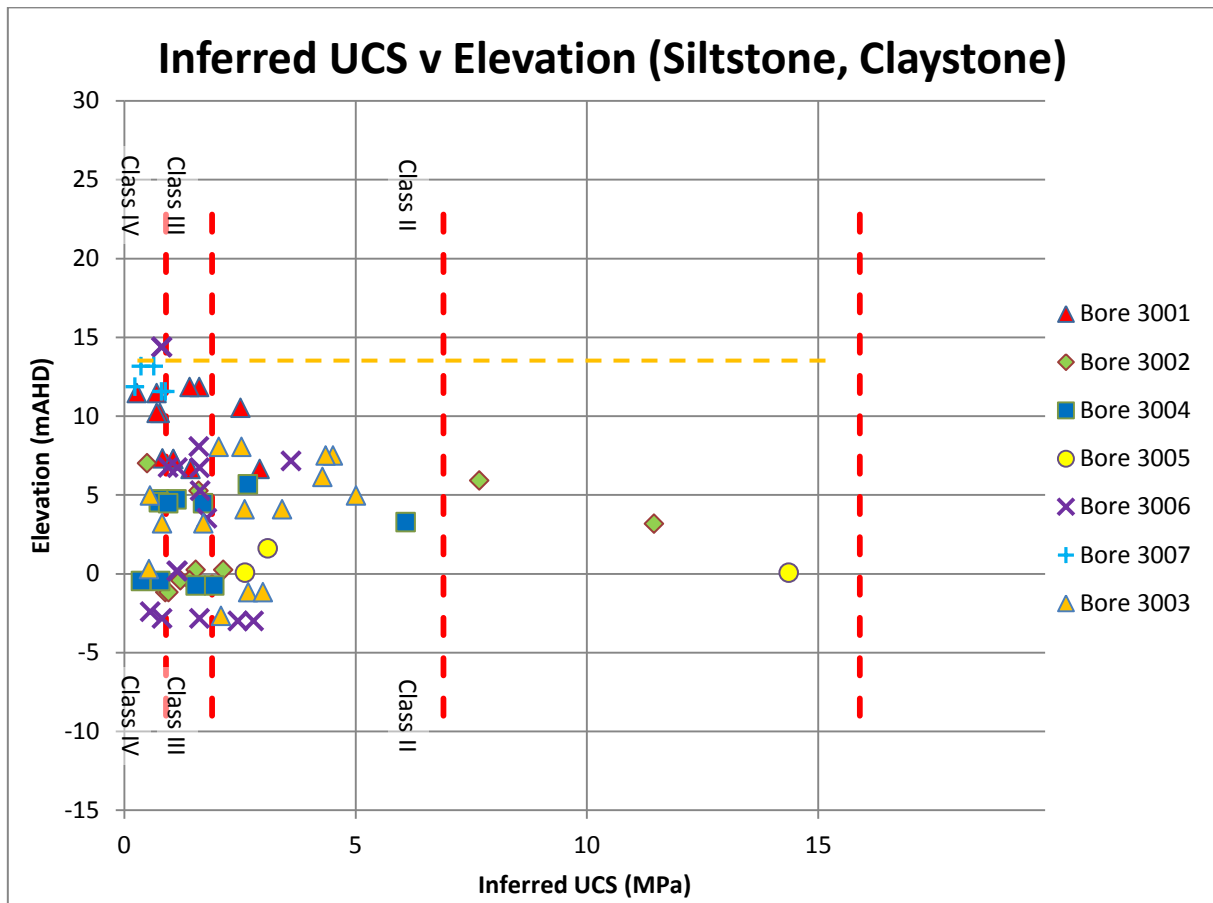
**Figure 18: Inferred UCS against elevation for Siltstone units**

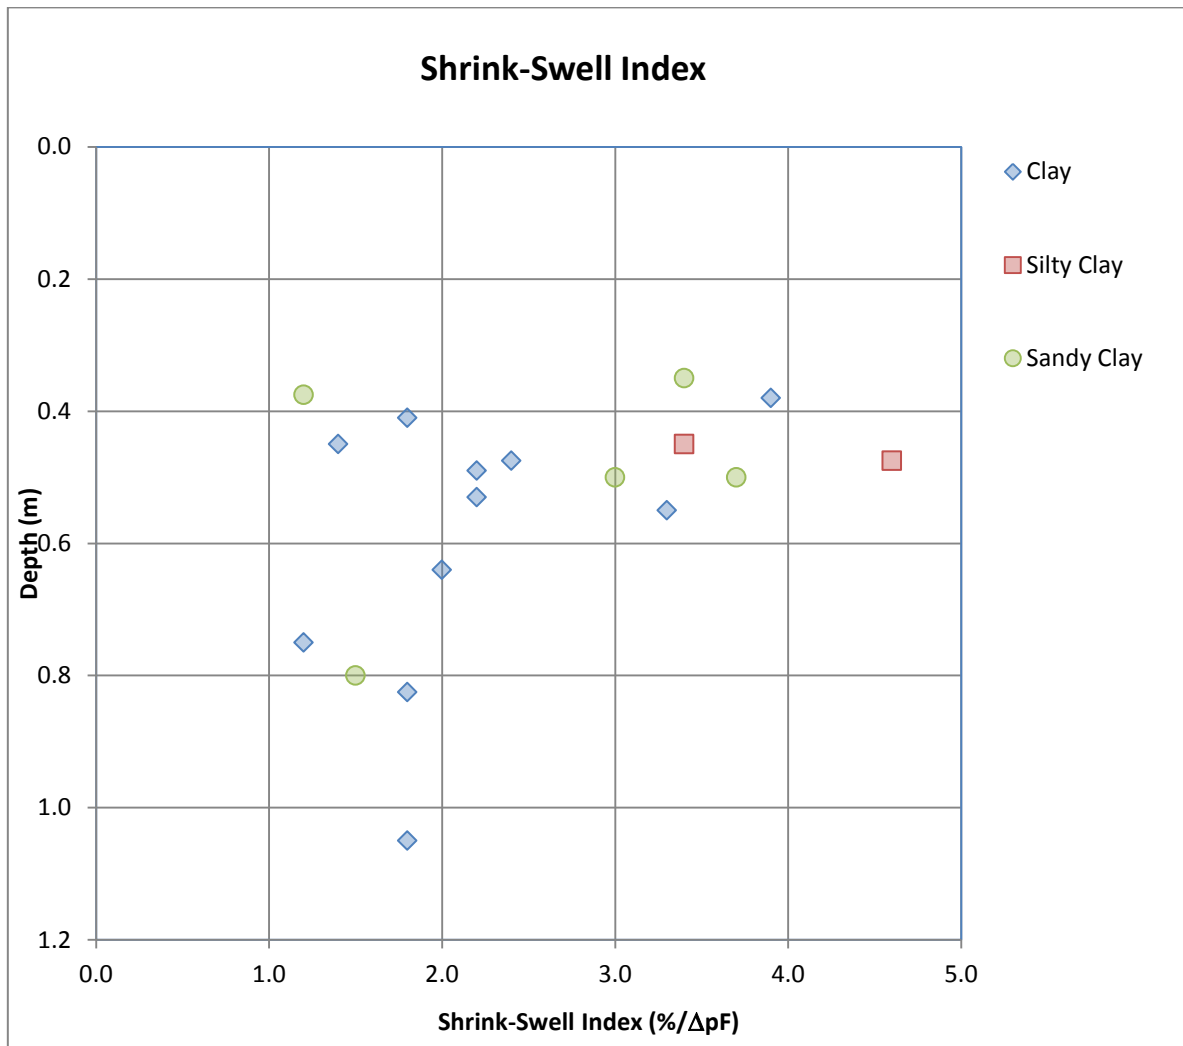
**Figure 20: Chart of Shrink-Swell Index Tests**

The testing indicates that the clay has a moderate propensity to change in volume with changes with moisture content. The results also indicate that the underlying clays have a moderate potential to soften on exposure to moisture, as indicated by the low soaked CBR values (as low as 5%).
