# Arboricultural Impact Assessment

Prepared for the Australian Turf Club  
Site Address: 77-79 Alison Road Randwick  
11th February 2022

Date	Revision	Change	Stage
15/2/2022	A	Plan	DA

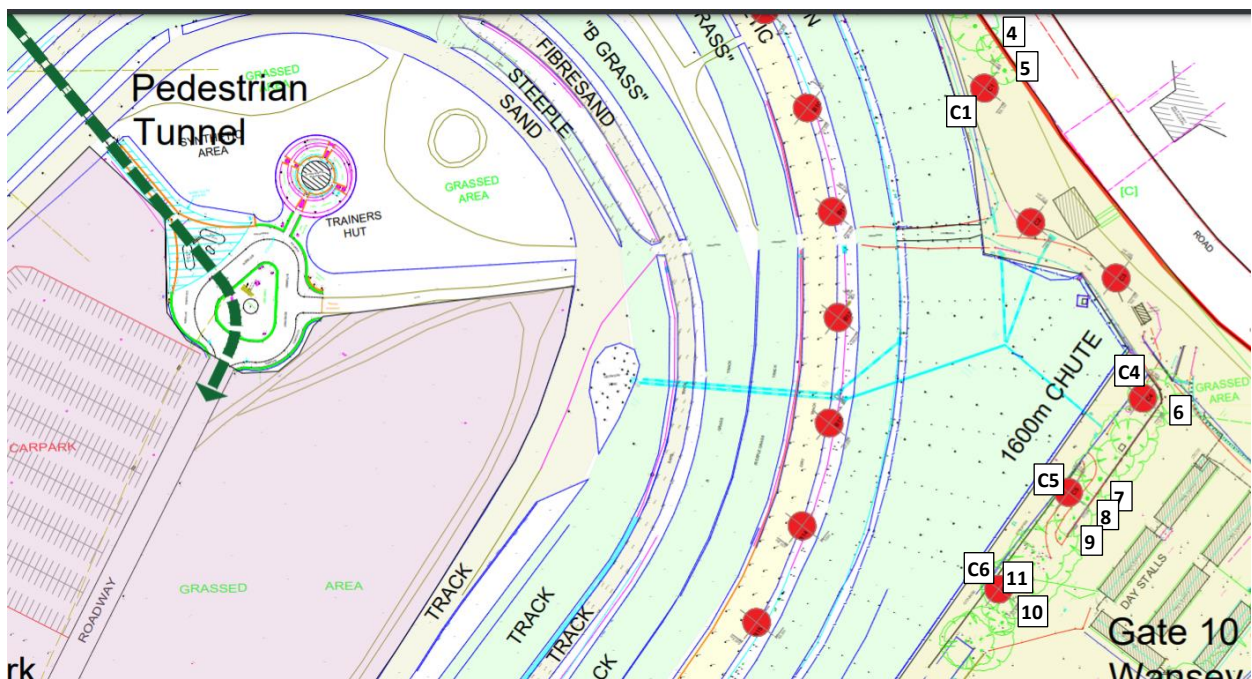
Trees 4, 5, 6, 7, 8, 9, 10, 11 and light posts C1, C4, C5 and C6

The position of the light post is approximately 17 metres from tree 4 and 14 metres from tree 5. The light post is outside the TPZ of tree 4 and at the periphery of tree 5. There will not be any impact to tree 4 and unlikely to be any impact to tree 5. As works are outside the TPZ or at its periphery, prior
