SINSW Centre Of Excellence (Richmond)

Road Safety Audit

Detailed Design Stage

JN22024_Report01 Rev01 - TTW Richmond COE

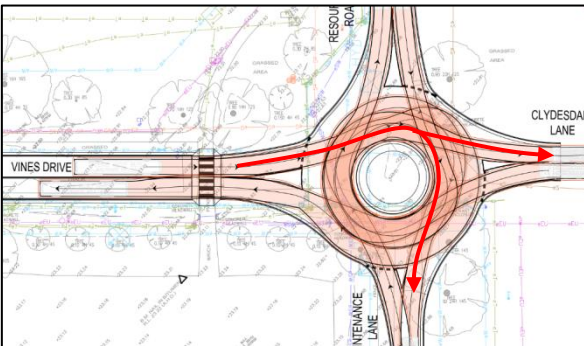
19. Pedestrian Crossing DO-PU	<p>The pedestrian crossing inside the DO-PU area has no lighting, no signage, no kerb ramp on the northern side, a tree blocking sight from the northern side and requires a pedestrian to cross 2 lanes of approaching traffic.</p> <p>There is a risk that an approaching motorist may not sight a pedestrian stepping out into the travel lane resulting in pedestrian-vehicle collisions.</p> <p>There is a risk that a parked vehicle may restrict sight between a through vehicle and a pedestrian resulting in pedestrian-vehicle collisions.</p>  	Probable	Serious	Intolerable	Zebra crossing to be deleted to avoid confusion, signage and line marking for PUDO vehicles and tree to be reviewed.
