## **BRANDY HILL QUARRY EXPANSION**

Michael Hill  
12 Leumeah Close  
Brandy Hill NSW 2324

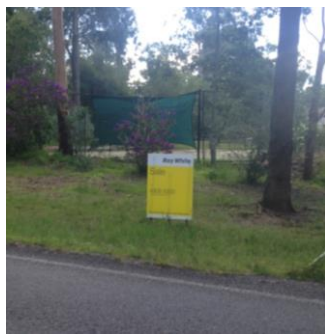
Photo X

Several homes are for sale and they are potential decreases in the value of the homes in Brady Hill due to the increase in noise especially if the trucks operate 24hrs a day. Photo "X & Y"

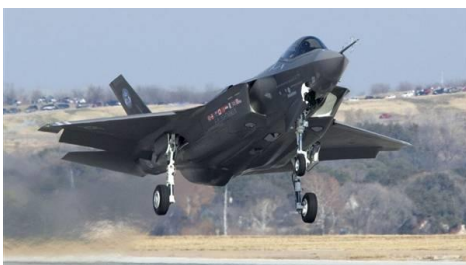
The noise of the quarry and the trucks greatly affect the resale value of properties. As mentioned the added noise of the Lead in fighters flying directly over Brandy Hill will just compound the noise issue. Photo Z

NOISY: The F-35 Joint Strike Fighter jet has noisier take-offs and landings than the current Australian fleet of F-18 Hornets at Williamtown RAAF Base, a senior US Department of Defence officer has told Australian media.

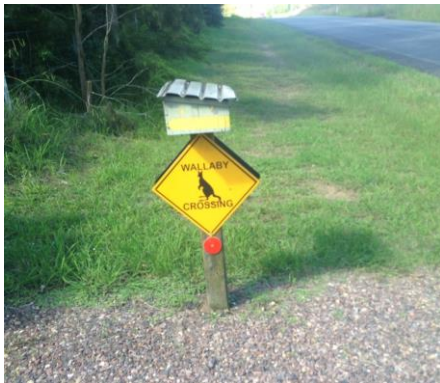
The wild life such as kangaroo, wallabies, possums, echidnas and many other animal cross Brandy Hill Road and over the last few years several have been hit and killed by vehicle.
