Report on  
Additional Geotechnical Investigation

Cranbrook School ECI  
Victoria Road, Bellevue Hill

Prepared for  
Cranbrook School

Project 84944.02  
October 2018

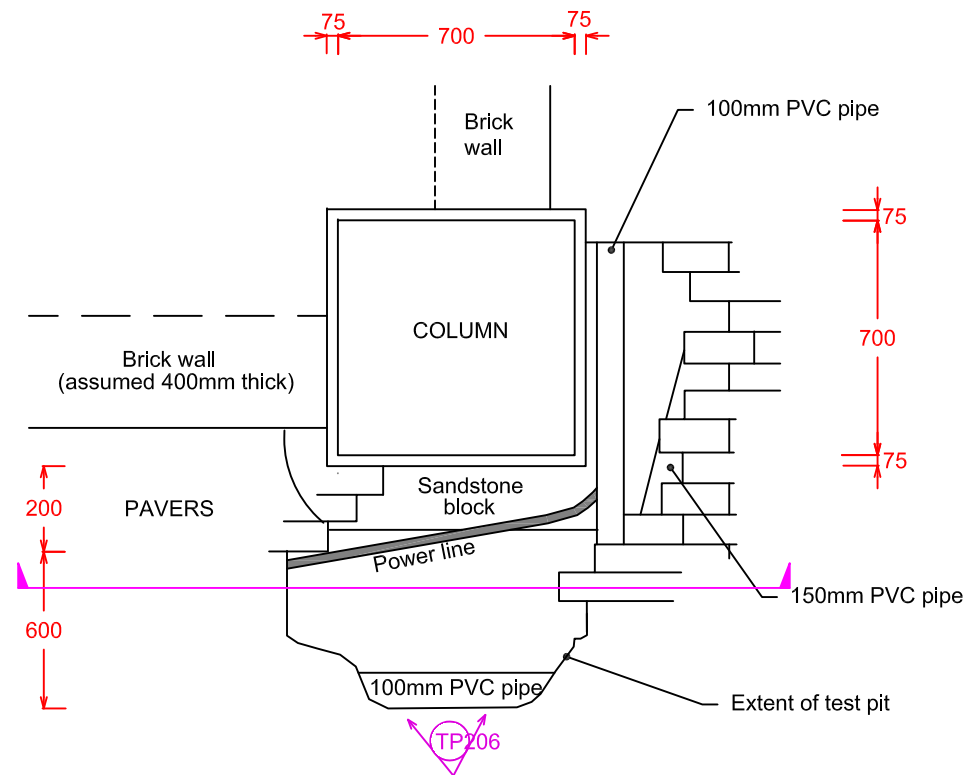
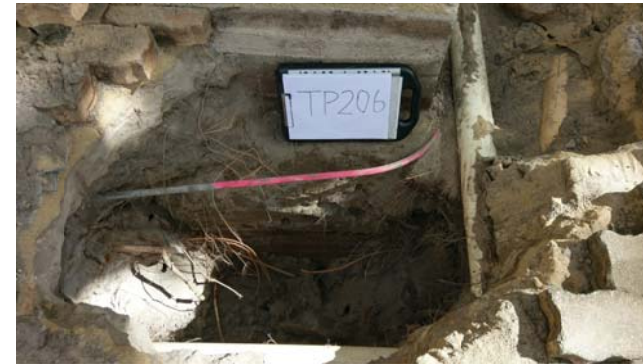
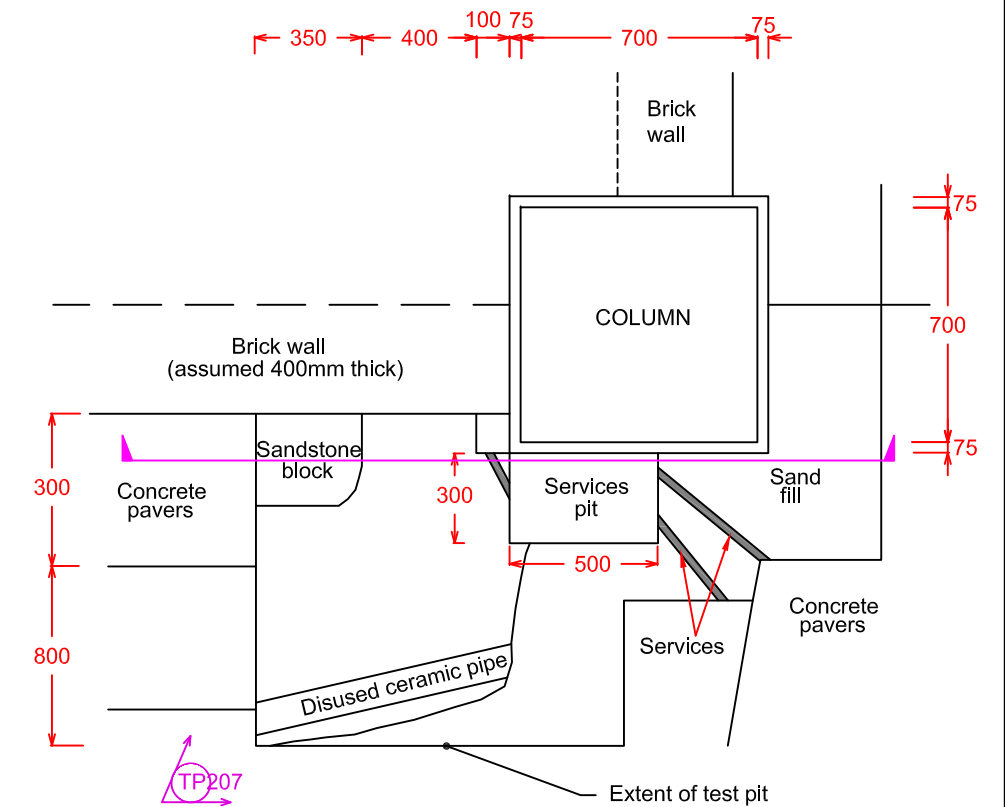
TP206

The test pits excavated adjacent to the northern side of the Perkins Building suggest that the building may be founded on strip footings that vary in depth from about 0.5 m to approximately 3 m depth. It is noted that confirmation by physically probing and inspecting the base of the footing could not be undertaken at all locations due to the depth of the pit and the safety and damage risks posed by such deep excavations in very loose sandy filling. The nearest boreholes to the test pits encountered loose sands at these depths.

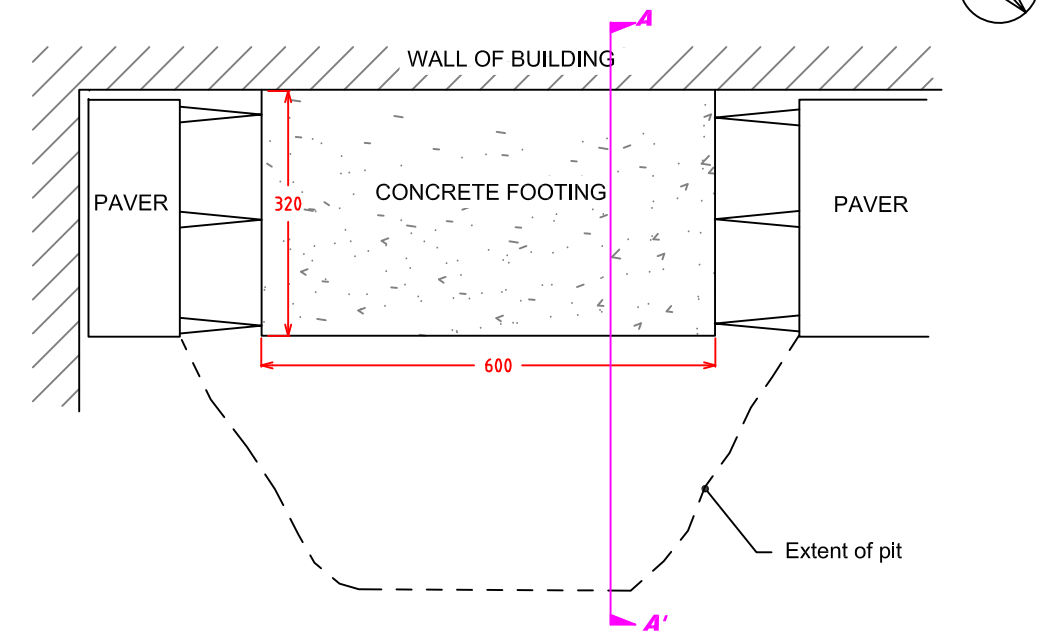
TP401 Section A-A'

DPT rod inserted at the base of the footing at angle of about 45°. It was inserted to a depth of 1.9m and no footing or hard surface was encountered.

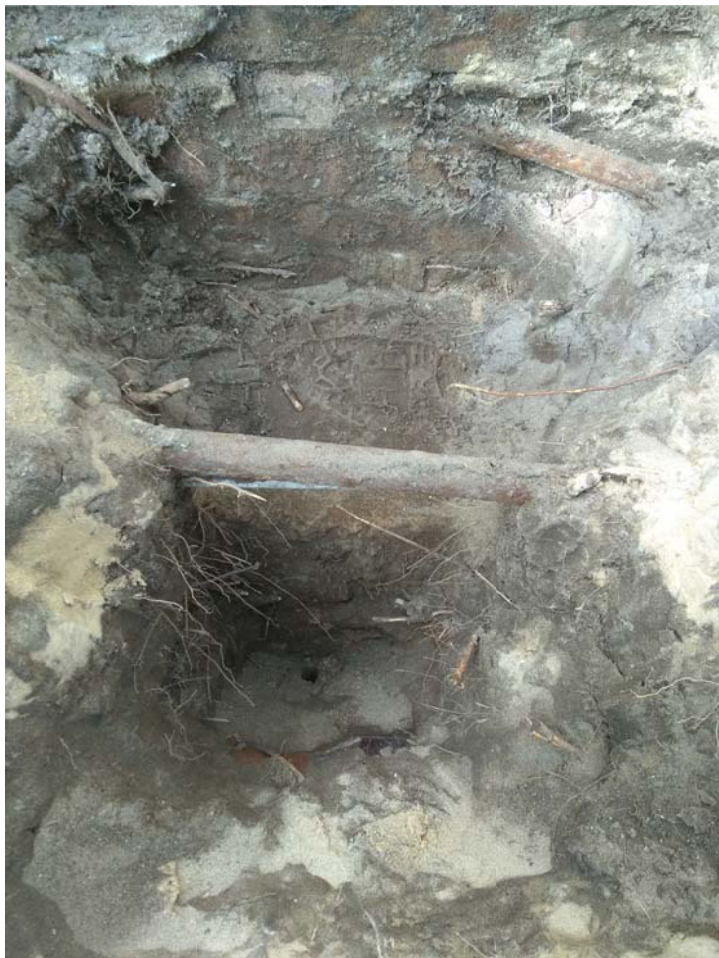
**TP402 Section A-A'**

DPT rod inserted at the base of the footing at angle of about 60°. It was inserted to a depth of 1.9m and no footing or hard surface was encountered.
