**PRELIMINARY GEOTECHNICAL SITE  
ASSESSMENT**

**STAGE 1- SALAMANDER WATERS  
KANIMBLA DRIVE, SALAMANDER BAY**

**Prepared for  
Hill PDA Pty Ltd  
Port Stephens Council**

**Project 39079  
JANUARY 2005**

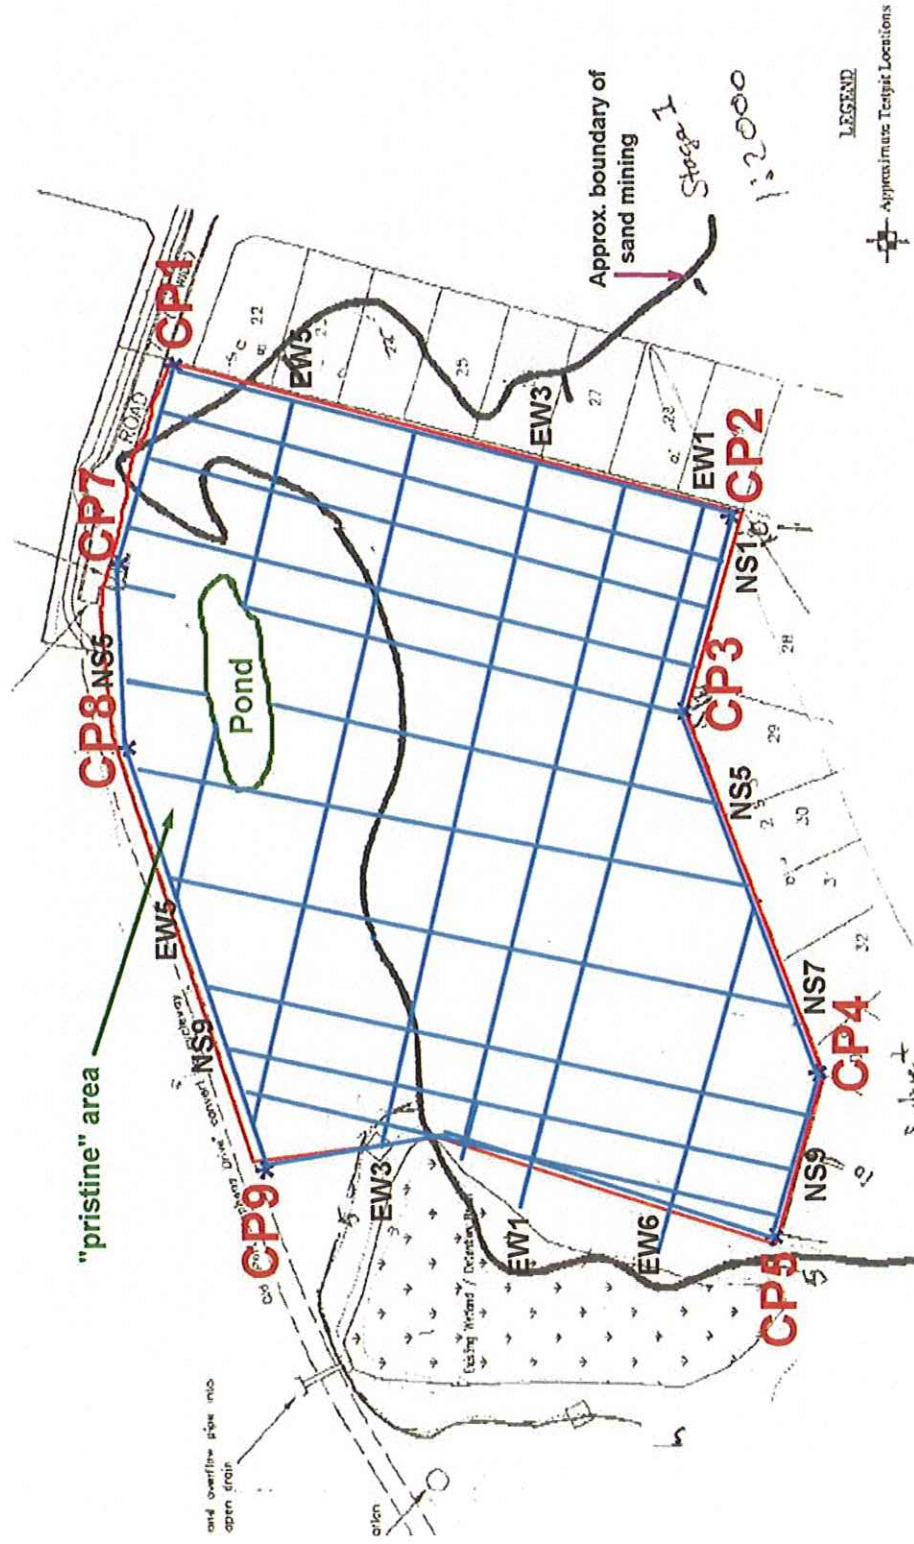
## Diagram of Approximate positions of Measurement Lines

Note: the red line is the approximate boundary of the Proposed Stage 1 Development; the blue lines are the approximate locations of the measurement lines applied to the site. The land that is between Old Port Stephens Road and the approximate boundary of the sand mining is generally not modified by mining or other processes.
