HAZARDOUS MATERIALS AUDIT REPORT

Transpacific Industries Pty Ltd

Lot 223 Kyle Street, Rutherford

AUGUST 2005

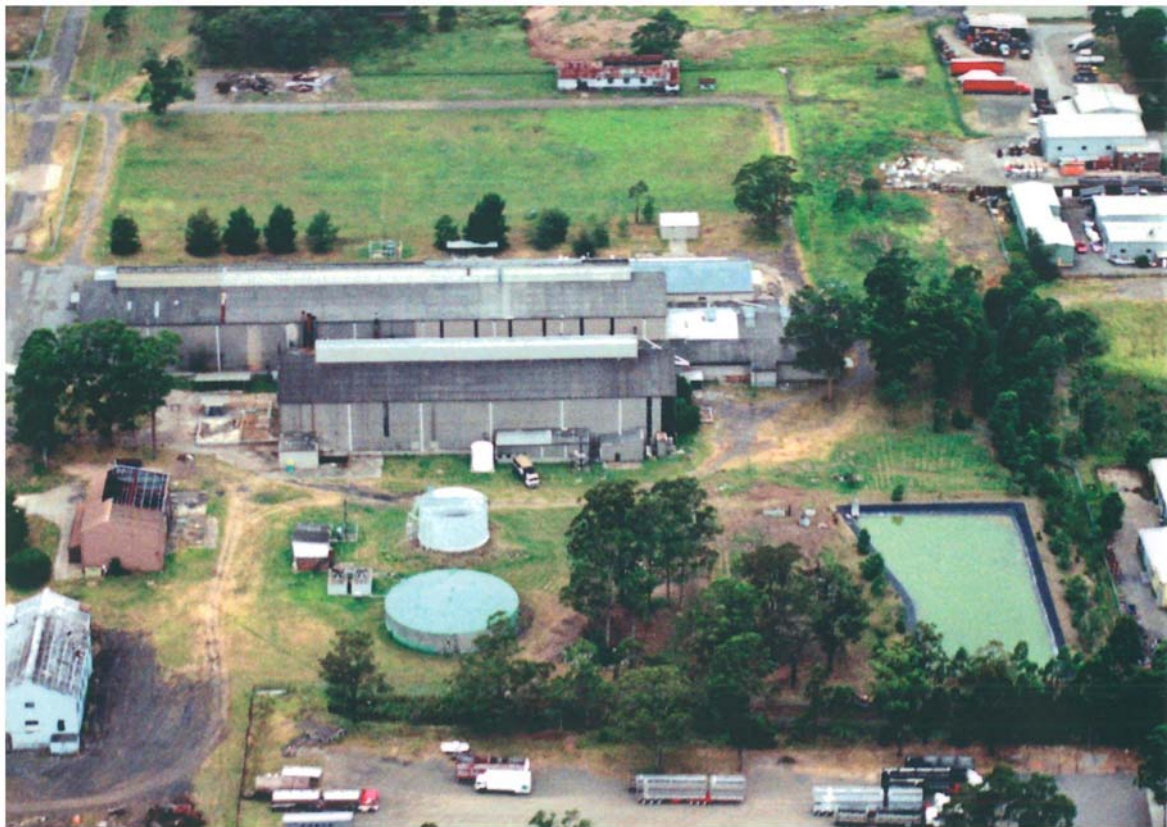
Figure 8. Aerial photograph of Lot 223 on DP990651 (2004)

The buildings located at Lot 223 are shown in Figure 8 as at the time of purchase by TPI.

Note the two large effluent treatment tanks and lagoon in the foreground. The Dye House is the consolidated group of buildings in the centre of the photograph and the Old and New Boiler Houses are located to the lower left of the photograph. The old laboratory building is located at the top centre.
