# Appendix F

## Estuarine assessment

Settlement City Shopping Centre – Port Macquarie  
Environmental Assessment proposed Stage 1

**SETTLEMENT CITY SHOPPING CENTRE  
COASTAL AND ESTUARINE PROCESSES, HAZARDS AND IMPACTS**

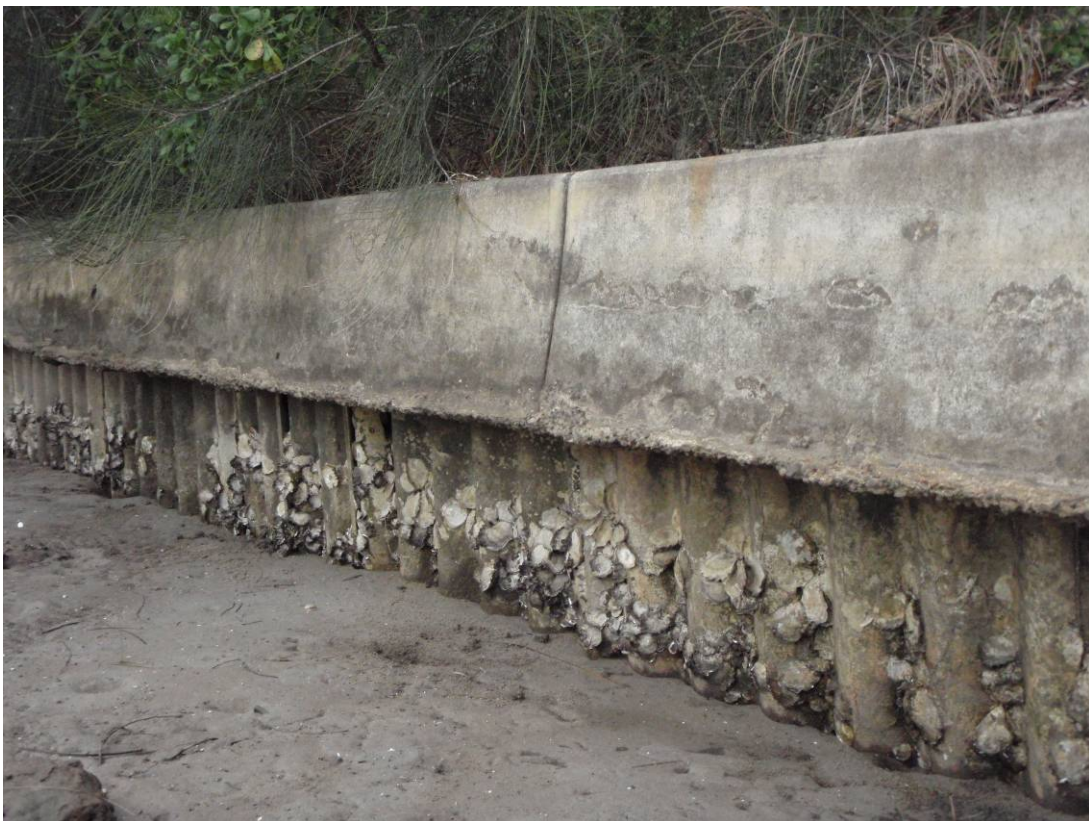
**Photo 4**

Along the western edge of the site (**Photos 1 and 3**) and around to the weir on the northern canal (**Photo 8**), we observed in general a canal edge treatment comparable to an “intertidal beach” cross-section as described in the NSW canal subdivision guidelines (*PWD, 1992*). The structural edge treatment at the site comprises a corrugated sheetpile, possibly asbestos-cement, with concrete capping beam along the crest (**Photos 3 and 4**). The treatment type changes east of the weir where a failed concrete walkway occurs.

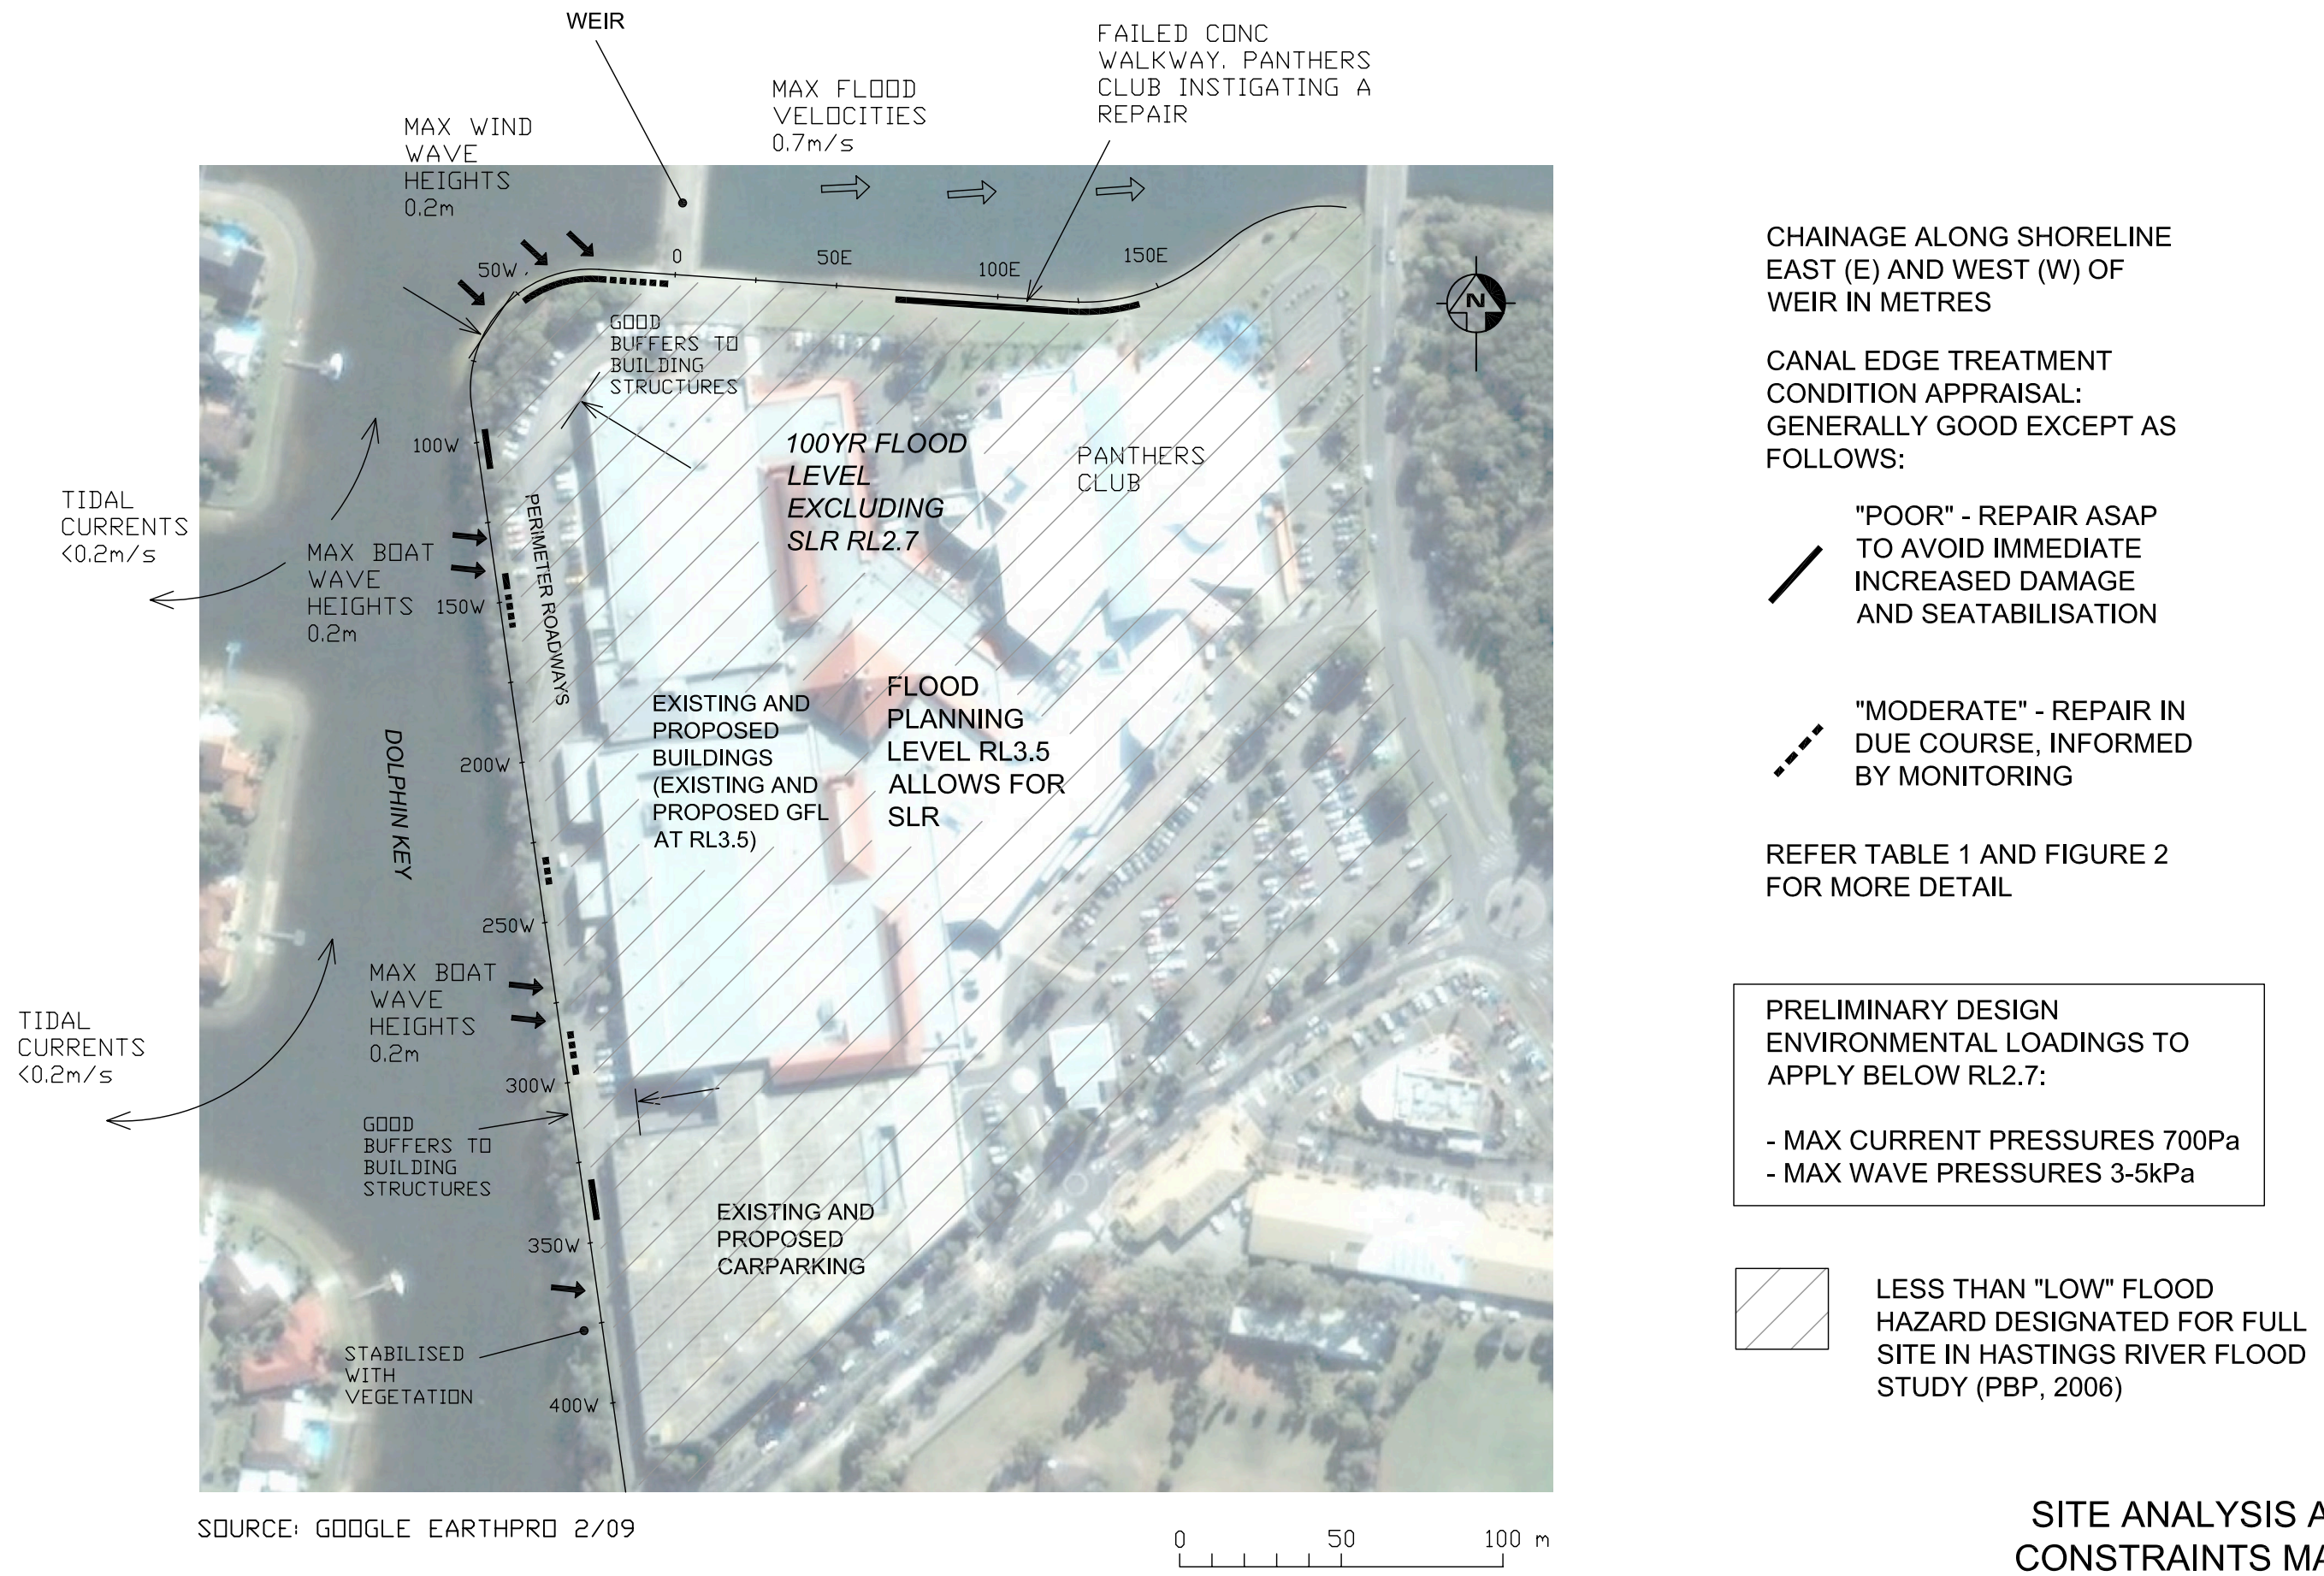
FIGURE 3

A mapping of the site depicting the key findings of this assessment is presented in **Figure 3**. This is included to address Clause 3 of General Requirements, DGR Attachment 1.
