Gary Blumberg & Associates Pty Ltd

gpb:gpb/07-33/lr775

29 January, 2008

**KIOLOA BEACH HOLIDAY PARK
23 ADDITIONAL SHORT-TERM SITES AND 93 ADDITIONAL CAMP SITES
COASTAL HAZARD ASSESSMENT**

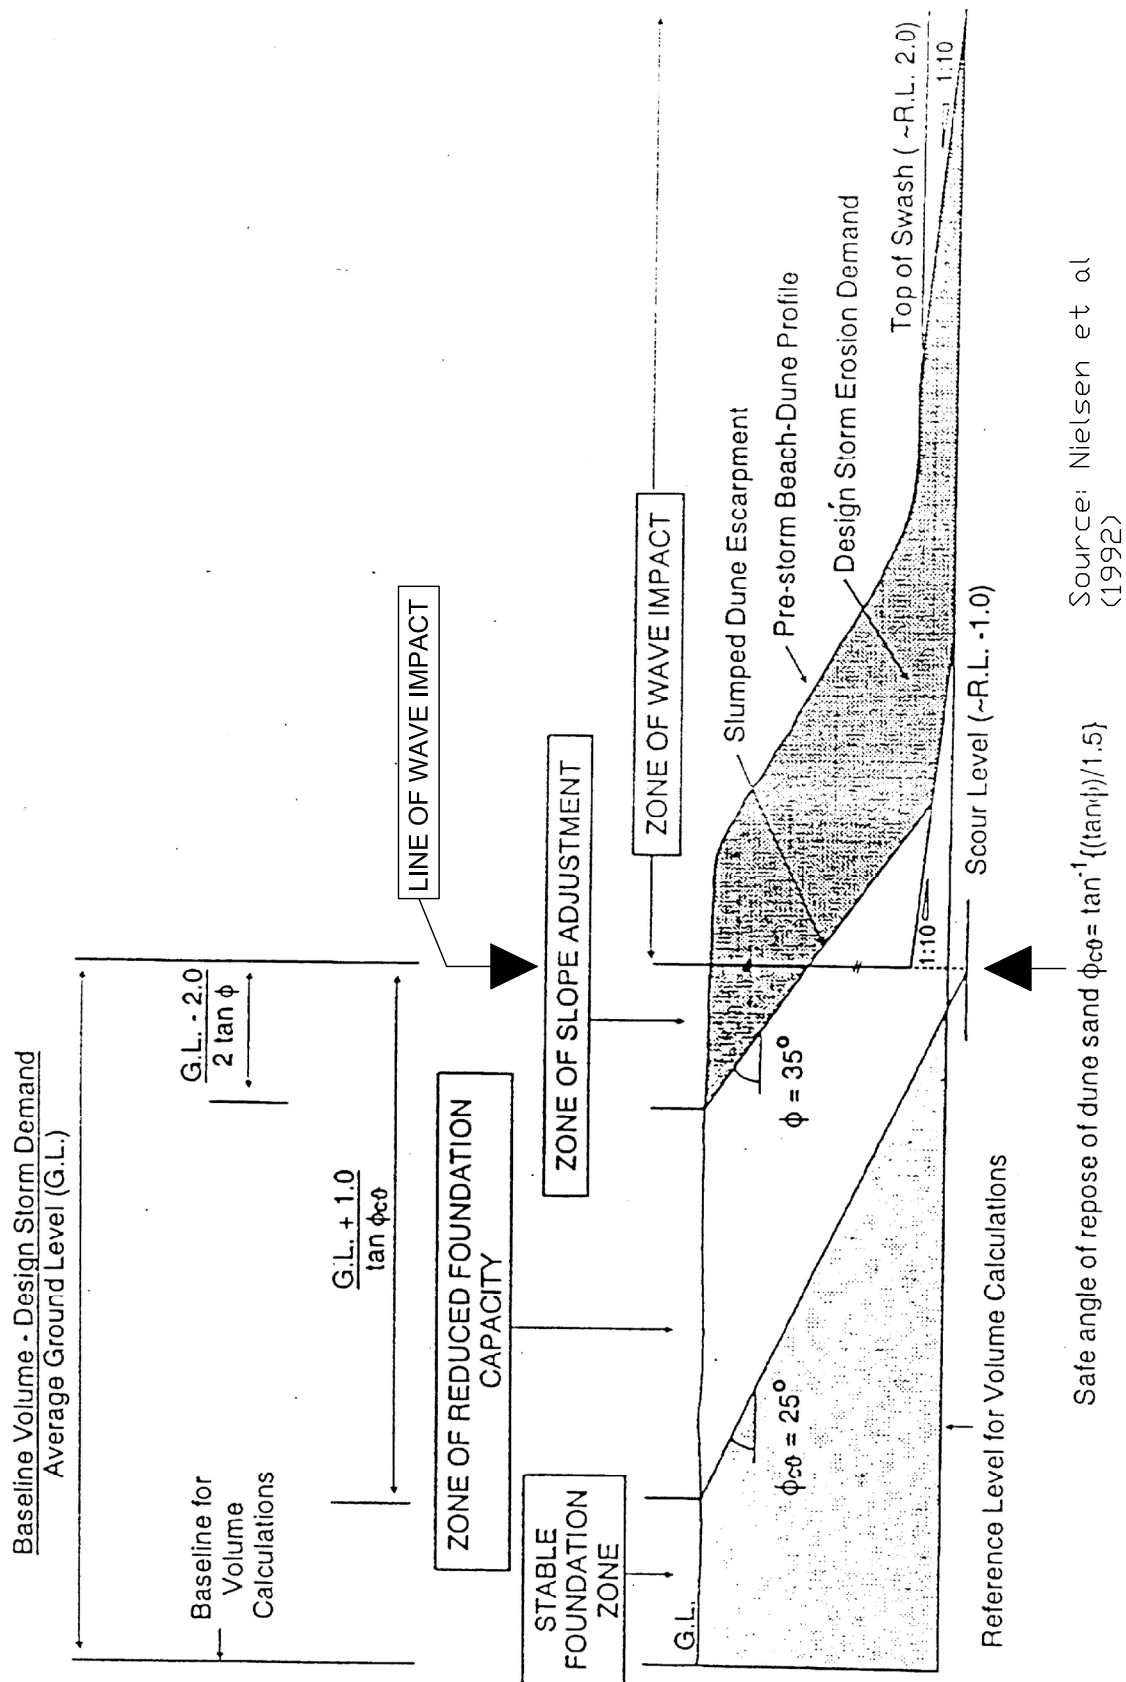
FIGURE 2

Wave erosion leads to the removal of beach and dune sand from the Zone of Wave Impact (**Section 6.1.1**). For a major event, the landward limit of this zone forms a near-vertical scarp at the peak of the storm. Within hours to days of the storm passing, the back-beach erosion escarpment dries out and slumps. The slumped slope is taken to equal the angle of repose of marine sand, nominally taken as 35 degrees. The slumped escarpment gives rise to a Zone of Slope Adjustment which extends further landward. The Zone of Reduced Foundation Capacity accounts for a reduced Factor of Safety from that which would normally be considered stable in the area immediately landward of the Zone of Slope Adjustment. These various zones were conceptualised in Nielsen et al (1995), and this model is currently adopted by DECC to represent the slope instability hazard at an eroding sandy coast (**Figure 2**).

GENERIC BEACH AND DUNE INSTABILITY MODEL ADOPTED BY DECC

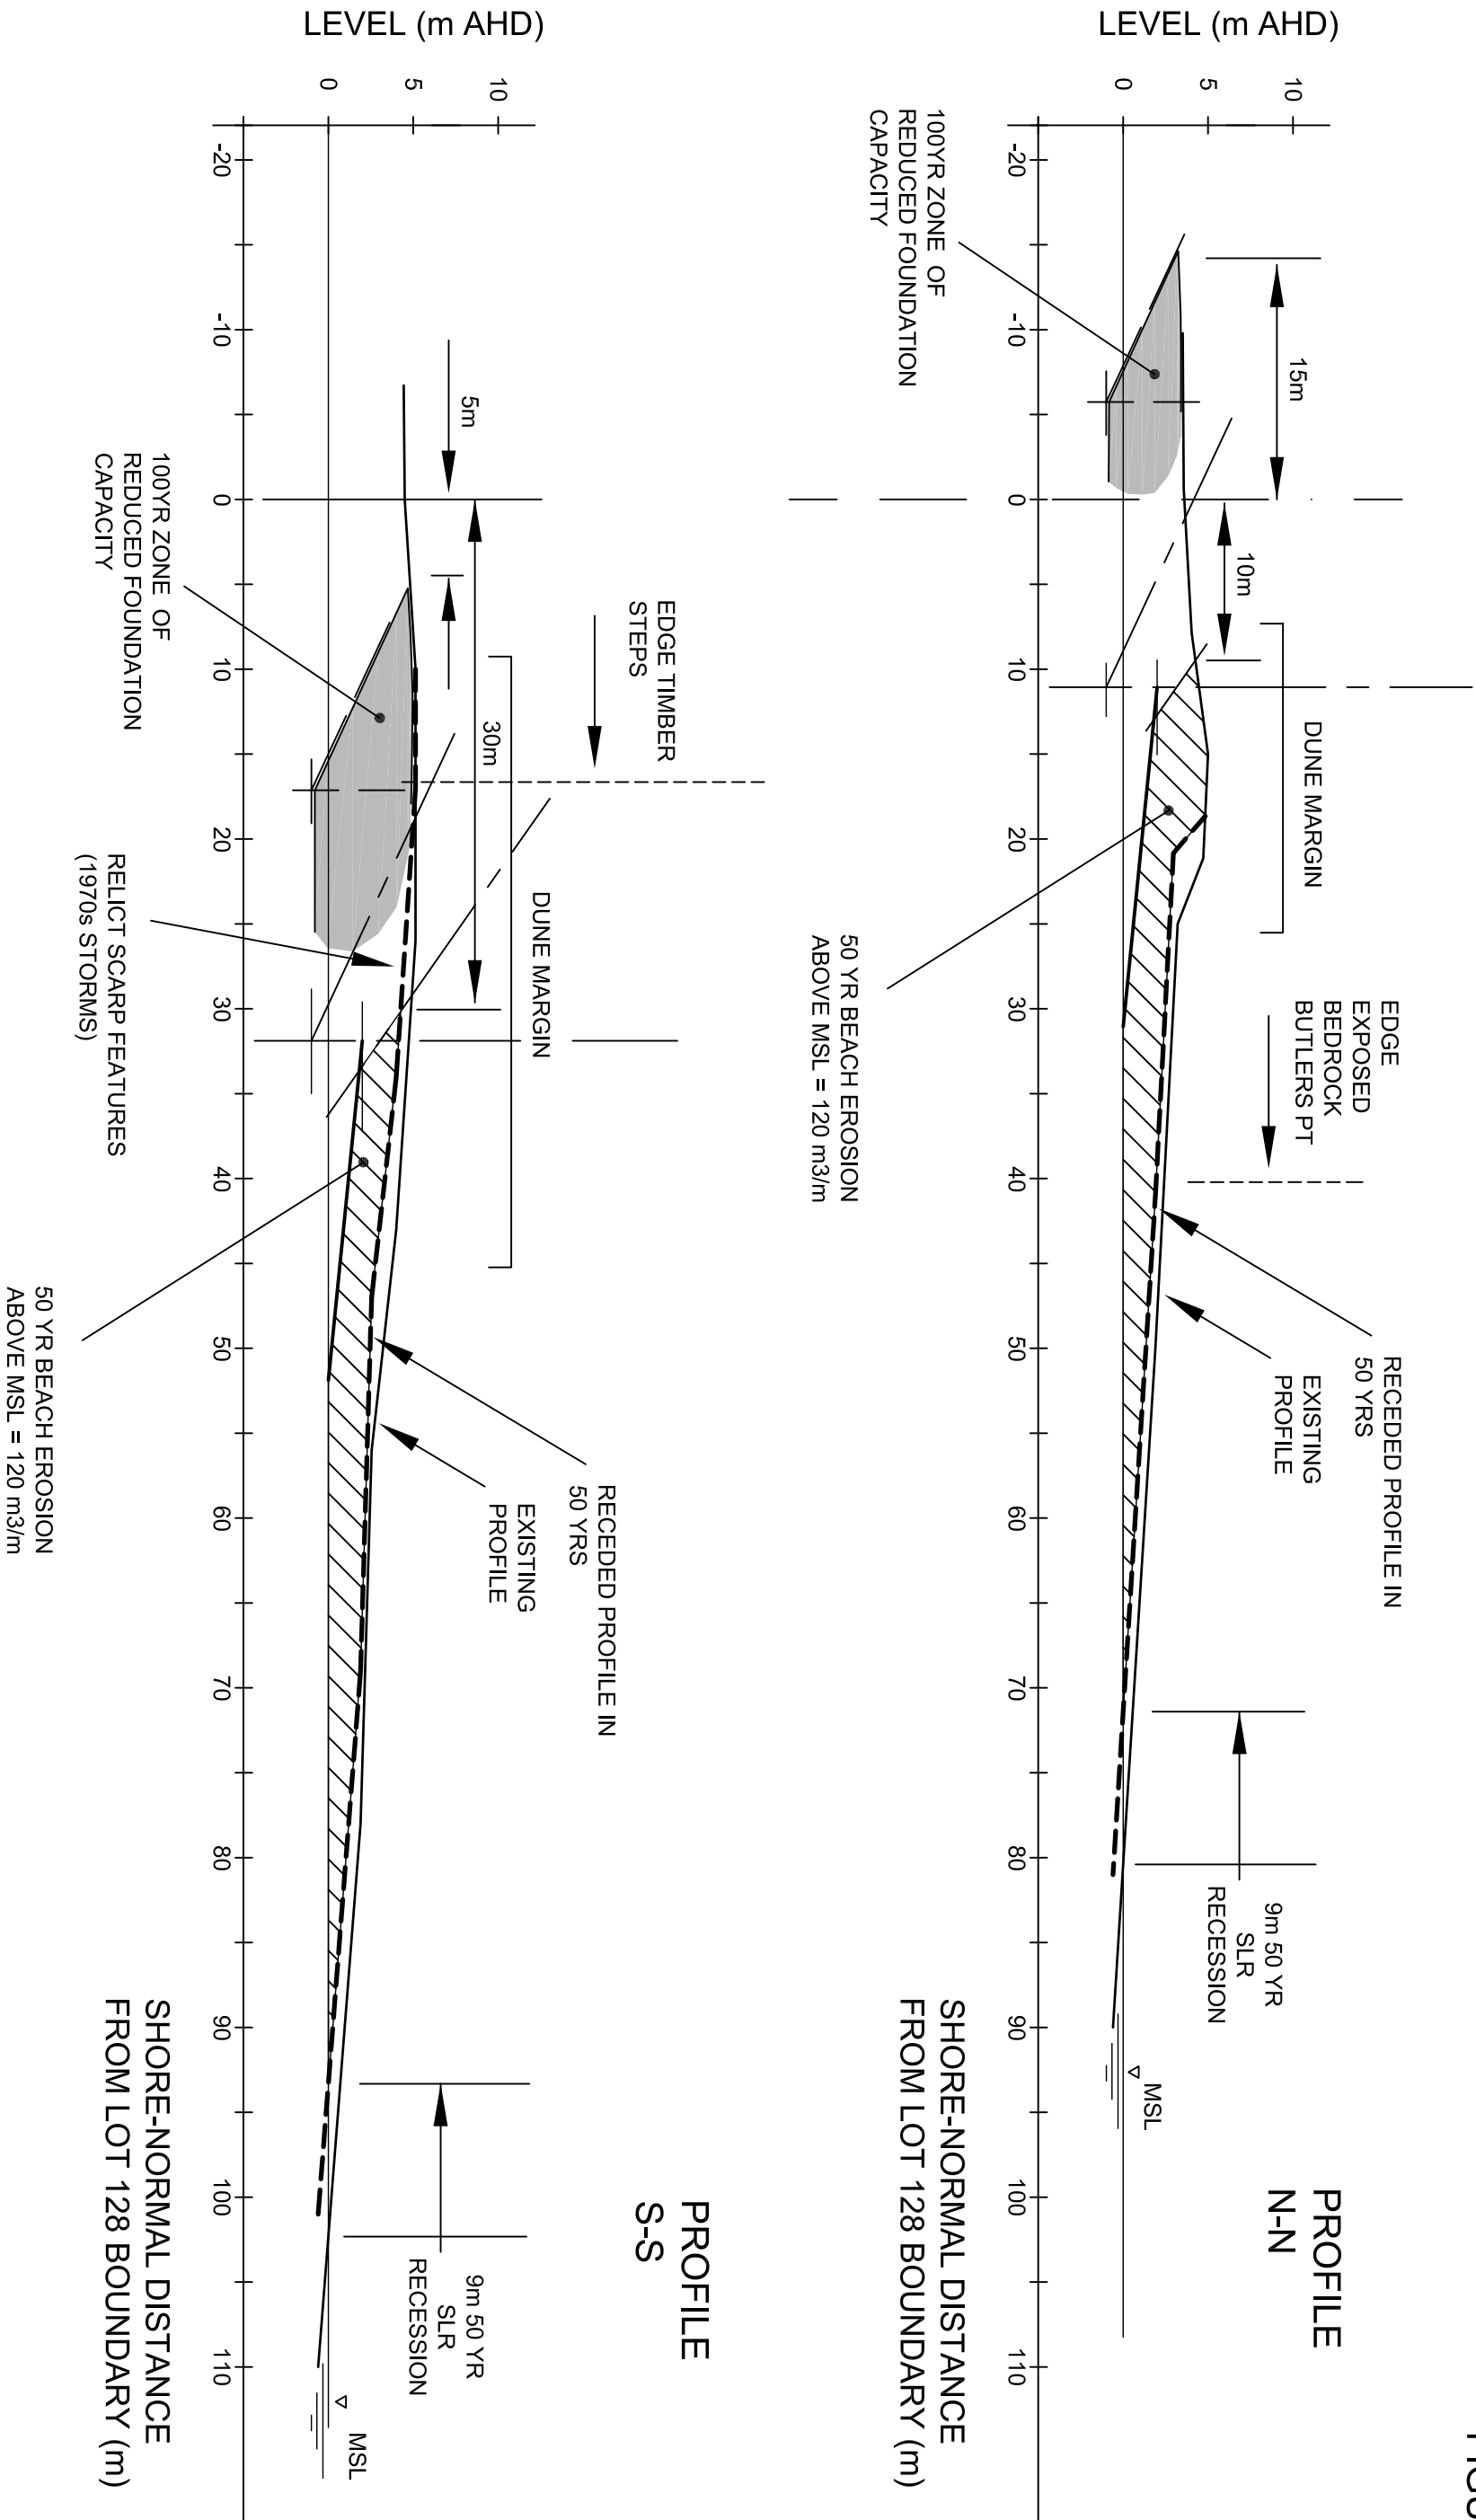
The application of the DECC model at Kioloa Beach is shown in **Figure 3** with the key outcomes summarised below in **Table 3**.

The investigation has applied DECC's back-beach and dune slope instability model to assess the impact on the Holiday Park of combined beach erosion and shoreline recession (**Figures 2 and 3**). The hazard zones are found to mainly reside in the dune. They are sufficiently seaward of sites within the Holiday Park such as to be readily manageable.

1. FIGURE 3 TO BE READ IN CONJUNCTION WITH FIGURES 1 AND 2
2. COASTAL INSTABILITY MODEL AFTER NIELSEN ET AL (1992) APPLYING 50 YR AND 100YR HAZARDS FOR RECESION (INCLUDING EFFECTS OF SLR) AND BEACH EROSION

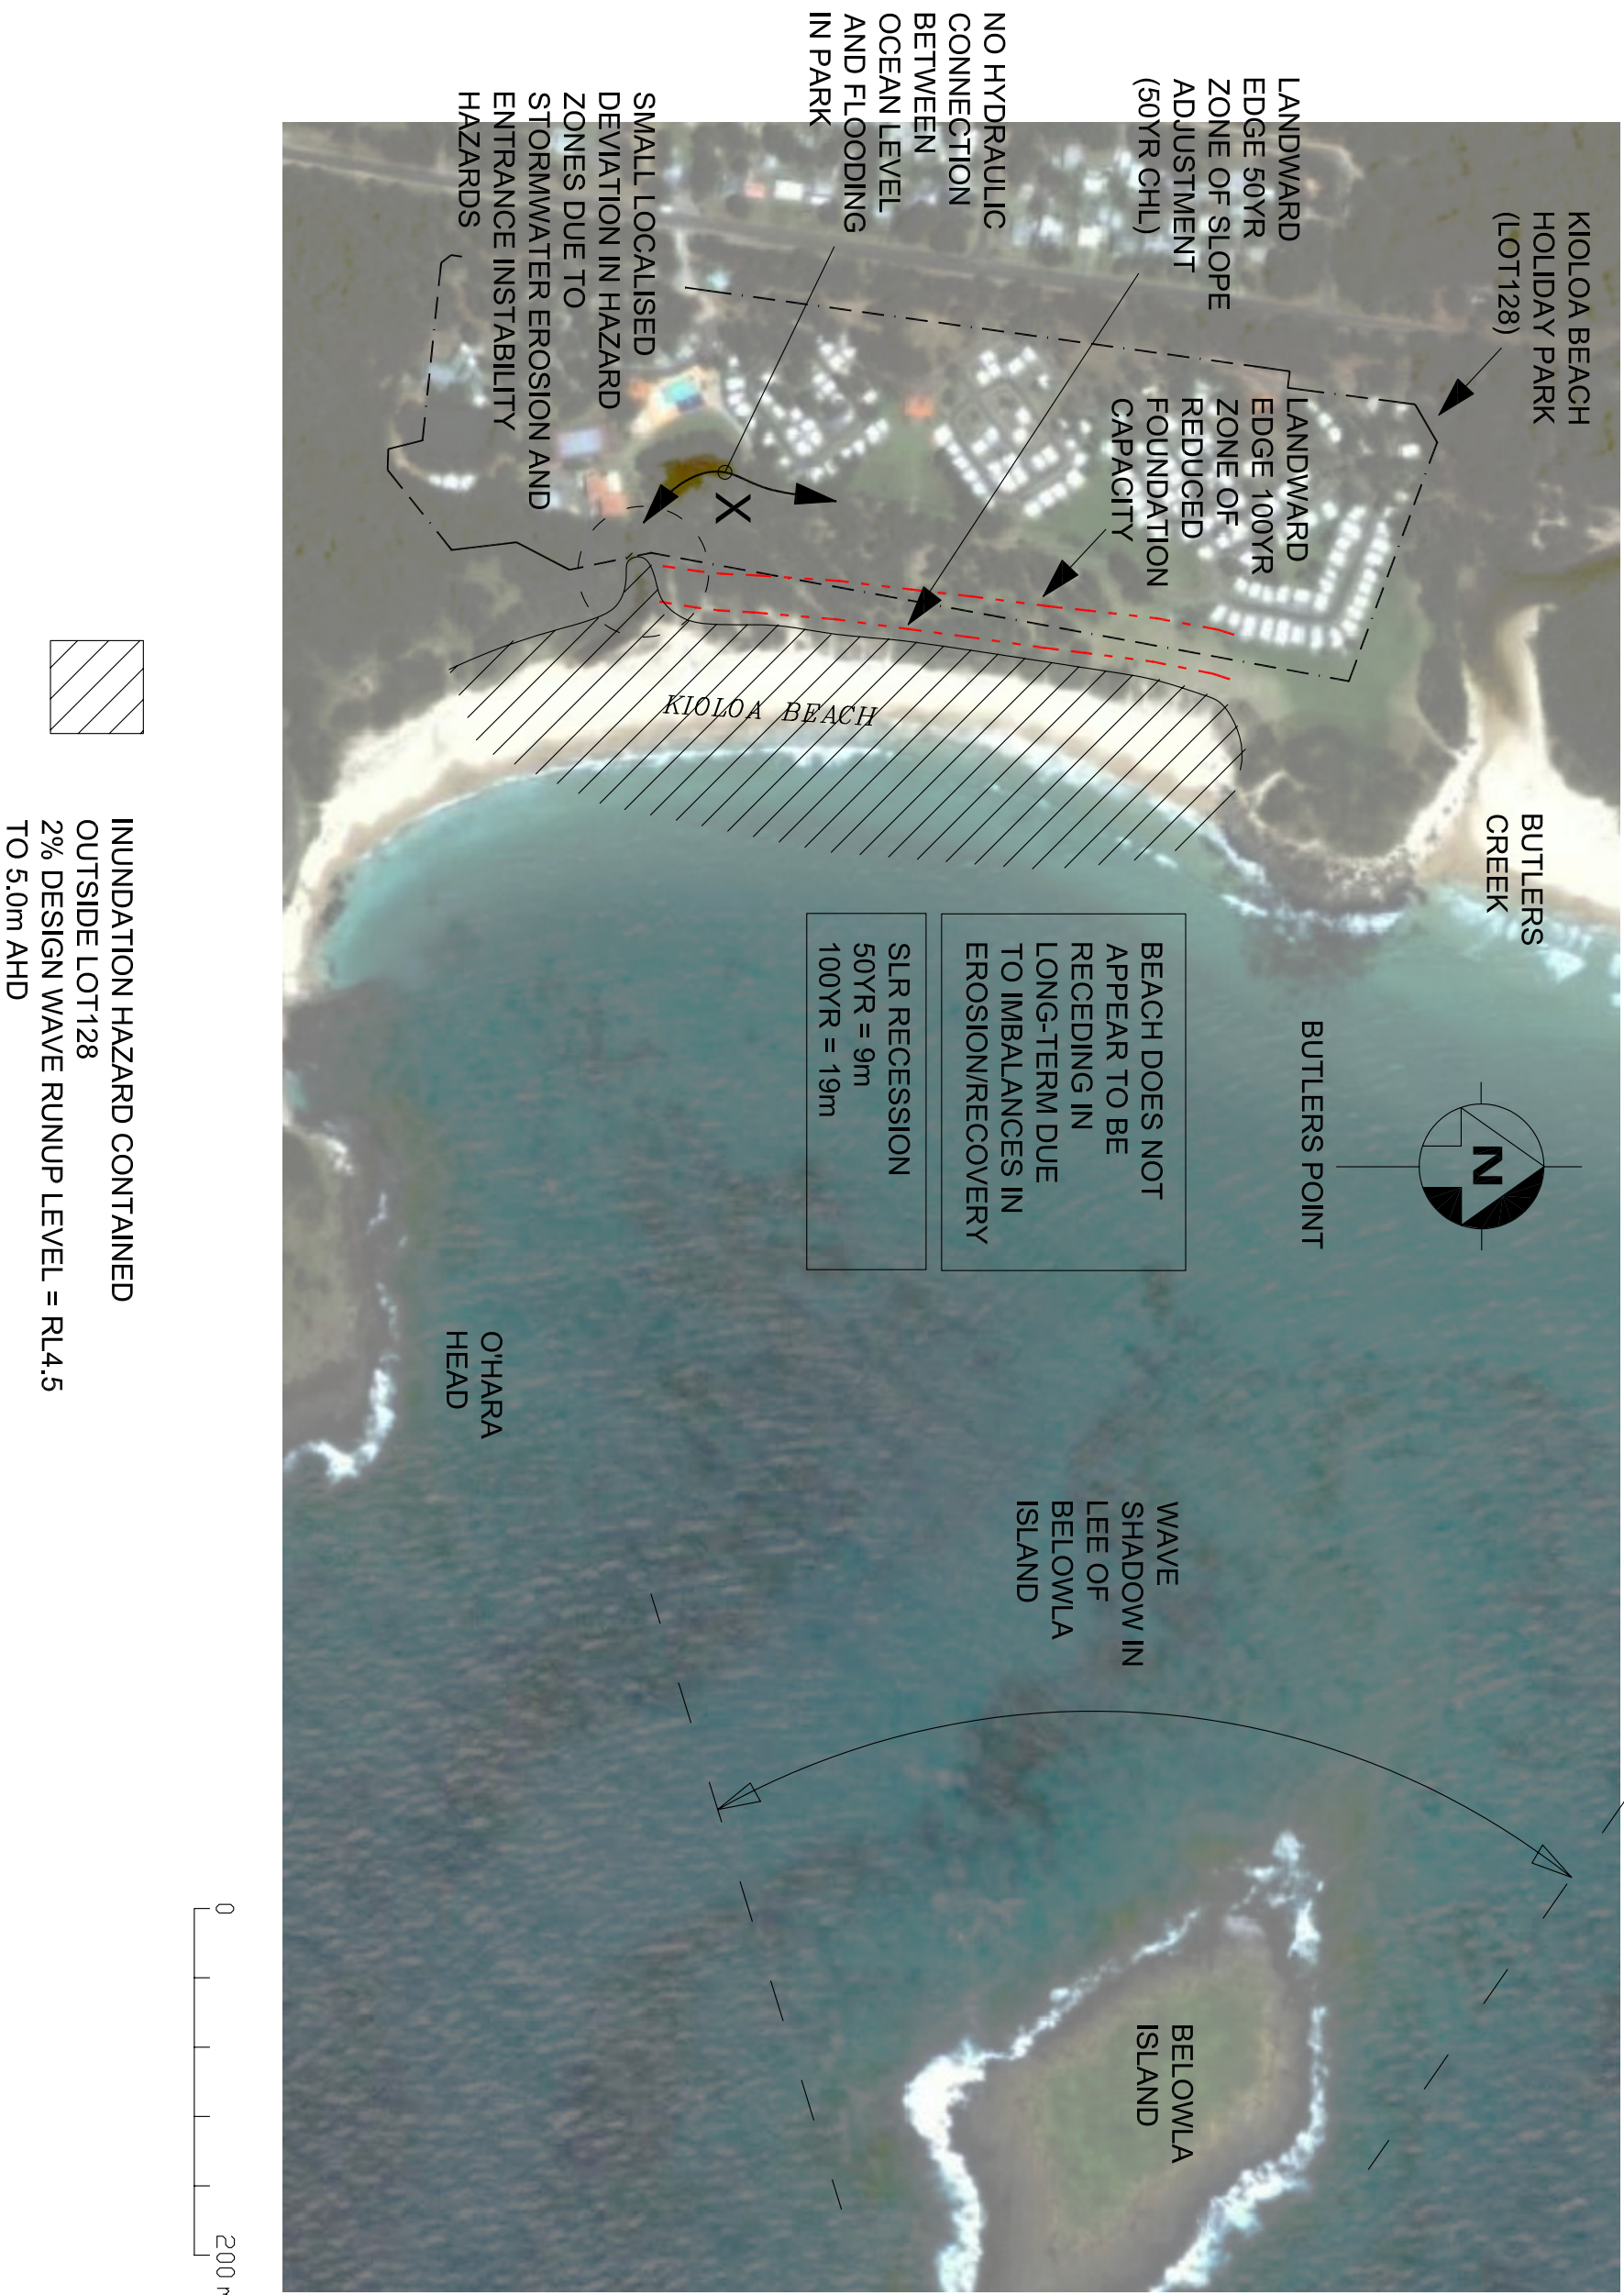
FIGURE 4

A break-out of the creek outlet would concentrate erosion of the berm, however any influence on erosion behaviour would be localised (*say within 50 m of the outlet*). While this may locally contribute to the erosion hazard, the magnitude of the impact would be such as to have no bearing on park infrastructure which is well removed from the SE corner of the site (**Figure 4**).

Figure 4 presents a summary of the key coastal hazards.
