**Appendix E. Geological Report on proposed Armidale Dumaresq Council Landfill site, with emphasis on investigation of a possible geological fault**

**Geological report on proposed Armidale Dumaresq  
Council landfill site, with emphasis on investigation of  
a possible geological fault**

EA Systems Pty Ltd

February, 2006

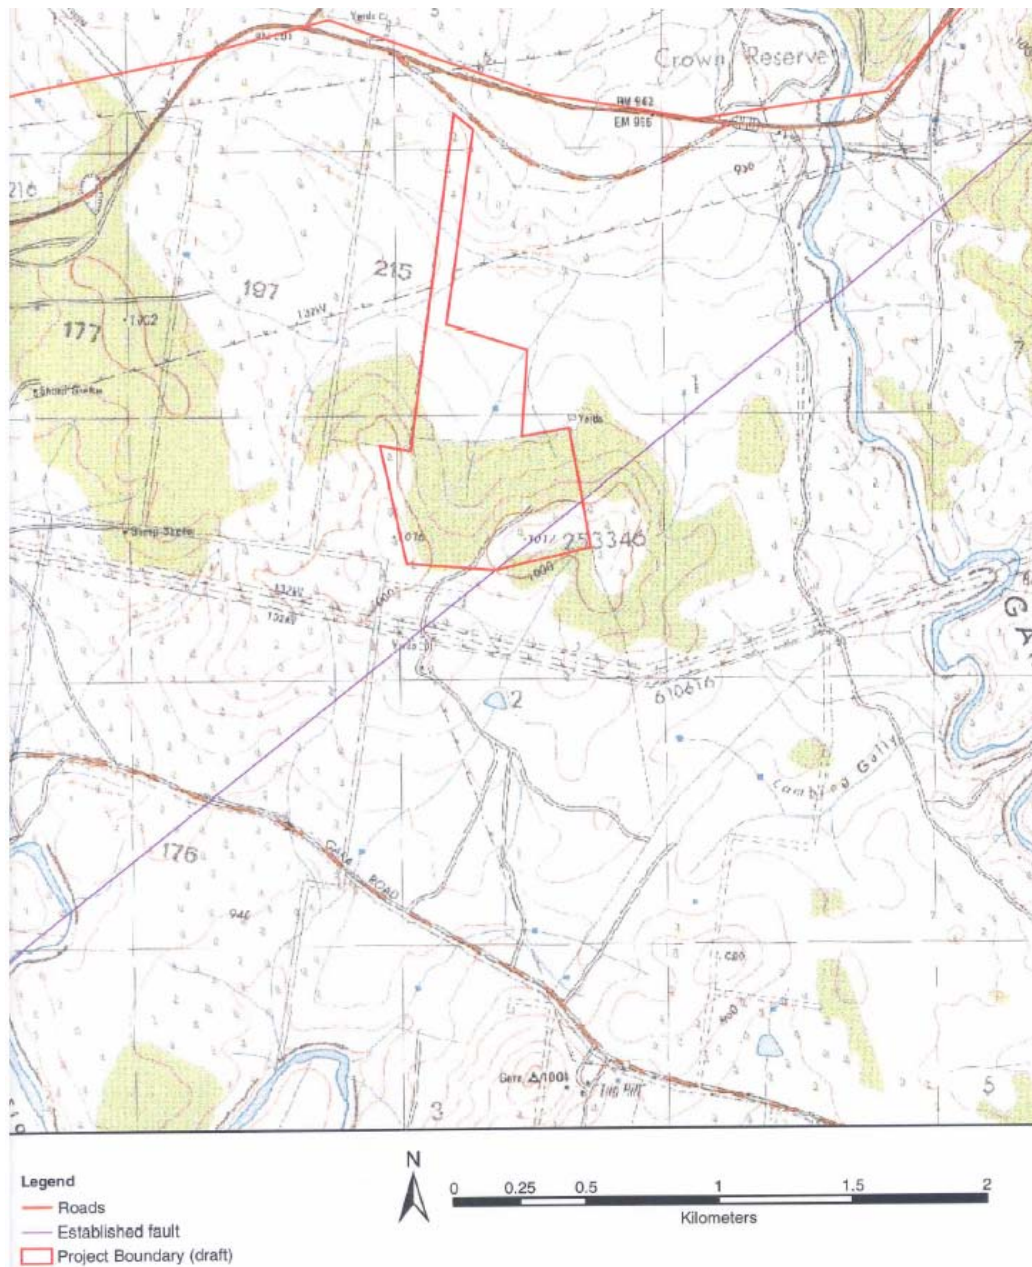
**Figure 1:** Portion of the Hillgrove 1:25 000 topographic map with the position of the proposed landfill site indicated by the red boundary. The projected trace of the fault indicated on the Dorrigo-Coffs Harbour 1:250 000 geological map is shown by the purple diagonal line. The term “established fault” in the legend was added by EA Systems. The term does not conform to that on the geological map which has the fault designated as “position approximate”. The road towards the northern margin of the map is the Waterfall Way.

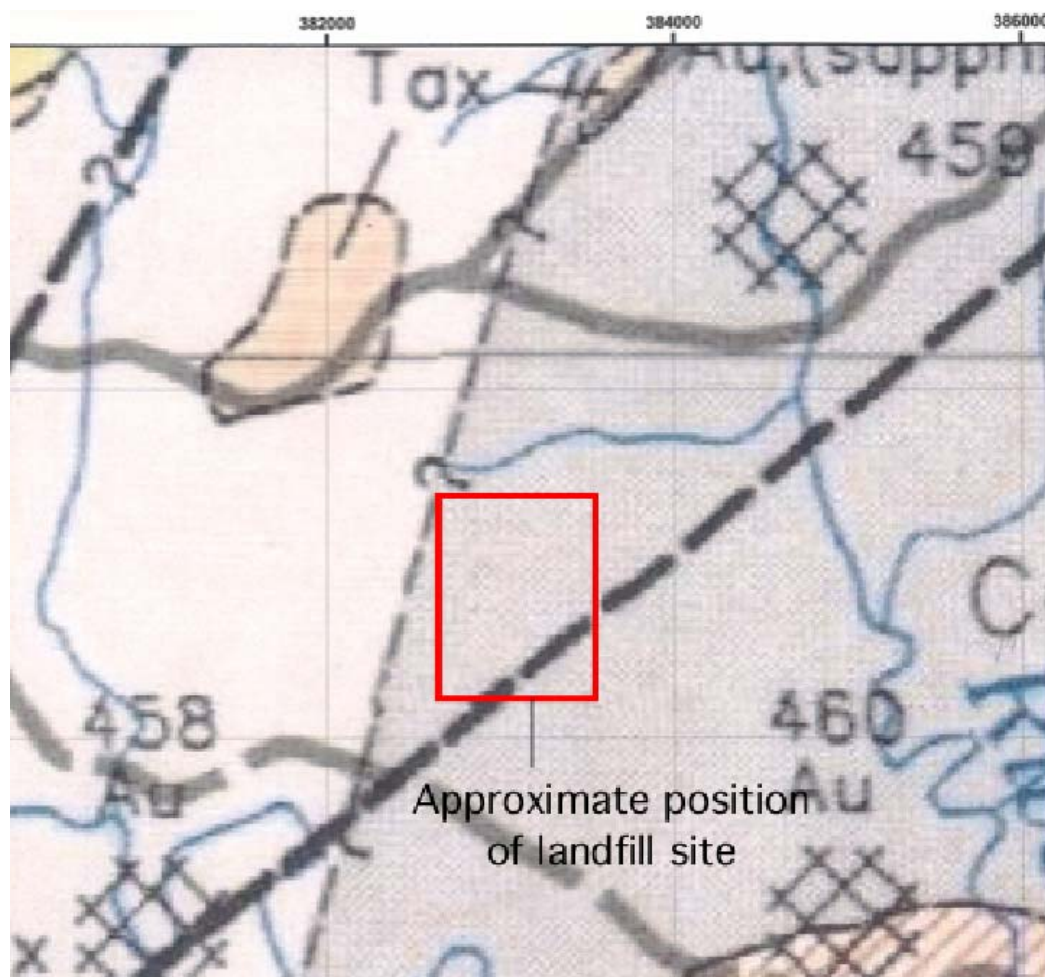
**Figure 2:** Portion of the Dorrigo-Coffs Harbour geological map (Gilligan et al., 1992), with the approximate position of the landfill site superimposed. The fault symbol (dashed diagonal line) designates “position approximate” on the published map. The pale mauve shading is designated as Girrakool Beds on the geological map.

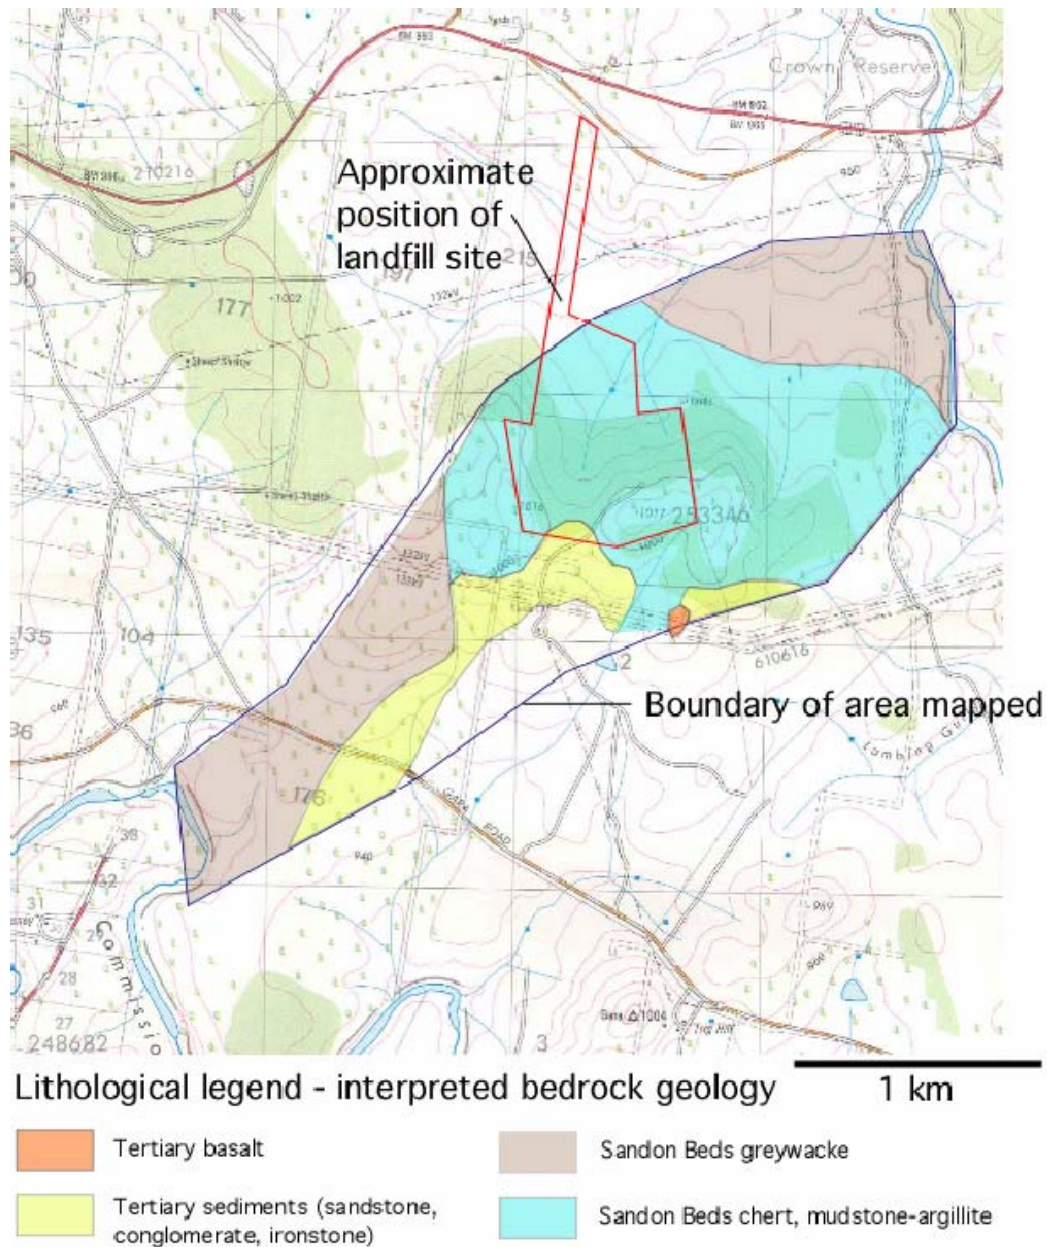
{conglomerate} and sandstone, along with a few masses of ferruginous cemented transported regolith (Figs 7, 9). These sedimentary materials appear to form only a thin, discontinuous veneer (up to a few metres thick) resting unconformably on the Sandon Beds. They probably represent remnants of former fluvial deposits. Closely associated with the Tertiary sediments about 0.5 km east of the Crisp homestead, there is a small (50-100 m diameter) mass of Tertiary basalt (Fig. 7), perhaps representing an erosional remnant of a lava flow or small intrusion.

**Figure 7:** Bedrock geology (rock types) interpreted from reconnaissance mapping, including the area of the landfill site.
