**INVINCIBLE SOUTHERN EXTENSION PROJECT - BLASTING
IMPACT ASSESSMENT**

REPORT NO. UM-1606-150916

**Thomas Lewandowski
15th September 2016**

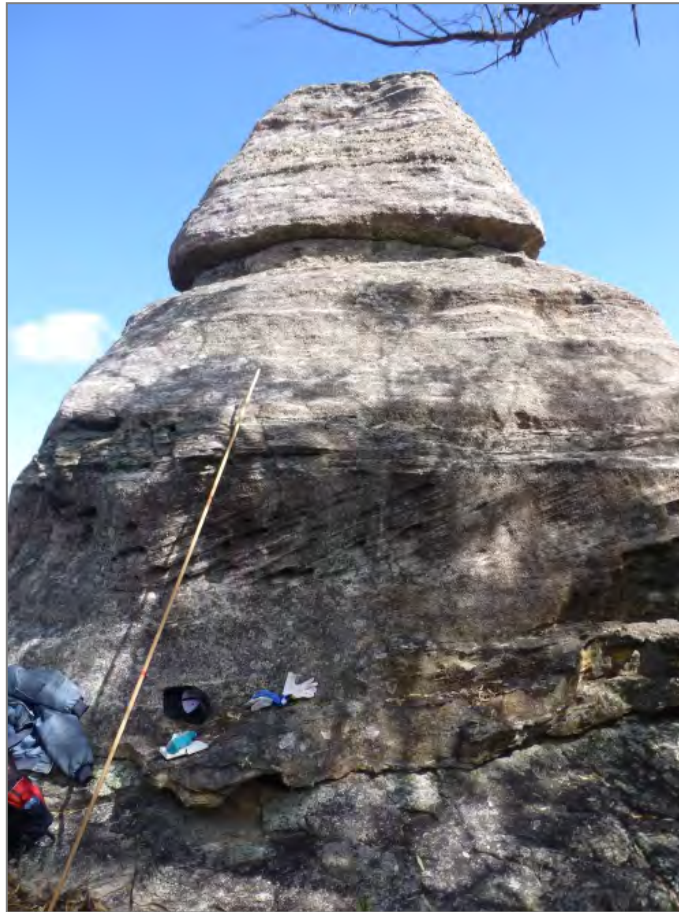
Figure 2C - Top Feature – Dome

The site inspection revealed that the majority of the formations in the top section are smooth dome shaped forms, showing an almost conical shape, which allows for immediate water dispersion, see **Figure 2C**.

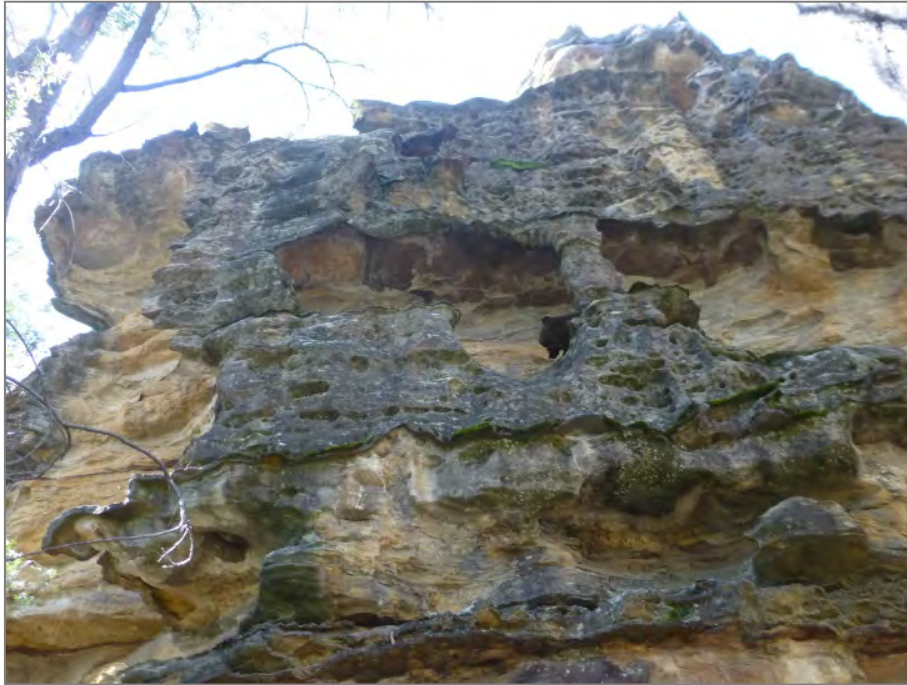
Figure 2F – ‘Window’ Feature

There are a number of unusual features including various formations such as “windows”, geological intrusions, honeycombing, dyke intrusion and others, see **Figures 2F** and **2G**.

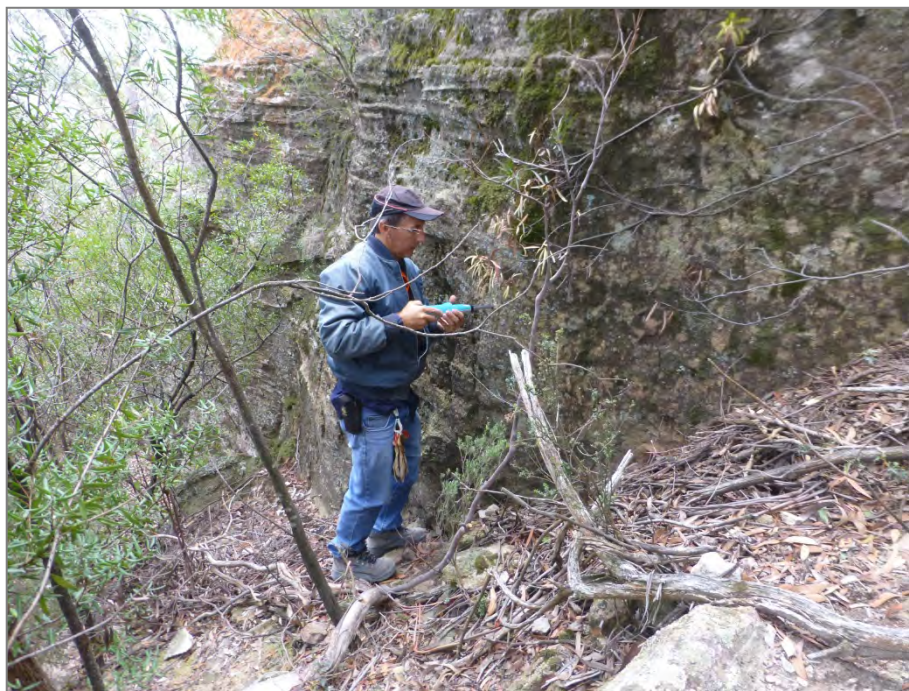
Figure 3 - In-field Rock Testing

To provide some indication about the rock strength of the sandstone strata, USC measurements were undertaken by ESC's engineer using the Silver Schmidt Hammer, which is a non-destructive type test, see **Figure 3**. The measurements are taken using a piston type device and rely on the rebound of a spring showing higher values of rebound (R value) for stronger rock and lower rebound values for lower strength rocks. The Silver Schmidt Hammer is an advanced device, which eliminates potential errors due to the effects of gravity and friction, and produces rebound results in Q-value. The Q-value is then converted to a compressive strength value expressed in Megapascals (MPa).

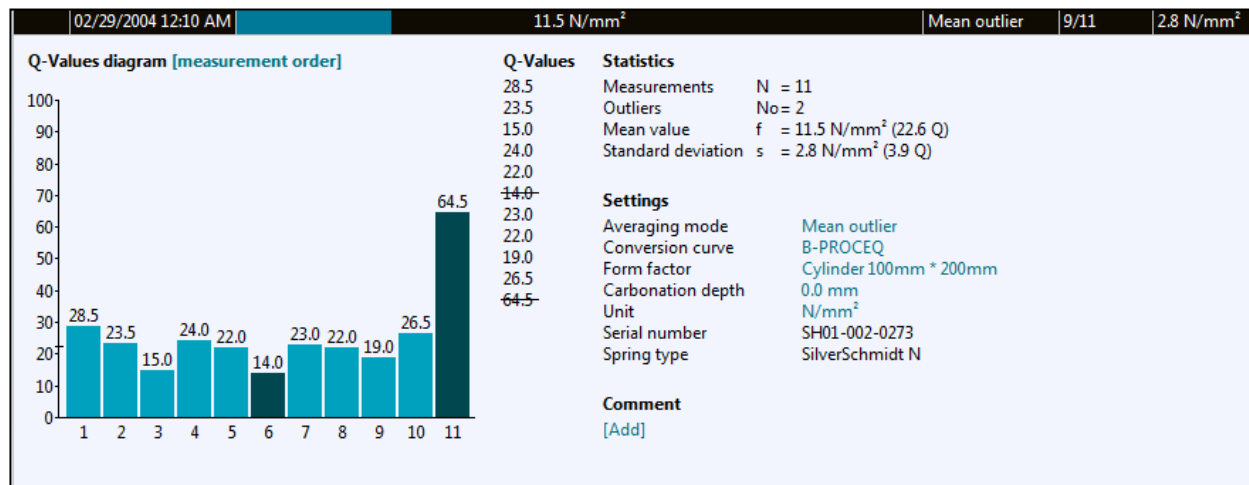
For samples of the measurements taken at the Sandstone Pagodas, refer to **Figures 4A** and **4B**. In both cases there were 11 measurements taken. After truncation of the extreme values an average value based on the remaining 9 readings was calculated. The average rock strength measurements for each sample are 11.5 and 25.5 MPa respectively.

Figure 4A - Sample of Rock Strength Estimation - Low Strength Sandstone, i.e. 11.5 MPa

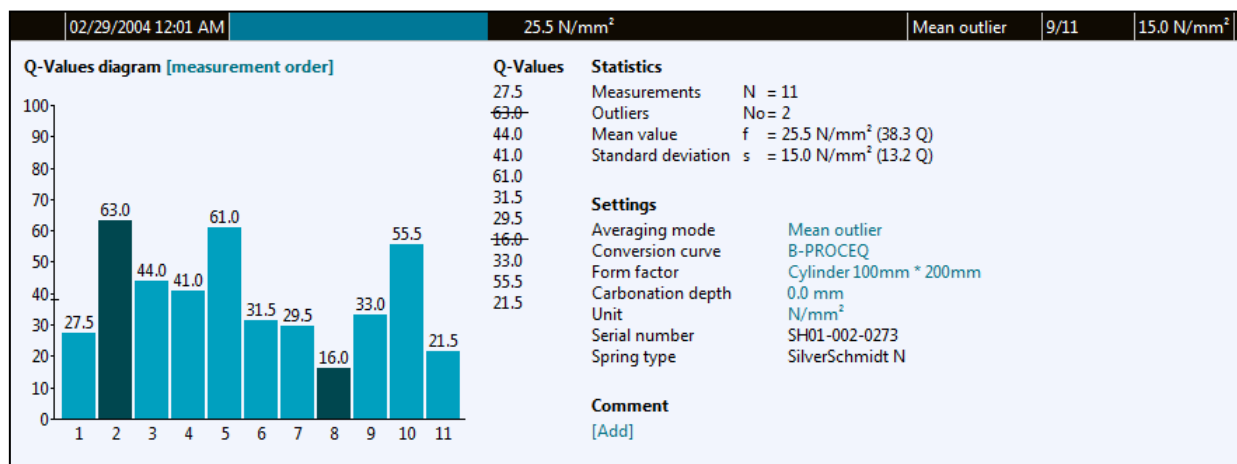
Figure 4B - Sample of Rock Strength Estimation - Medium Strength Sandstone, i.e. 25.5 MPa

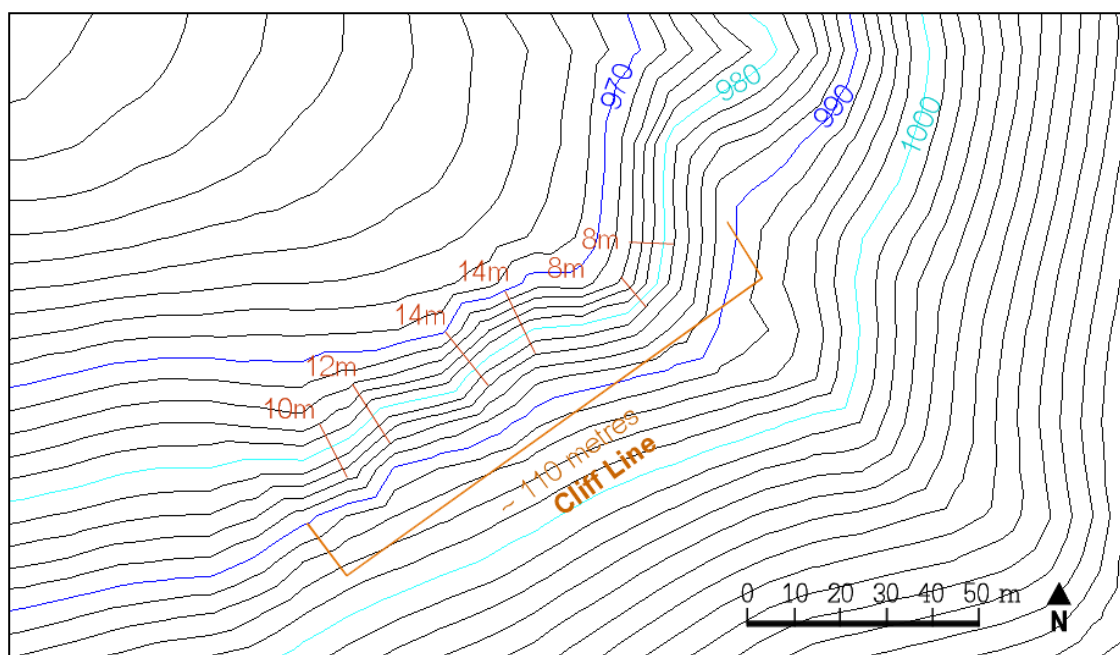
The identified area of the Cliff Line extends for approximately 100 metres in length and varies between 8 and 14 metres in height. The Cliff Line is of northeast / southwest orientation, see **Figure 9A**. The area is accessible from the south-west corner and the inspection of the Cliff Line identified at least 5 different strata layers, which varied in appearance / colour and strength (see rock strength estimation section).

In summary, the structure is described as a major vertical wall of 8 – 14 m high. One section of the Cliff Line appears to be heavily damaged by inferred surface subsidence from previous underground operations. The extent of the damage for the affected area is classified as significant, showing signs of slope sliding. The damage occurred at some time in the past and does not appear to be actively continuing. The remaining section appears structurally sound.

Figure 9A – Heights and Extent of the Cliff Line; (2 metre contour line)
