Client	UNSW c/o Capital Insight Pty Ltd
Location	Tyree Energy Technologies Building UNSW.
Document Type	Arboriculture Assessment for Project Application
Date/Time	26 th November 2009

Client	UNSW c/o Capital Insight Pty Ltd
Location	Tyree Energy Technologies Building UNSW.
Document Type	Arboriculture Assessment for Development Application
Date/Time	26 th November 2009

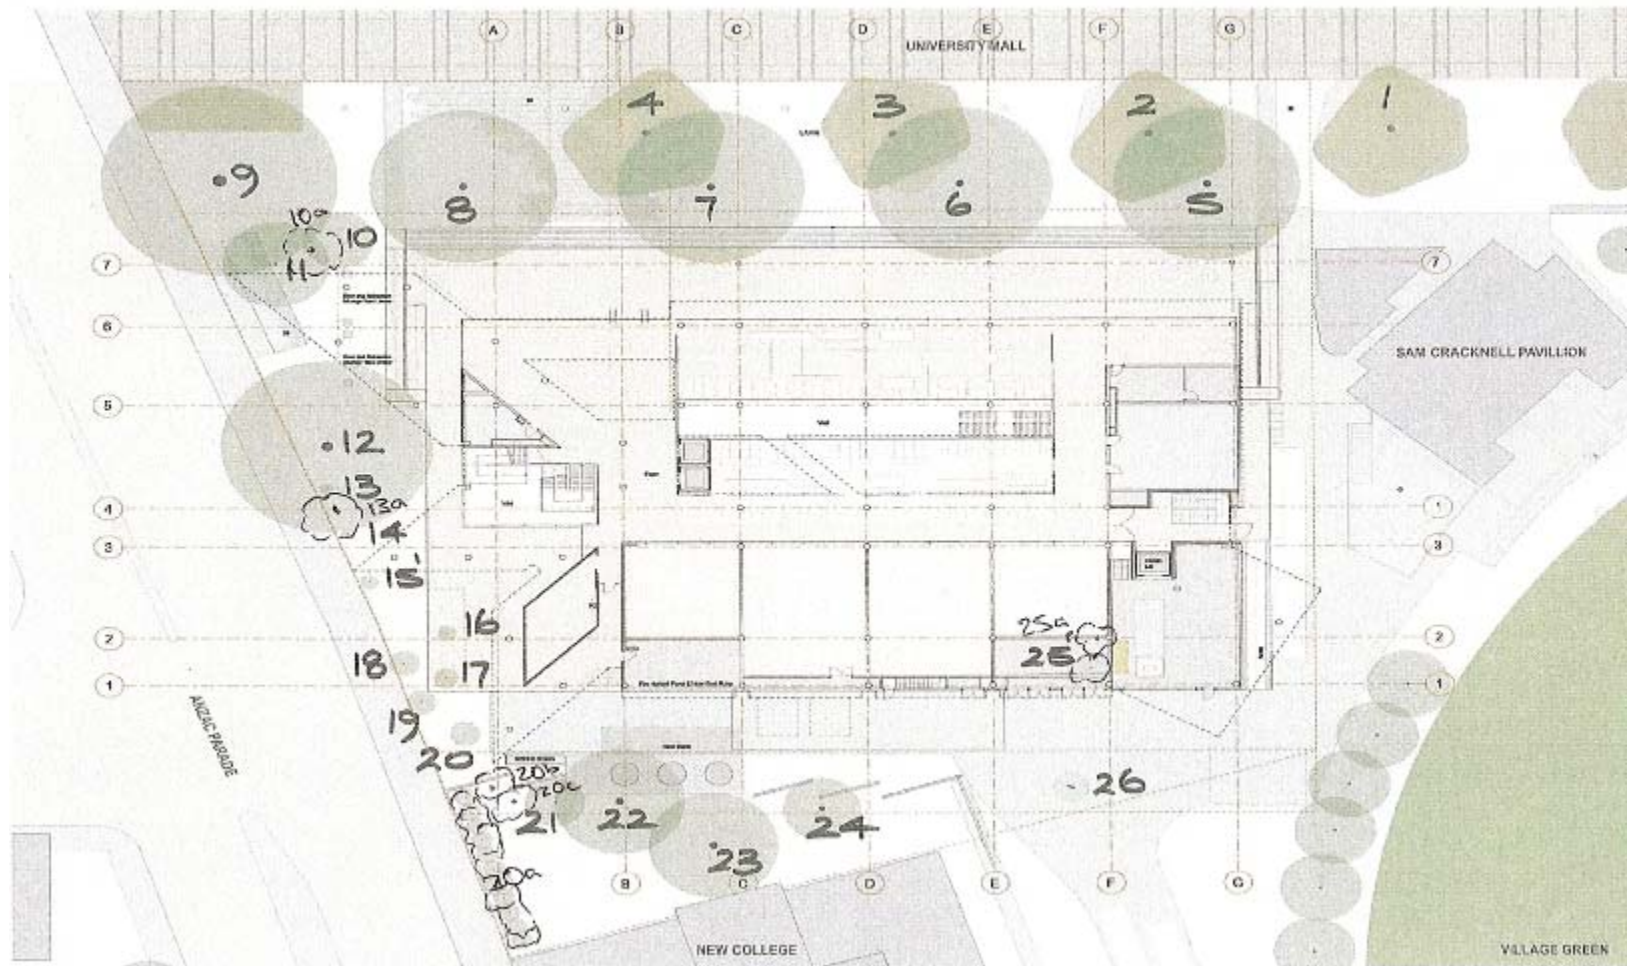
Appendix 5 Site Plan

Site Plan Provided by FJMT, Landscape plan with trees numbered.

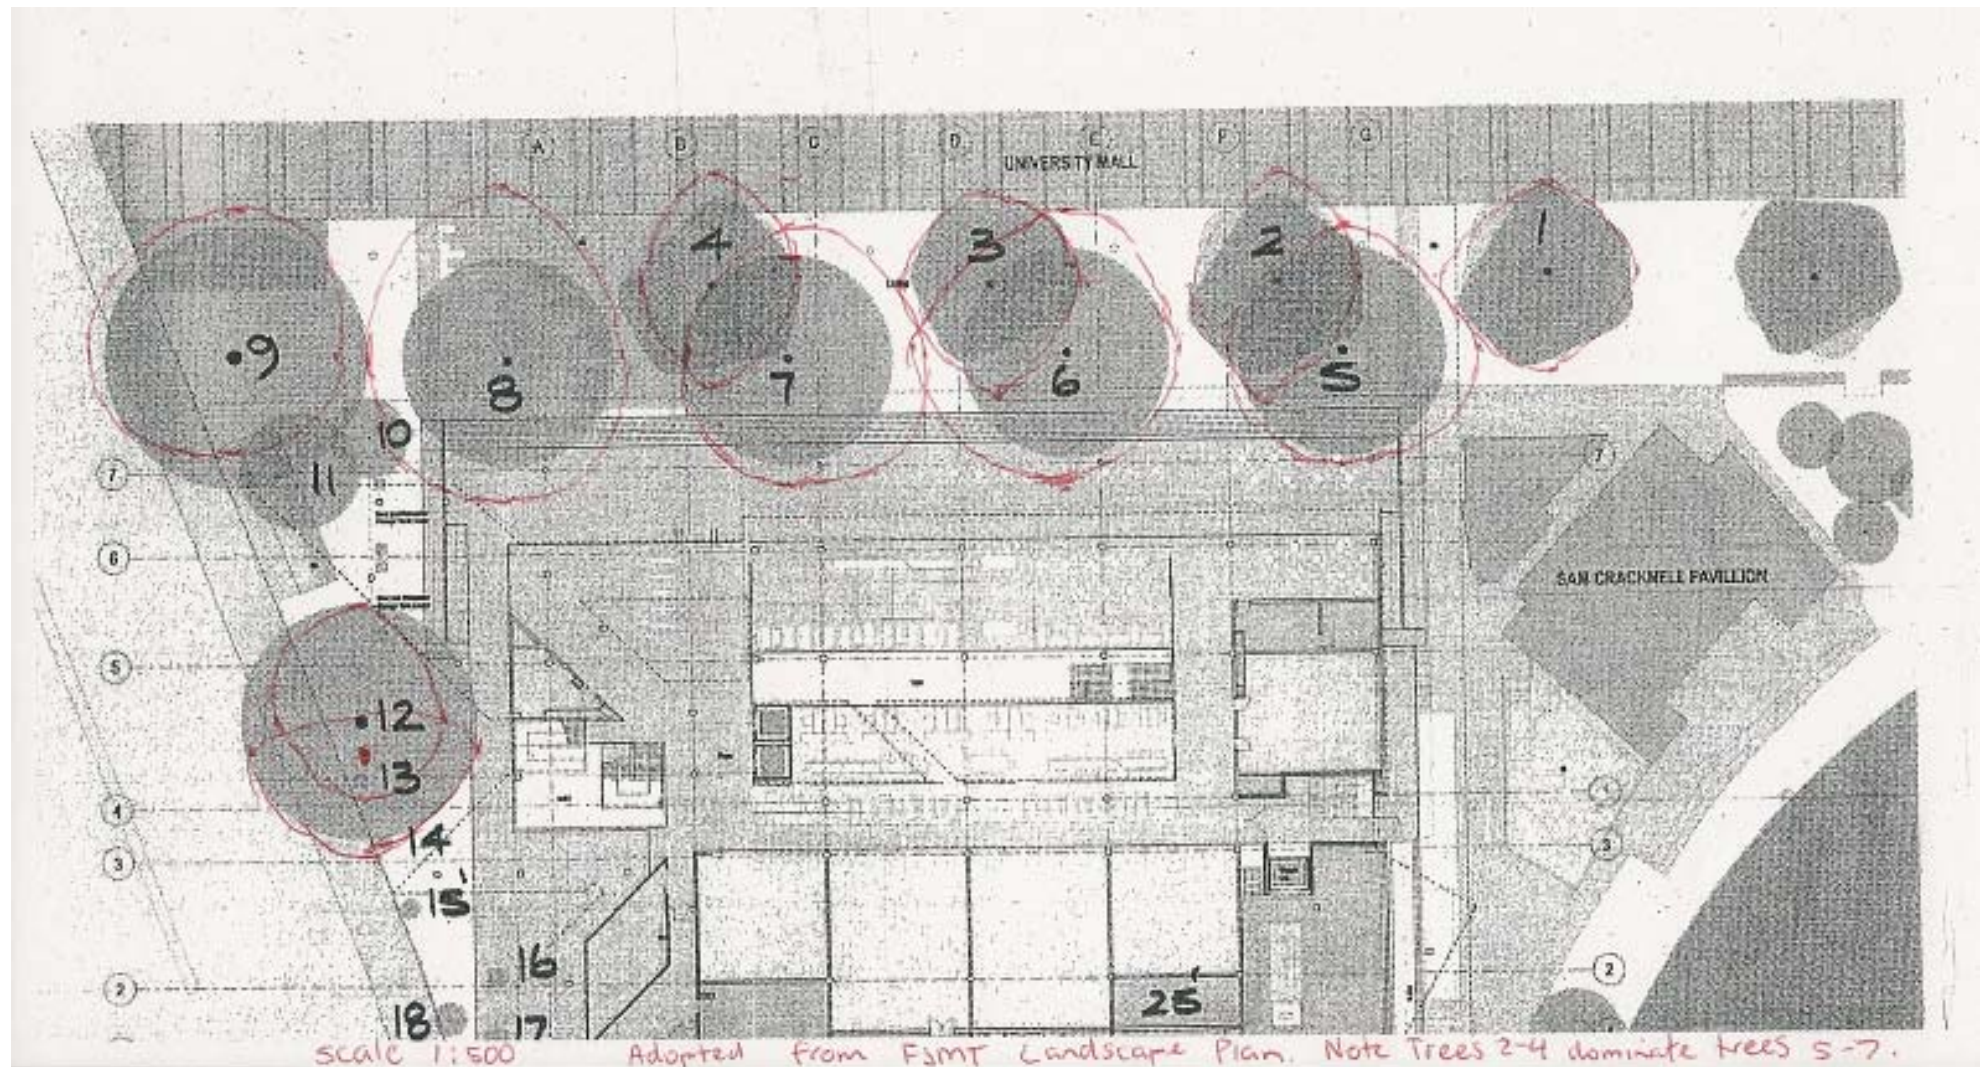
Appendix 6 Canopy Plan for nominated trees

Tree Numbers	Aspect and Distance to Canopy edge (M=Metres)	Aspects and Heights to canopy from ground level (M=Metres)	Comments
Tree1	North = 5.5m, East 5.5m South=7m, West= 8m	North = 7m, East 10m South=15m, West= 9m	No pruning anticipated for works.
Tree 2	North = 7.5m, East 5m South=7.5m, West= 5.5m	North = 7m, East 15m South=11m, West= 7-12m	No pruning anticipated for works.
Tree 3	North = 5.5m, East 9m South=7m, West= 5.5m	North = 10m, East 4-7m South=15m, West= 11m	No pruning anticipated for works.
Tree 4	North = 7m, East 4m South=5m, West= 4m	North = 7m, East 15m South=16m, West= 16m	No pruning anticipated for works.
Tree 5	North = 9m, East 10m South=7m, West= 7m	North = 3-5m, East 6m South=9-11m, West= 4m	This tree may require minor pruning works to allow for clearance from columns supporting the extended roof on the South side of the tree. Refer to 4.7.2.
Tree 6	North = 9m, East 7m South=8.5m, West= 9.5m	North = 4-7m, East 5m South=6.5m – 8.5m, West= 2-4m	This tree may require minor pruning works to allow for clearance from columns supporting the extended roof on the South side of the tree. Refer to 4.7.2. Low canopy to West of tree.
