RUSSELL VALE COLLIERY - MG6 CORRIMAL FAULT INSPECTION

Memo: MG6 Panel

WOLLONGONG COAL RUSSELL VALE COLLIERY

GEOLOGICAL REPORT ON THE CORRIMAL FAULT

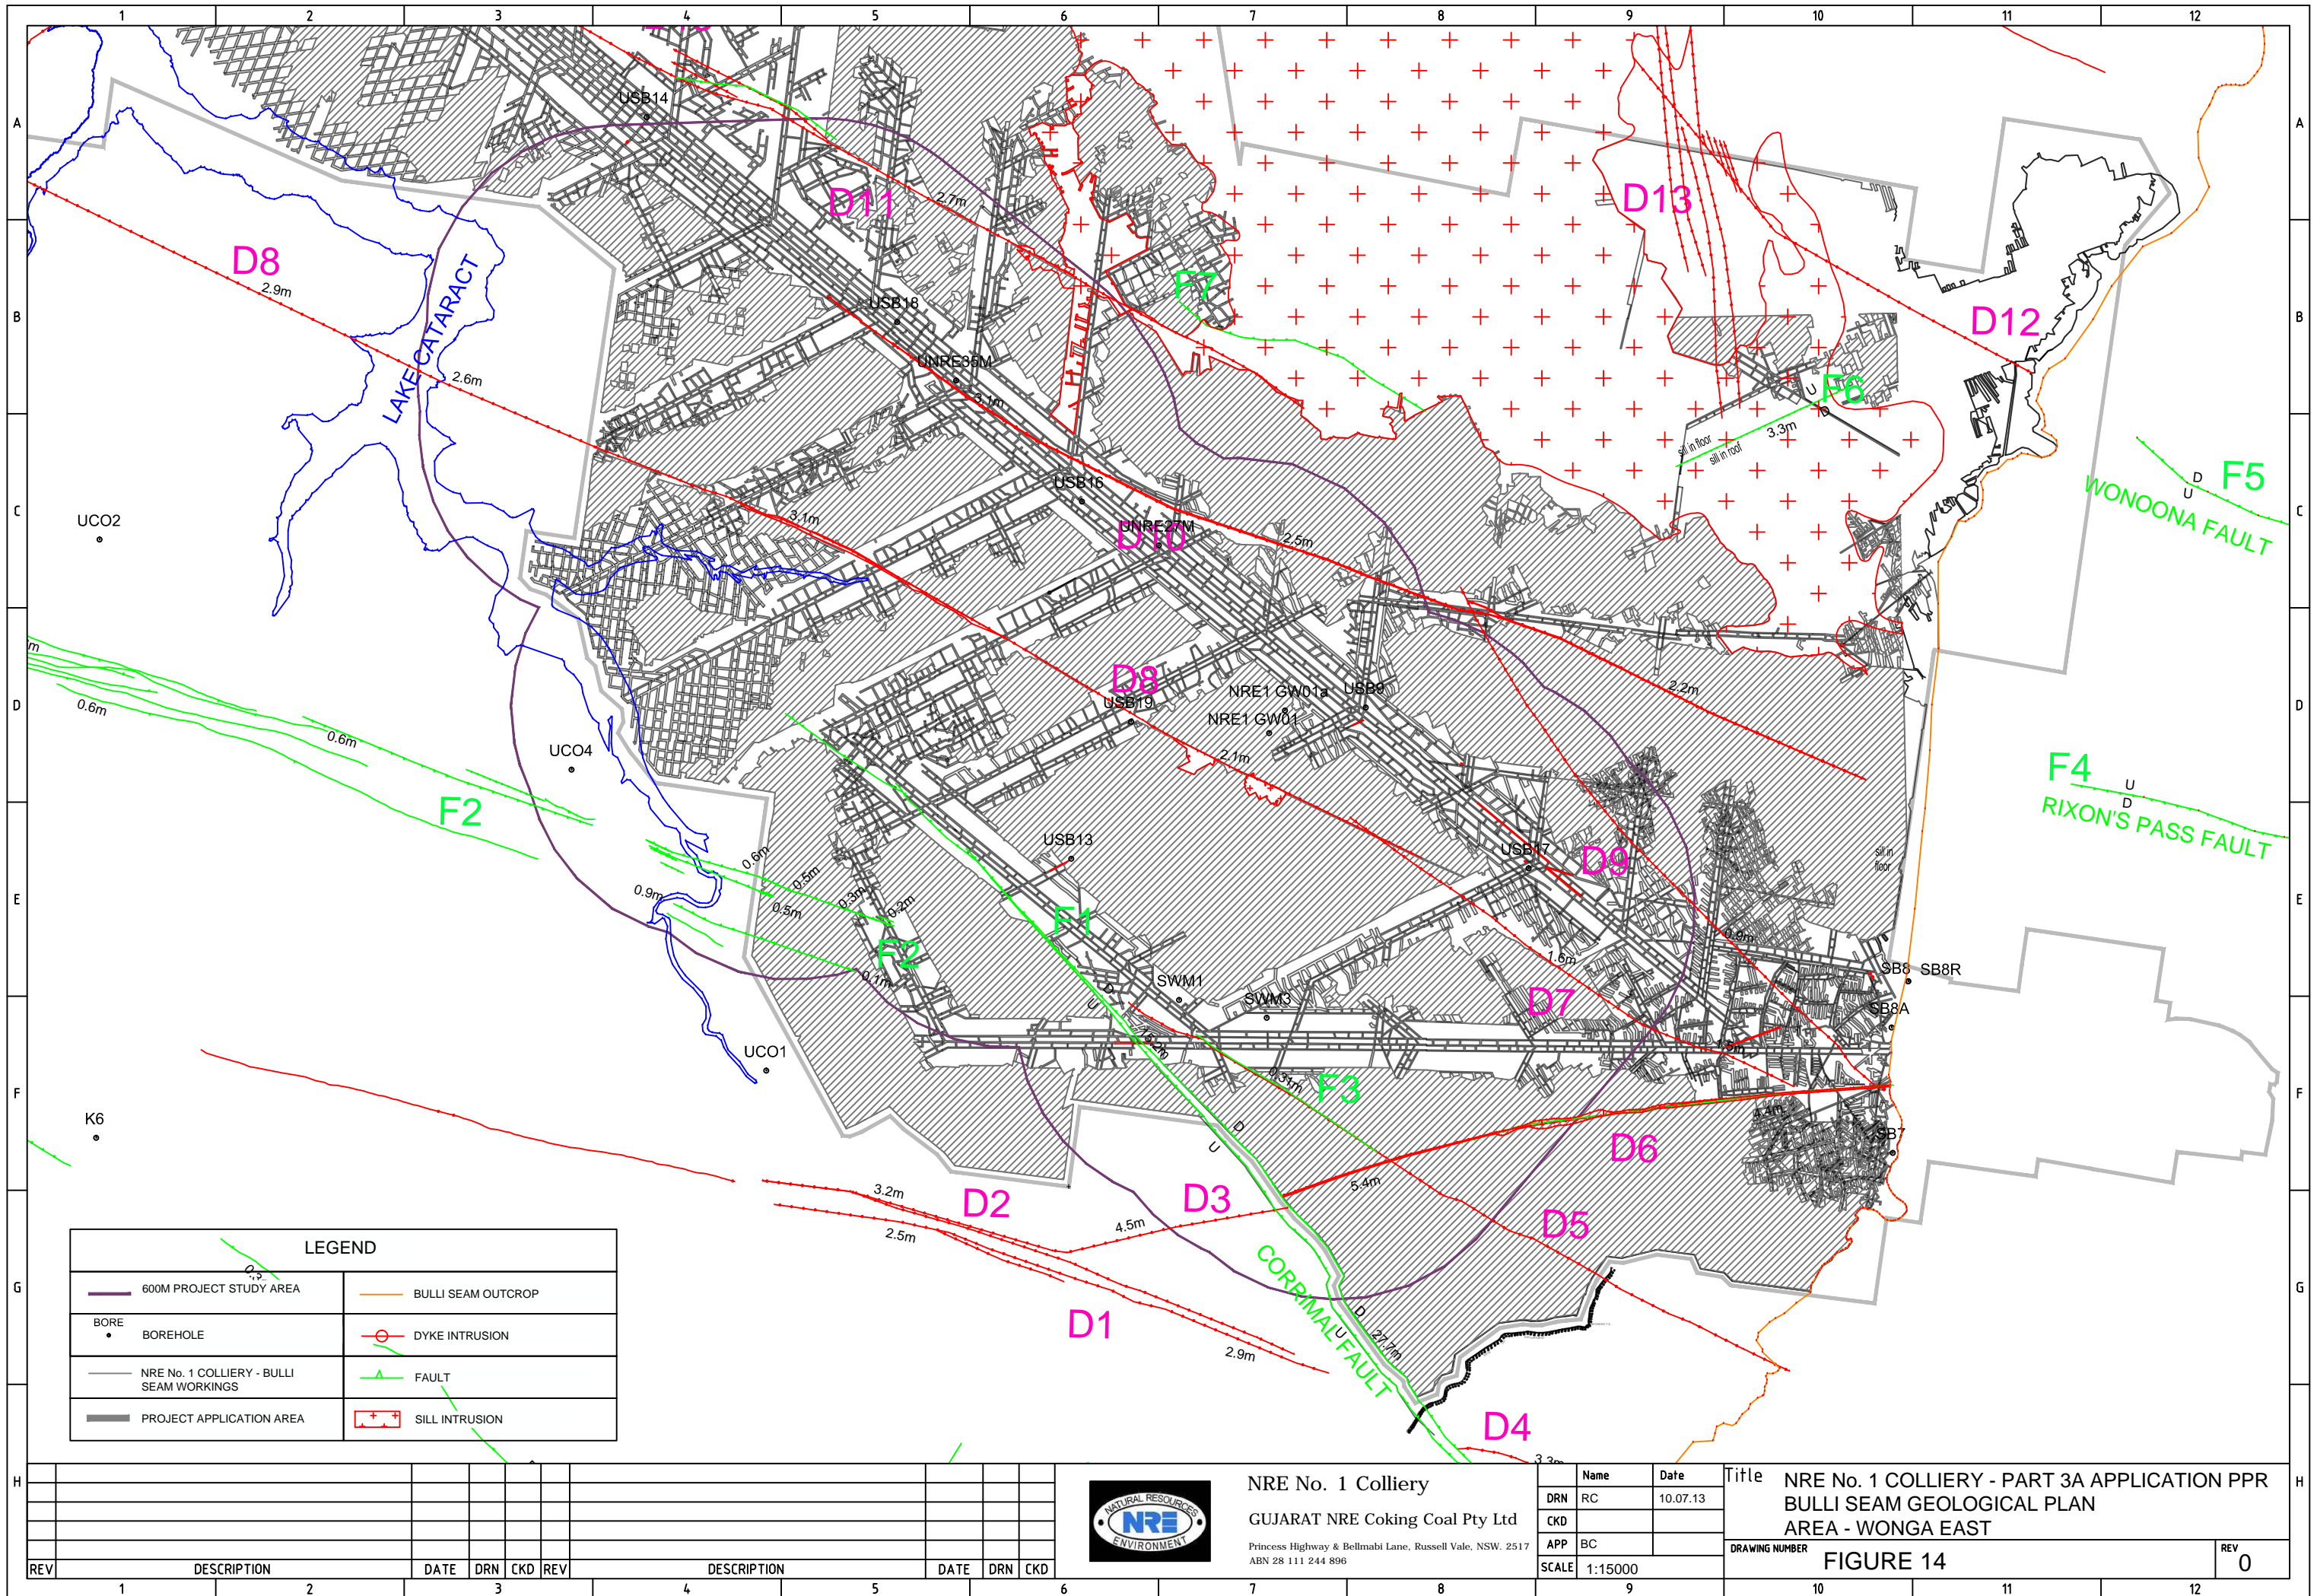
Figure 14 details the known structures in the Bulli Seam for the Wonga East Study Area. These structures have been derived from detailed examination of available mine plans. Each structure is annotated for easy reference and discussed in the following sections on faulting and igneous intrusions.

Fault F1, commonly known as the Corrimal Fault, occurs from outcrop and extends approximately 3000m to the northwest (bearing 320 degrees) before dying out. Maximum recorded displacement has been measured at 28.7m with a fault width of approximately 20m. There are no records or documentation indicating moisture ingress being associated with the fault.

Fault F2 is a fault zone, some 170m wide, prominent in Corrimal Colliery and extending approximately 400m into the workings of South Bulli Colliery before dying out. Maximum displacement within the zone is 0.9m with the majority of the faults 0.6m or less and with a range in displacements from 0.1m to 0.9m. Strike of the fault zone is 110 degrees.

Fault F3 is a short strike length feature (approximately 610m long) bearing 300 degrees and is associated with dyke D5. It has a recorded displacement of 0.31m downthrown to the north. It is probable the fault formed as a result of the forces occurring during the injection of the dyke due to its concurrence with the dyke and its short strike length.

Fault F4 is recognized as the Rixon's Pass Fault and is believed to have been intersected, possibly in the Tongarra Seam, in a clay quarry east of the escarpment (Illawarra Brick Company quarry). The fault is annotated as being downthrown to the south and bears 285 degrees. No record of displacement of the fault has been found. Detailed examination of the South Bulli mine plans indicate the fault does not project to the west into the workings. There is a possible correlation with a thin, soft dyke (dyke D10) within the South Bulli Colliery workings but there is no record of this dyke being associated with faulting.

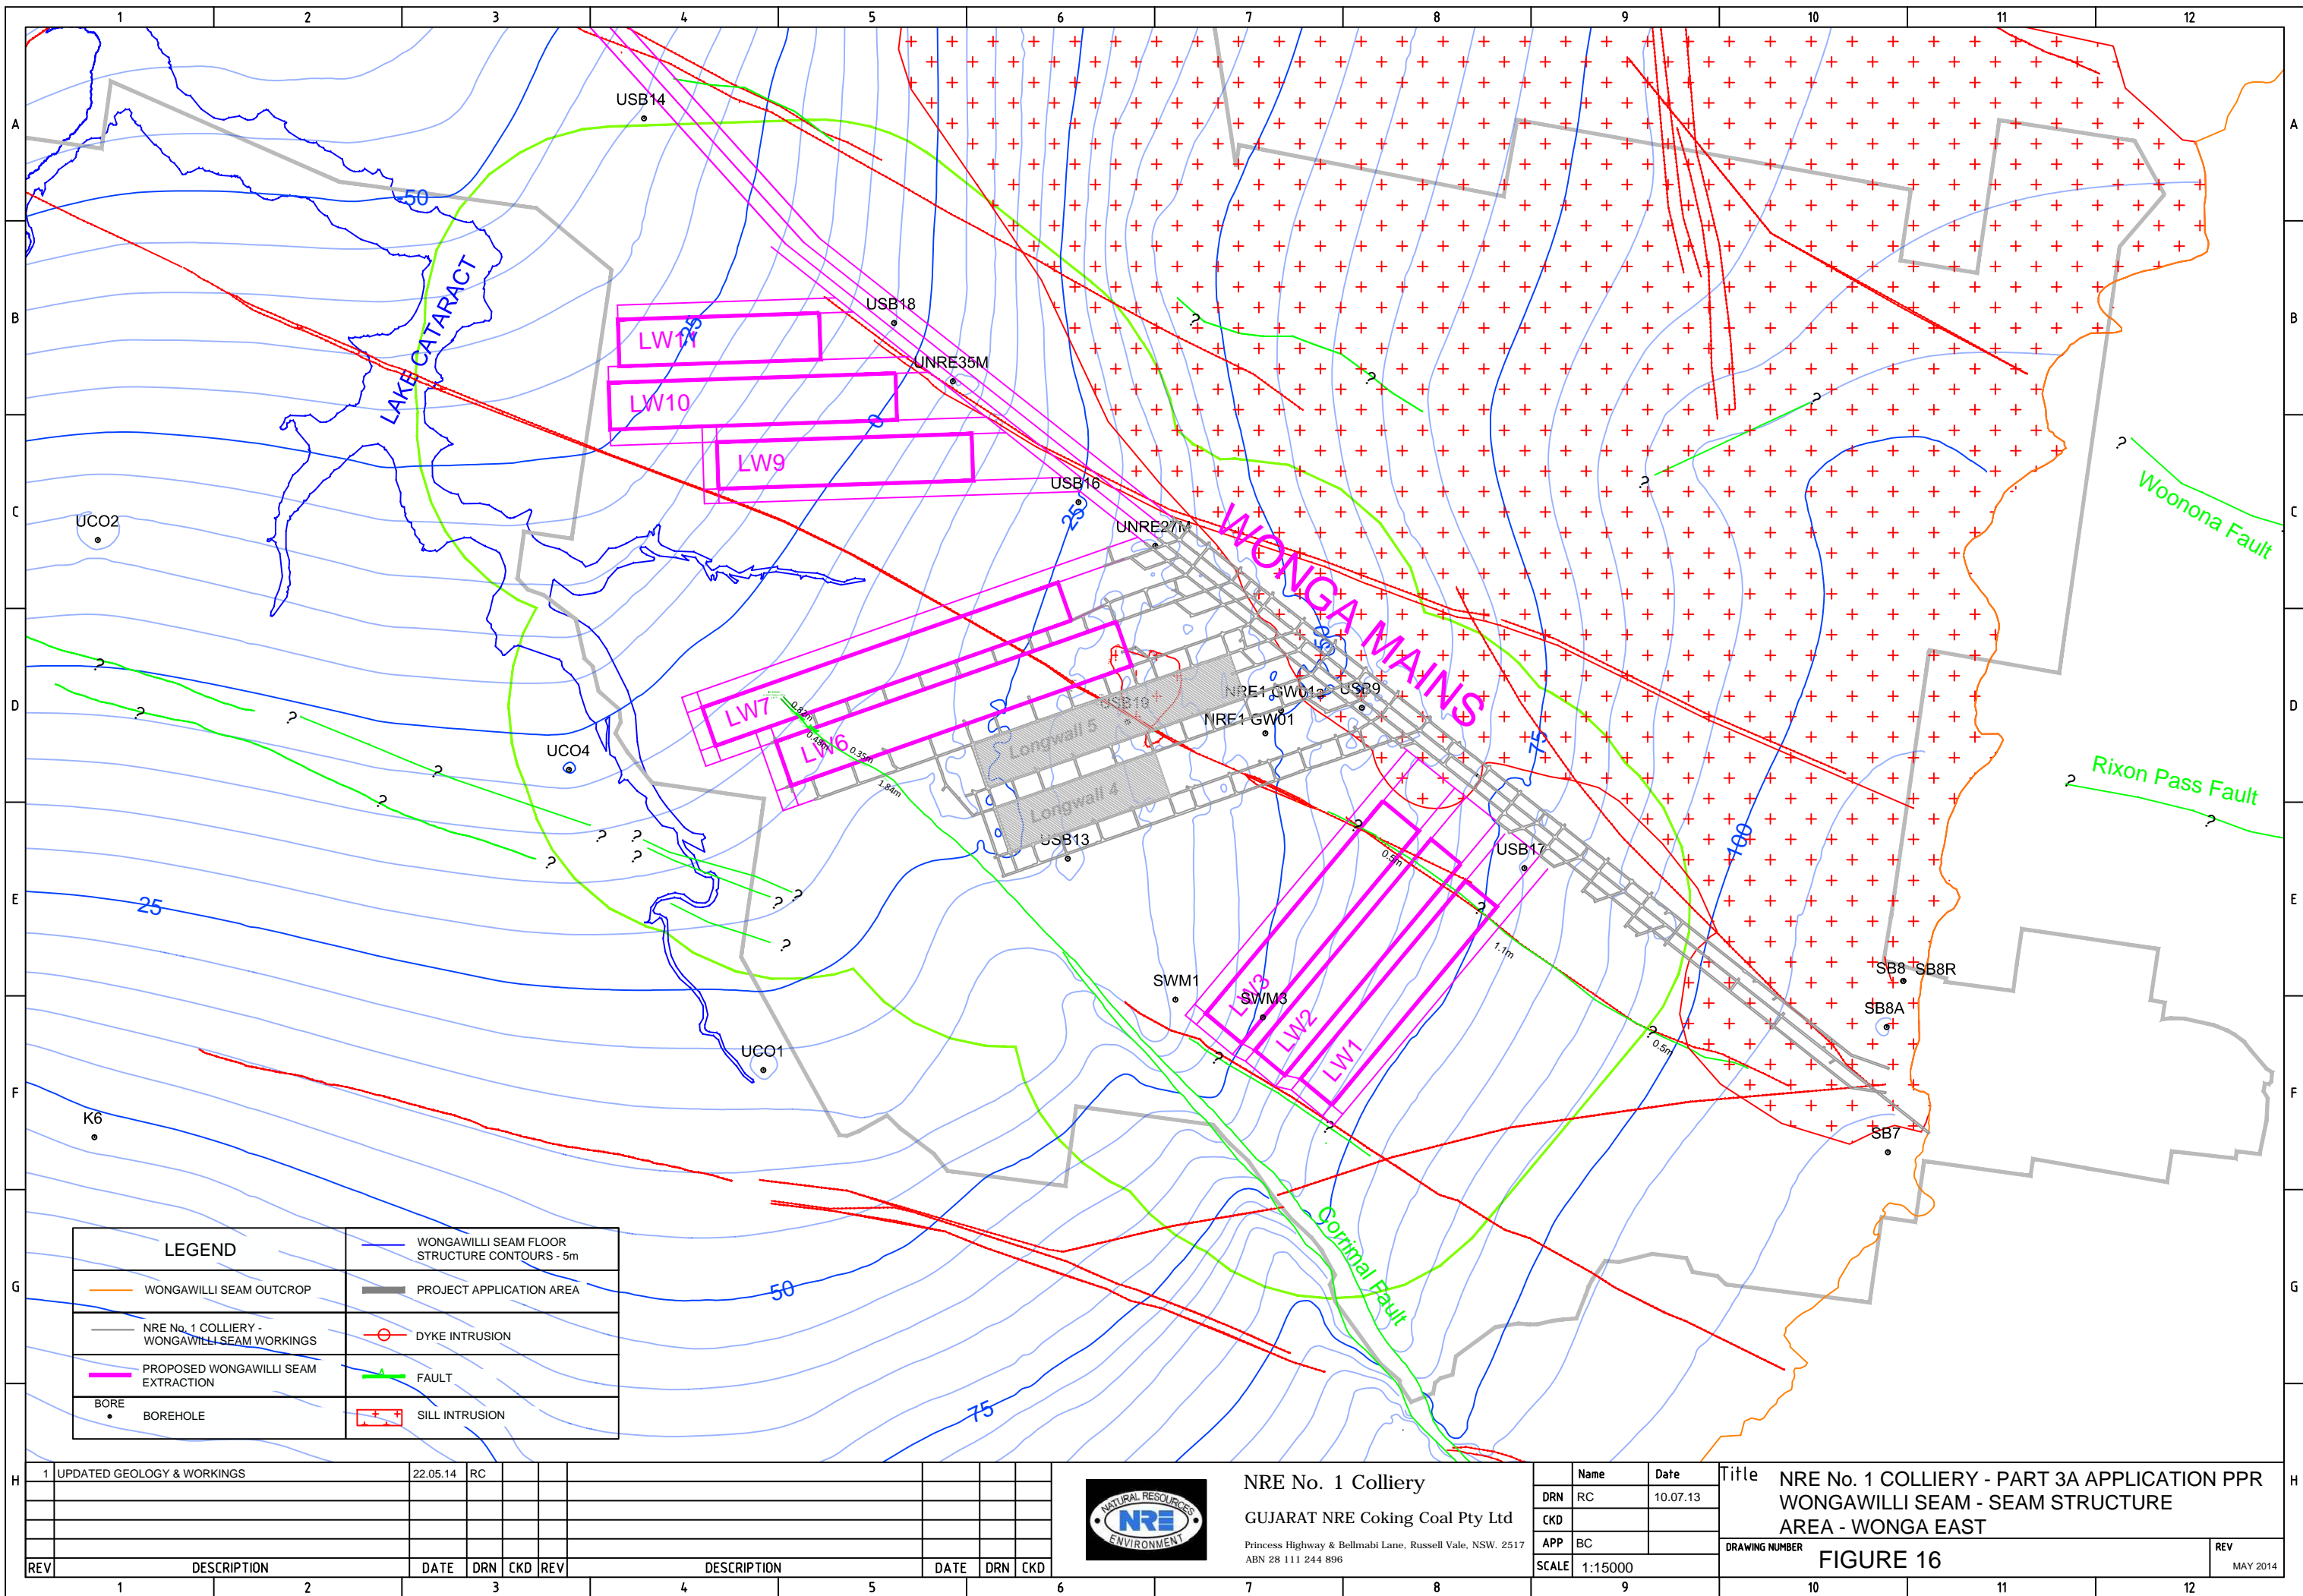
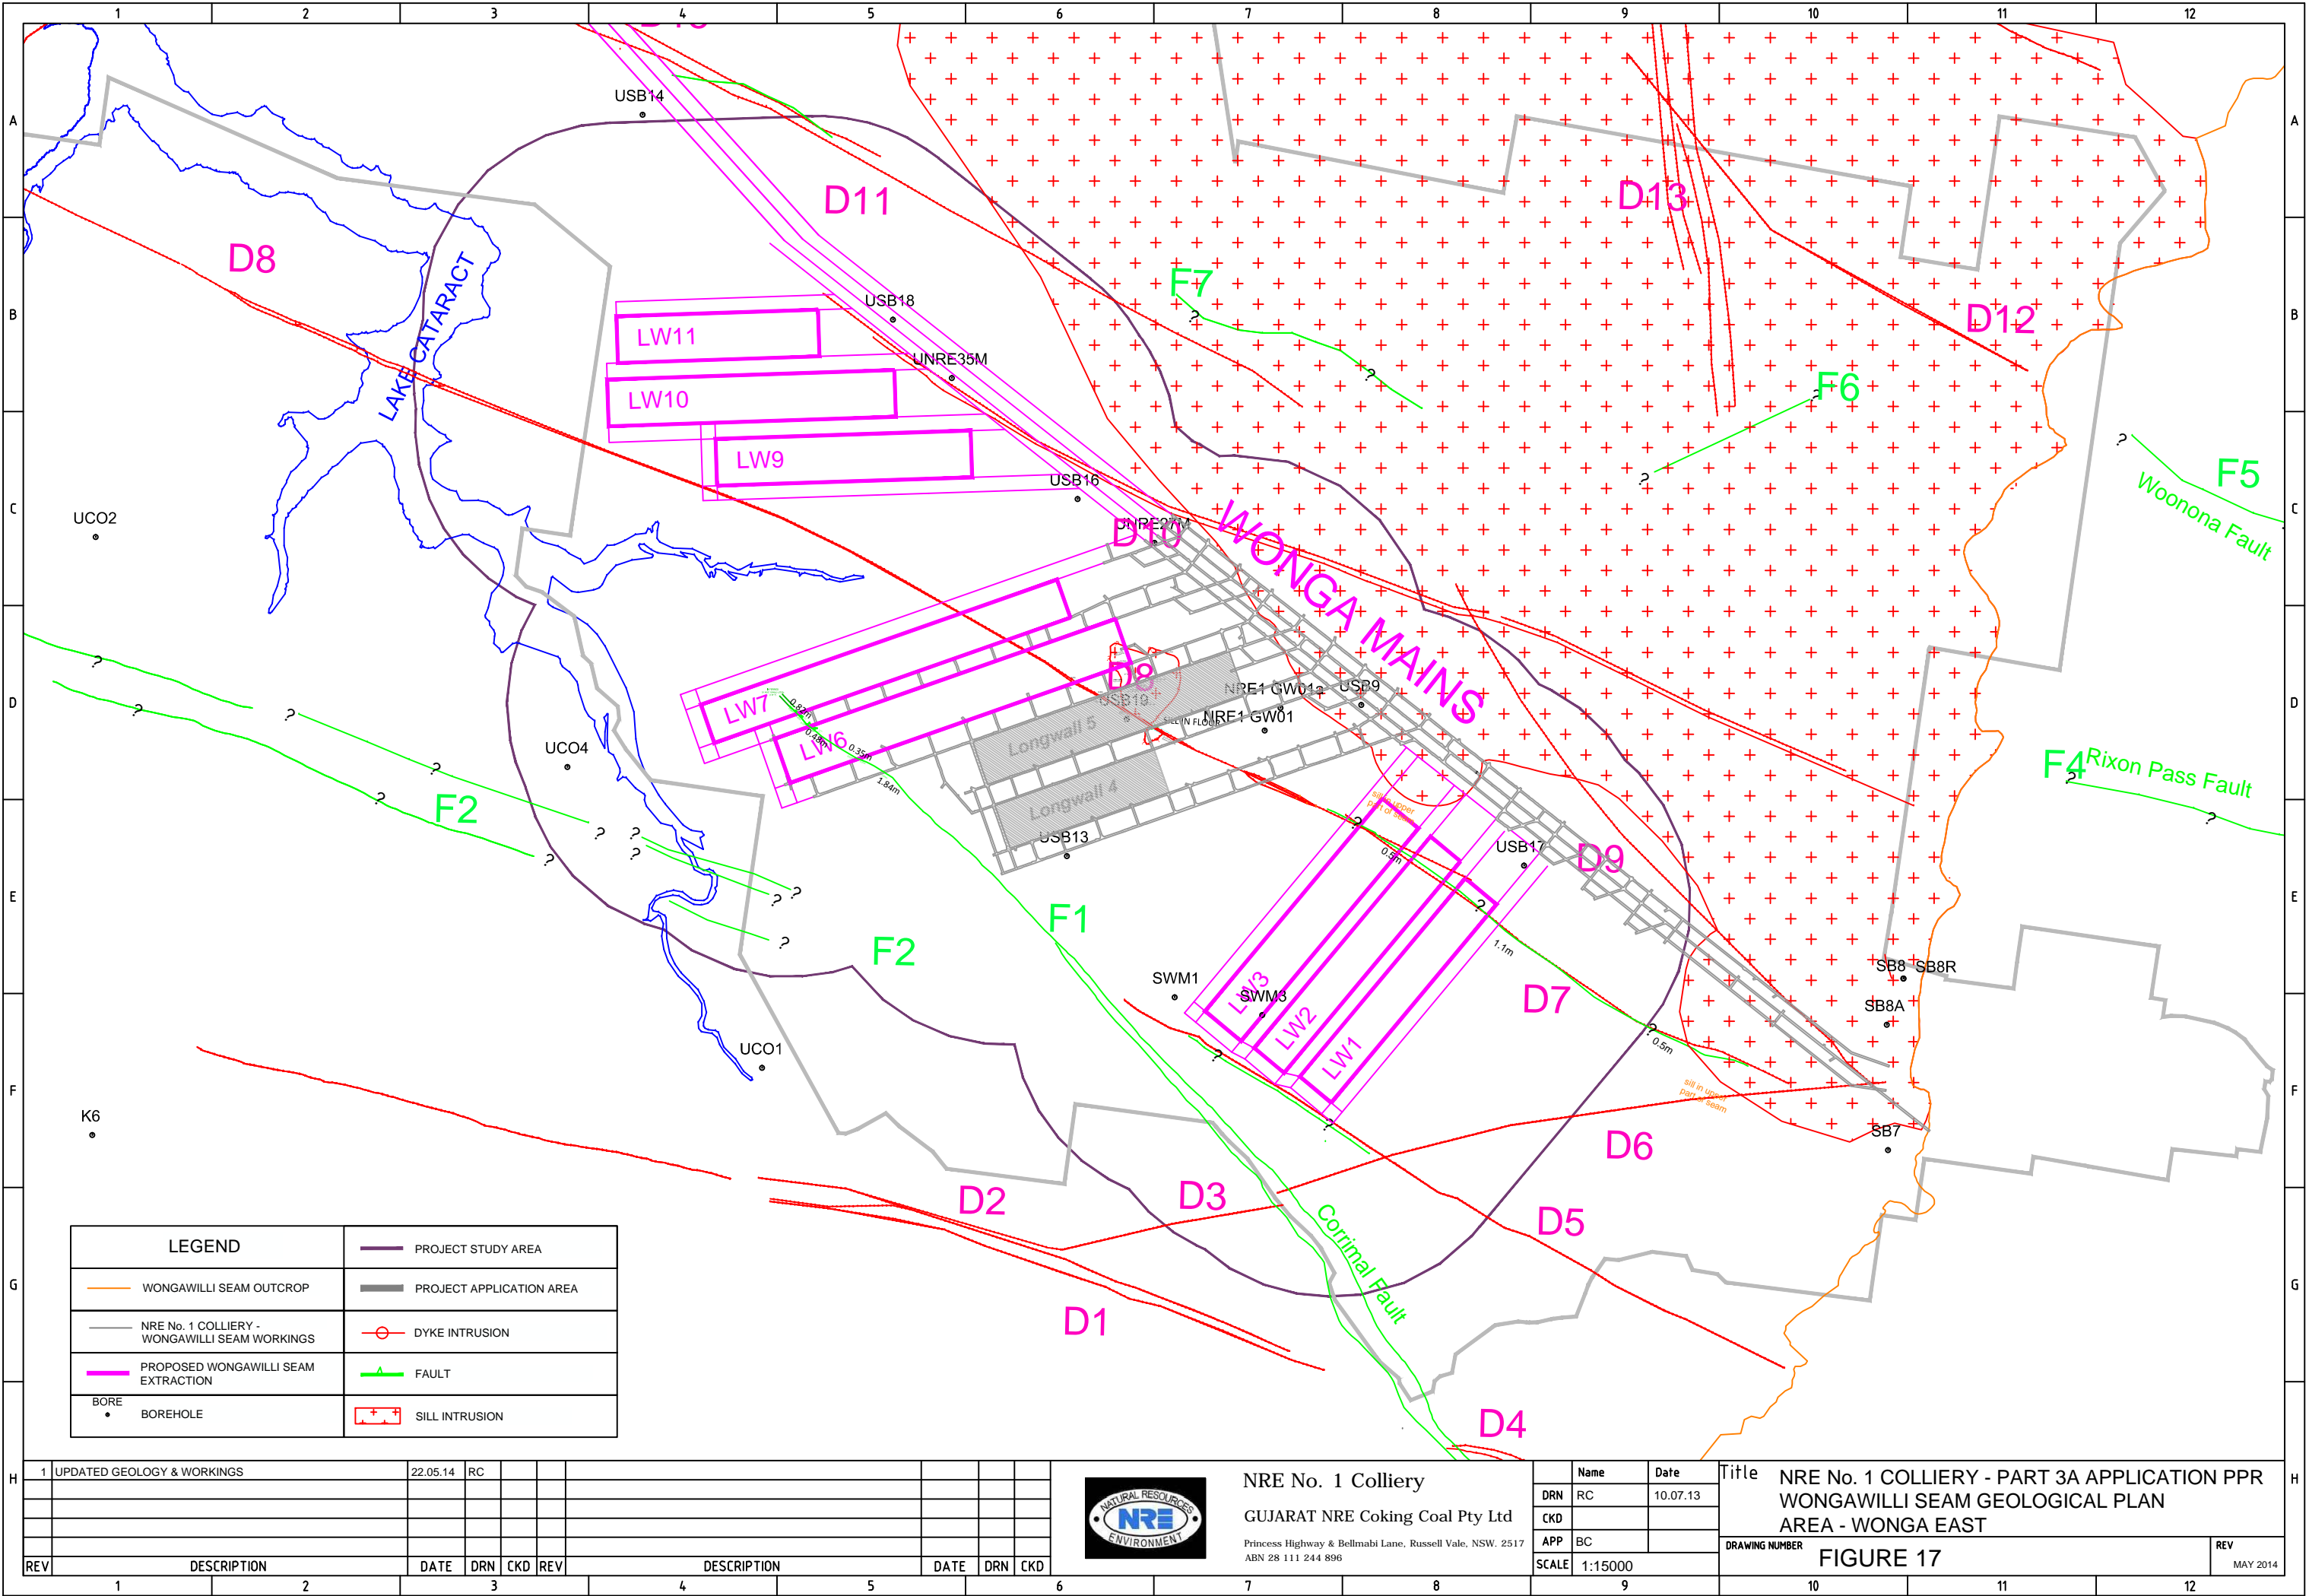
Within the mine workings of the Wongawilli Seam the Corrimal Fault (Fault F1 in the Bulli Seam) has been intersected. No other faulting of significance has been intersected. The Corrimal Fault was first intersected in Maingate 5 development and had displacement of 1.84m to 0.35m (displacement was reassessed in MG5 B heading from 1.50m displacement to 0.35m after mining had progressed past the fault intersection) across the two headings, decreasing in displacement along its projected strike to the northwest. Characteristics of the fault are similar to those known from the Bulli and Balgownie Seams, being a normal fault down thrown to the north. Where intersected the fault had a measured dip of 35 degrees. The fault plane is offset approximately 24m to the north from its position in the Bulli Seam.

Further mine development in Maingate 6 has also intersected the Corrimal Fault. First intersected in the A Heading the fault has developed into a structural zone consisting of a set of three faults. The first fault is upthrown 0.93m followed by a downthrown fault of 0.55m and then another downthrown fault of 0.48m which decreases to 0.33m across the mined heading. This third fault is on the actual projection of the Corrimal Fault from Maingate 5. Also intersected in the B Heading the structural zone has the first fault downthrown 0.17m with the second fault downthrown 0.23m and the third fault plane downthrown 0.82m in the A heading and increasing to 0.98m across to the B heading.

The Corrimal Fault has become erratic in nature and is displaying typical characteristics of terminating as it fragments into a series of small non-correlated faults of inconsistent displacement and sense of dip.

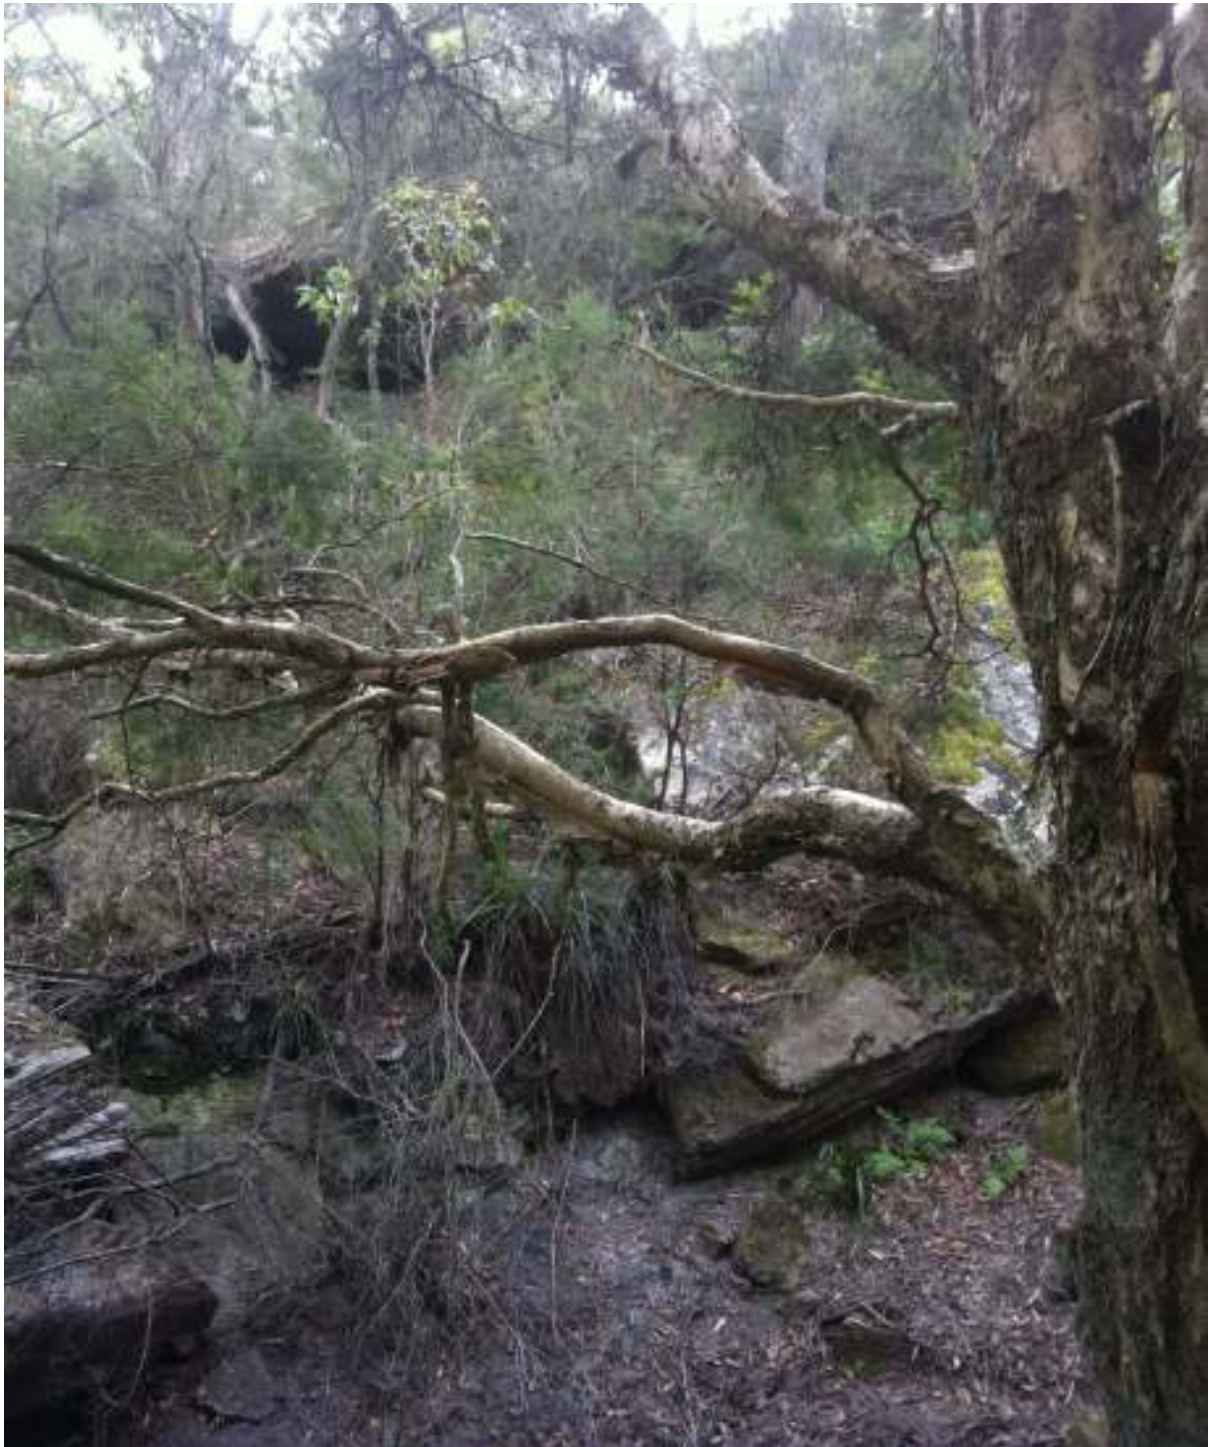
No surface expression of the Corrimal Fault has been found during the ground profiling traverses. Dominant over the plateaux and ridges on both sides of the Cataract Reservoir is the Hawkesbury Sandstone forming prominent cliff lines in most areas inspected. Prominent jointing within the Hawkesbury Sandstone is generally striking 055⁰ to the northeast / southwest with a less prominent conjugate set at 155⁰ to the southeast / northwest. These joint directions tend to control many of the prominent topographic features particularly the cliff lines within the Hawkesbury Sandstone which are commonly formed by block failure along the prominent 055⁰ joint direction as shown in Figure 2. The Corrimal Fault projects at approximately 125⁰ to the southeast / northwest. Minor jointing with a similar strike was measured within the proximity of the projected strike of the fault on the western edge of the Cataract Reservoir but no evidence of movement along this jointing was found.

Figure2 Prominent 055 jointing and cliff formation of the Hawkesbury Sandstone
